# Shoreline Inventory and Assessment of City of Hamilton Owned Assets

City of Hamilton

Final Report

Document No. 663821-1000-4PER-0001\_R0.docx

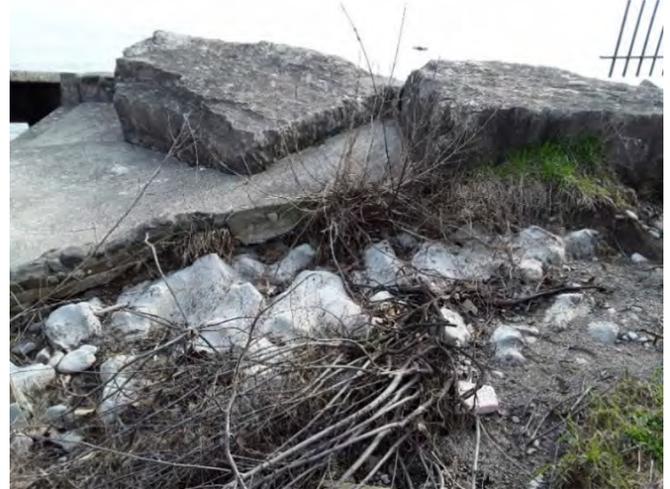
Figure 1-2 Existing Damage at the backside of the crest and geotextile exposure

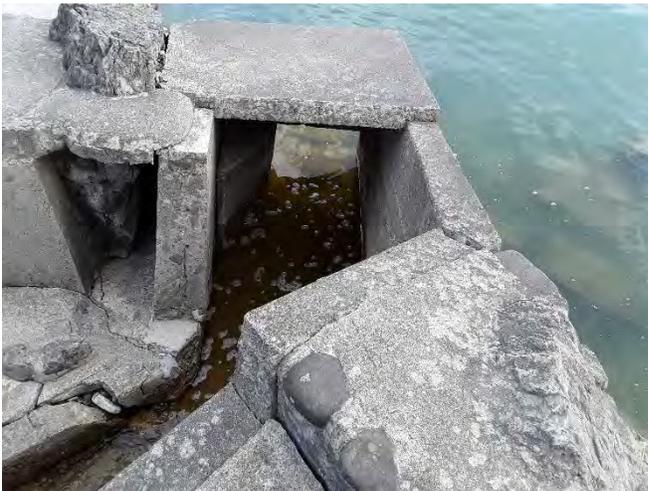
Figure 1-3 Outfall Channel

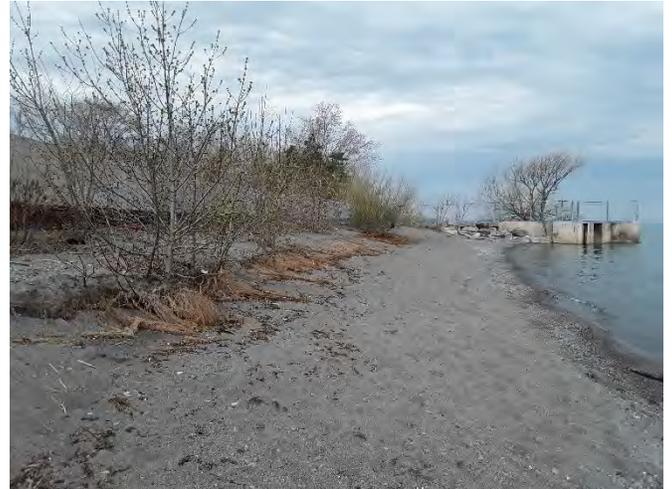
Figure 3-6 Overview wall with outfall

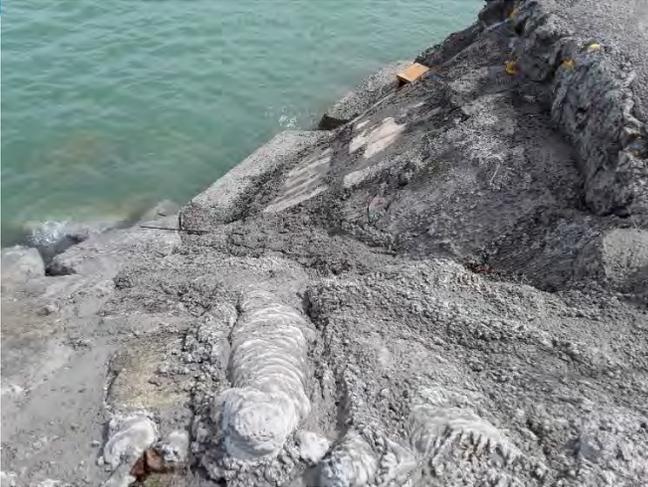
**Figure 9-5 Concrete poured over rock at east end, adjacent to property shoreline**

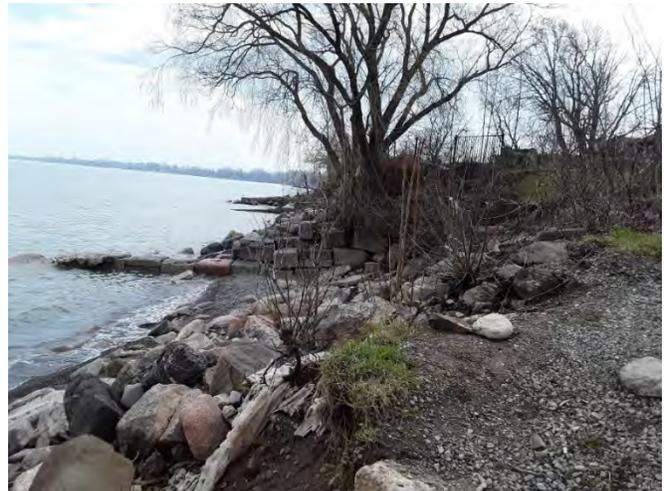
Figure 10-4 Crest erosion and deteriorated geotextile

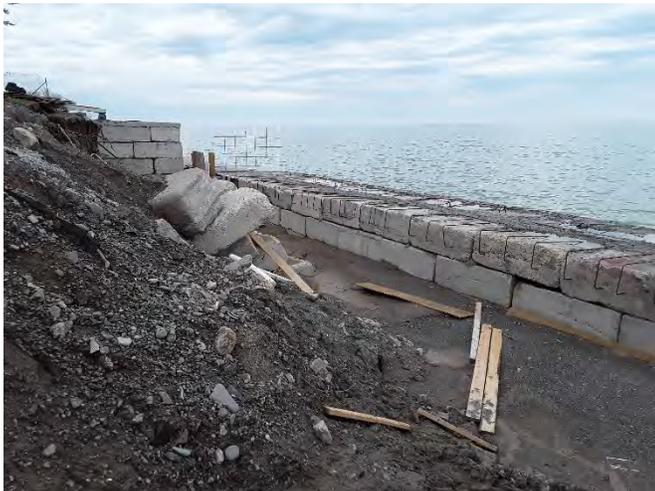
Figure 12-3 Site 12 Seabreeze Cr. adjacent protection under construction

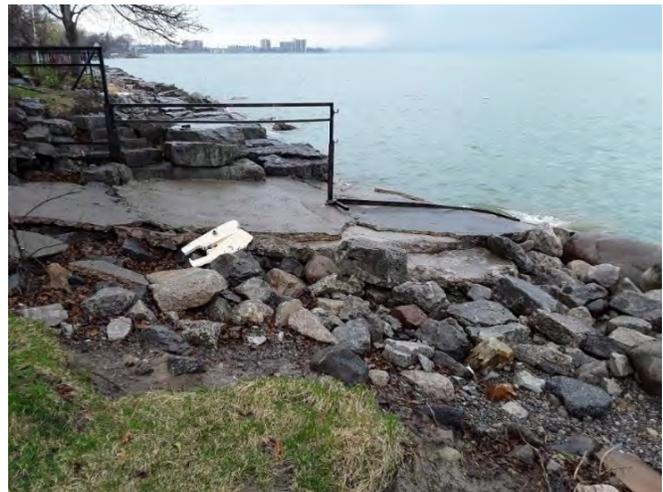
Figure 16-2 Damaged Concrete Ramp

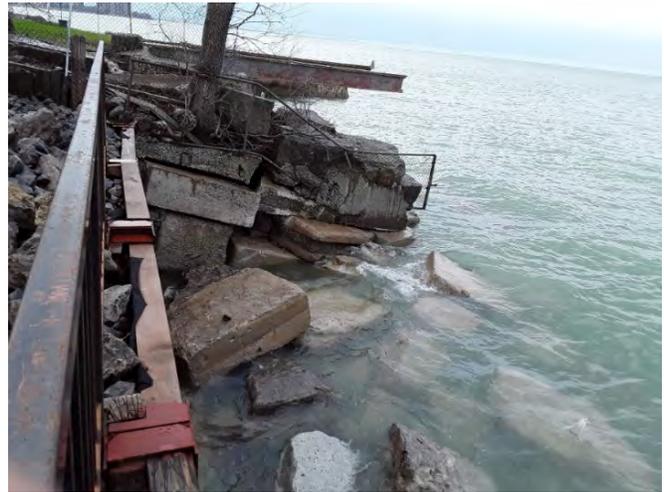
**Figure 17-2 Presence of Geotextile and West Adjacent Property protection in poor condition**

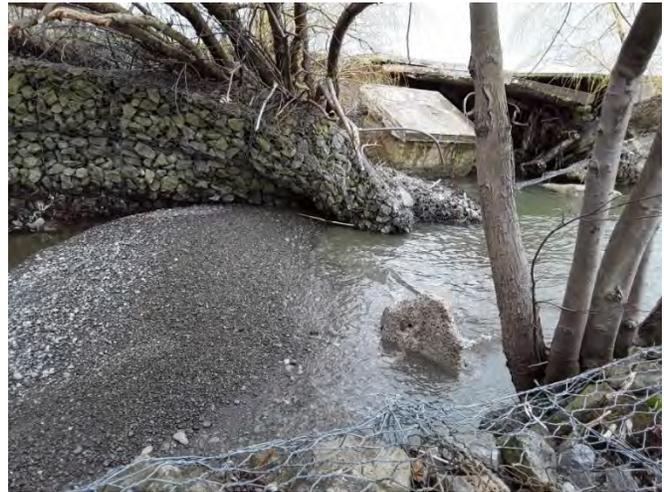
**Figure 18-2 Damaged Gabion and West Adjacent Property Shoreline**

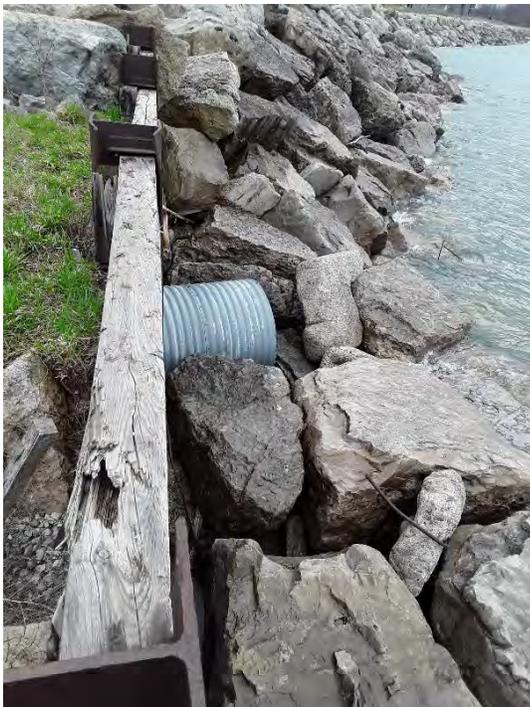
**Figure 22-3 Damaged Timber Lagging**

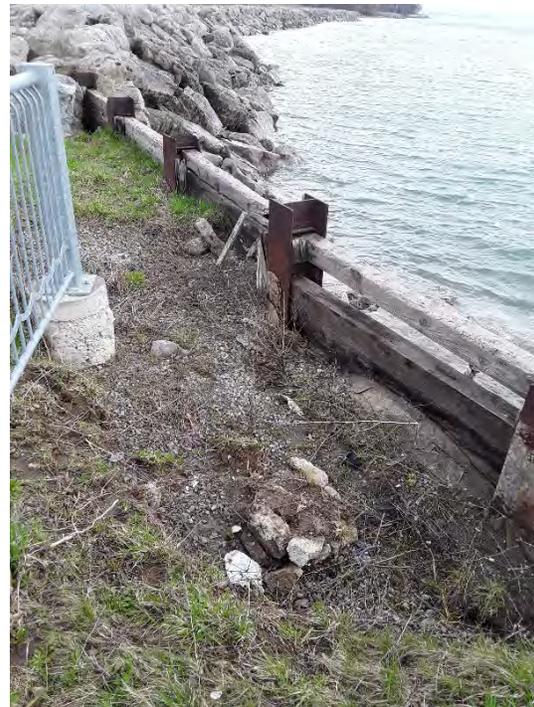
**Figure 22-4 Erosion at the east end of site**

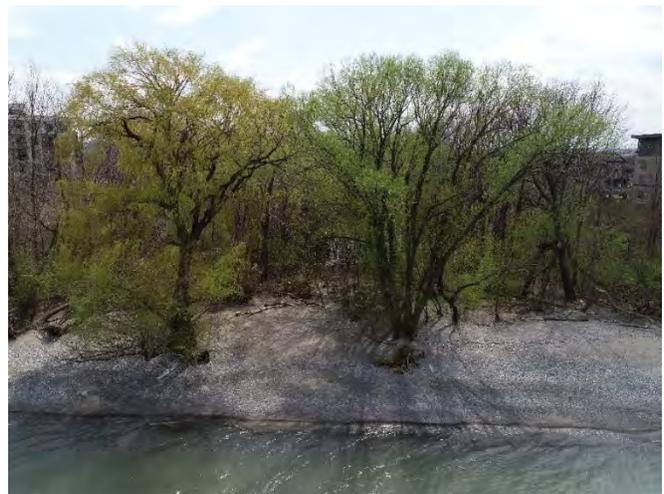
Figure 22-8 Site 22B Woodlot unprotected shoreline

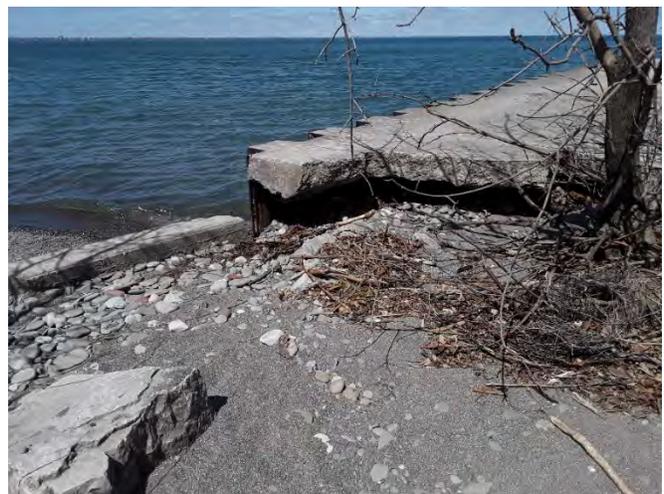
Figure 27-10 Site 27 Deterioration of structure

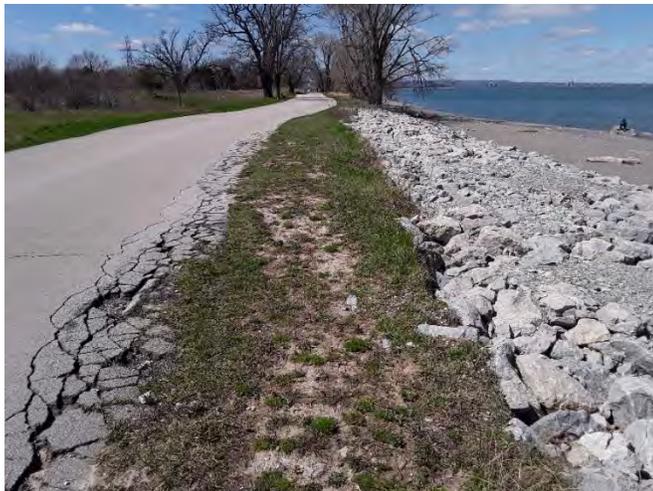
Figure 27-11 Site 27 Asphalt pathway erosion
