Fluvial Geomorphology

Fluvial Geomorphology Study Fruitland-Winona Block 1 Servicing Strategy City of Hamilton, Ontario

March 8, 2024
PN21043

Report Title: Fluvial Geomorphology Study - Fruitland-Winona Block 1
Servicing Strategy

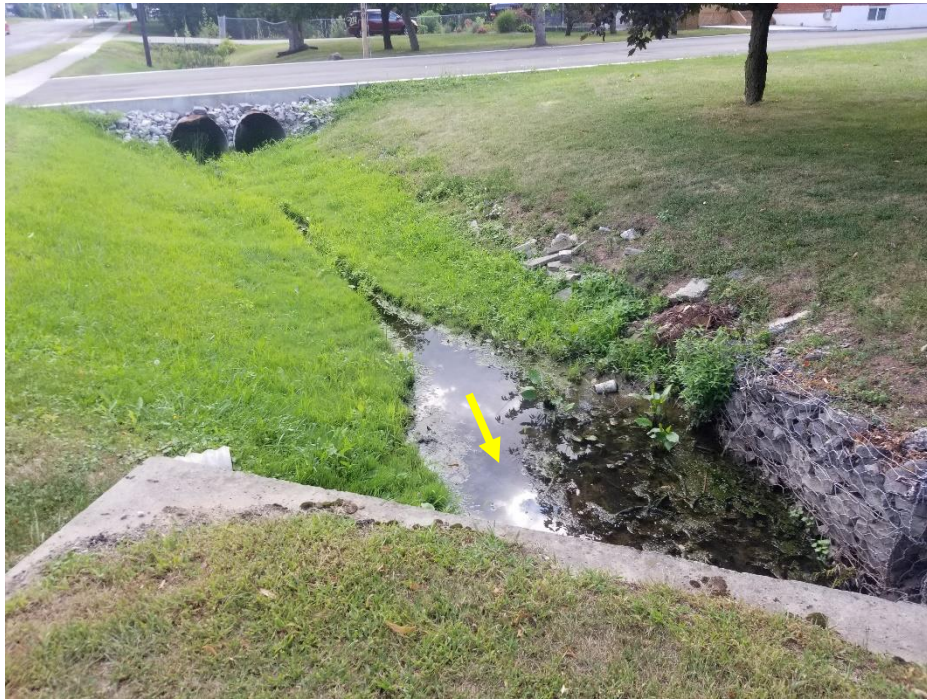
Photo 1
Reach **WC5**

Flows enter reach **WC5** through a concrete box culvert passing under Fruitland Road. No erosion concerns were noted. Yellow arrow denotes flow direction.

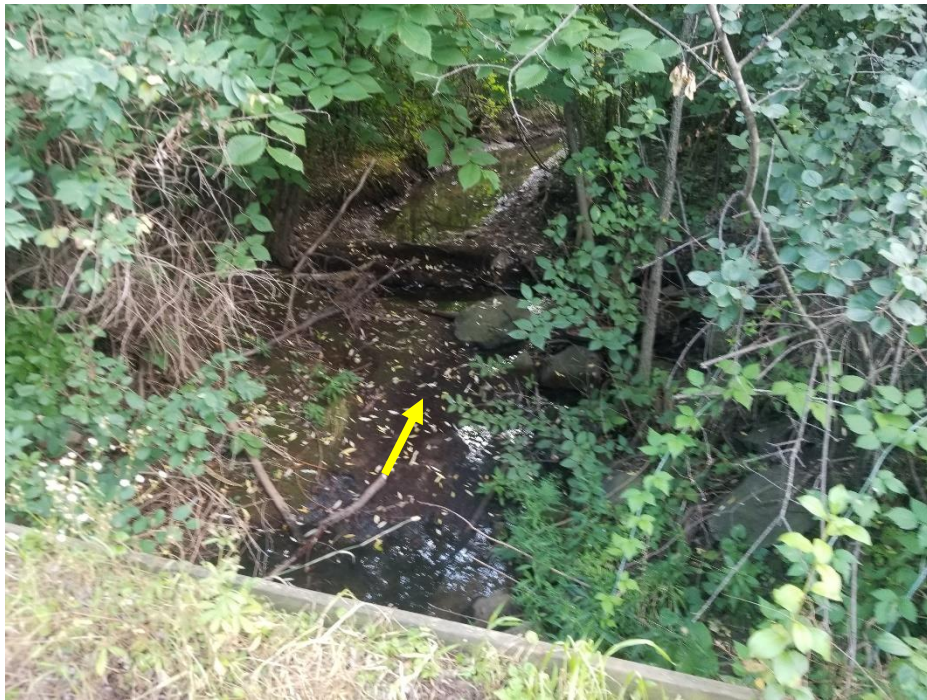
Photo 2
Reach **WC5**

No bed scour was noted downstream of the Fruitland Road culvert.

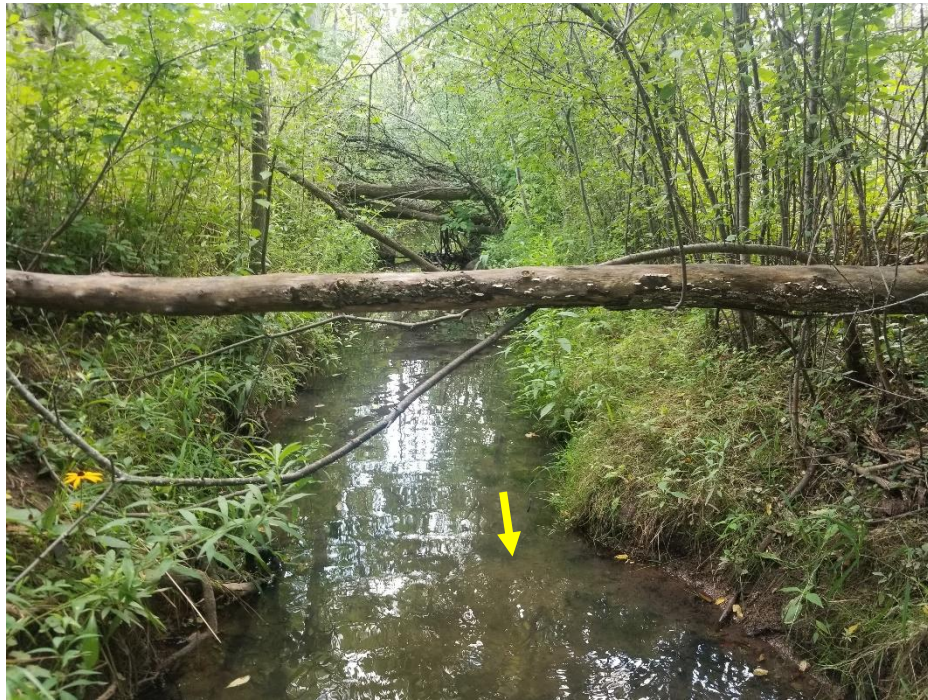
Photo 3
Reach **WC5**

Reach **WC5** has a predominantly trapezoidal channel shape throughout the study area. Minimal flow velocities were observed during the assessment.

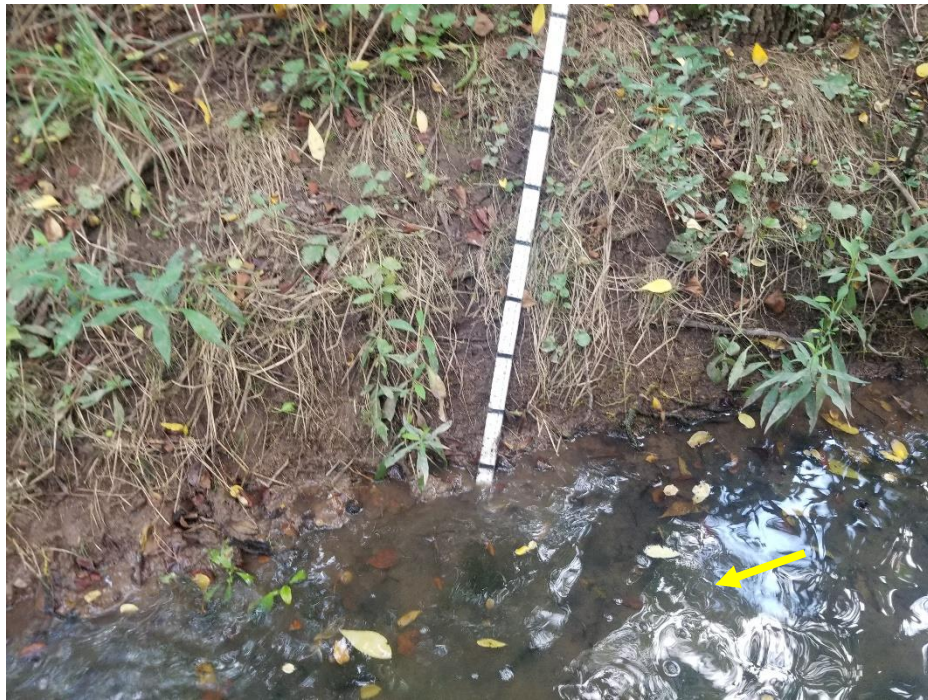
Photo 4
Reach **WC5**

Bank materials across the entire reach are characterized by silty clay. Occasional tree roots were observed, but the bottom third of the bank is typically exposed.

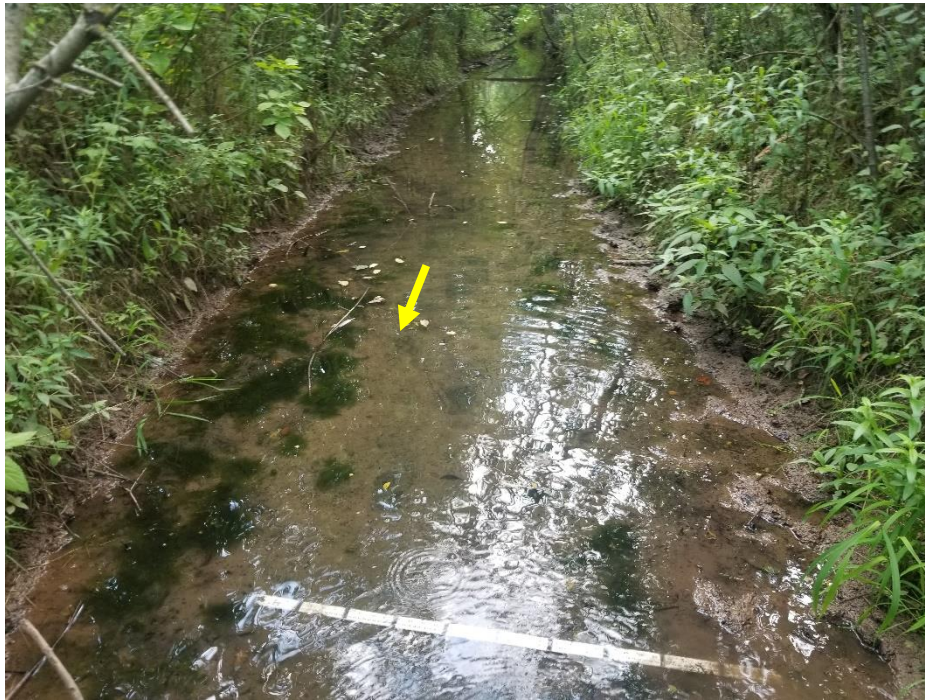
Photo 5
Reach **WC5**

Bed materials are consistent with the bank materials but are much less compact. Algae is abundant throughout the reach.

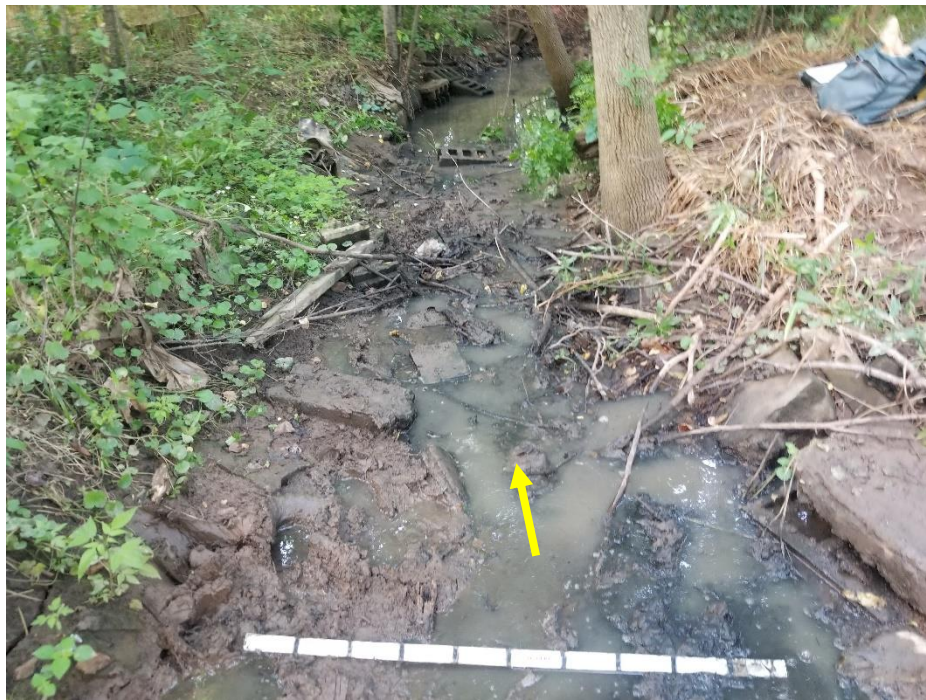
Photo 7
Reach **WC5**

Several sections of shallow flow, abundant debris, and loose bed material are present. Debris is largely associated with past agricultural infrastructure.

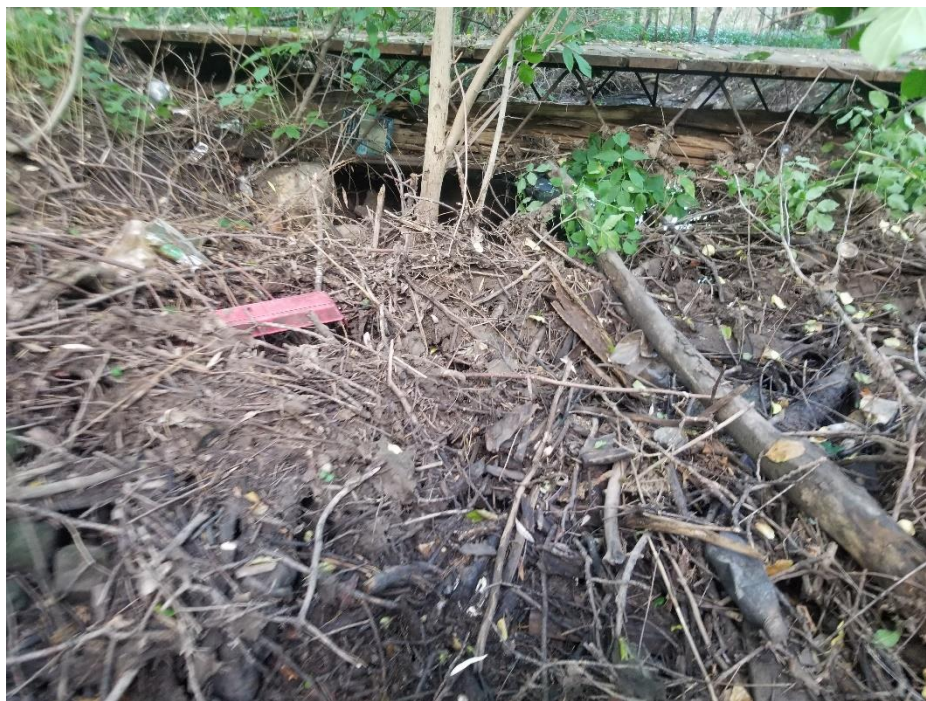
Photo 8
Reach **WC5**

A small footbridge is present in **WC5**. A thick debris jam exists immediately upstream and retains a level of flow.

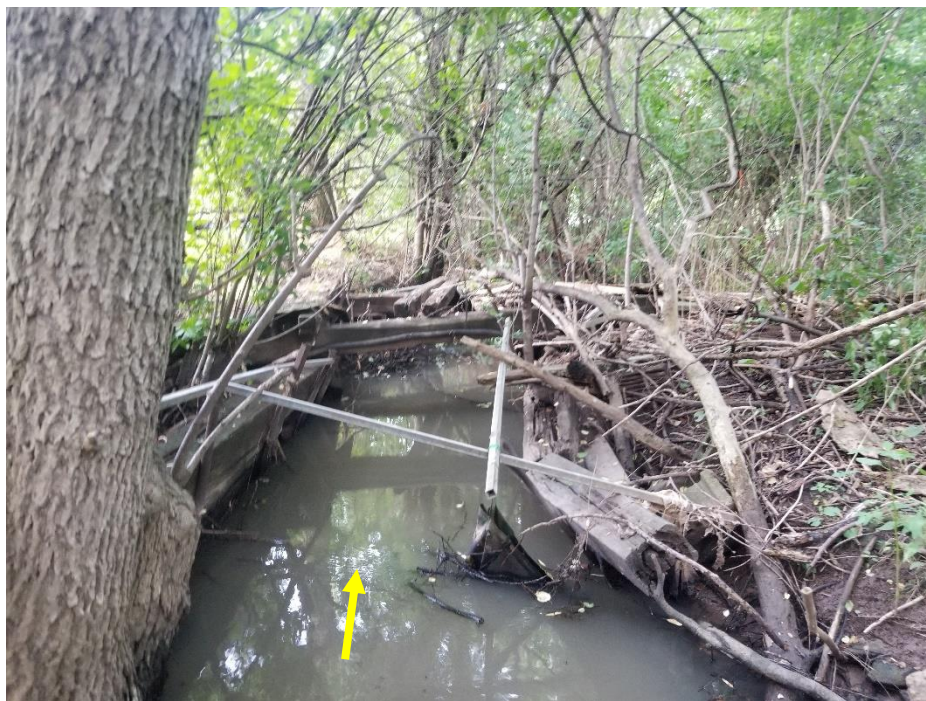
Photo 10
Reach **WC5**

Bank armoring and a footbridge were observed further downstream. This infrastructure is significantly degraded and has evidently not been maintained for many years.

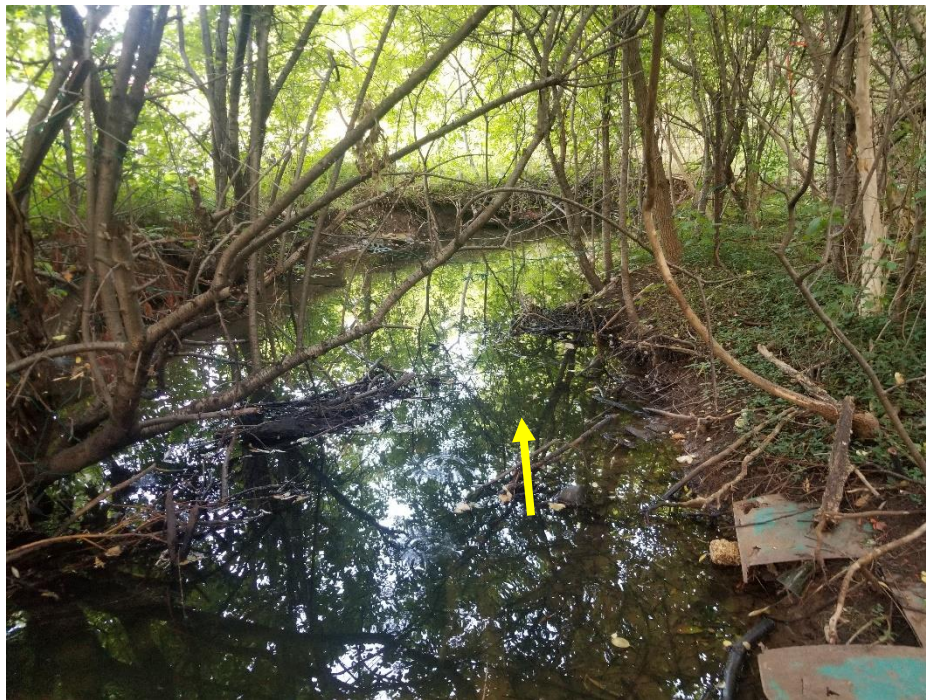
Photo 11
Reach **WC5**

Flows near the downstream extent of the reach are slightly deeper. The channel width expands in this section. The leaning trees indicate a level of channel widening.

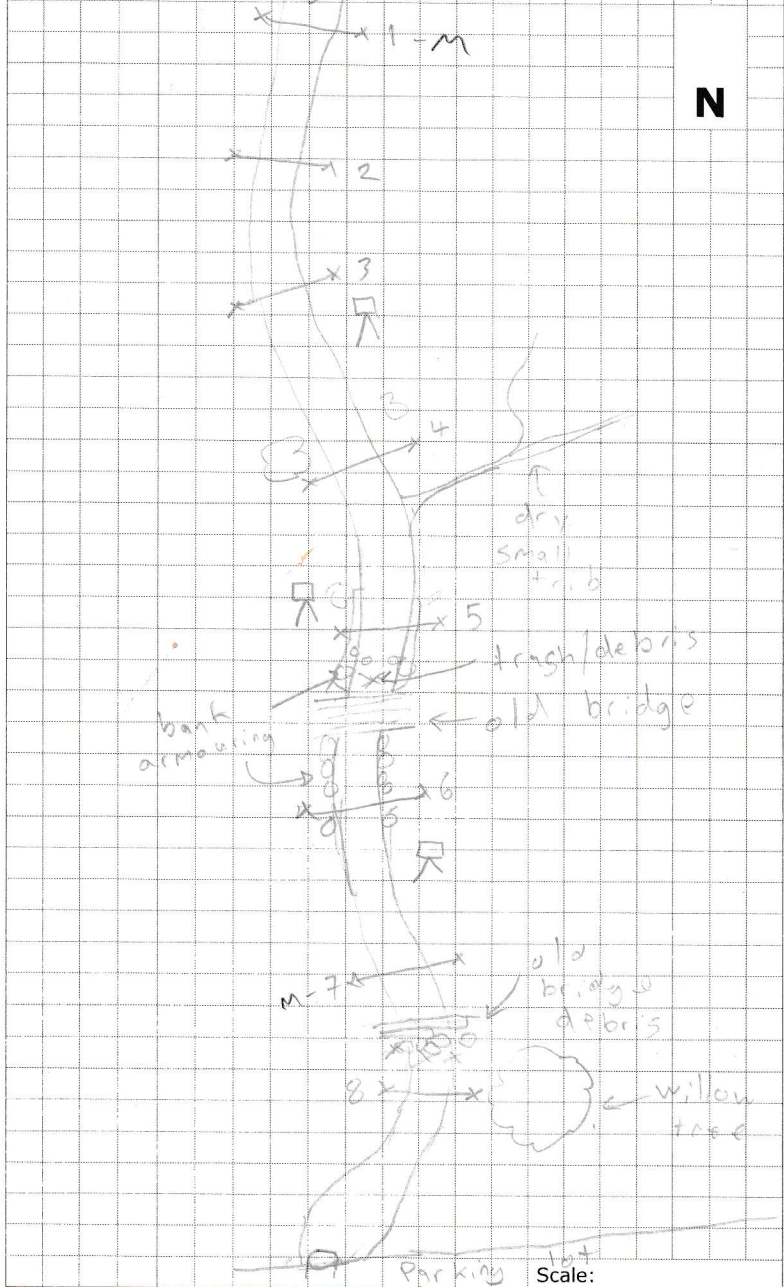
Site Sketch:

Additional Notes: clay silt throughout
- Channel more entrenched upstream
- Minimal flow

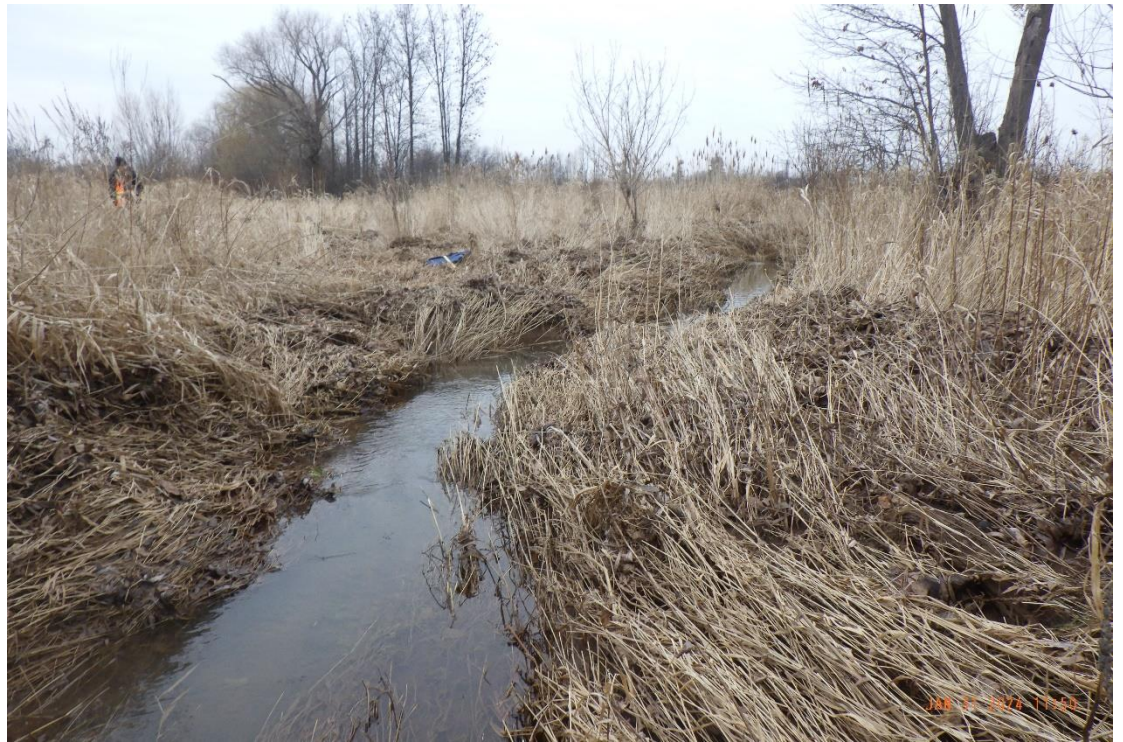
Photo 1
Reach WC-6 - Watercourse 6, Hamilton, Ontario

Upstream extent of **Reach WC-6** facing downstream. The channel was well defined within a grassy corridor and dominated by runs.

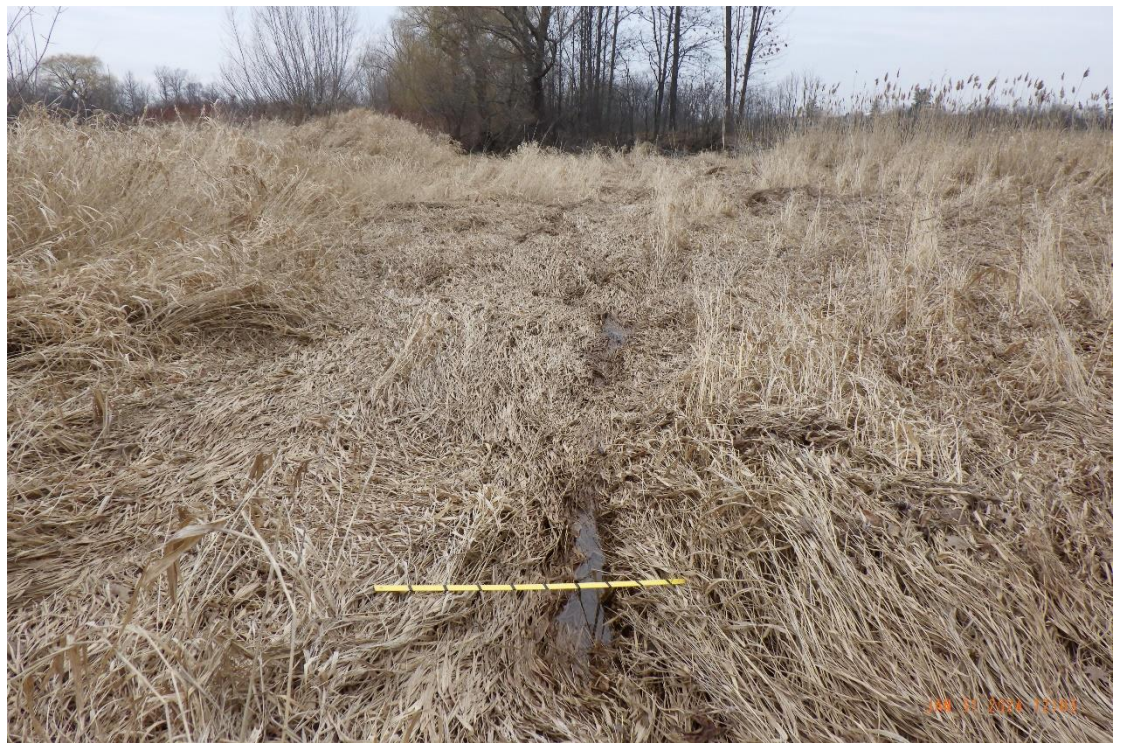
Photo 2
Reach WC-6 - Watercourse 6, Hamilton, Ontario

Multiple poorly defined secondary flow paths were also present within the corridor.

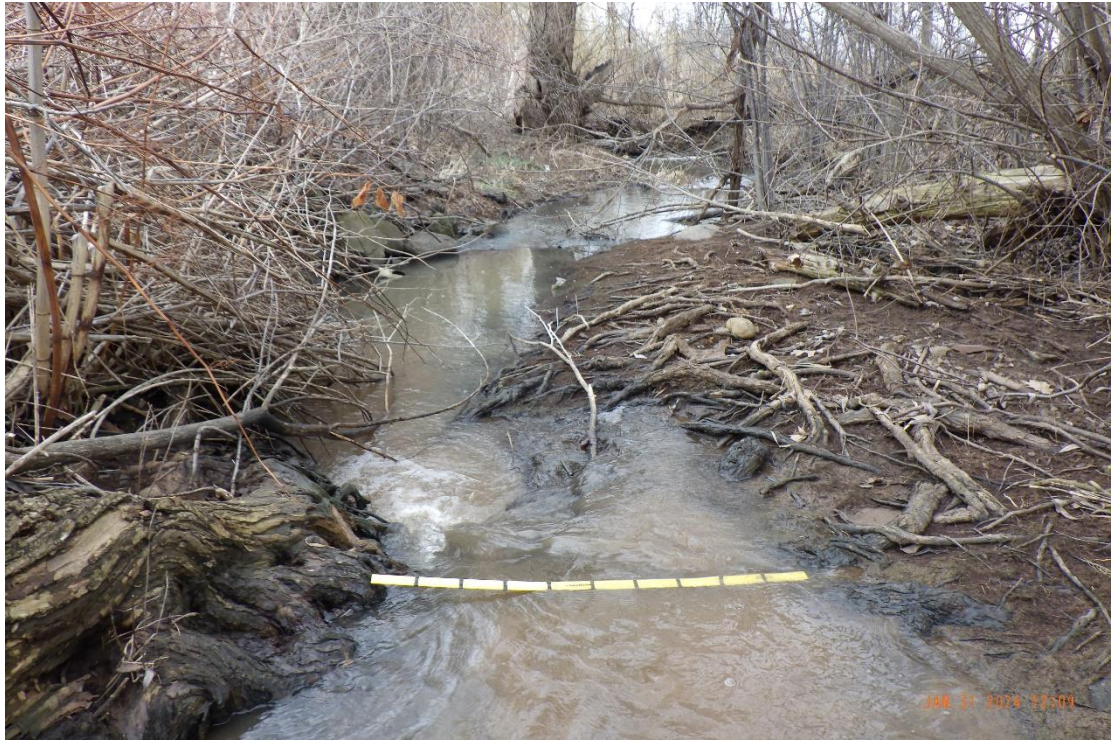
Photo 3
Reach WC-6 - Watercourse 6, Hamilton, Ontario

The middle of the reach consisted of a single channel within a narrow forested riparian zone.

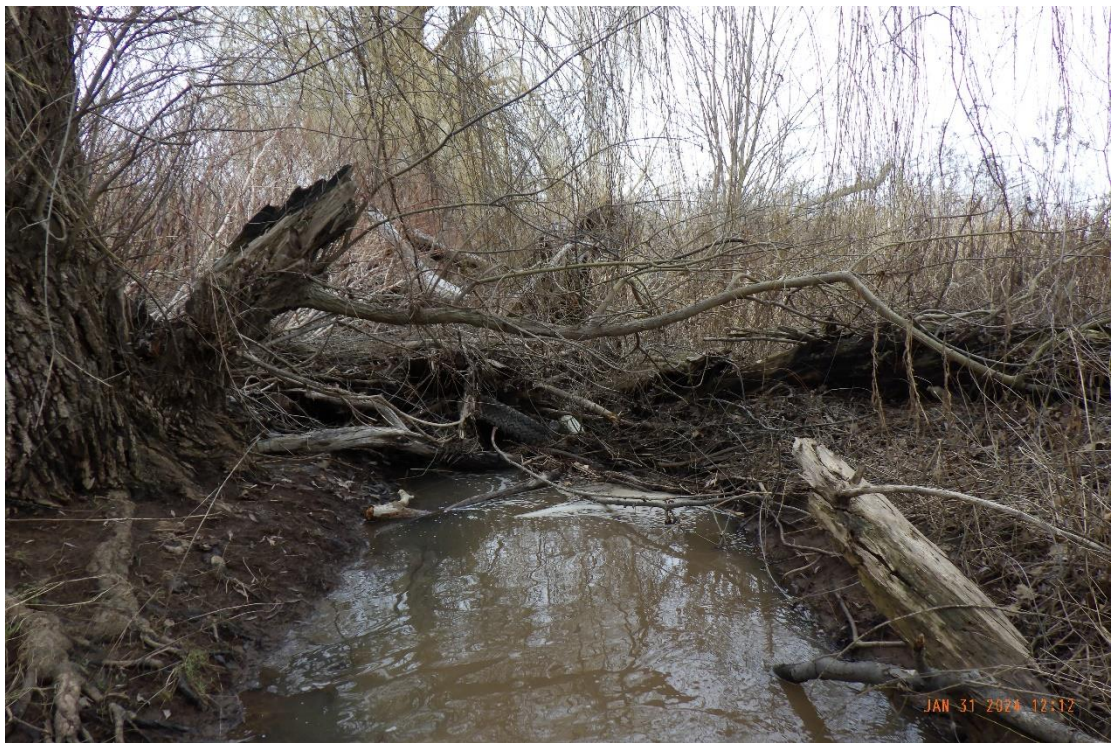
Photo 4
Reach WC-6 - Watercourse 6, Hamilton, Ontario

Several woody debris jams were present throughout the mid-section of the reach. Woody debris was common along the banks as well.

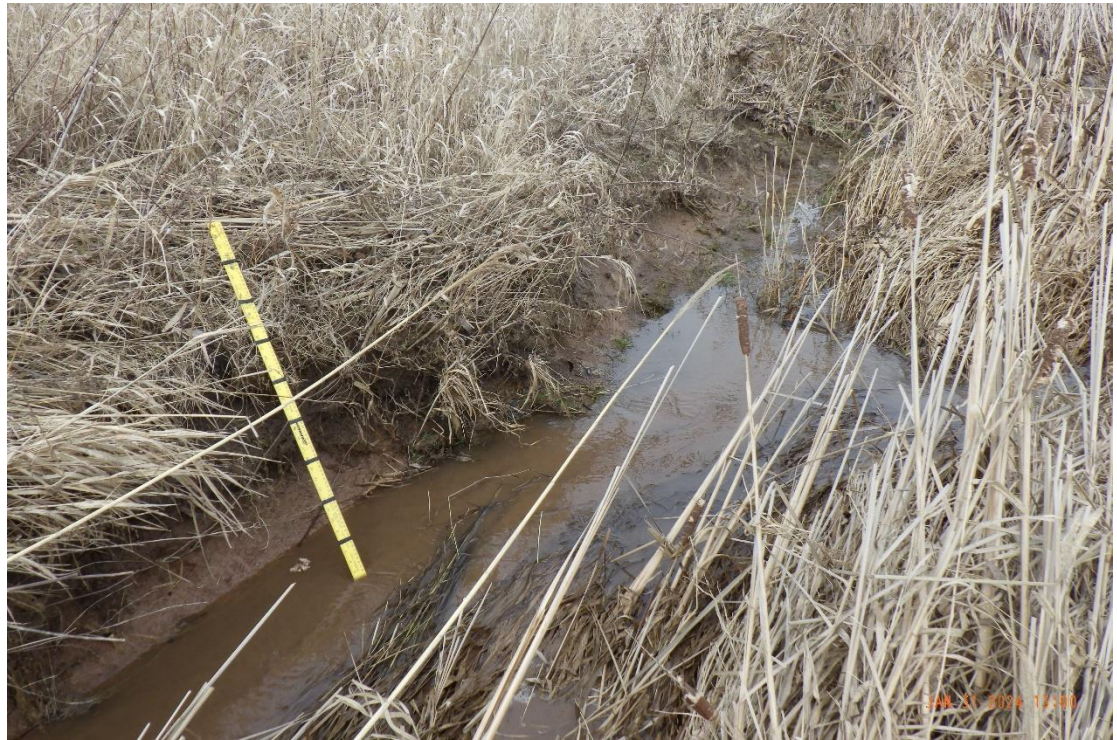
Photo 5
Reach WC-6 - Watercourse 6, Hamilton, Ontario

Basal scouring was observed throughout the reach, in particular at the downstream section. Bed and bank materials consisted primarily of clay.

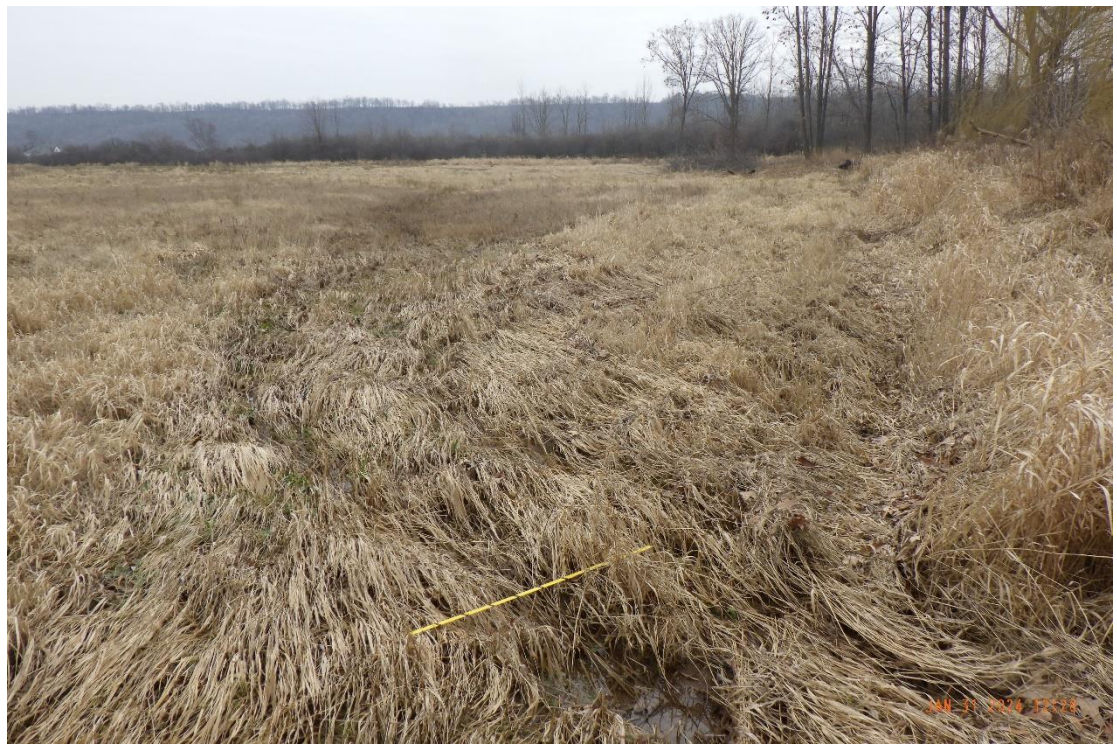
Photo 6
Reach WC-6 - Watercourse 6, Hamilton, Ontario

A swale present in the adjacent agricultural field contributed to stream flow.

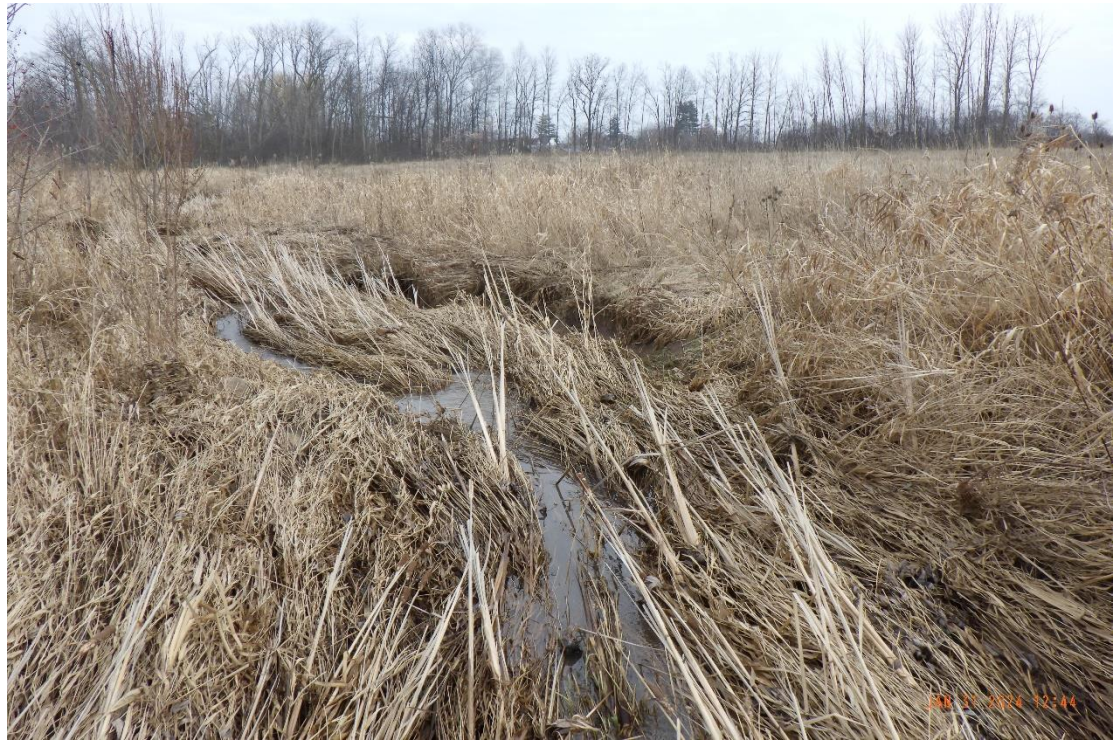
Photo 7
Reach WC-6 - Watercourse 6, Hamilton, Ontario

Multiple flow paths were present within a swale feature at the downstream section of the reach.

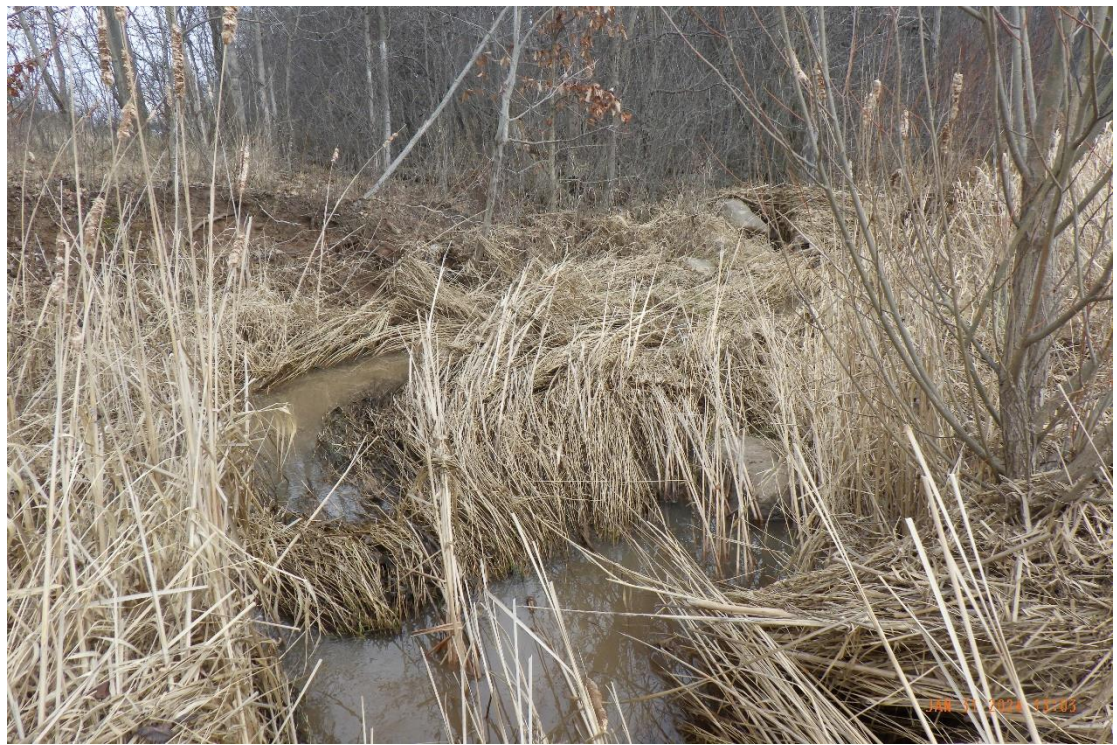
Photo 8
Reach WC-6 - Watercourse 6, Hamilton, Ontario

Downstream extent of **Reach WC-6** facing downstream.

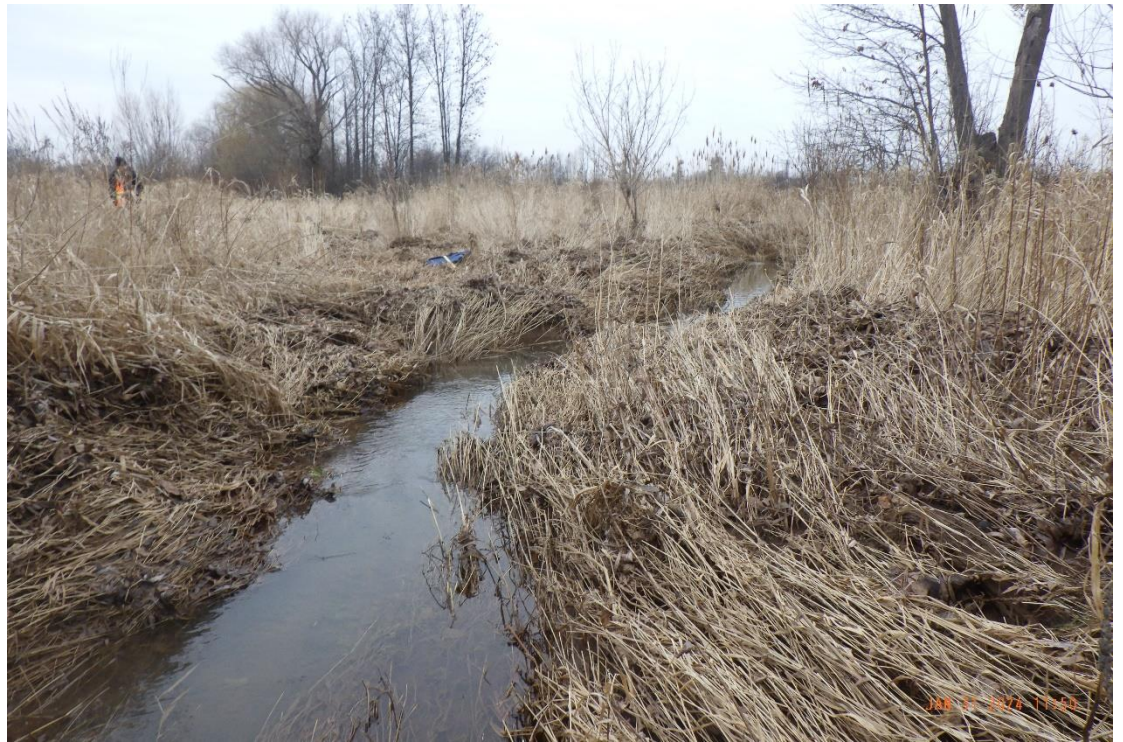
Photo 1
Reach WC-6 - Watercourse 6, Hamilton, Ontario

Upstream extent of **Reach WC-6** facing downstream. The channel was well defined within a grassy corridor and dominated by runs.

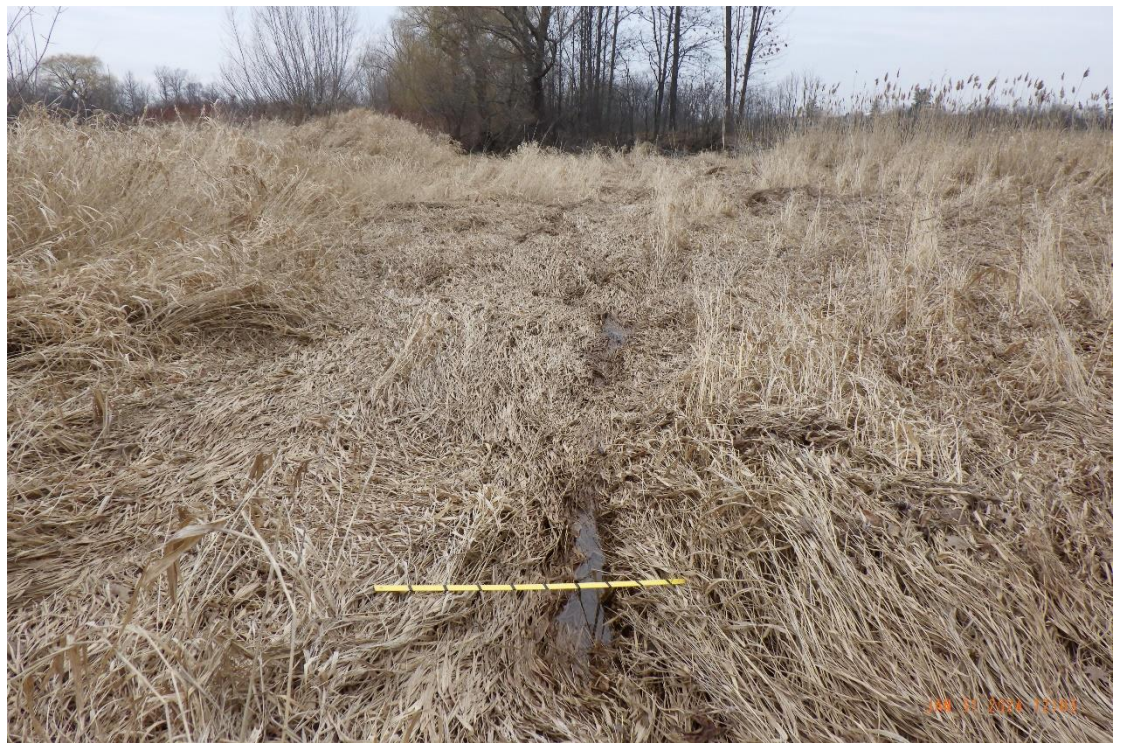
Photo 2
Reach WC-6 - Watercourse 6, Hamilton, Ontario

Multiple poorly defined secondary flow paths were also present within the corridor.

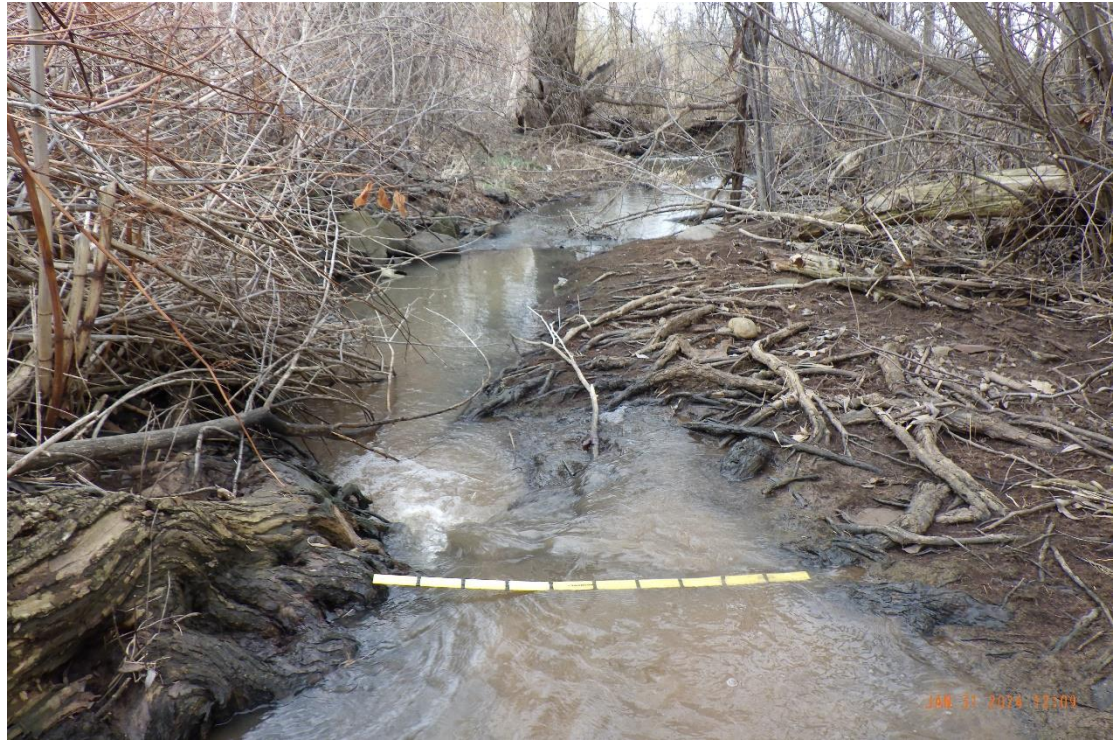
Photo 3
Reach WC-6 - Watercourse 6, Hamilton, Ontario

The middle of the reach consisted of a single channel within a narrow forested riparian zone.

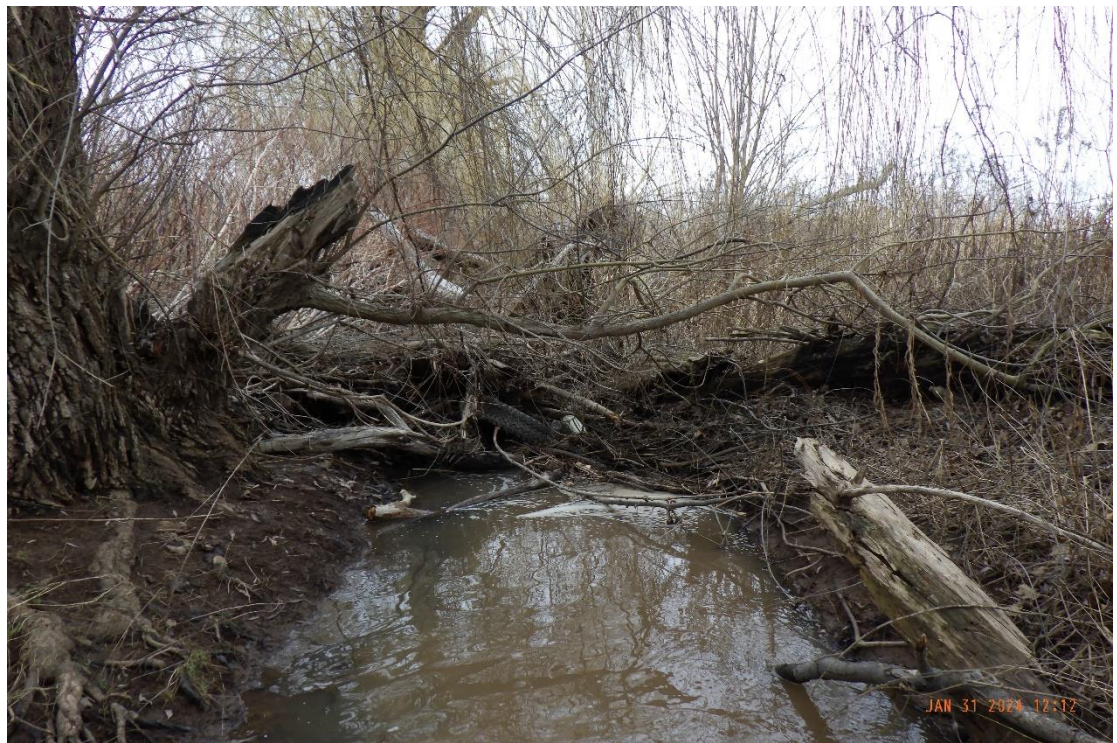
Photo 4
Reach WC-6 - Watercourse 6, Hamilton, Ontario

Several woody debris jams were present throughout the mid-section of the reach. Woody debris was common along the banks as well.

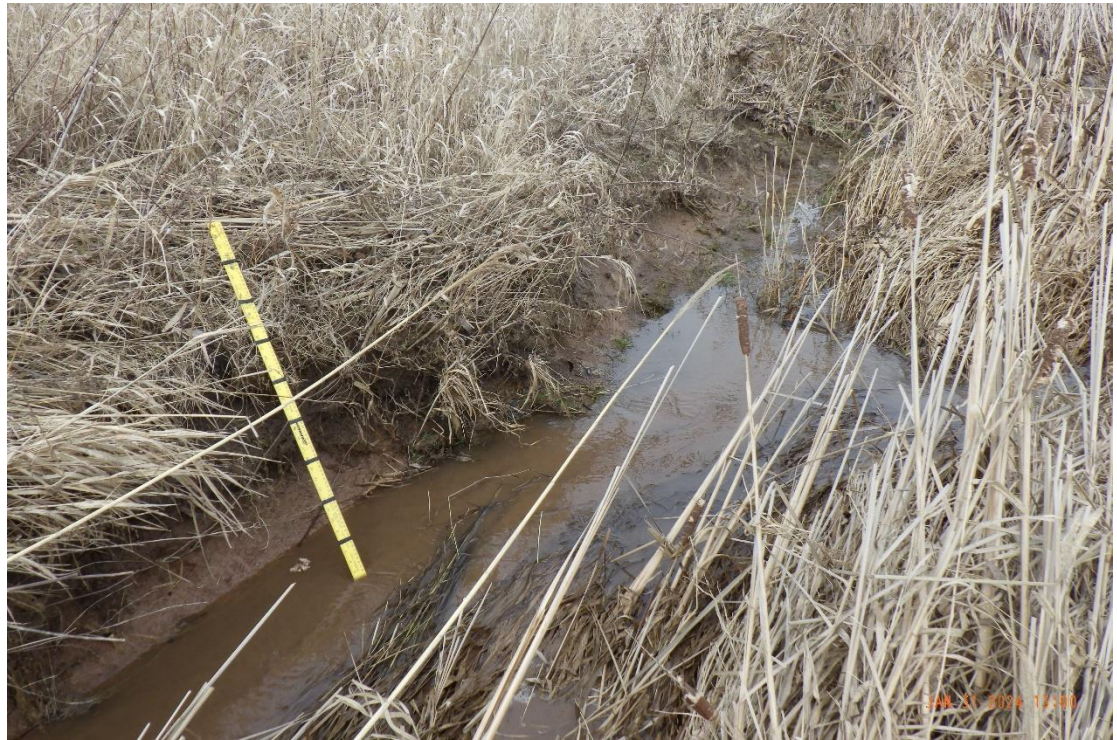
Photo 5
Reach WC-6 - Watercourse 6, Hamilton, Ontario

Basal scouring was observed throughout the reach, in particular at the downstream section. Bed and bank materials consisted primarily of clay.

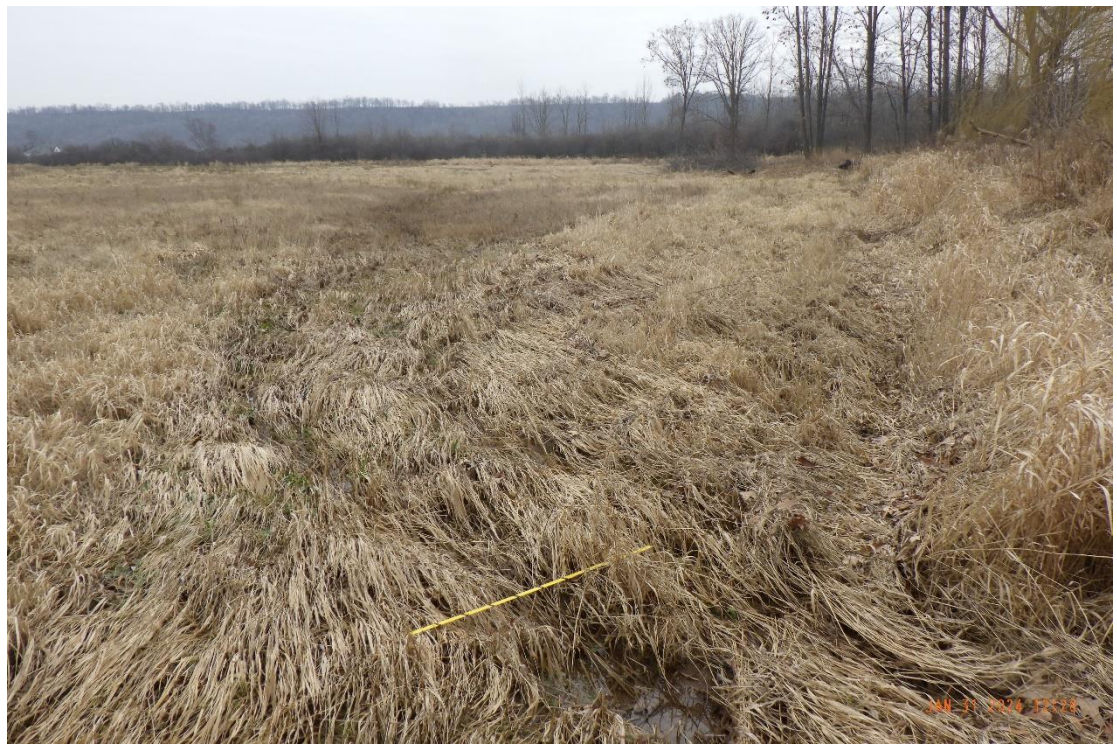
Photo 6
Reach WC-6 - Watercourse 6, Hamilton, Ontario

A swale present in the adjacent agricultural field contributed to stream flow.

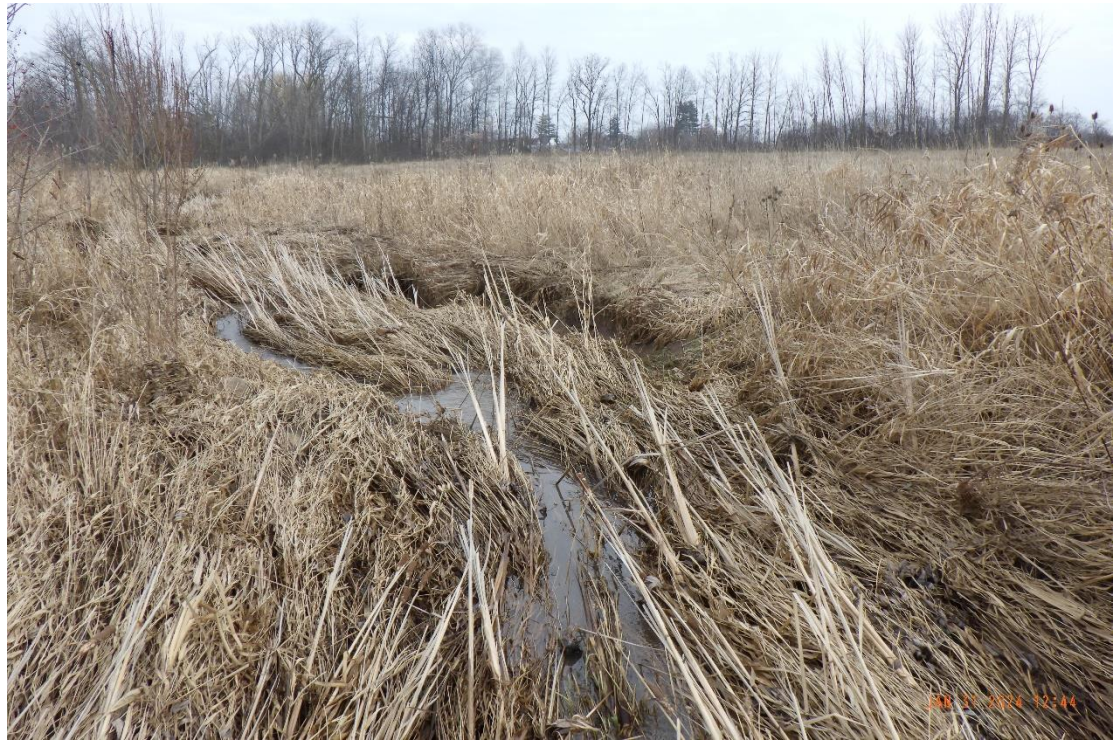
Photo 7
Reach WC-6 - Watercourse 6, Hamilton, Ontario

Multiple flow paths were present within a swale feature at the downstream section of the reach.

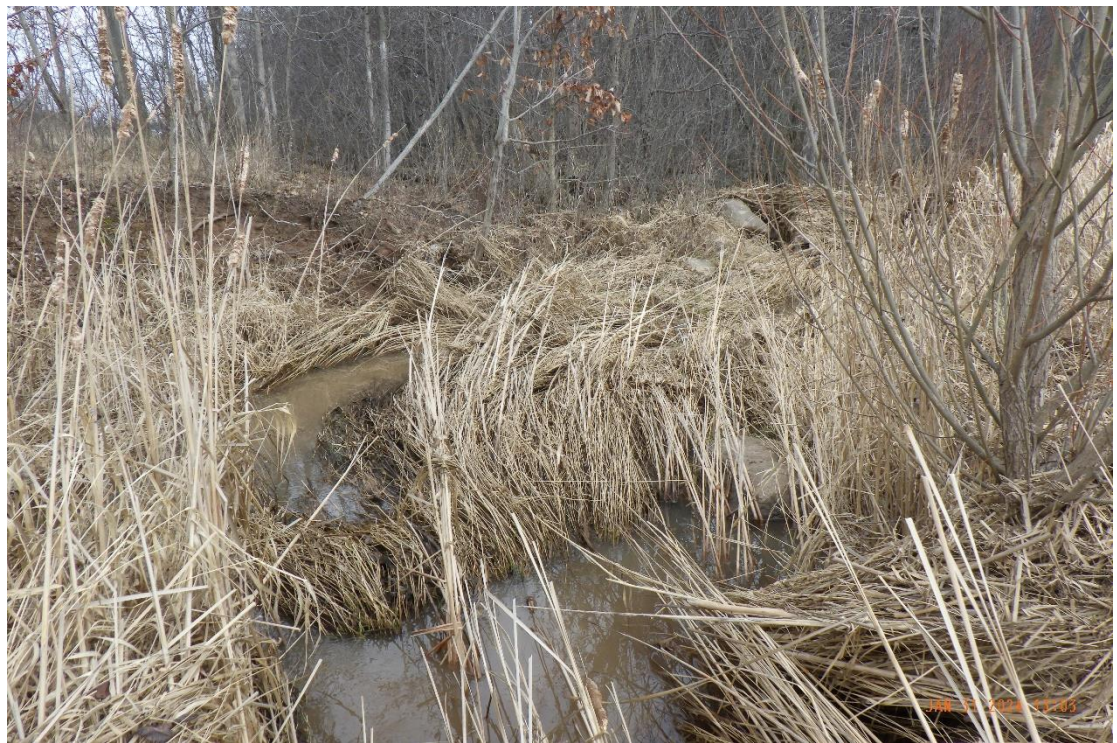
Photo 8
Reach WC-6 - Watercourse 6, Hamilton, Ontario

Downstream extent of **Reach WC-6** facing downstream.
