FINAL REPORT

Cultural Heritage Impact Assessment

Twenty Road West Plan of Subdivision in Glanbrook, City of Hamilton, Ontario

19125764-R01

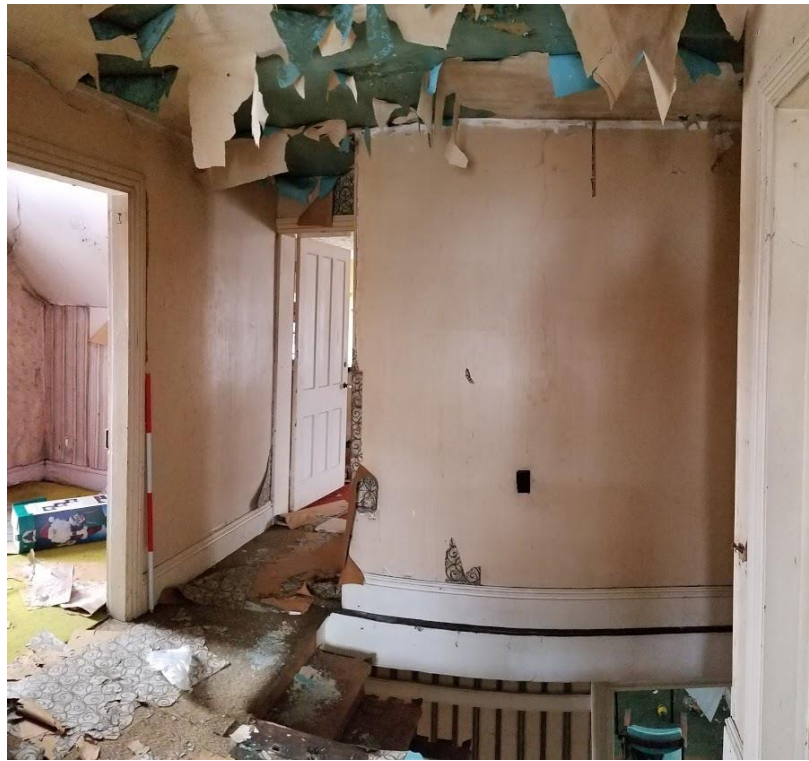
Figure 79: 9751 Twenty Road West: Peeling ceiling on the second storey

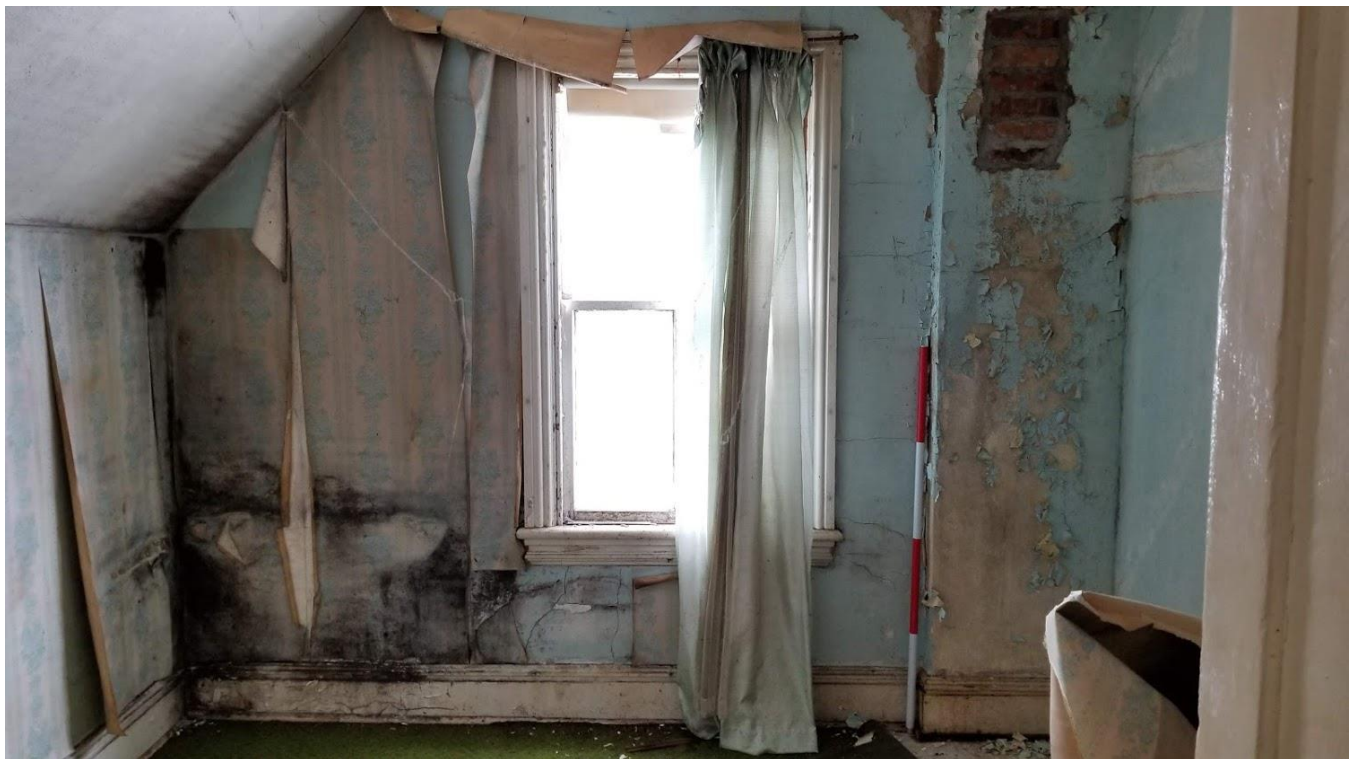
Figure 80: 9751 Twenty Road West: Damaged plasterwork in one of the second storey bedrooms

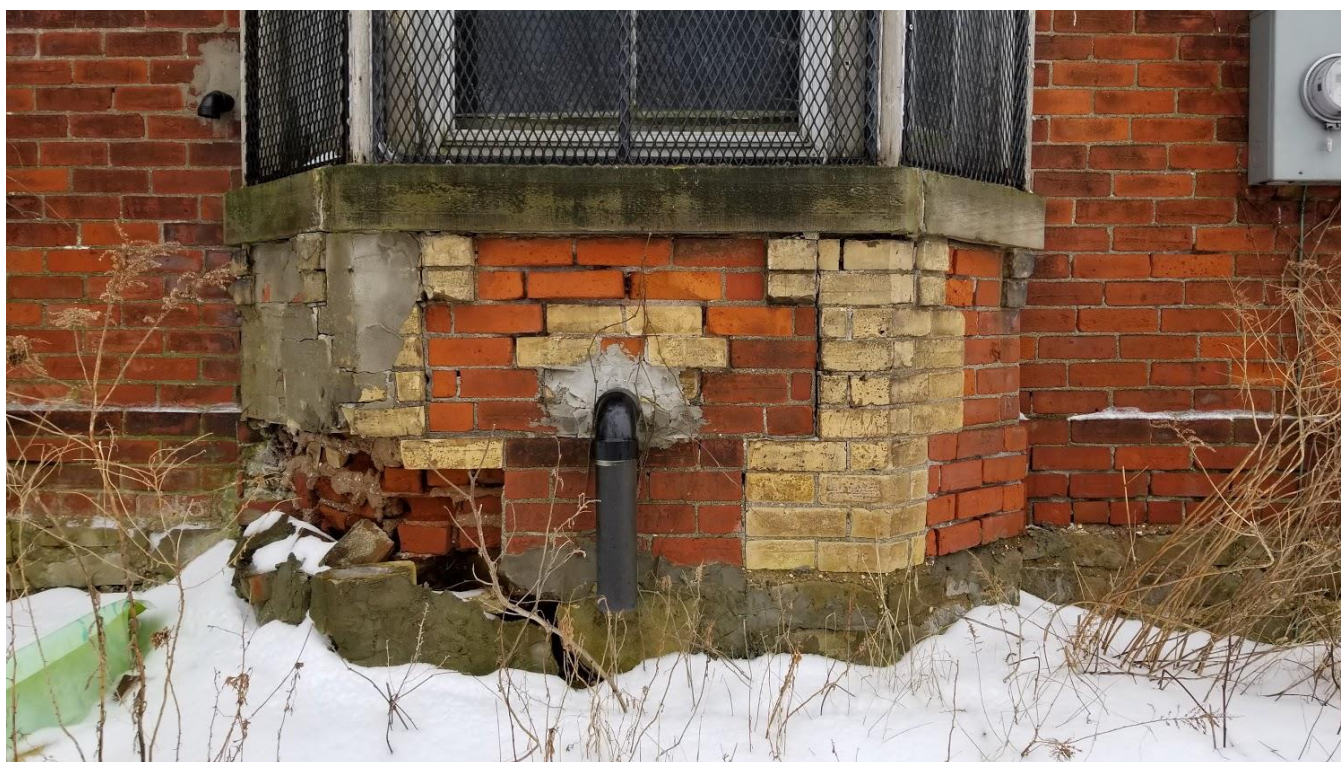
Figure 119: 9285 Twenty Road West: Missing brick at the corner of the bay window and evidence of concrete parging

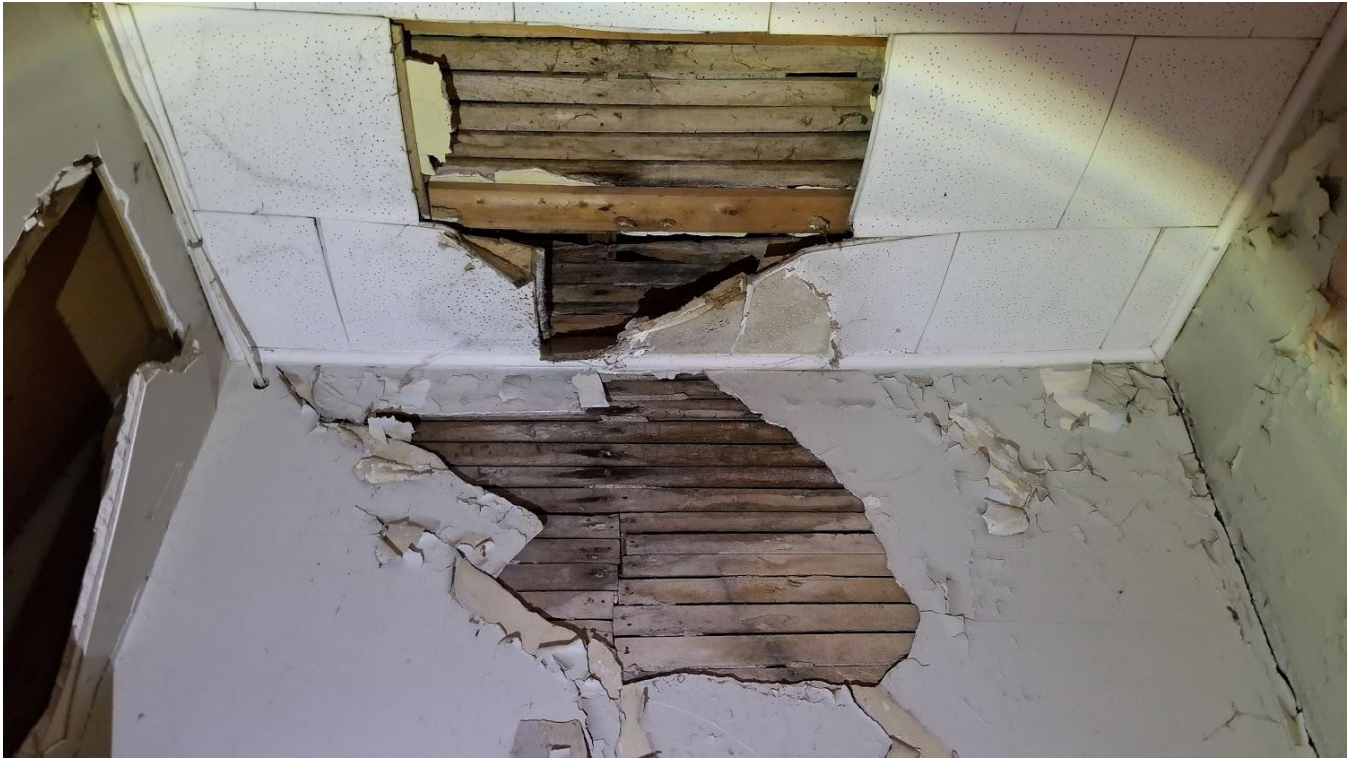
Figure 120: 9285 Twenty Road West: Exposed lathe from fallen plaster

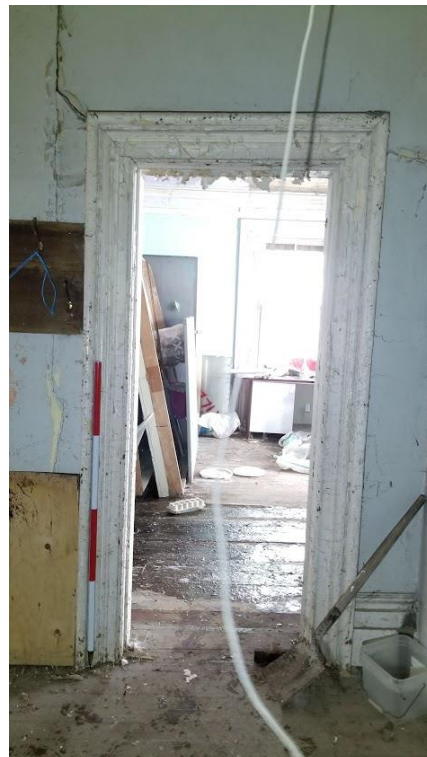
Figure 121: 9285 Twenty Road West: Water damage on the floors

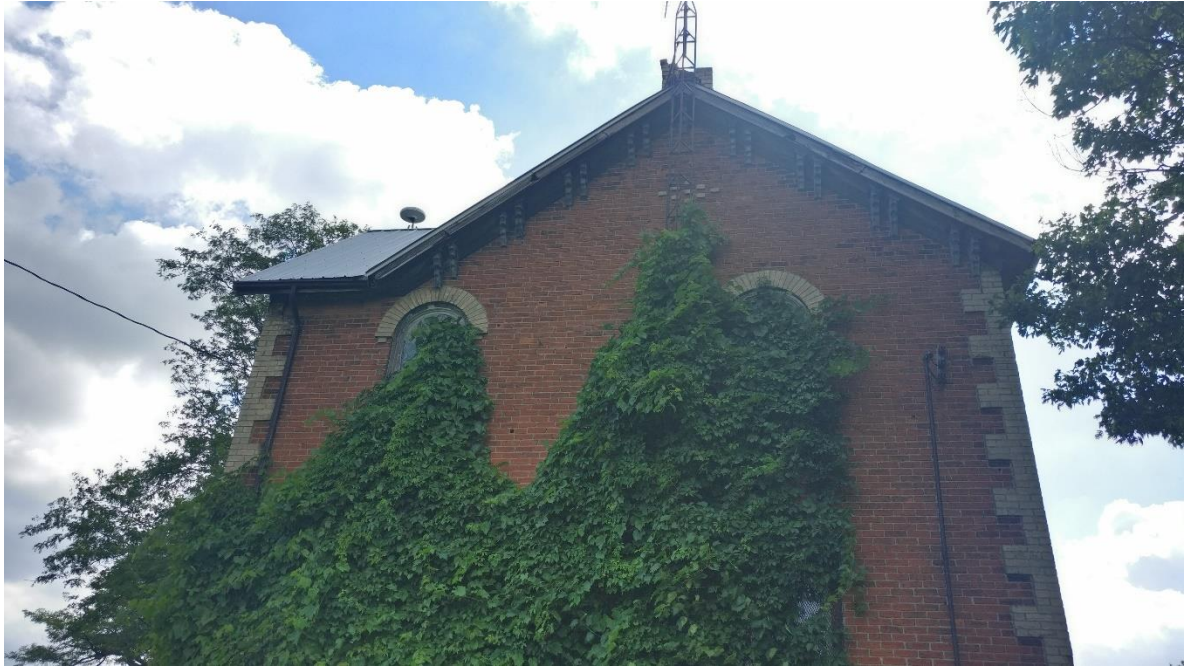
Figure 7.0: West Façade of Building
Vine growing up the face of the building hiding the condition of brick

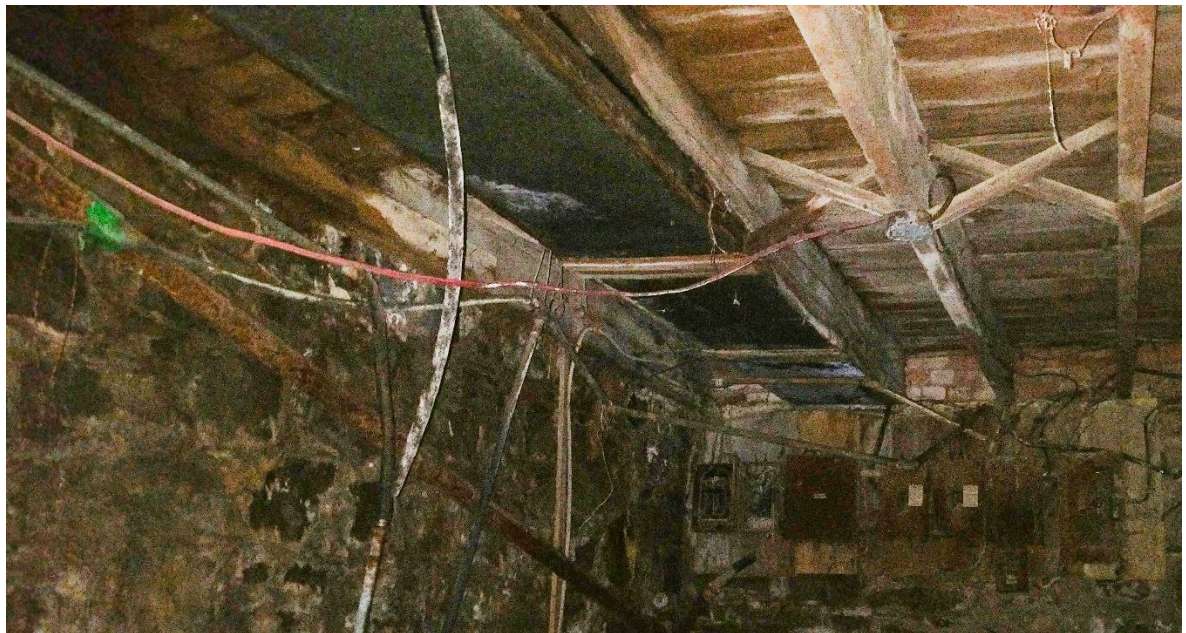
Figure 14.0: Existing Ground Level Floor Joist at South-West Corner
Significant water damage noted on floor joists and floor decking
Floor joist second from left completely split apart

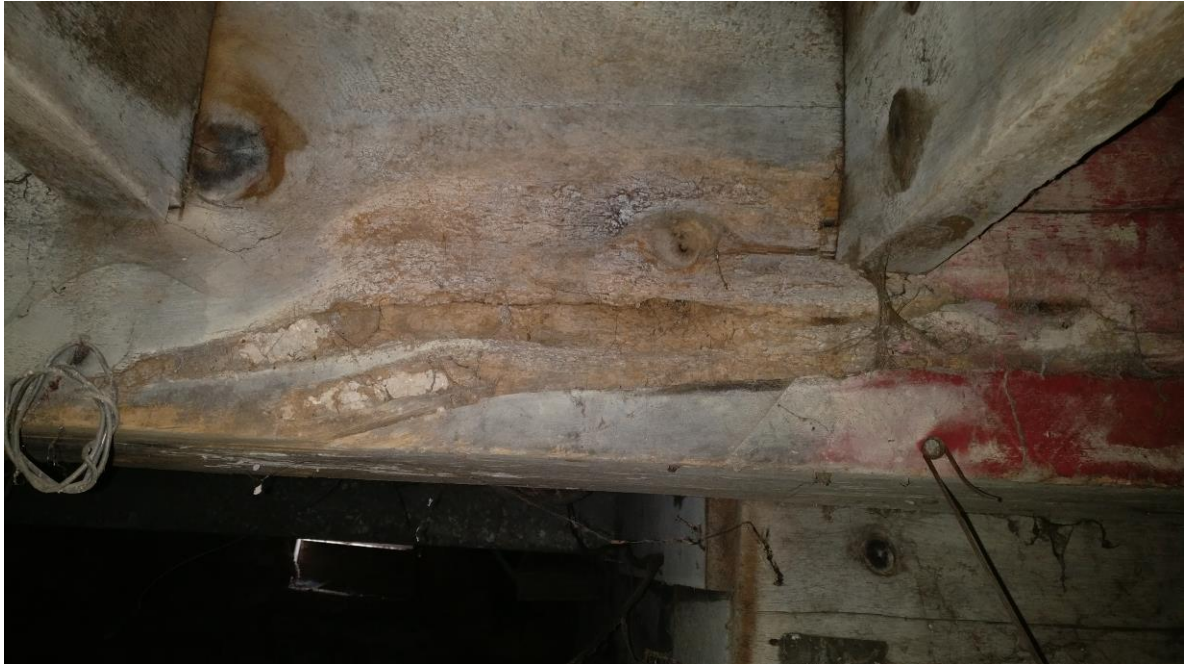
Figure 15.0: Termite Damage Noted on Large Wood Beam in Basement

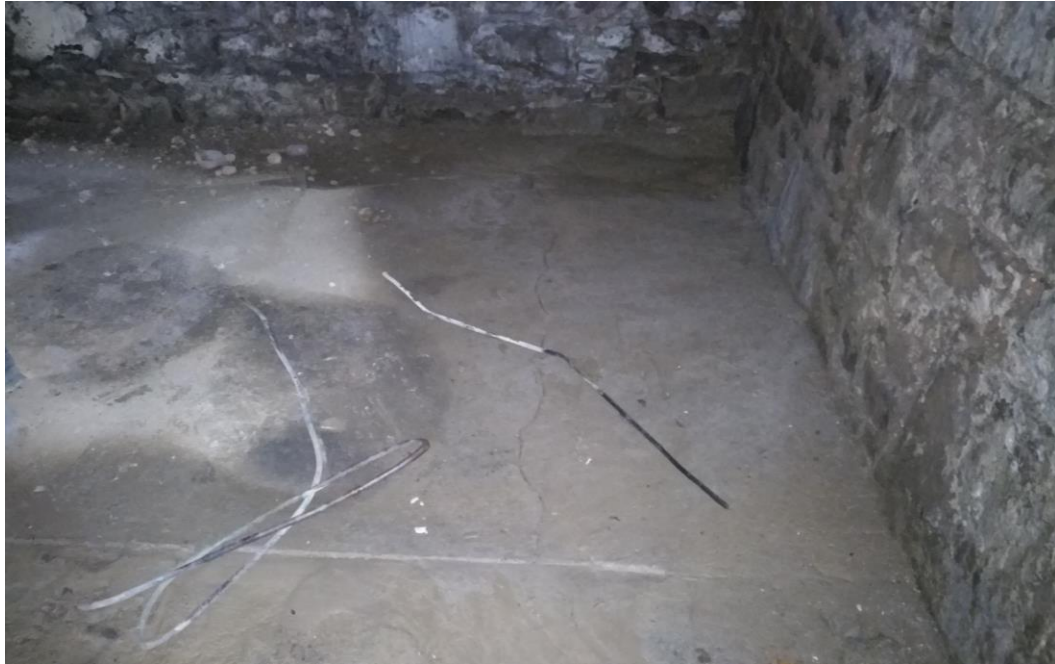
Figure 17.0: Small Portion of Slab on Grade in Basement
Multiple cracks throughout slab
Soil floor throughout majority of basement

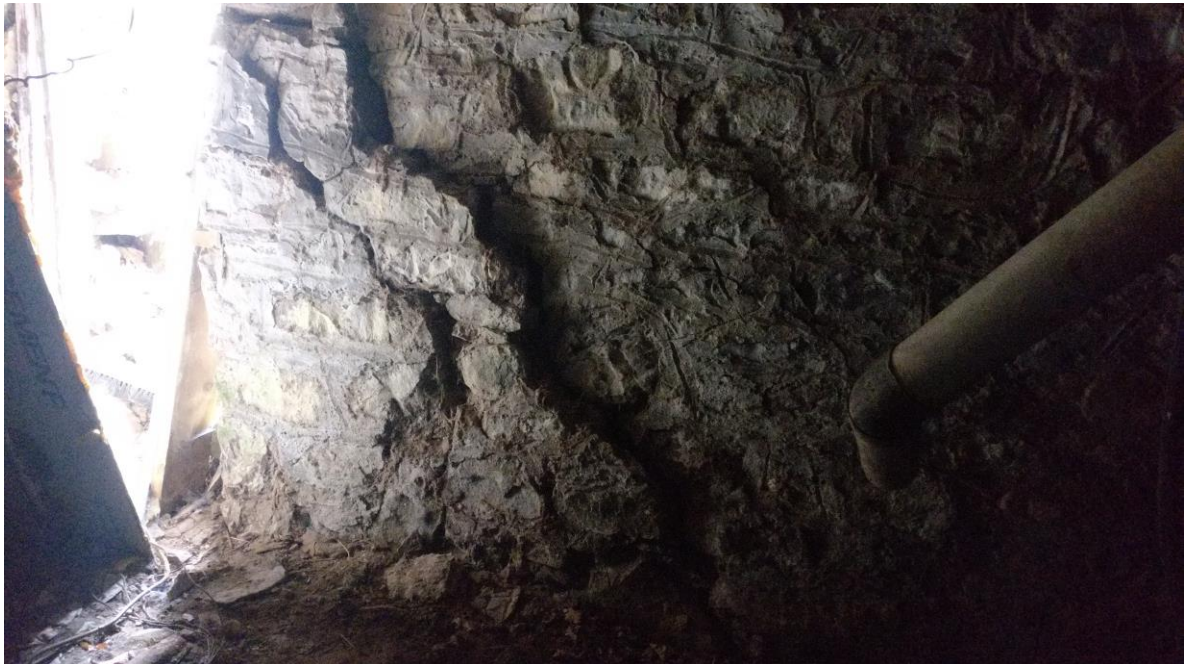
Figure 18.0: Severely Cracked and Shifted Foundation Wall

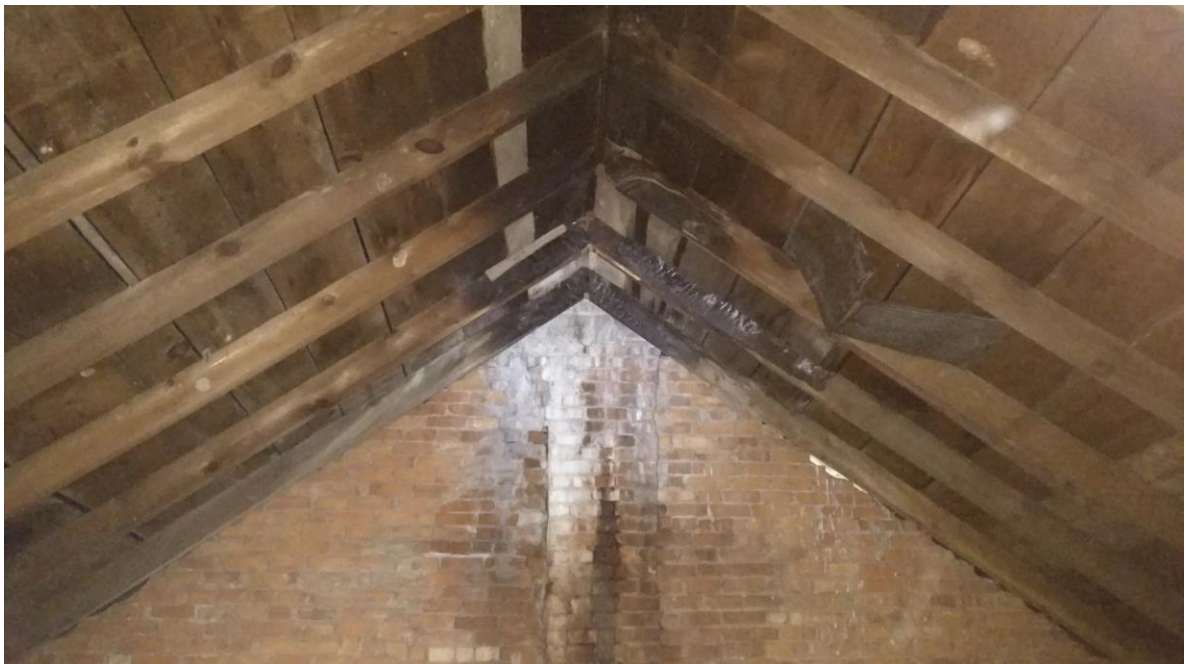
Figure 22.0: Roof Framing at East Side
Rafters and planks charred showing evidence of fire damage
