November 27, 2024

Subject: Project-Specific, Pre-Demolition Designated Substances Survey
Barton-Tiffany Lands, Hamilton, Ontario

Englobe File No.: 02410660.000

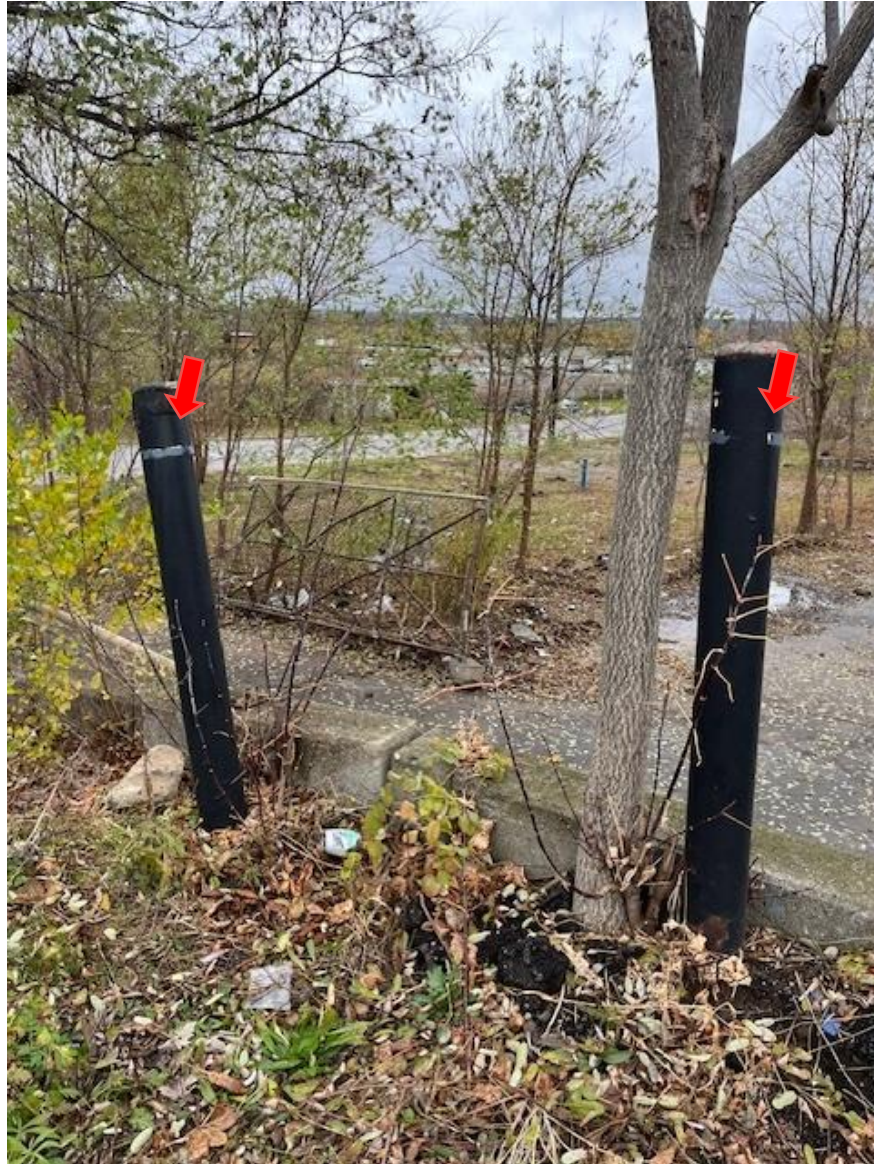
Paint described as Black (applied to metal posts) in the Project Area is considered to be lead-containing.

Photo 1. Representative view of lead-containing black paint applied to metal posts.

Black paint on metal posts in the Project Area are considered to be lead-containing. Disturbance of these materials will require lead precautionary measures in accordance with the above-noted guideline.
