# Upper West Side - Fluvial Geomorphological Assessment Twenty Road West, City of Hamilton

June 12, 2020  
PN18013

Report Title: Upper West Side Draft Plan of Industrial Subdivision  
Fluvial Geomorphological Assessment - Update

Project Number: PN18013

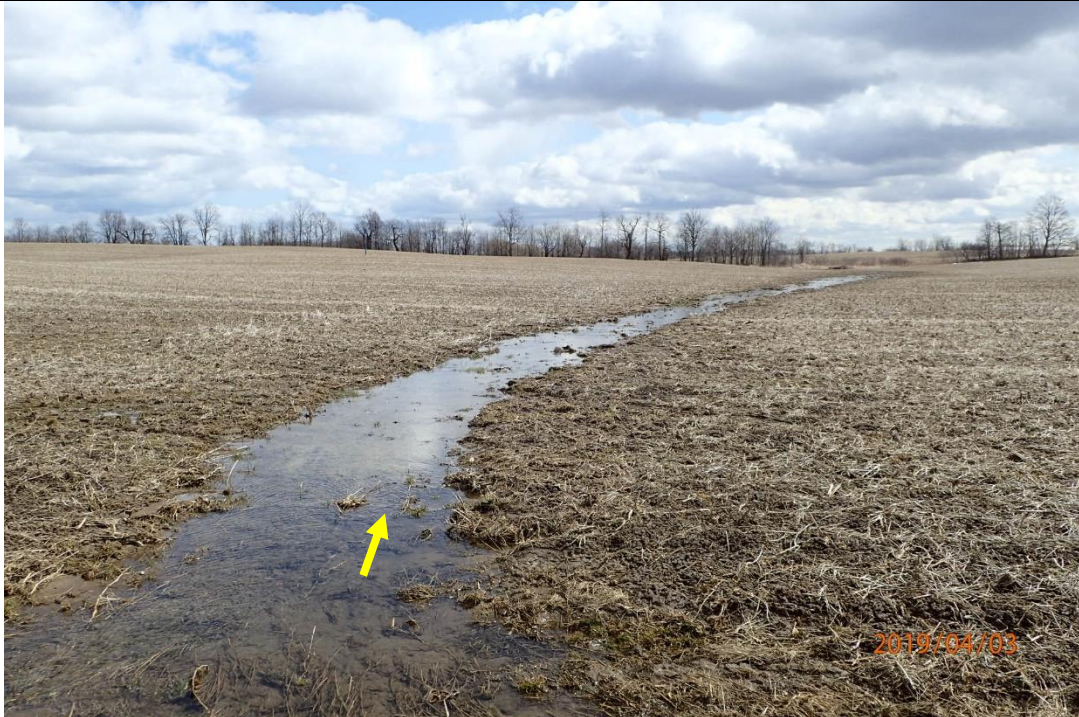
Photo 1  
Tributary of Twenty Mile Creek: Visit 1  
Reach TTCM2-9

The feature lacked defined bed and banks and conveyed substantial flow through an agricultural field during the spring visit. The Yellow arrow denotes the flow direction.

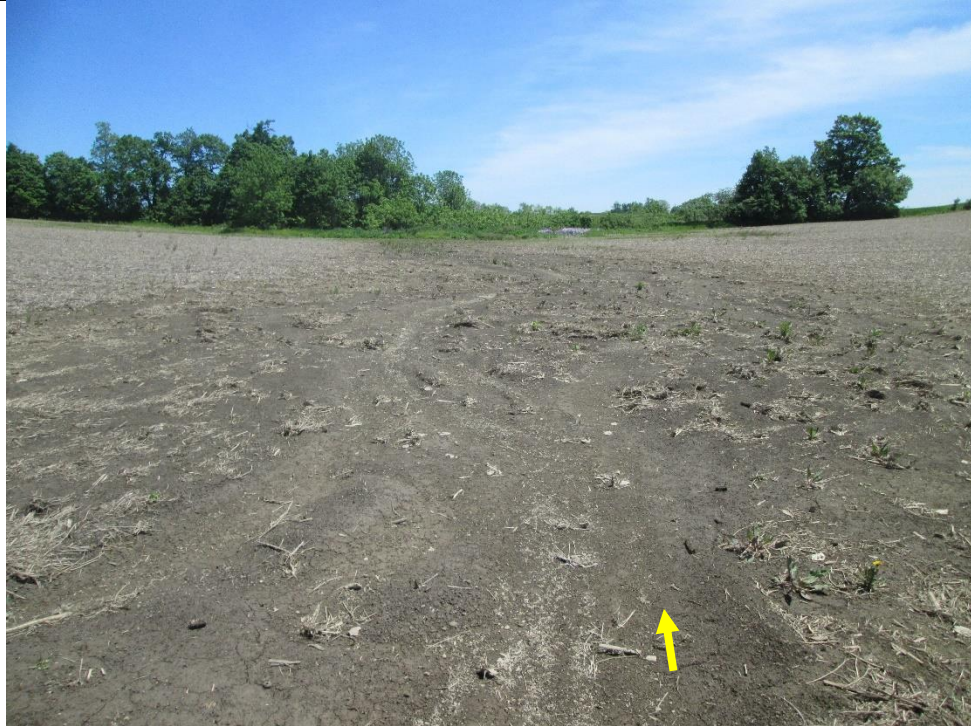
Photo 2  
Tributary of Twenty Mile Creek: Visit 2  
Reach TTCM2-9

No riparian or aquatic vegetation was observed within or adjacent to the feature. Notably, the feature's substrate was equivalent to that of the surrounding fields.

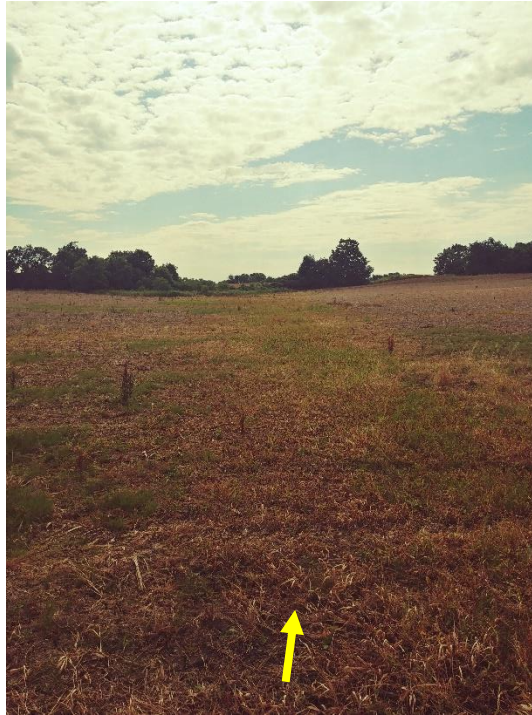
Photo 3  
Tributary of Twenty Mile Creek: Visit 3  
Reach **TTCM2-9**

The feature was indistinguishable from the surrounding landscape during the summer, with no channel formation or hydrophilic vegetation observed.

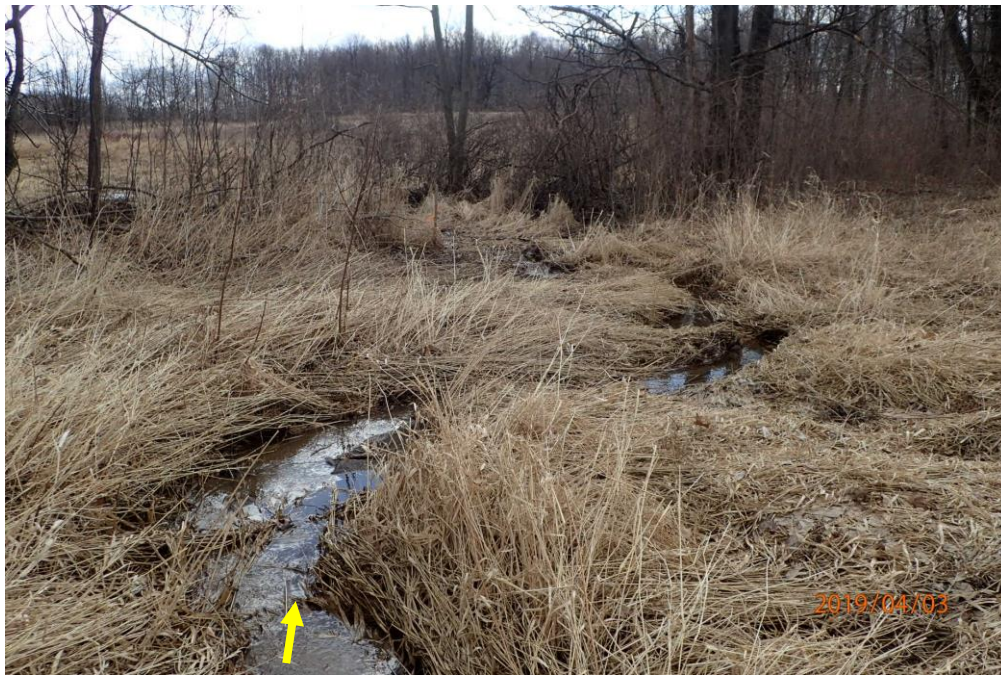
Photo 4  
Tributary of Twenty Mile Creek: Visit 1  
Reach **TTMC2-10**

The feature was a poorly-defined channel with substantial water flowing through an agricultural field and a hedgerow during the spring visit.

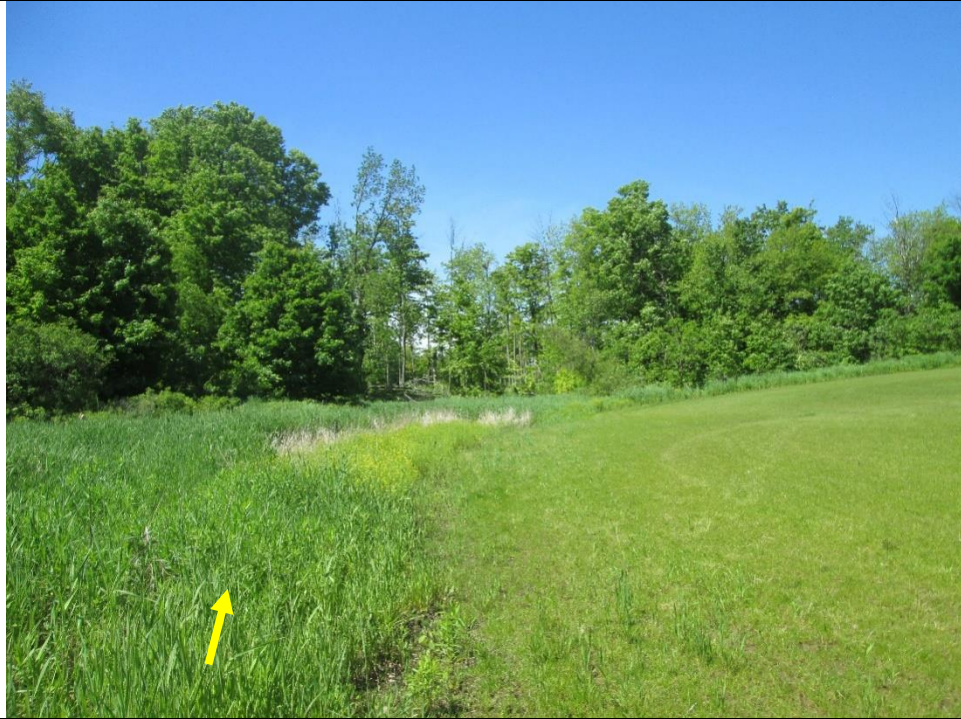
Photo 5  
Tributary of Twenty Mile Creek: Visit 2  
**Reach TTM2-10**

Herbaceous and grass vegetation were observed within and adjacent to the channel. Bed materials were equivalent to the surrounding fields.

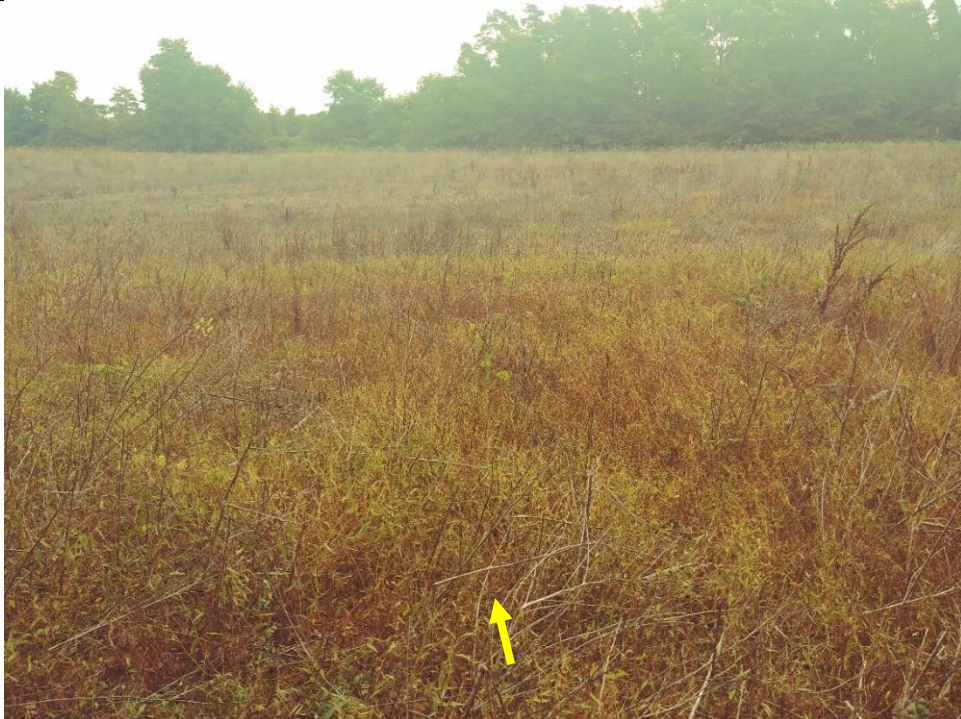
Photo 6  
Tributary of Twenty Mile Creek: Visit 3  
**Reach TTM2-10**

The feature was dry and indistinguishable from the surrounding fields during the summer, with no channel formation or hydrophilic vegetation observed.

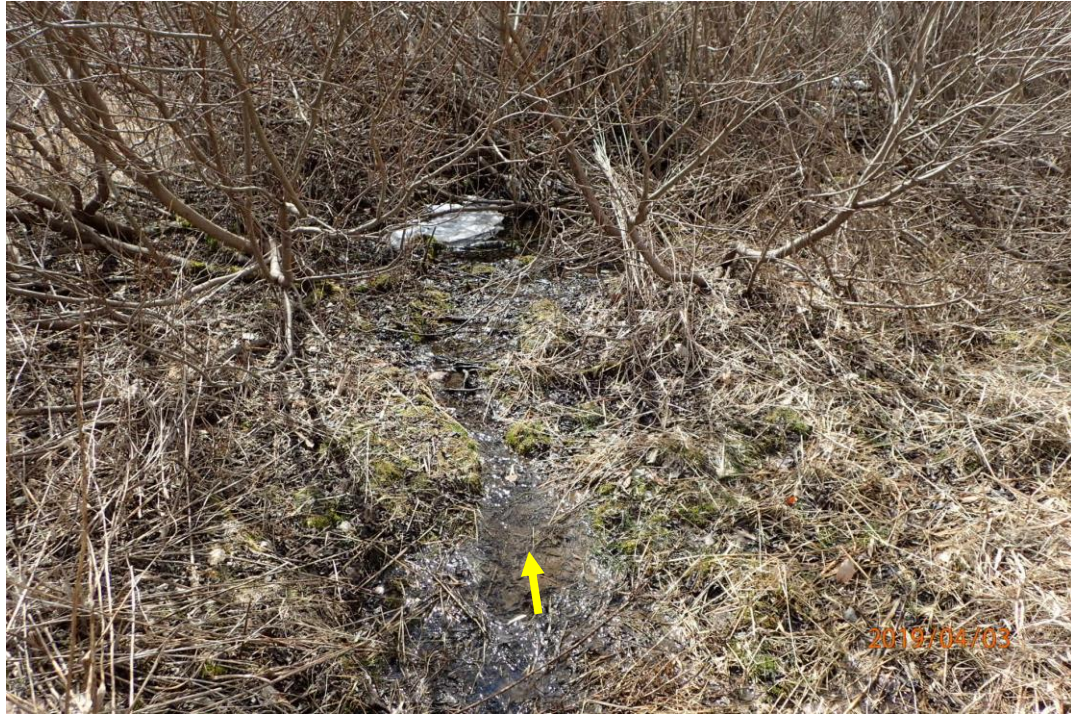
Photo 7  
Tributary of Twenty Mile Creek: Visit 1  
Reach **TTMC2-10-1**

The feature lacked defined bed and banks and conveyed minimal flow through an agricultural field and a hedgerow during the spring visit.

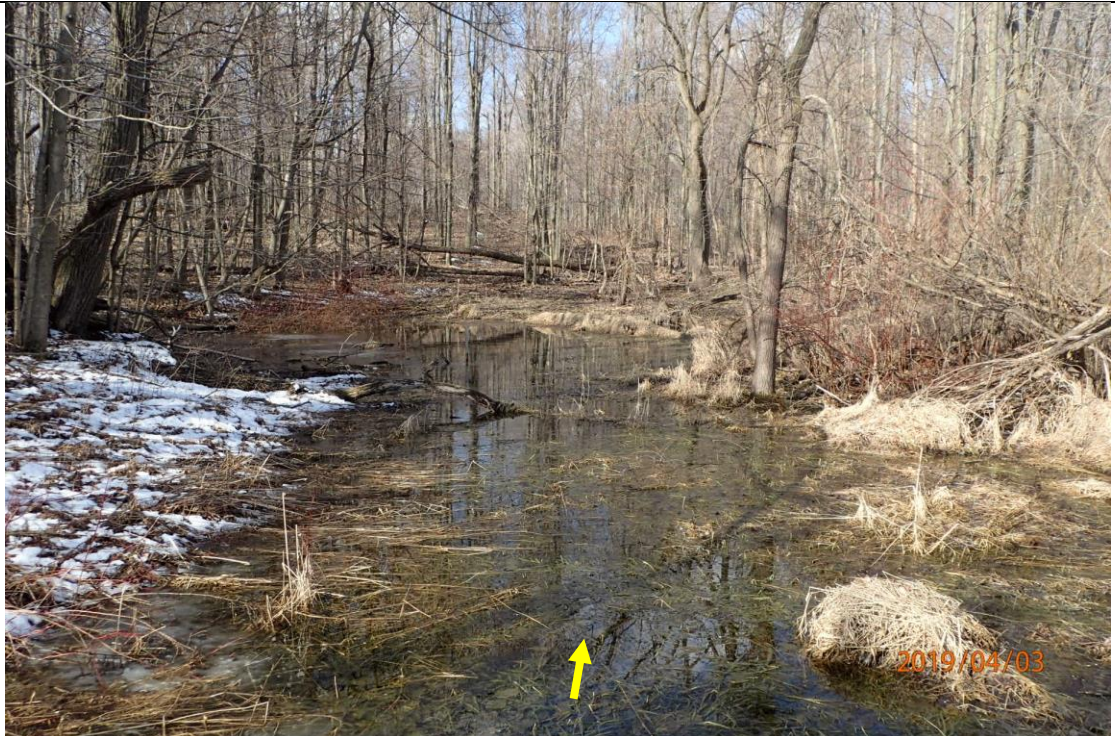
Photo 10  
Tributary of Twenty Mile Creek: Visit 1  
Reach **TTMC2-10-2**

The feature lacked defined bed and banks and conveyed substantial flow through a woodlot during the spring visit.

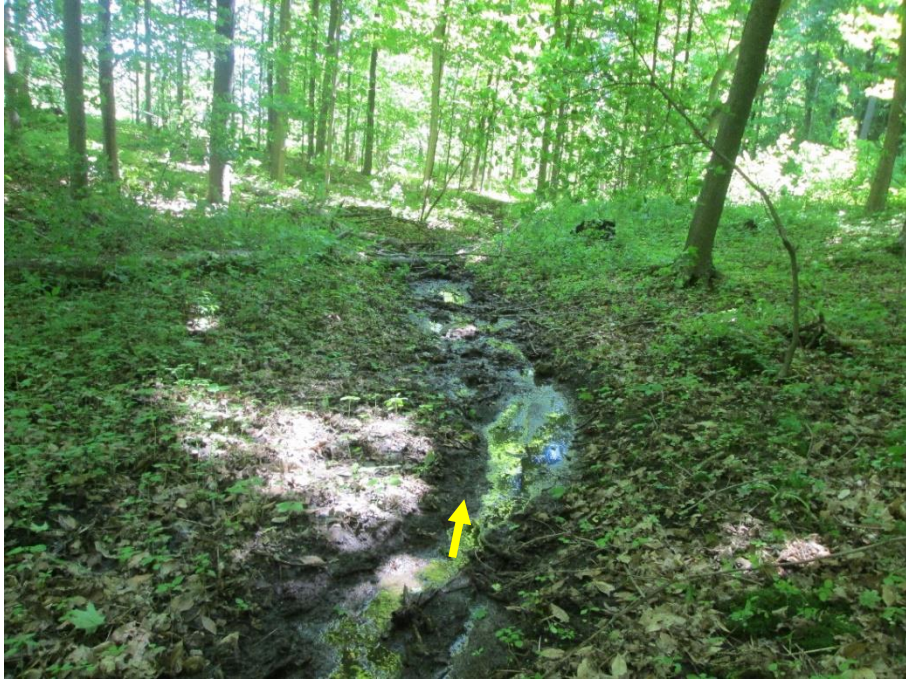
Photo 11  
Tributary of Twenty Mile Creek: Visit 2  
Reach **TTMC2-10-2**

Deciduous tree species were observed adjacent to the channel and minimal flow was present during the second visit.

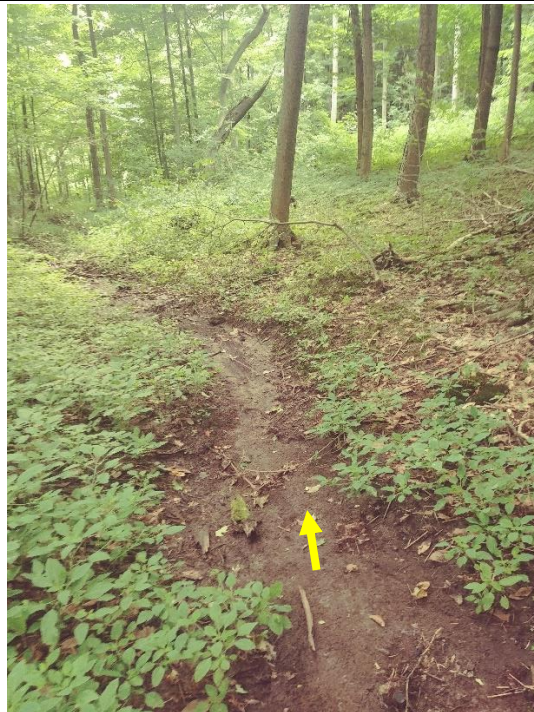
Photo 12  
Tributary of Twenty Mile Creek: Visit 3  
Reach **TTMC2-10-2**

Feature was dry but distinguishable from the surrounding landscape during the third visit. Bed materials consisted predominantly of silt and clay.

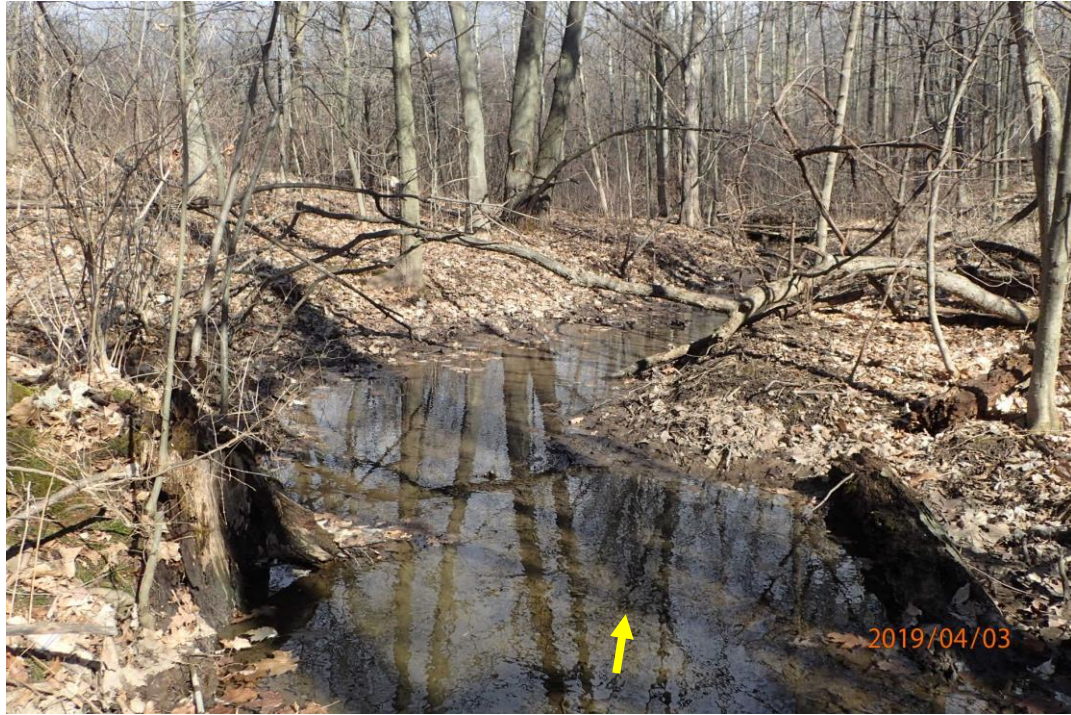
Photo 13  
Tributary of Twenty Mile Creek: Visit 1  
Reach TTM2-11

The feature had defined bed and banks, with substantial water flowing during the spring visit.

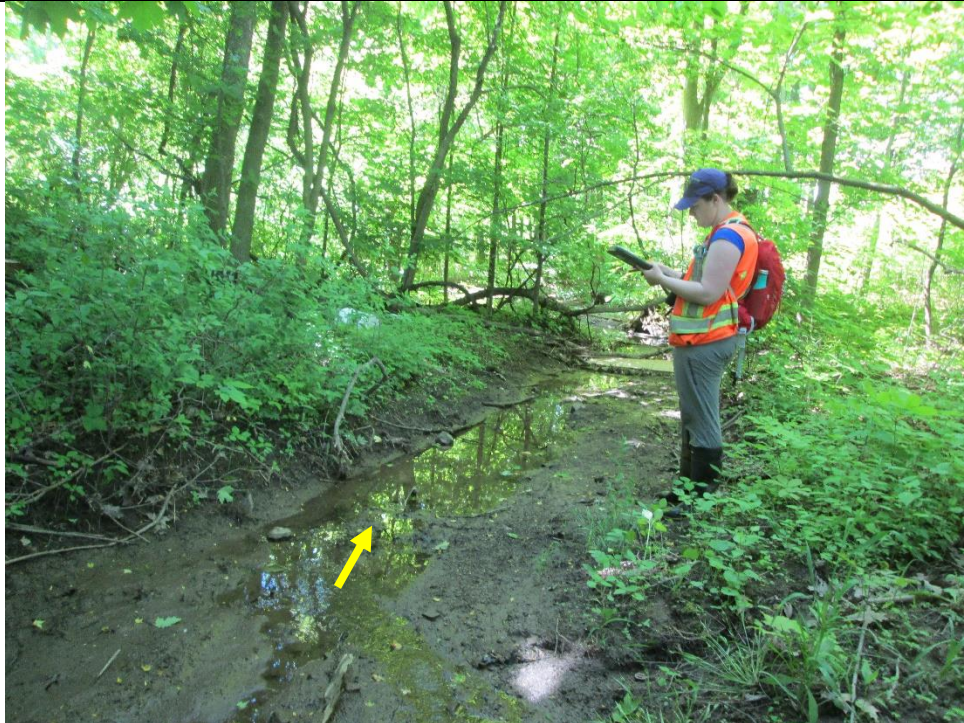
Photo 14  
Tributary of Twenty Mile Creek: Visit 2  
Reach TTM2-11

Minimal flow was conveyed through the deciduous forest during the second visit.

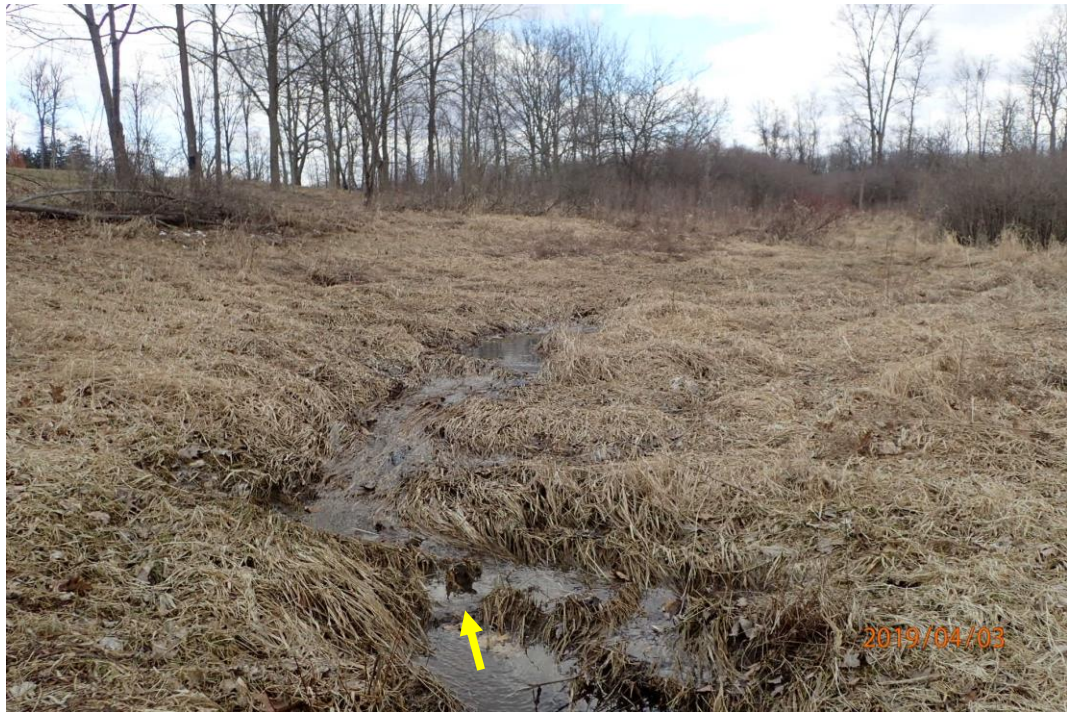
Photo 16  
Tributary of Twenty Mile Creek: Visit 1  
Reach **TTMC2-12**

The feature lacked defined bed and banks and conveyed minimal flow nearby to the woodlot during the spring visit.

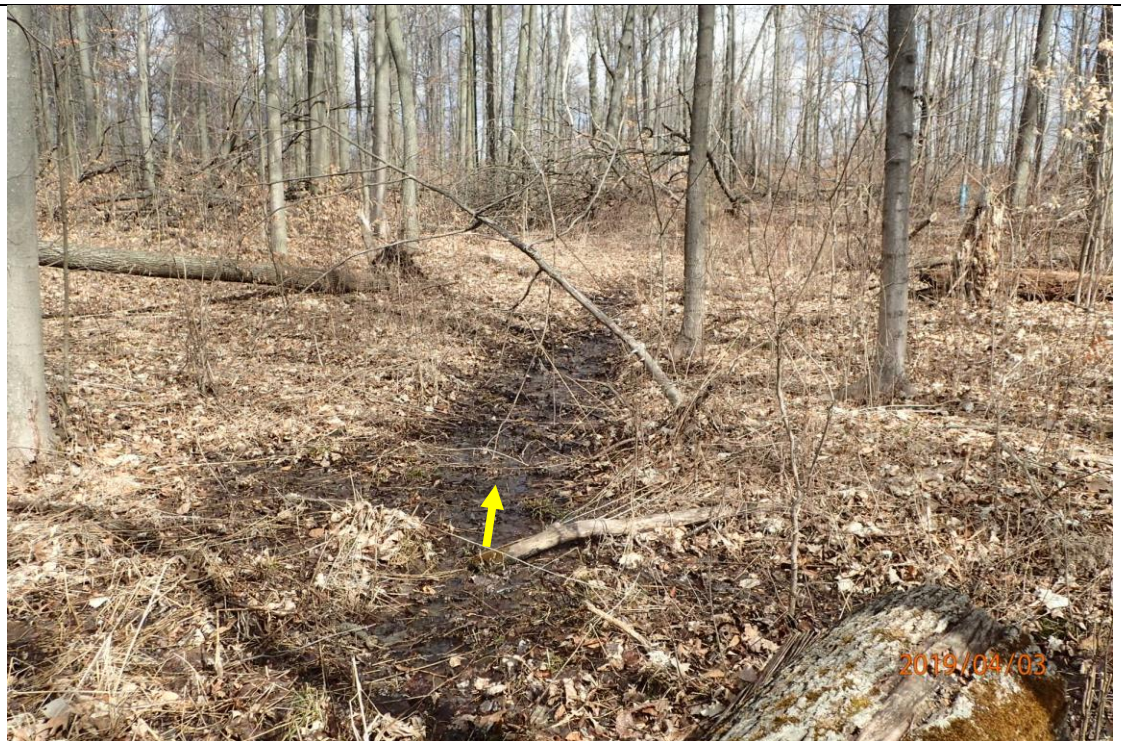
Photo 22  
Tributary of Twenty Mile Creek: Visit 1  
Reach TTM2-12-1b

The feature was a low gradient swale conveying minimal flow through a woodlot. No bed or bank definition were observed.

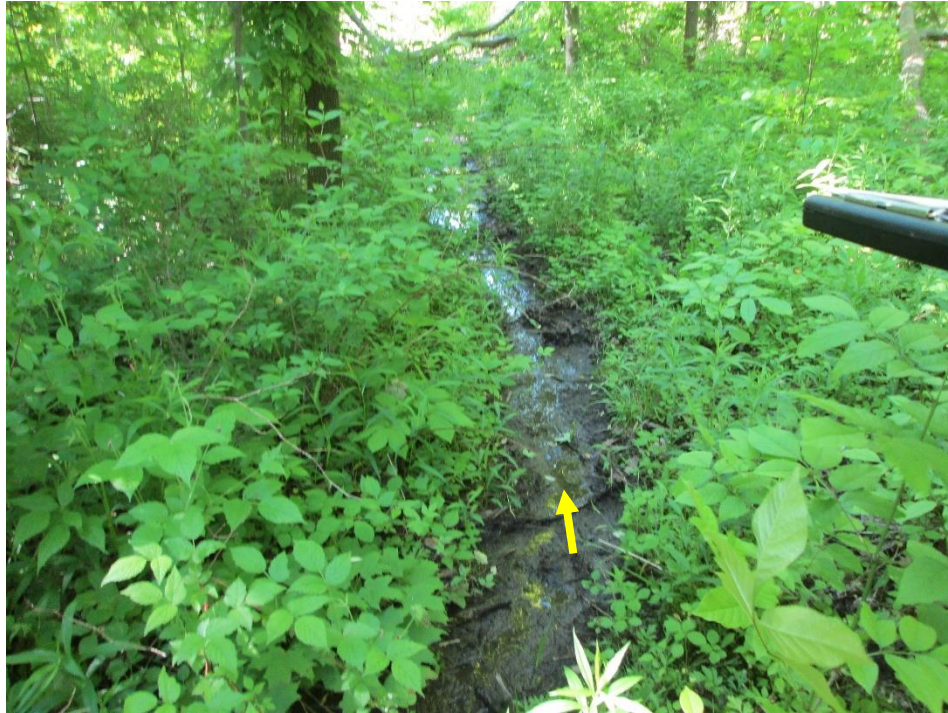
Photo 23  
Tributary of Twenty Mile Creek: Visit 2  
Reach TTM2-12-1b

Riparian vegetation consisted of herbaceous vegetation and deciduous tree species. Standing water was observed during the second visit.

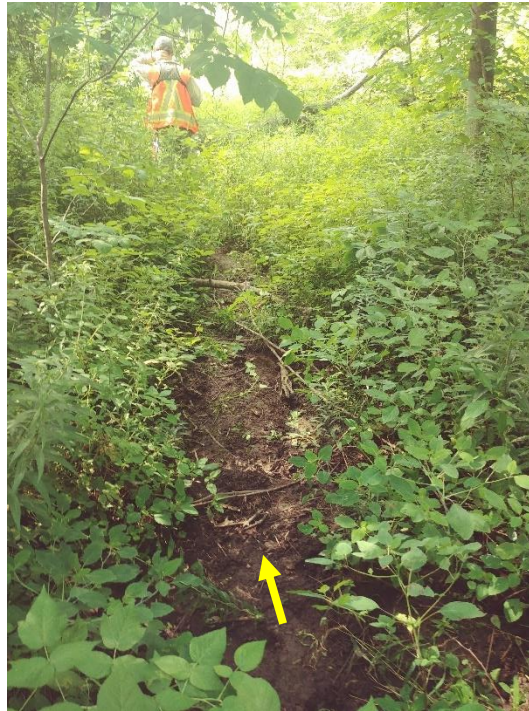
Photo 24  
Tributary of Twenty Mile Creek: Visit 3  
Reach TTM2-12-1b

The feature was dry during the summer visit but distinguishable from the surrounding woodlot. Bed materials consisted of sand, silt and organic matter

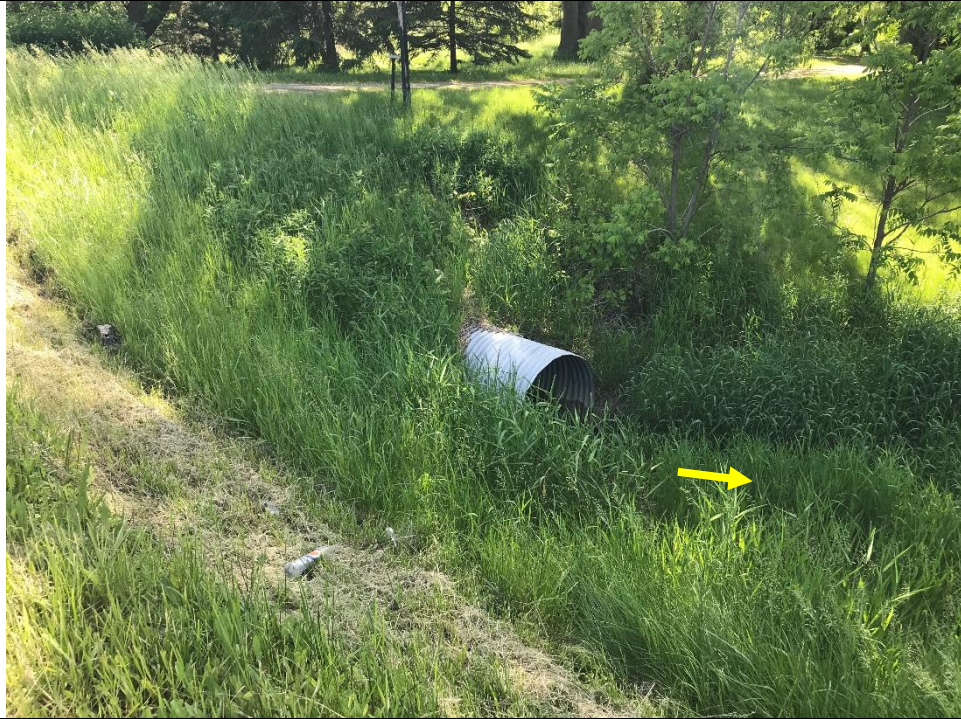
Photo 27  
Tributary of Twenty Mile Creek: Visit 2  
**Reach TTMC3-1**

A culvert discharged flows into the feature near its downstream extent. No water was observed within the pipe during the second visit.

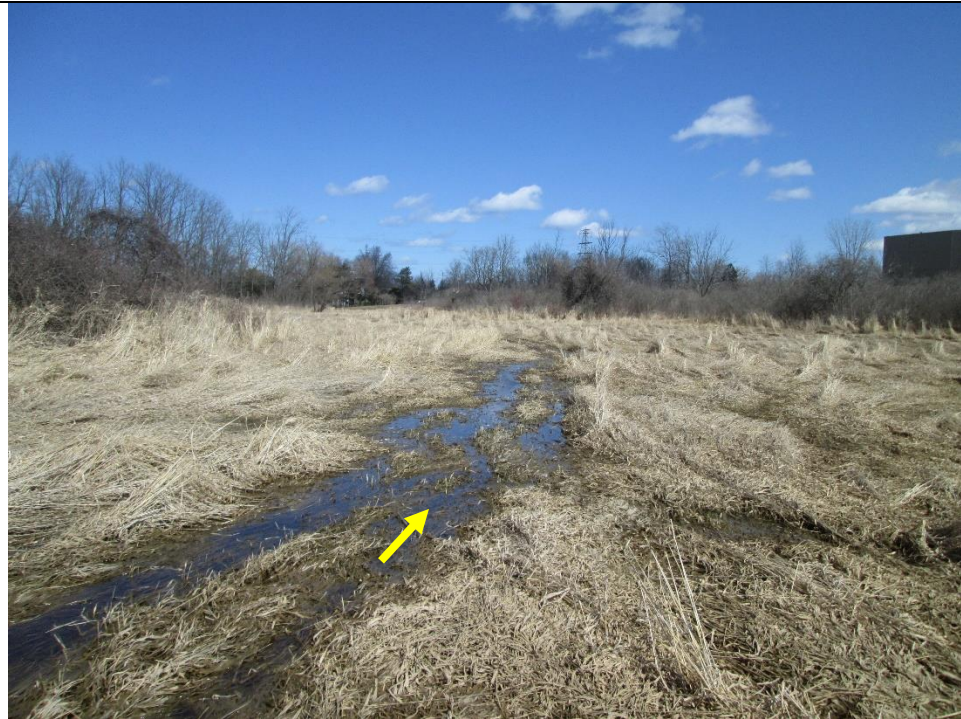
Photo 28  
Tributary of Twenty Mile Creek: Visit 1  
**Reach TTMC3-2**

The feature had no discernible banks, and occupied a wide grassy corridor characterized as a provincially significant wetland (PSW).

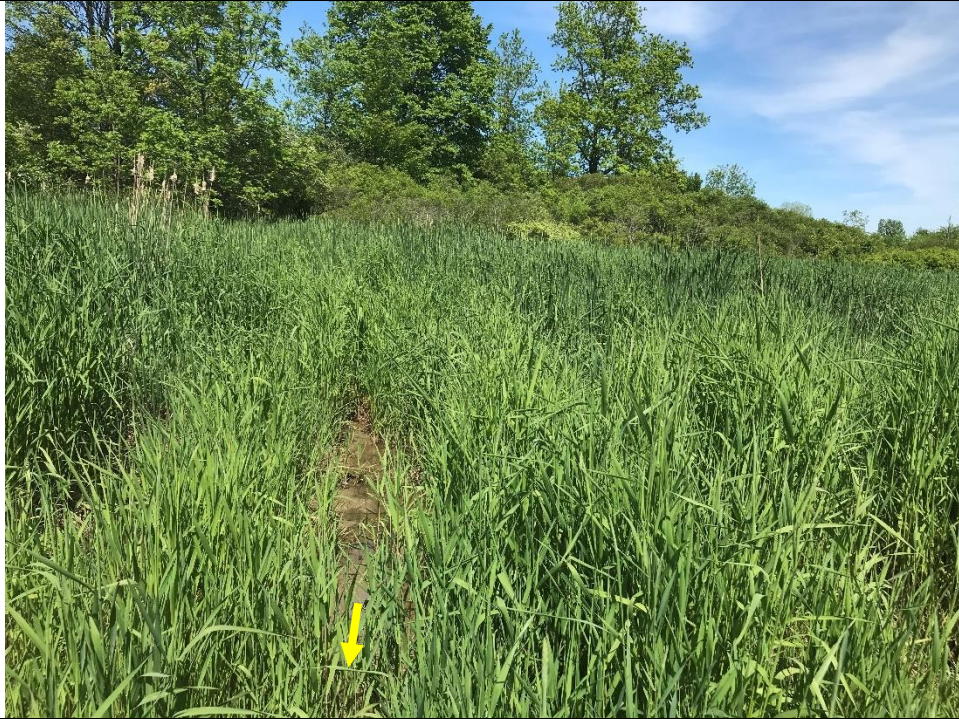
Photo 29  
Tributary of Twenty Mile Creek: Visit 2  
**Reach TTMC3-2**

Riparian vegetation consisted of grasses with sparse herbaceous vegetation, and water was present during all 3 visits.

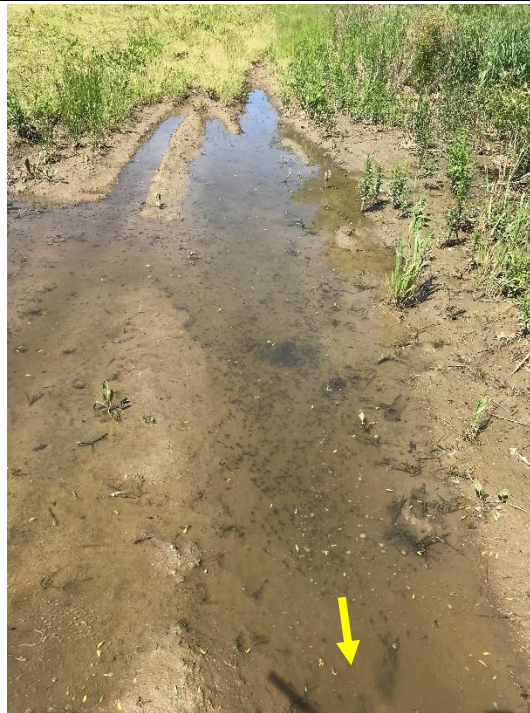
Photo 30  
Tributary of Twenty Mile Creek: Visit 3  
**Reach TTMC3-2**

Tadpoles were observed within an isolated pool. Substrate consisted of clay, silt and organic materials.

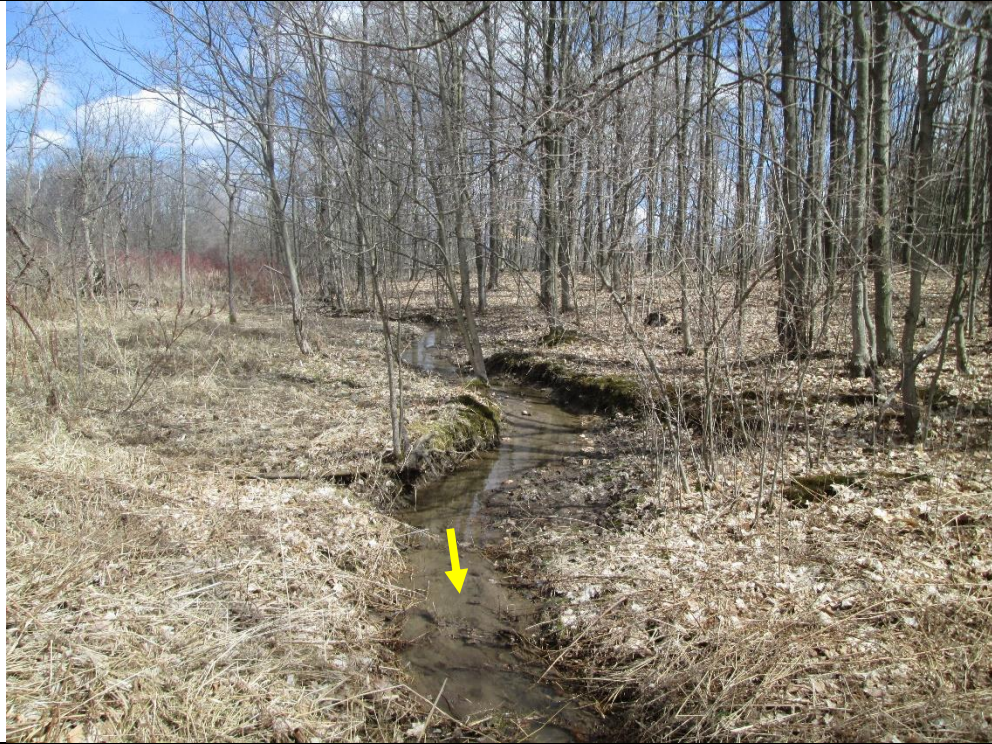
Photo 31  
Tributary of Twenty Mile Creek: Visit 1  
Reach **TTMC3-2-1**

The feature was a defined channel which conveyed flows through a woodlot.

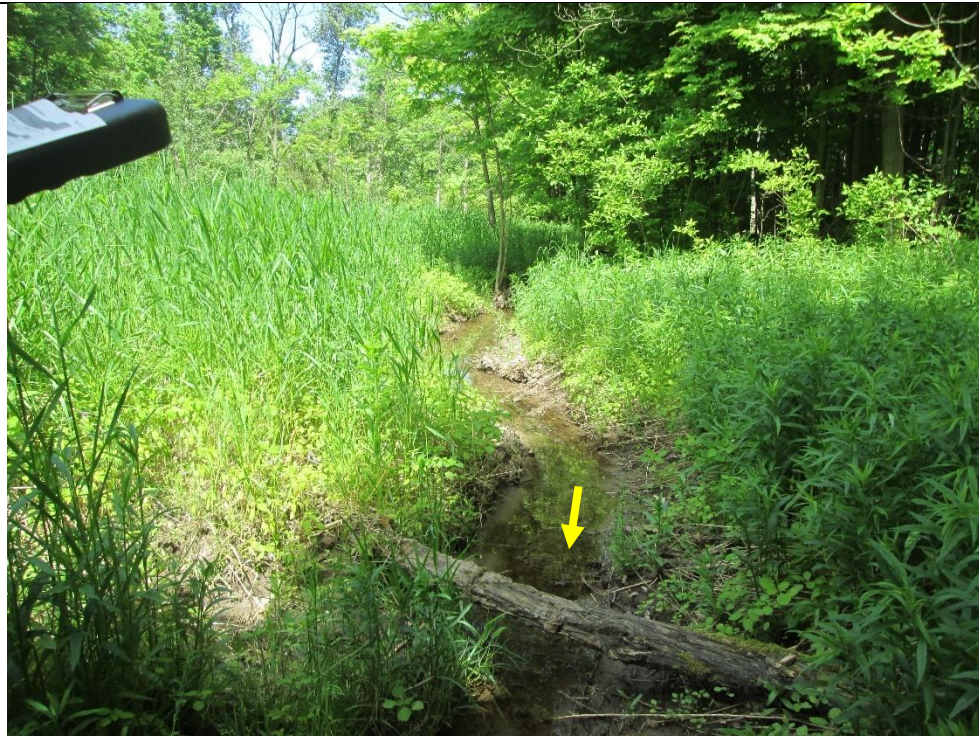
Photo 32  
Tributary of Twenty Mile Creek: Visit 2  
Reach **TTMC3-2-1**

Riparian vegetation included mature deciduous trees as well as some shrubs and hydrophilic herbaceous vegetation

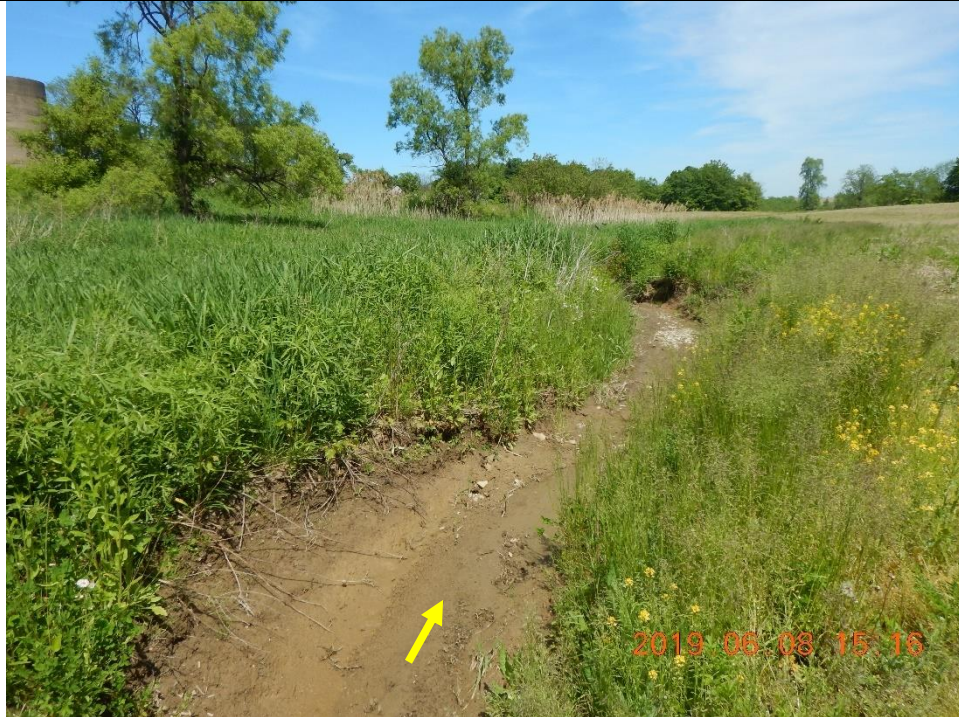
Photo 41  
Tributary of Twenty Mile Creek: Visit 2  
**Reach TTM3-4**

The riparian buffer consisted predominantly of herbaceous species, with some agricultural crops noted on the south side of the channel further downstream.

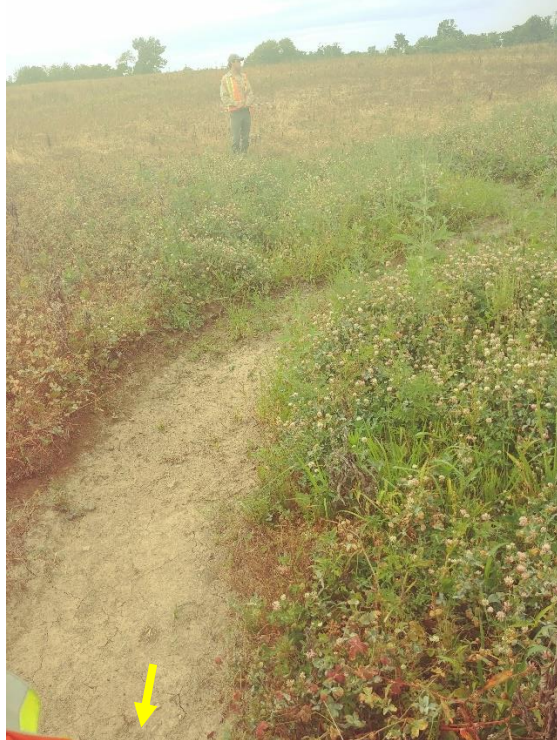
Photo 42  
Tributary of Twenty Mile Creek: Visit 3  
**Reach TTM3-4**

The channel bed was predominantly composed of clay and gravel and was dry during the summer visit.

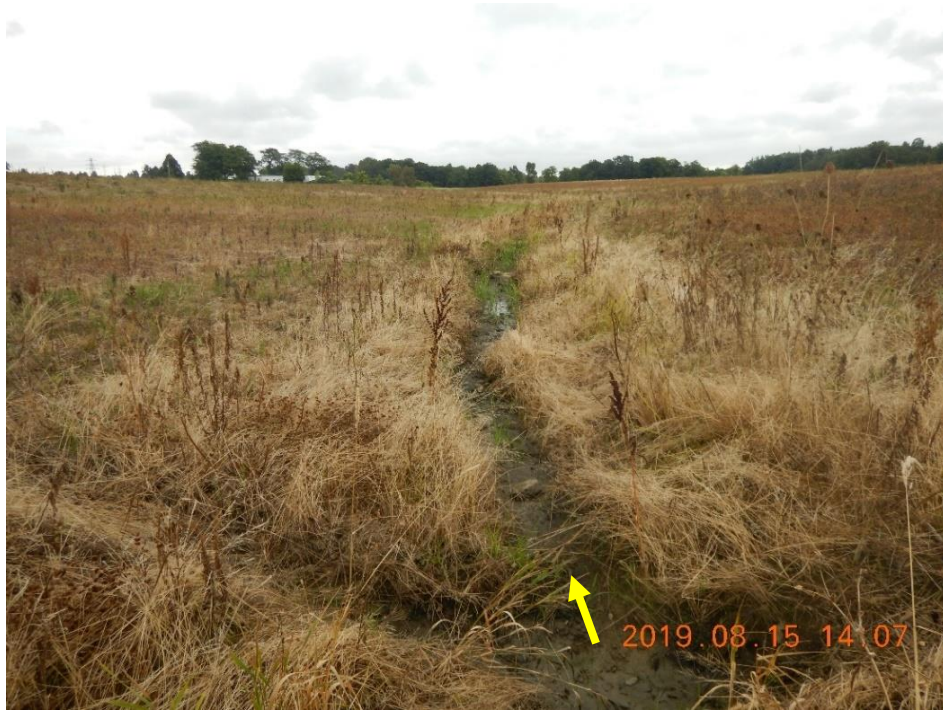
Photo 45  
Tributary of Twenty Mile Creek: Visit 3  
Reach **TTMC3-5**

The dominant substrate was clay and silt, but some sand, gravel and, cobbles were also observed. The channel was mainly dry with some isolated stagnant pools.

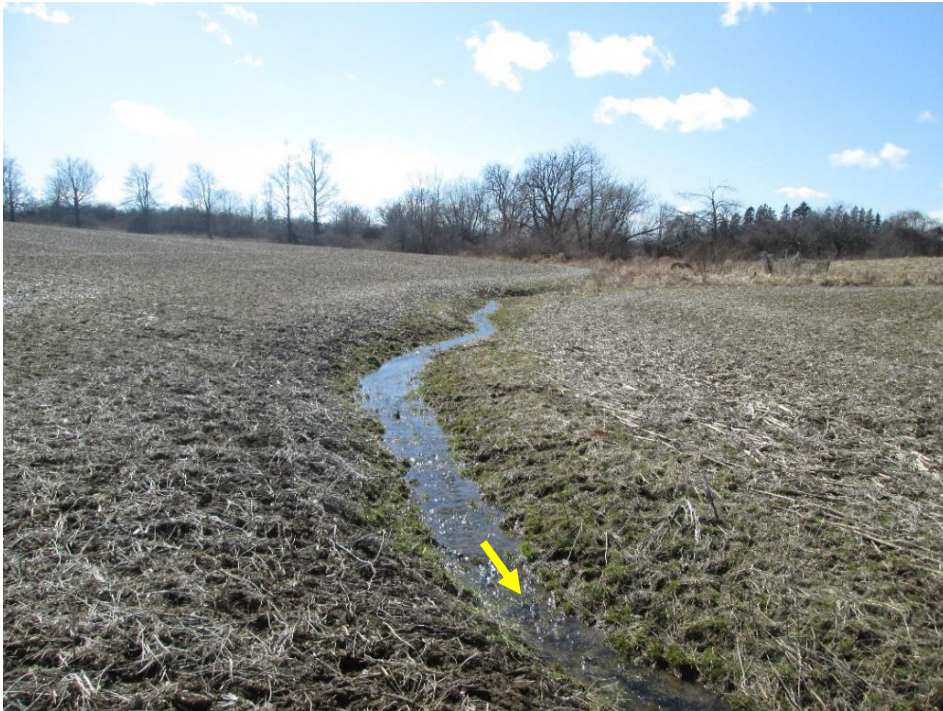
Photo 46  
Tributary of Twenty Mile Creek: Visit 1  
Reach **TTMC3-6**

The feature conveyed flows through an agricultural field, with water present during the spring visit.

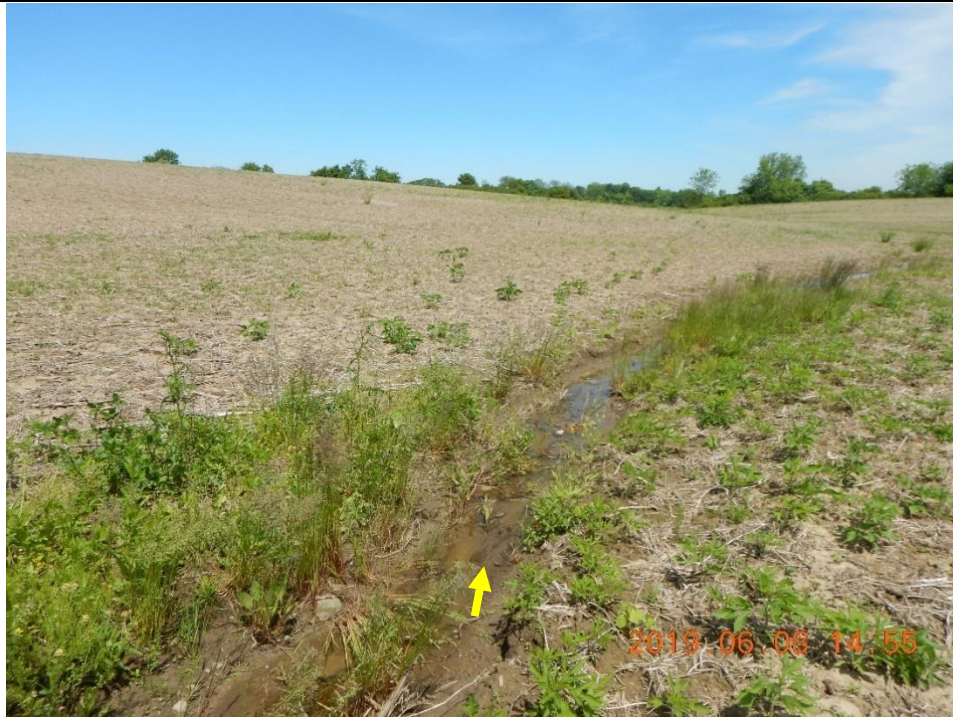
Photo 47  
Tributary of Twenty Mile Creek: Visit 2  
Reach TTM3-6

Riparian vegetation was predominantly agricultural crops, with some herbaceous and grass species also observed.

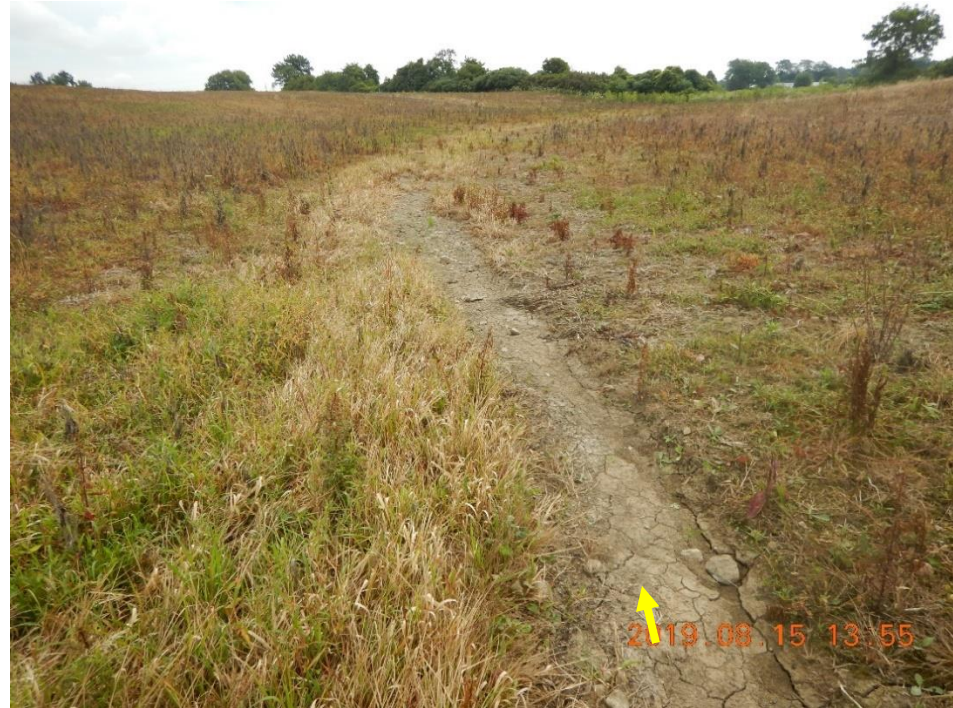
Photo 48  
Tributary of Twenty Mile Creek: Visit 3  
Reach TTM3-6

Bed and banks were mostly composed of the same material as the agricultural fields, a clay, silt, sand mixture, although some cobbles were present.

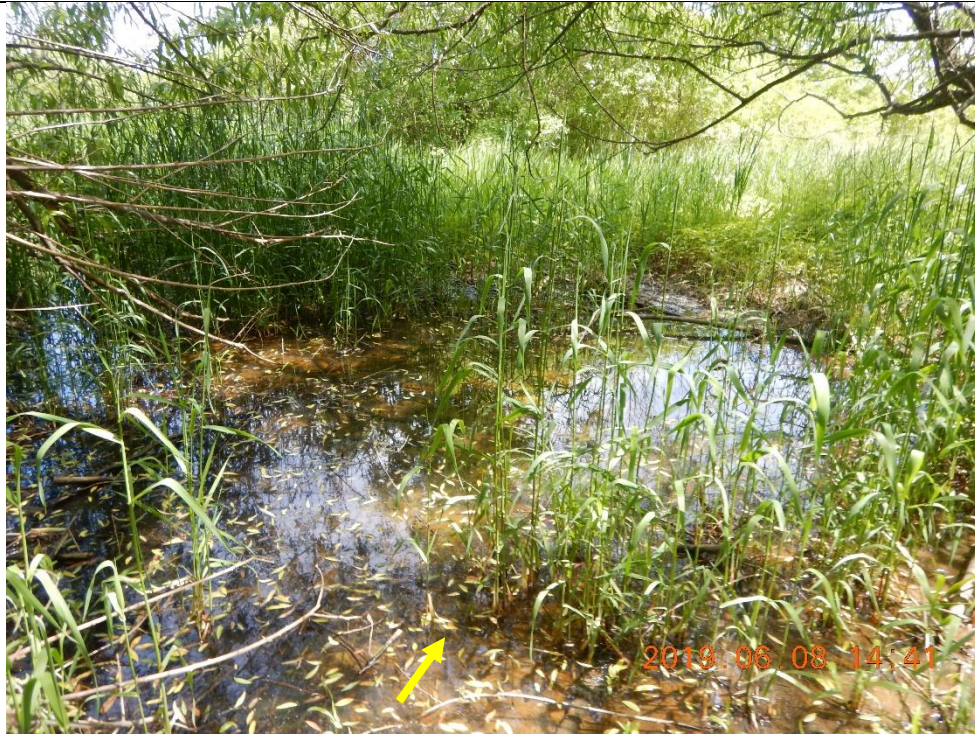
Photo 53  
Tributary of Twenty Mile Creek: Visit 2  
Reach TTM3-8

Riparian vegetation consisted of deciduous trees and herbaceous vegetation.

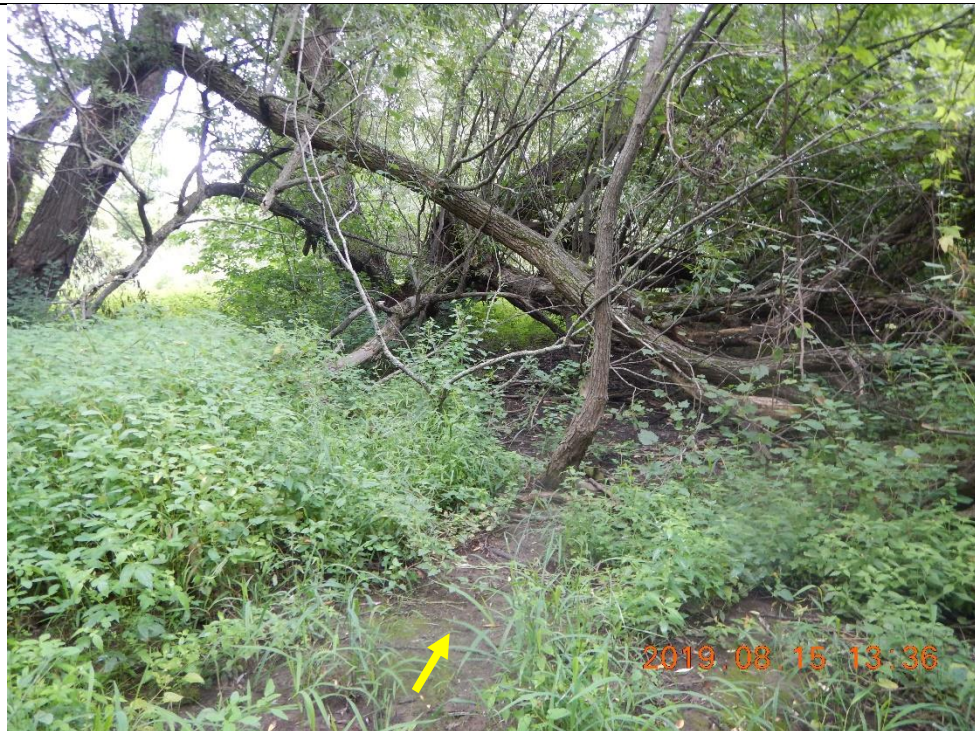
Photo 54  
Tributary of Twenty Mile Creek: Visit 3  
Reach TTM3-8

Bed materials consisted of clay, silt, sand and organic material. The feature was dry during the summer visit.

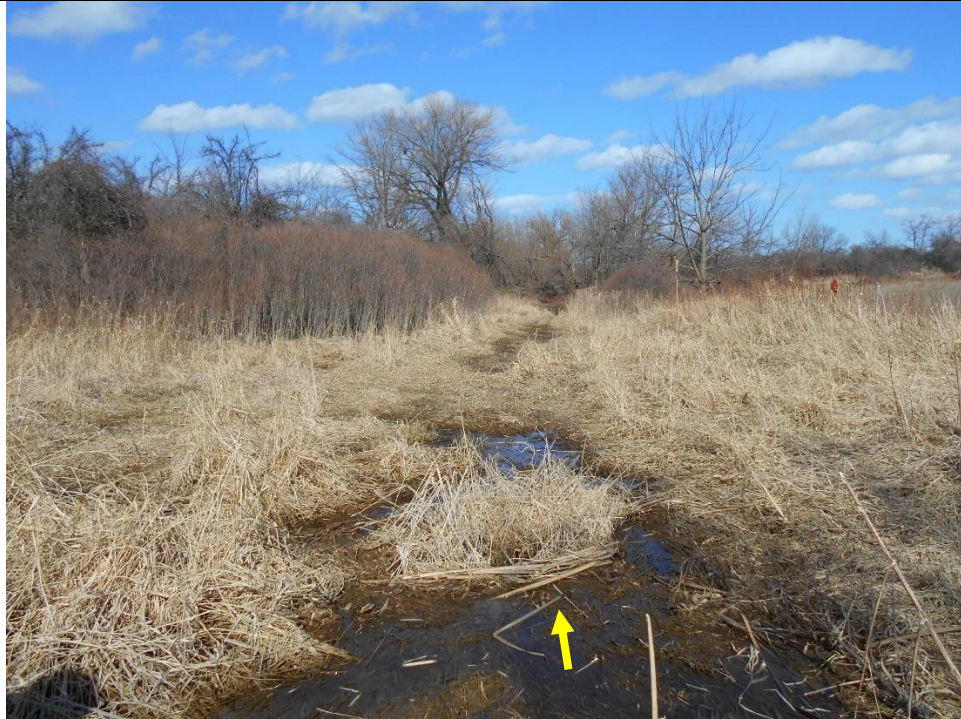
Photo 57  
Tributary of Twenty Mile Creek: Visit 1  
Reach TTM3-10

The feature lacked bed and bank definition and conveyed flows through a meadow.

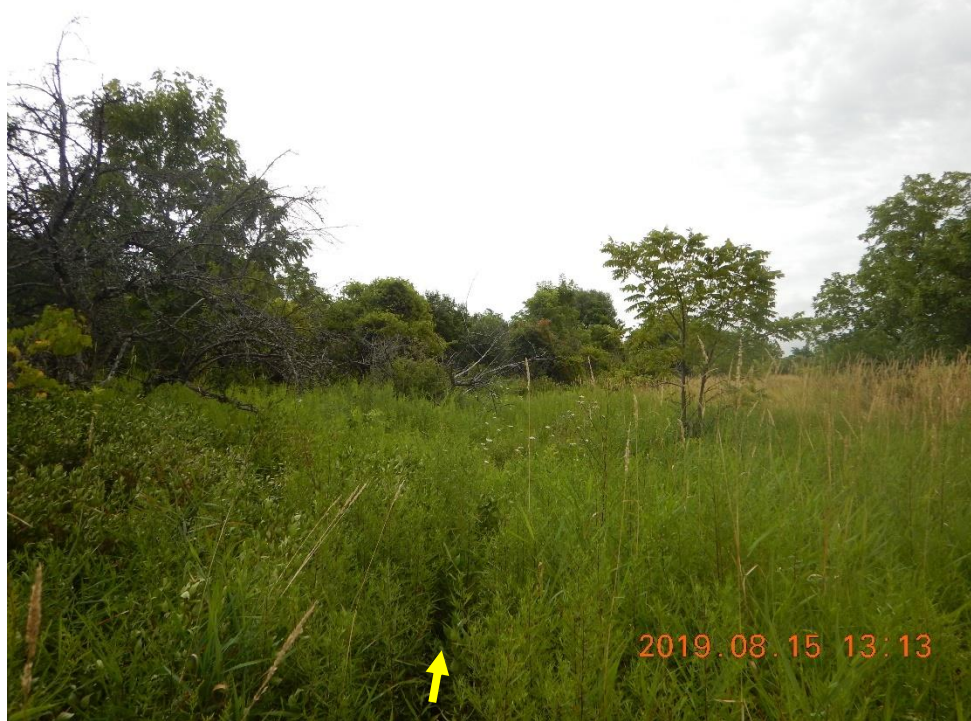
Photo 59  
Tributary of Twenty Mile Creek: Visit 3  
**Reach TTM3-10**

The substrate within the reach was clay, silt and sand. No flows were observed during the summer visit.
