# Upper West Side - Fluvial Geomorphological Assessment Twenty Road West, City of Hamilton

June 12, 2020  
PN18013

Report Title: Upper West Side Draft Plan of Industrial Subdivision  
Fluvial Geomorphological Assessment - Update

Project Number: PN18013

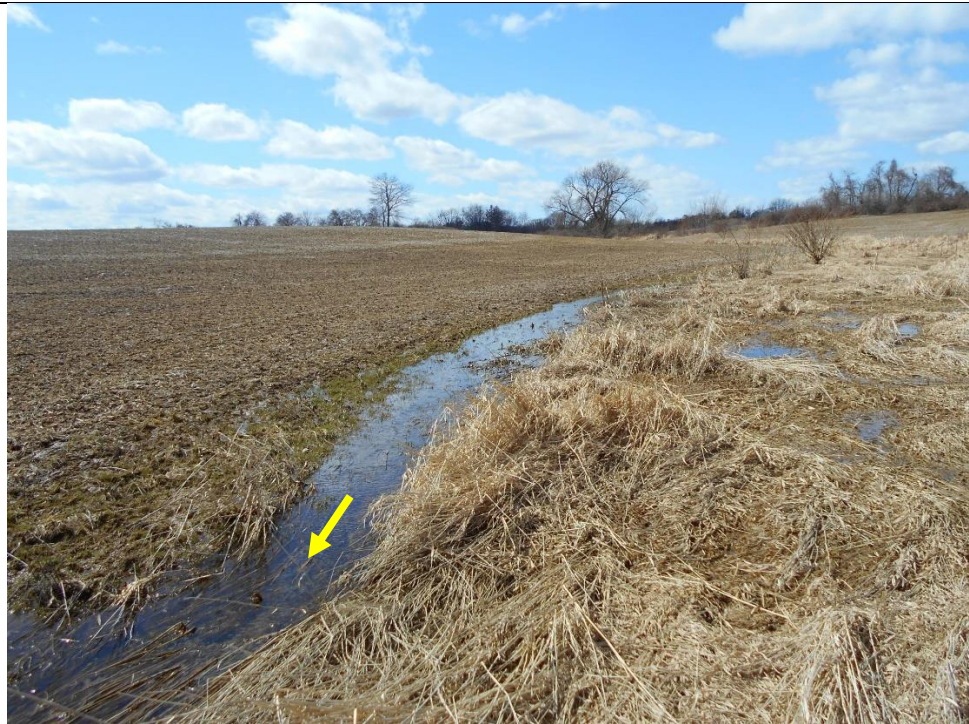
Photo 60  
Tributary of Twenty Mile Creek: Visit 1  
**Reach TTM5-4**

The feature had poor channel definition and conveyed flows through an agriculture field.

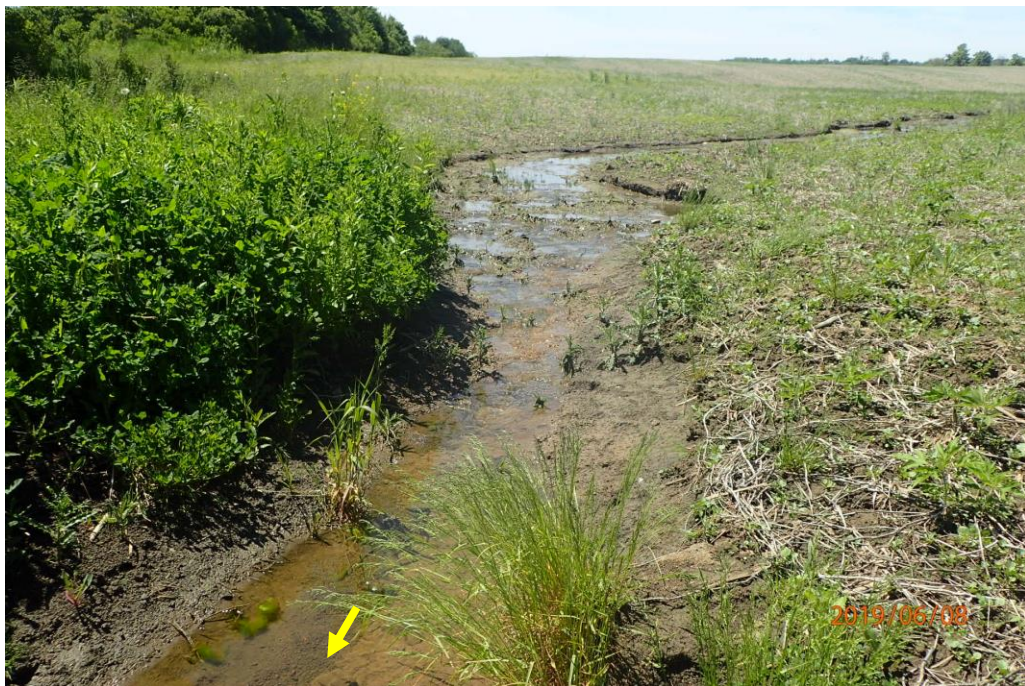
Photo 64  
Tributary of Twenty Mile Creek: Visit 2  
**Reach TTMC5-5**

The swale lacked a natural riparian corridor and was instead flanked by agricultural fields.

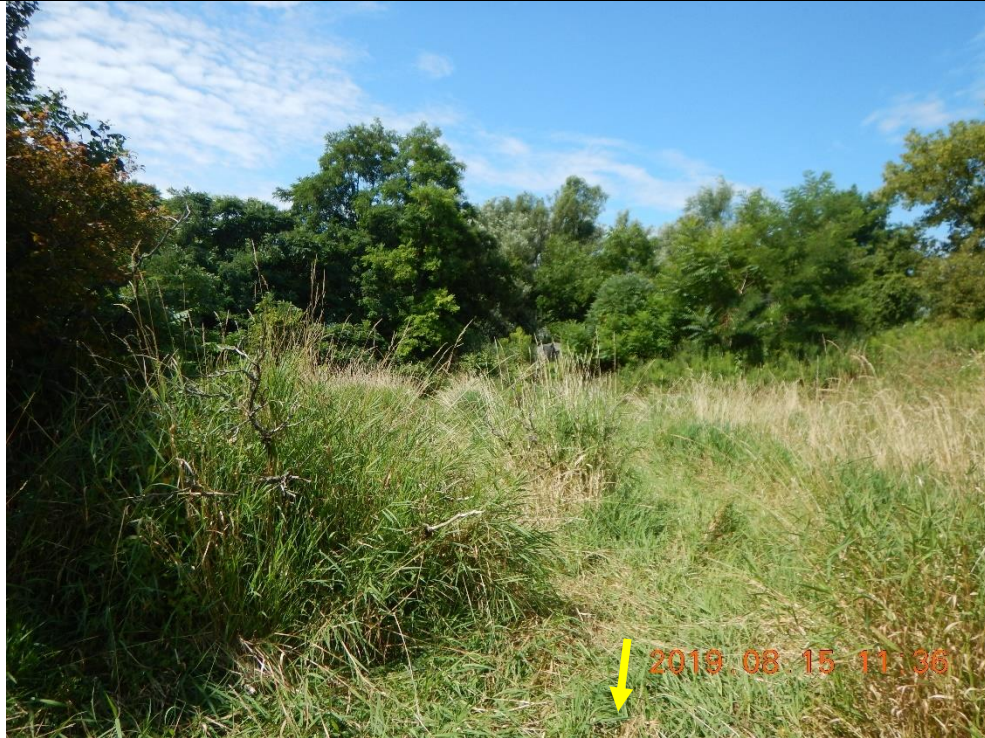
Photo 67  
Tributary of Twenty Mile Creek: Visit 3  
Reach TTMCS-6

The feature was a wide grassy corridor composed of hydrophilic vegetation with deciduous trees occupying the riparian buffer.

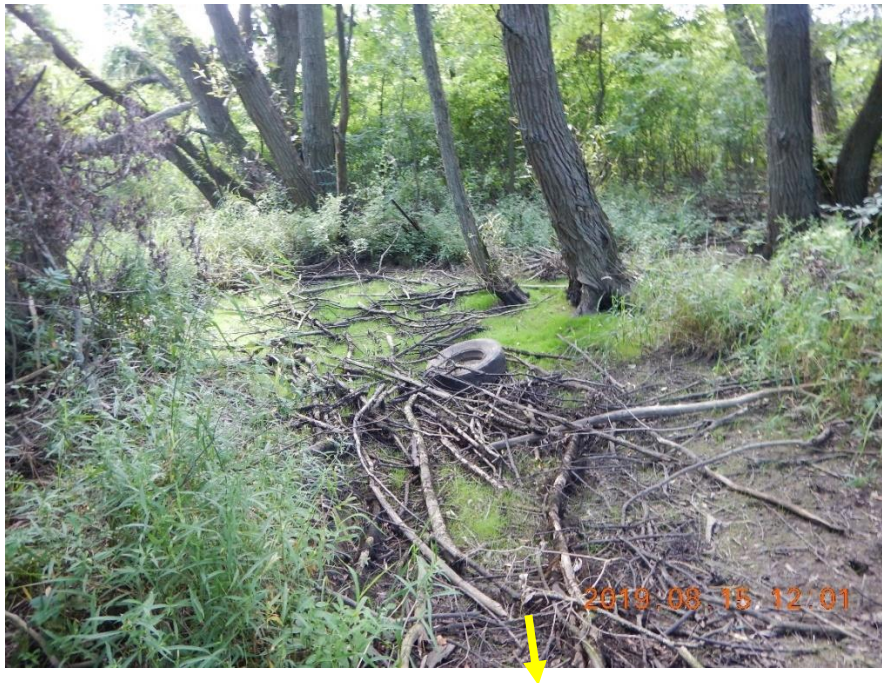
Photo 68  
Tributary of Twenty Mile Creek: Visit 3  
Reach TTMCS-6

The substrate within the channel was predominantly clay, silt and sand. No water was observed during the summer visit.

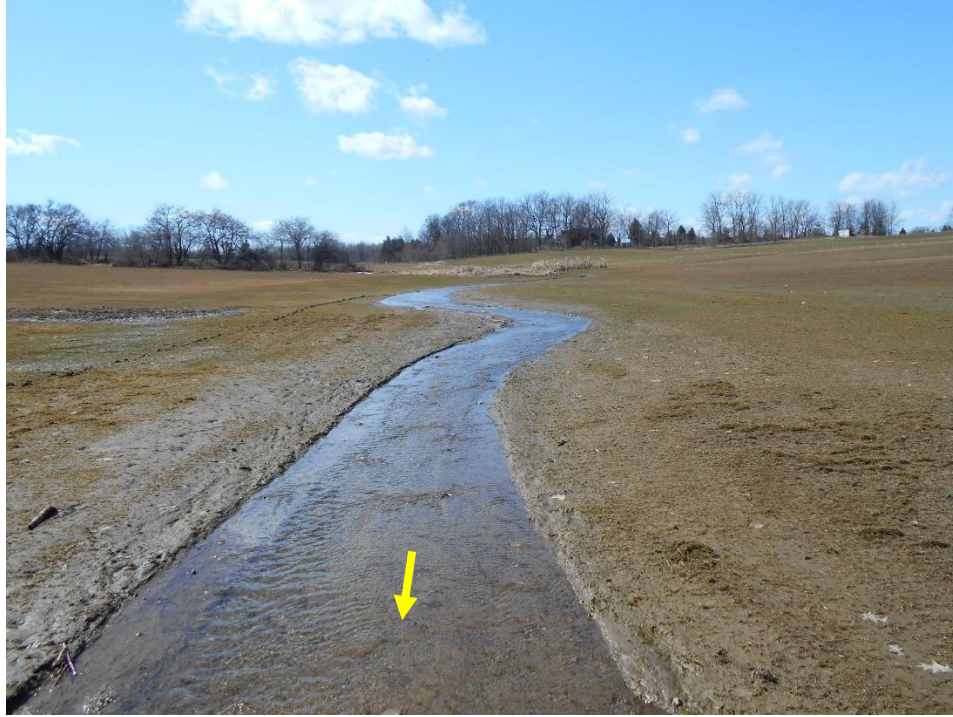
Photo 69  
Tributary of Twenty Mile Creek: Visit 1  
**Reach TTMCS-7**

The feature had some bed and bank definition during the spring as it conveyed flows through an agricultural field.

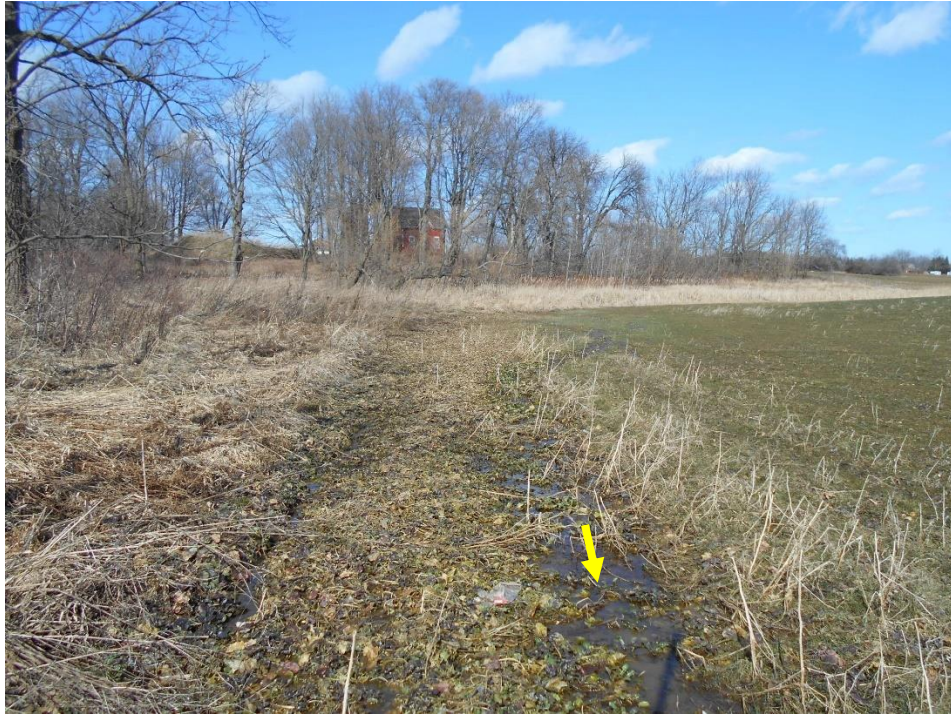
Photo 75  
Tributary of Twenty Mile Creek: Visit 1  
Reach **TTMC5-8-1**

The feature had poorly defined banks, but a discernible channel was observed. Water was flowing during the spring visit.

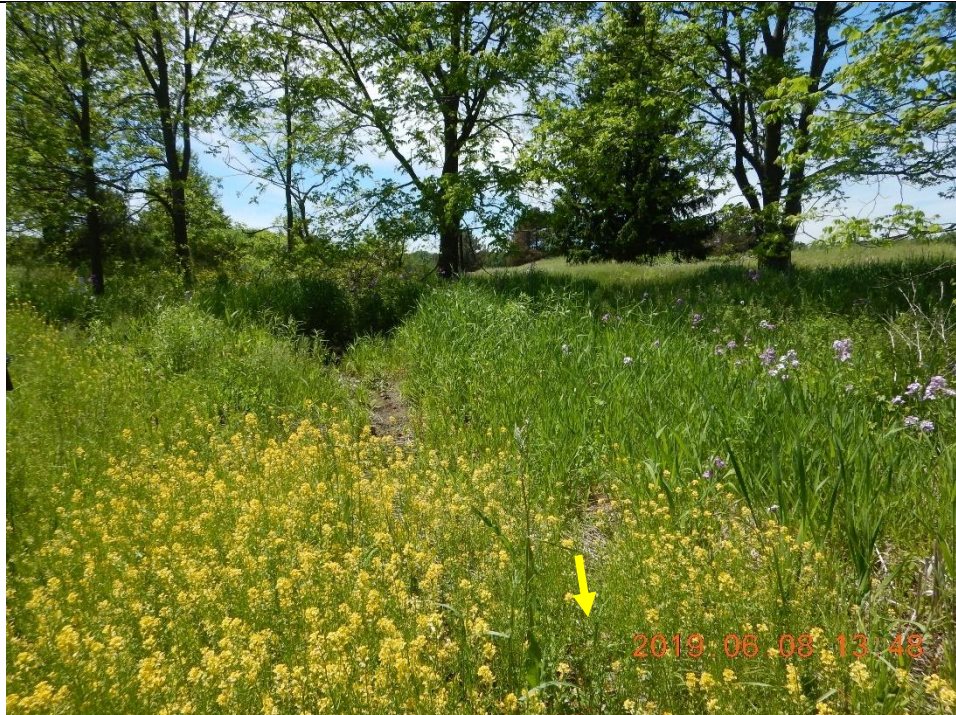
Photo 76  
Tributary of Twenty Mile Creek: Visit 2  
Reach **TTMC5-8-1**

Riparian vegetation consisted of herbaceous vegetation and grasses. The channel was dry during the second visit.

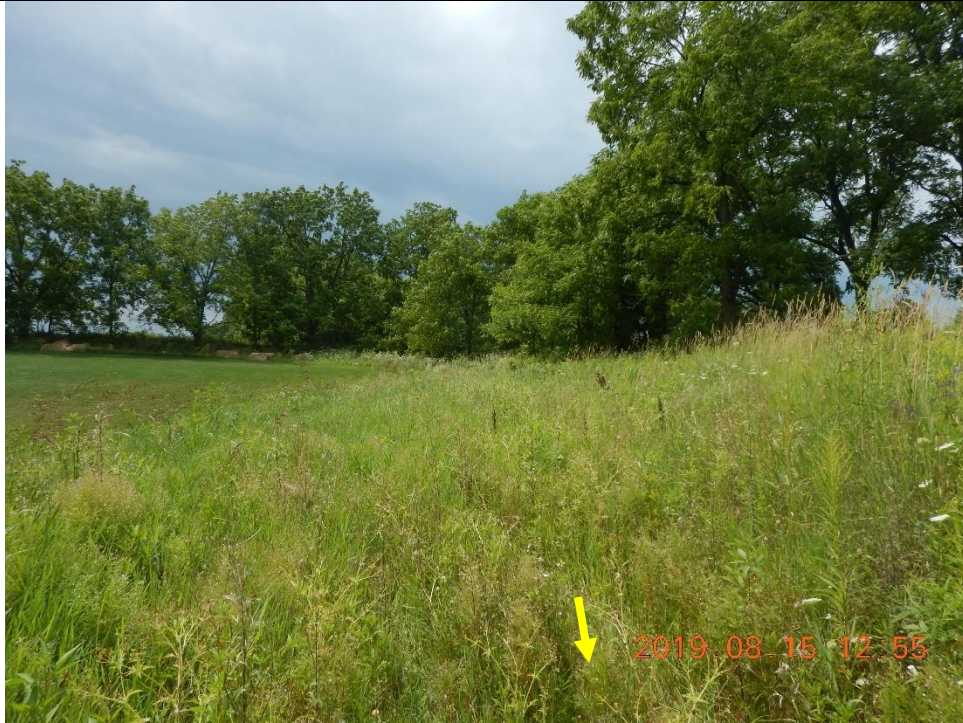
Photo 77  
Tributary of Twenty Mile Creek: Visit 3  
Reach **TTMC5-8-1**

Bed substrate consisted of clay, silt and sand. The feature was again dry during the summer visit.

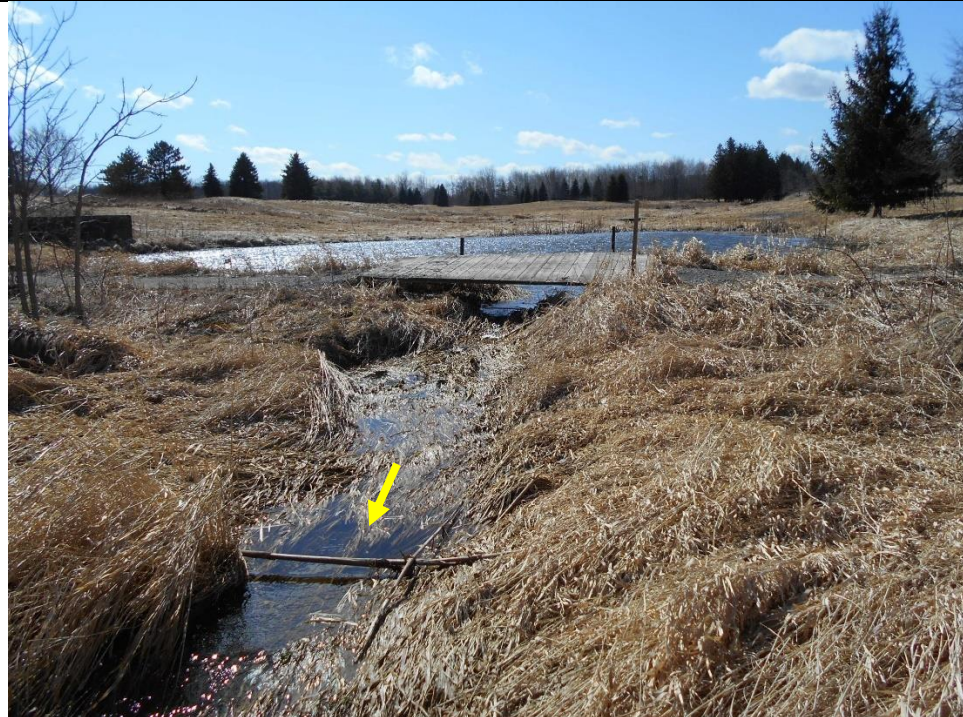
Photo 78  
Tributary of Twenty Mile Creek: Visit 1  
Reach **TTMC5-9**

The feature originated at the outlet of a small pond within the former Glancaster Golf and Country Club and conveyed flows through an agricultural field.

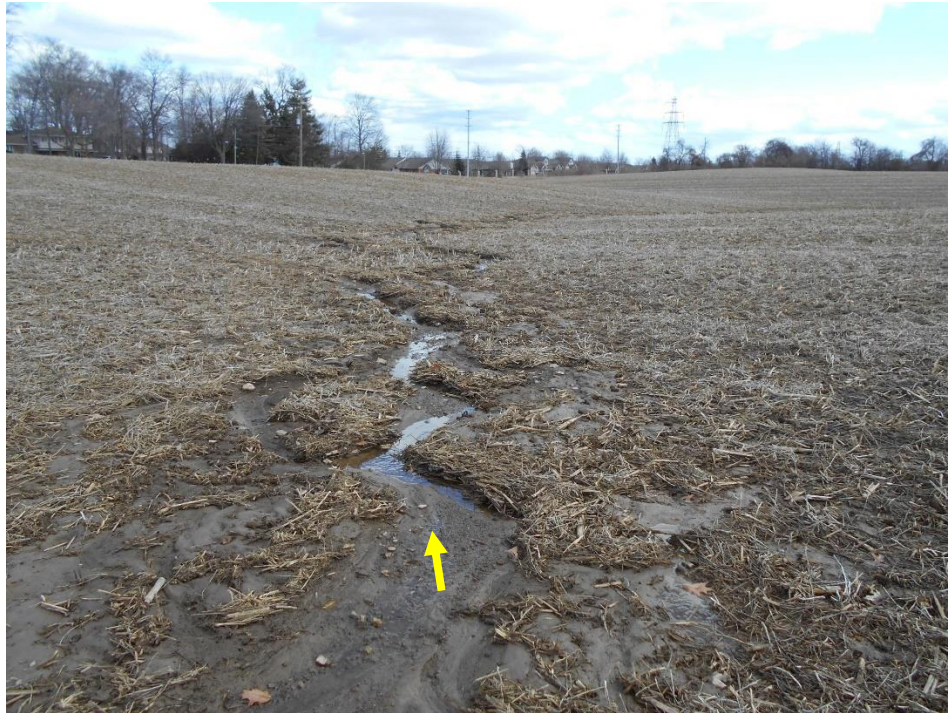
The feature lacked defined bed and banks, and minimal flow was observed during the spring site visit.

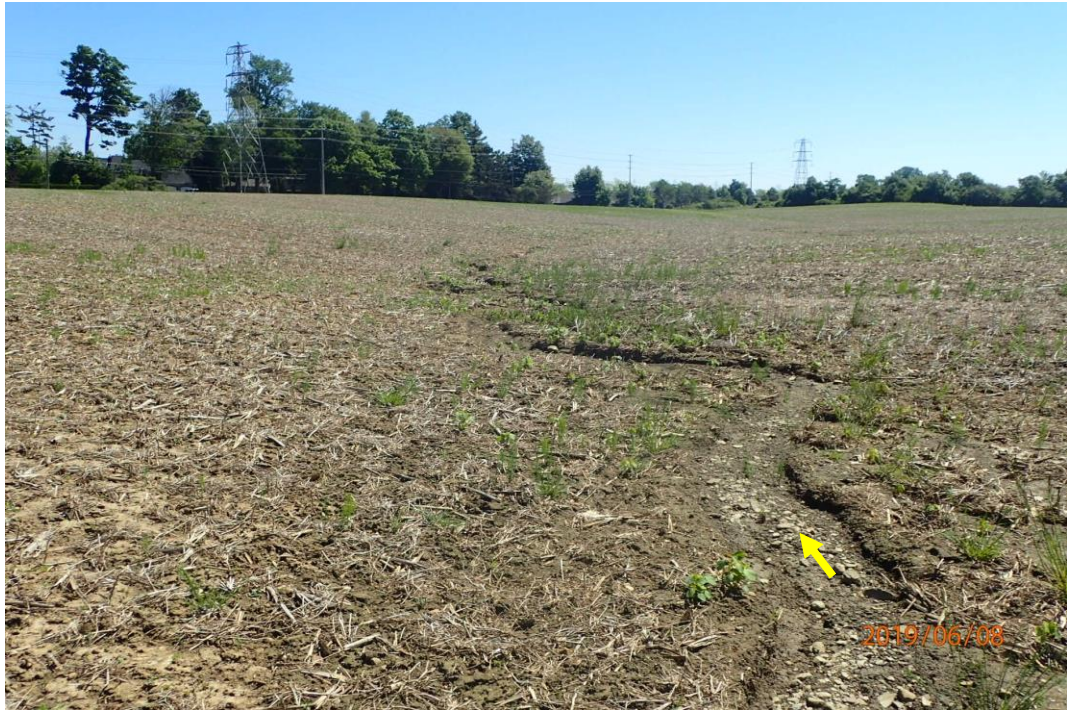
The channel was dry during the 2<sup>nd</sup> visit and the substrate was predominantly clay, silt, and sand. Some gravel and cobbles were also observed.

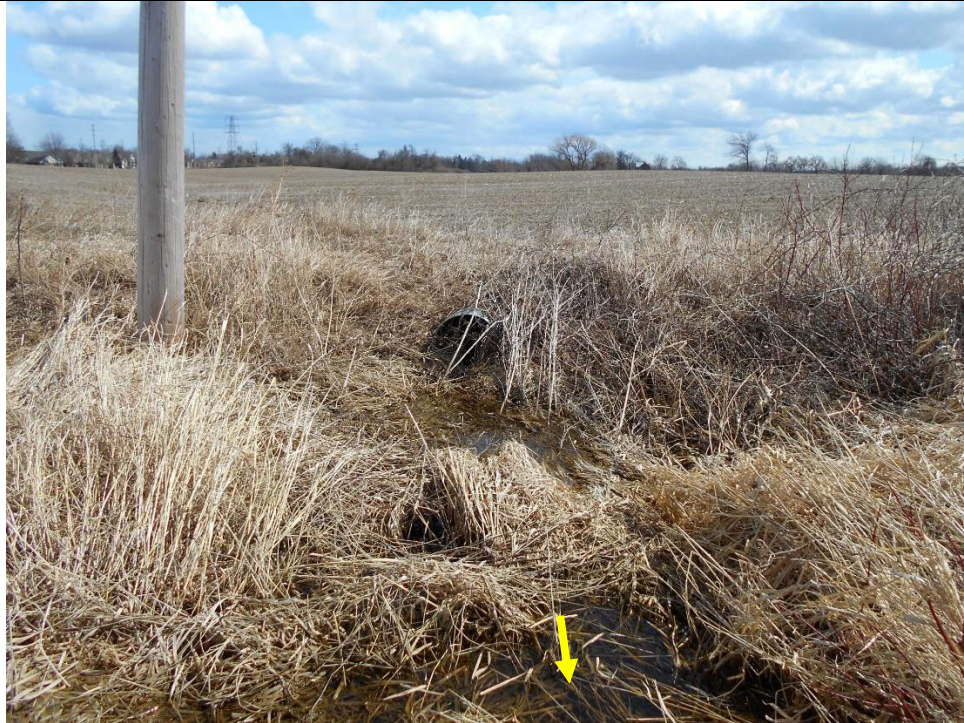
The feature had poor channel definition and originated at a culvert. The reach conveyed flows within the fallow orchard.

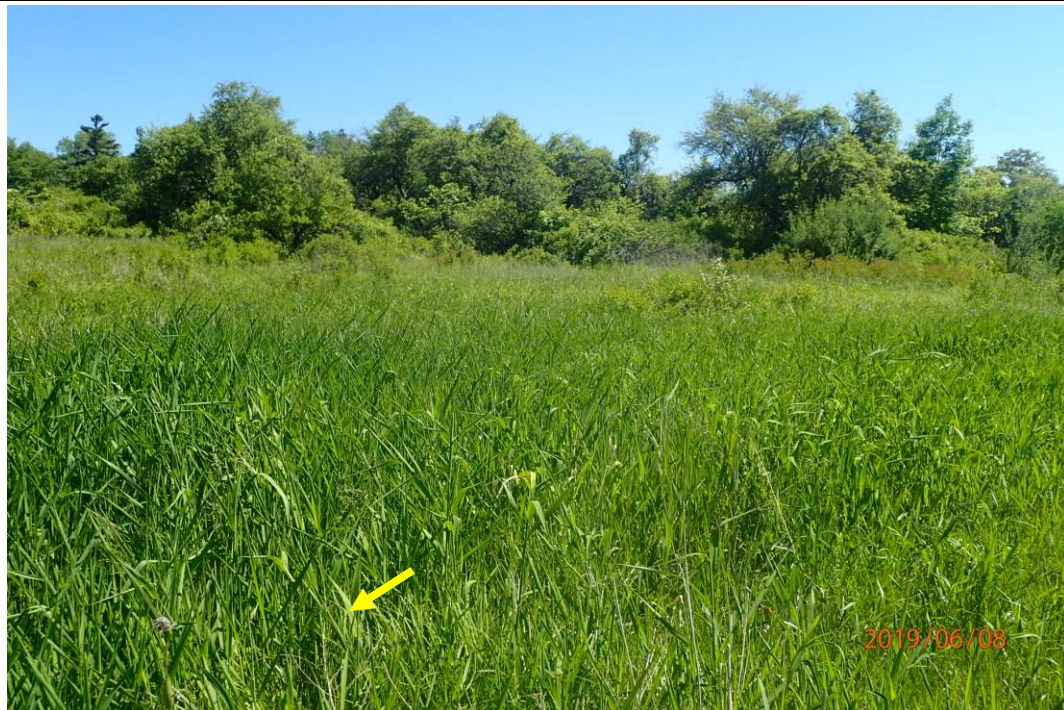
The feature was filled with dense, rooted emergent aquatic vegetation, particularly grasses, and was flanked by both meadow and scrubland within the riparian buffer.

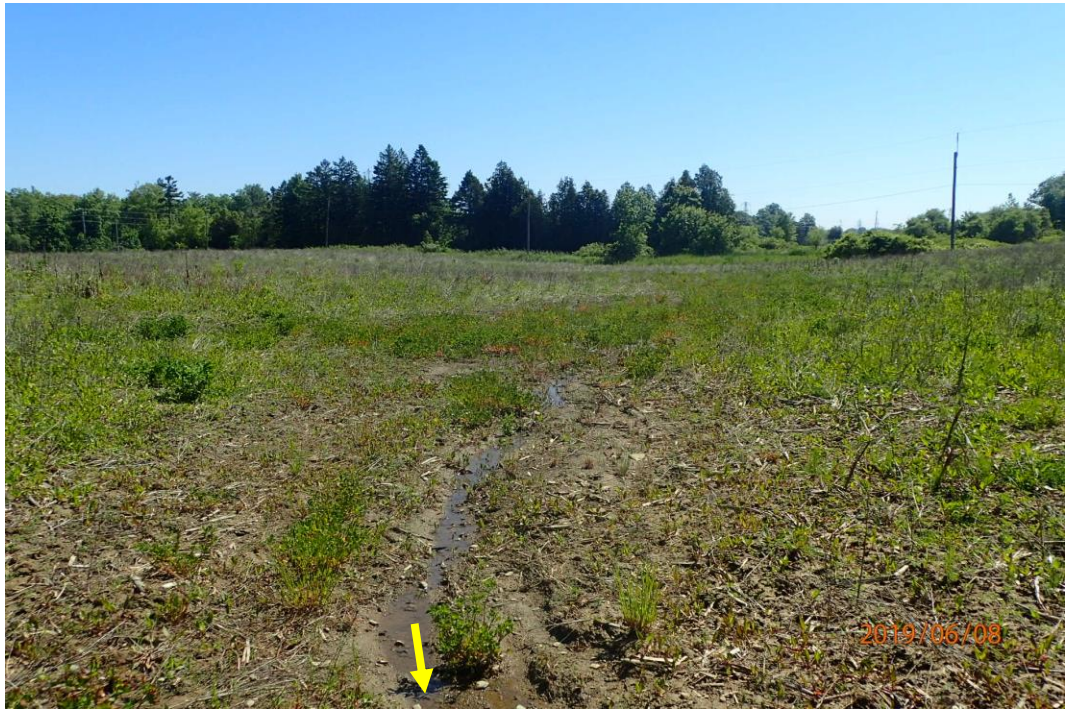
The channel was located adjacent to an un-planted agricultural field and had a narrow herbaceous riparian buffer.

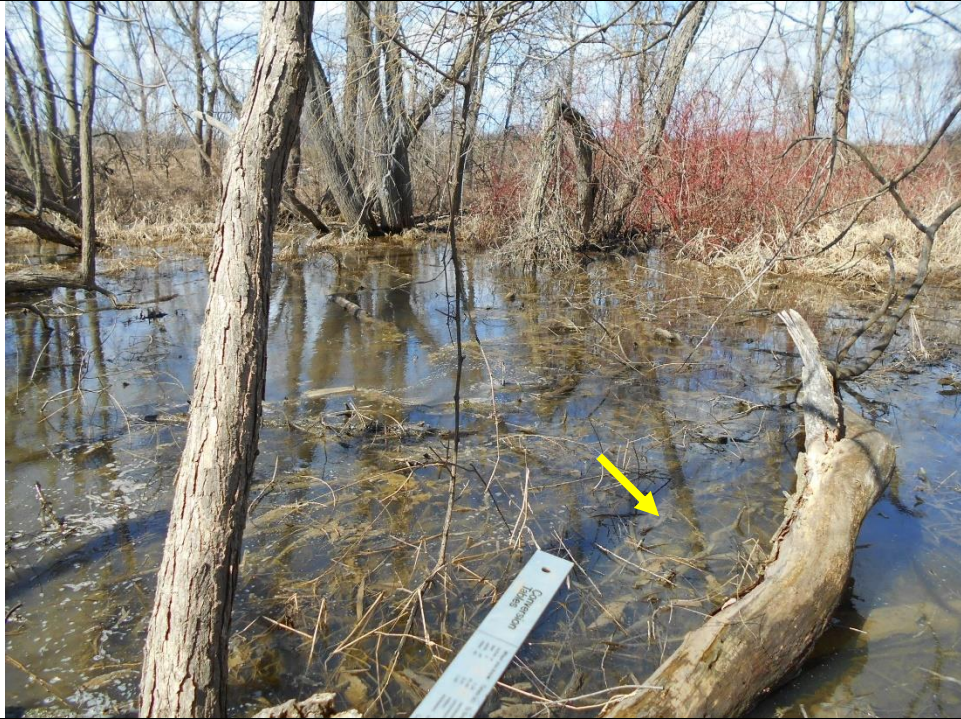
The feature lacked definition and is best described as a vernal pool within a wide hedgerow between two agricultural fields.

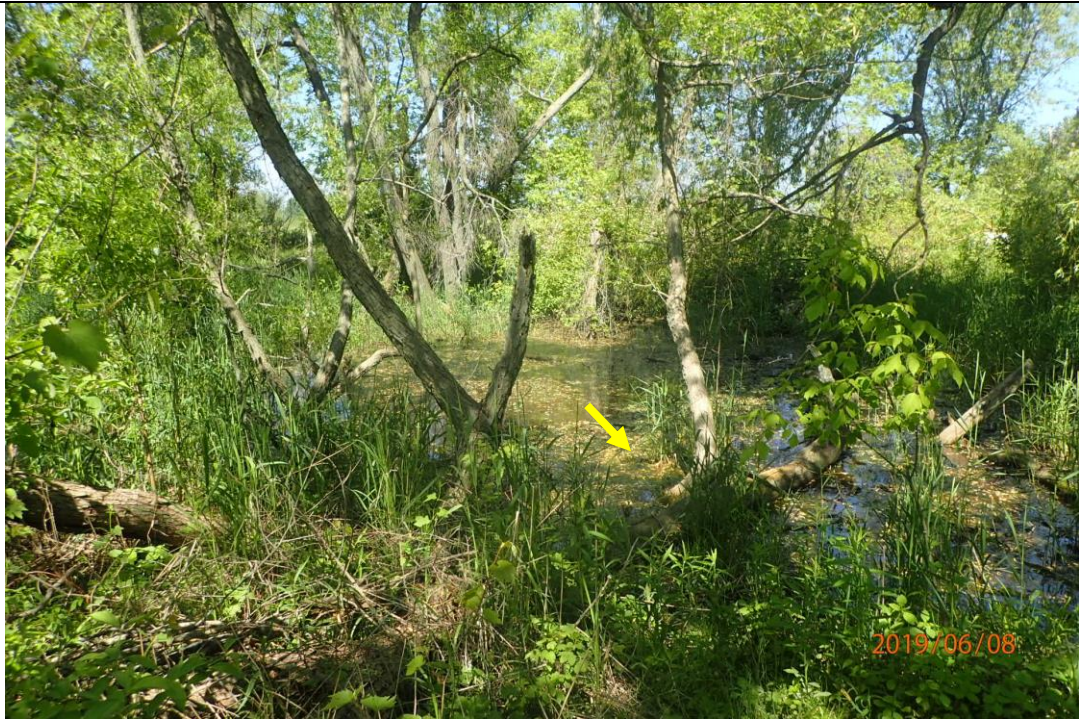
The feature was surrounded by scrubland and deciduous trees.

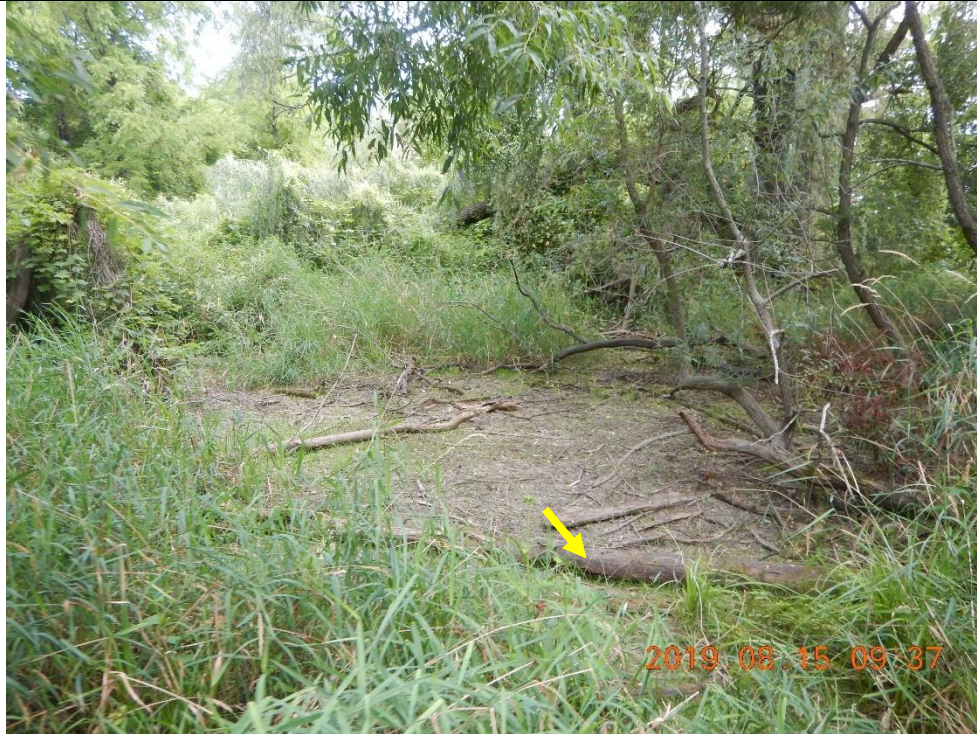
The feature was dry during the summer visit and its substrate consisted predominantly of decomposing organics.

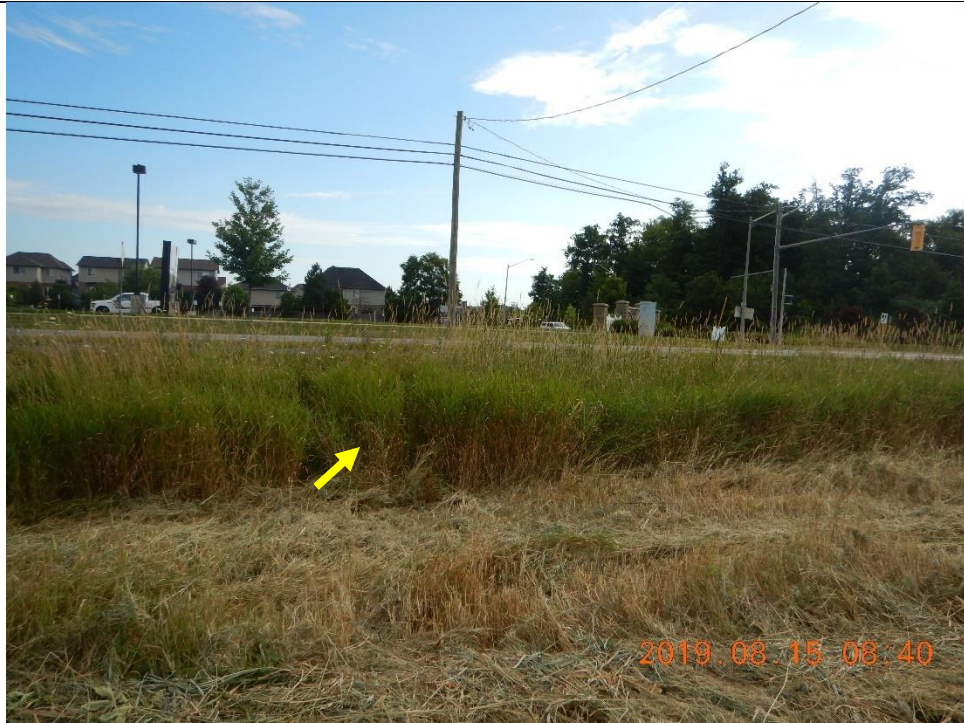
Bed material for the reach was predominantly clay, silt and sand. No water was present within the reach during the third visit.

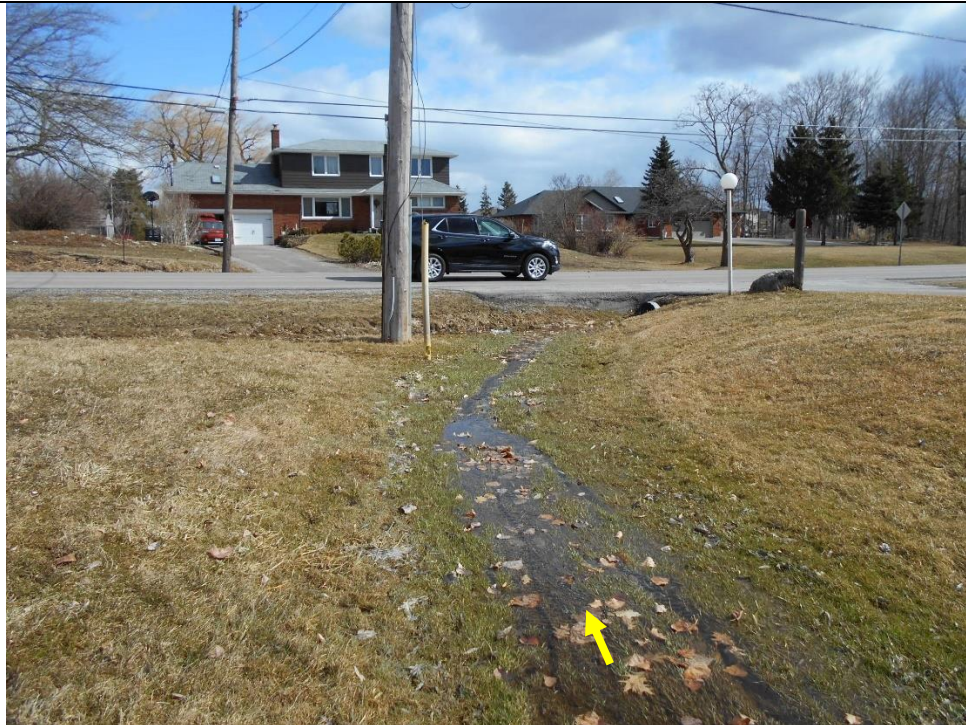
The feature lacked bed and bank definition and conveyed flows towards a roadside ditch at Twenty Road West.

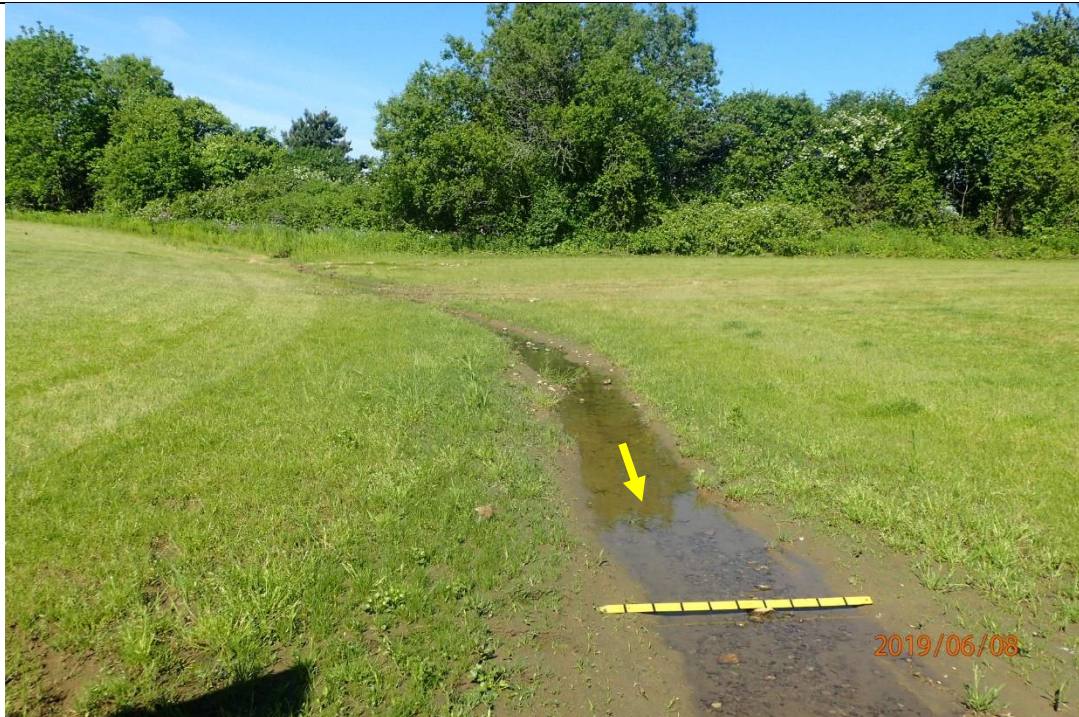
The feature lacked a natural riparian buffer, and was predominantly cropped with some areas lacking any vegetation.

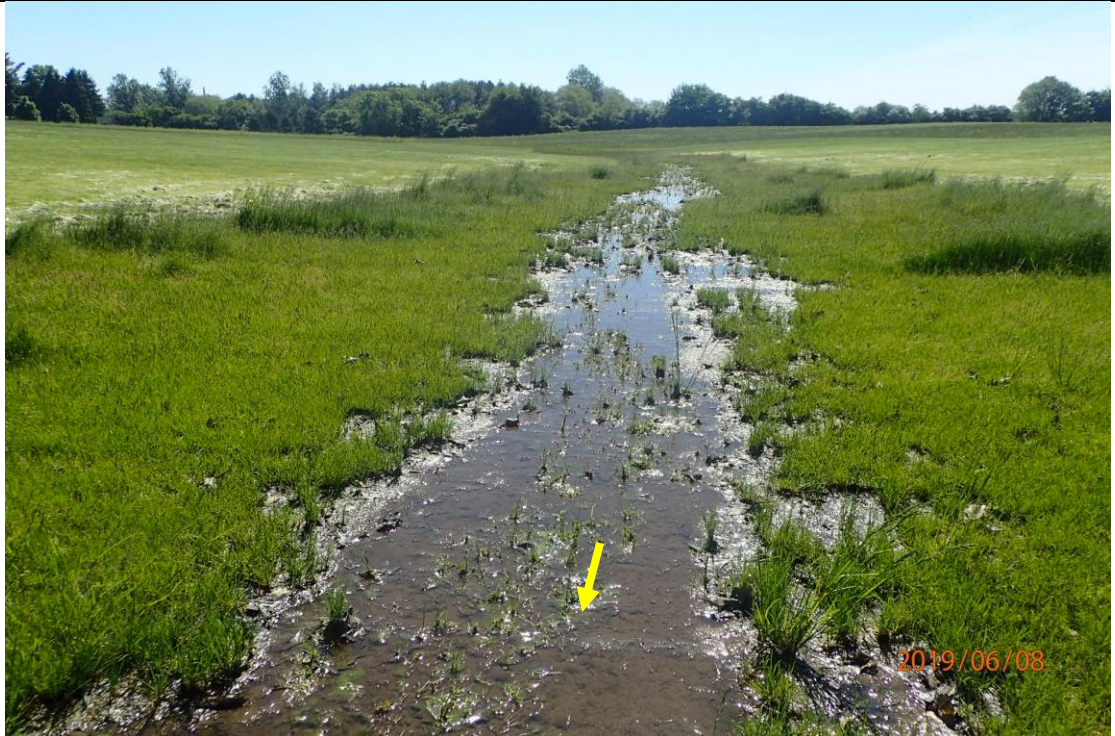
The feature was a swale which conveyed flows through an agricultural field.

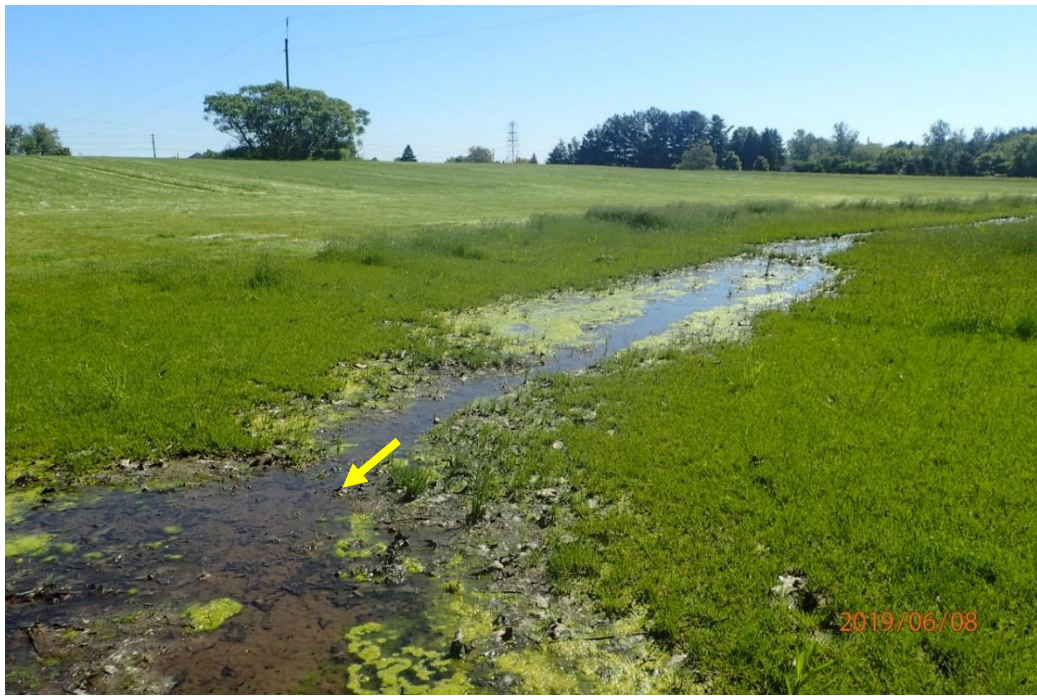
Riparian vegetation consisted predominantly of agricultural crops, which were generally absent from the channel during the spring.

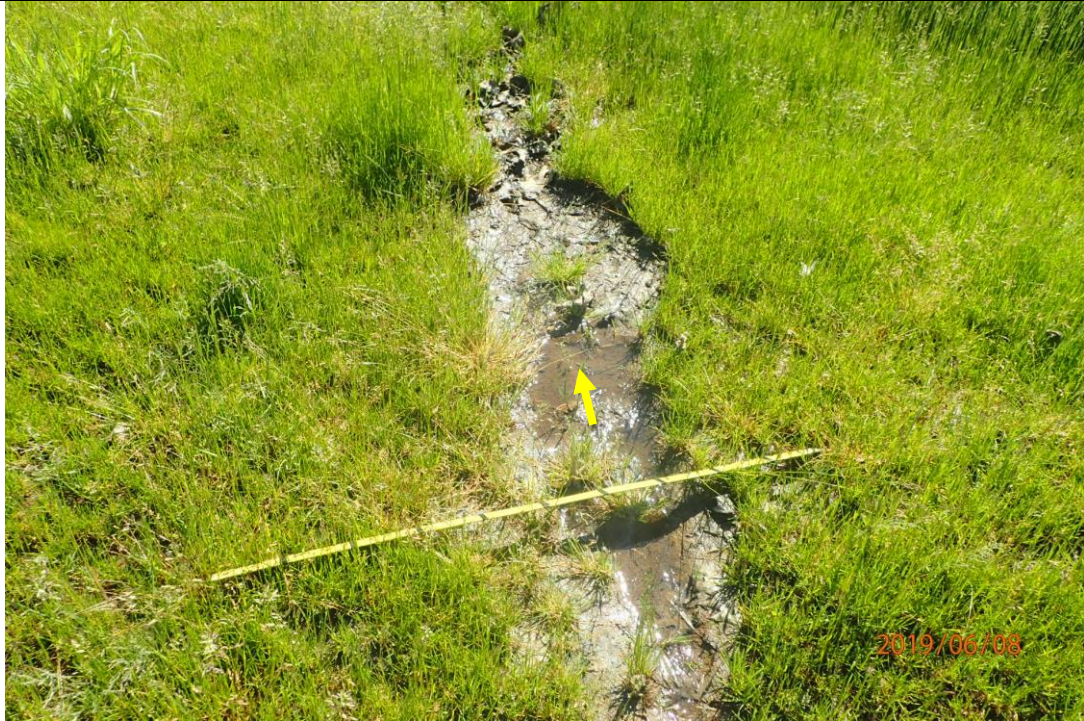
The feature lacked definition and conveyed flows through an agricultural field. Standing water was observed during the 2<sup>nd</sup> visit.

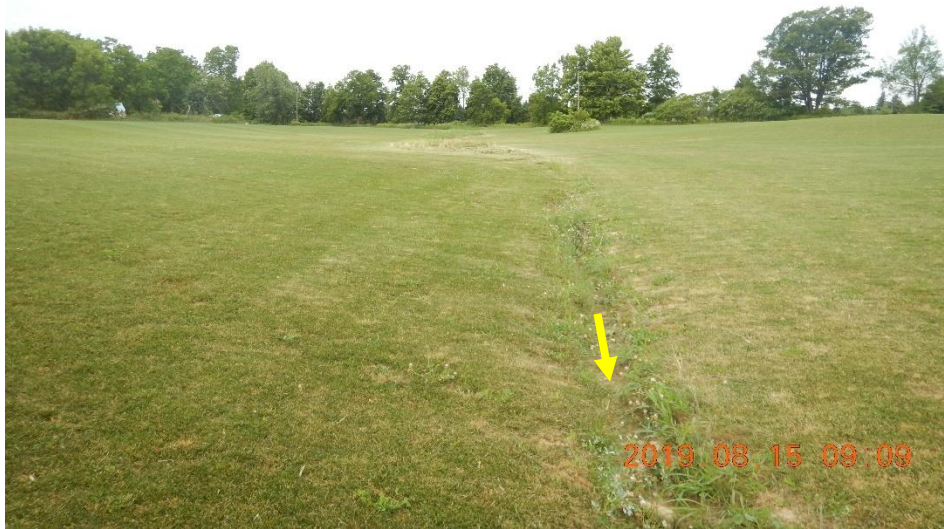
Bed composition was predominantly clay, silt and sand. The feature was dry during the summer visit.

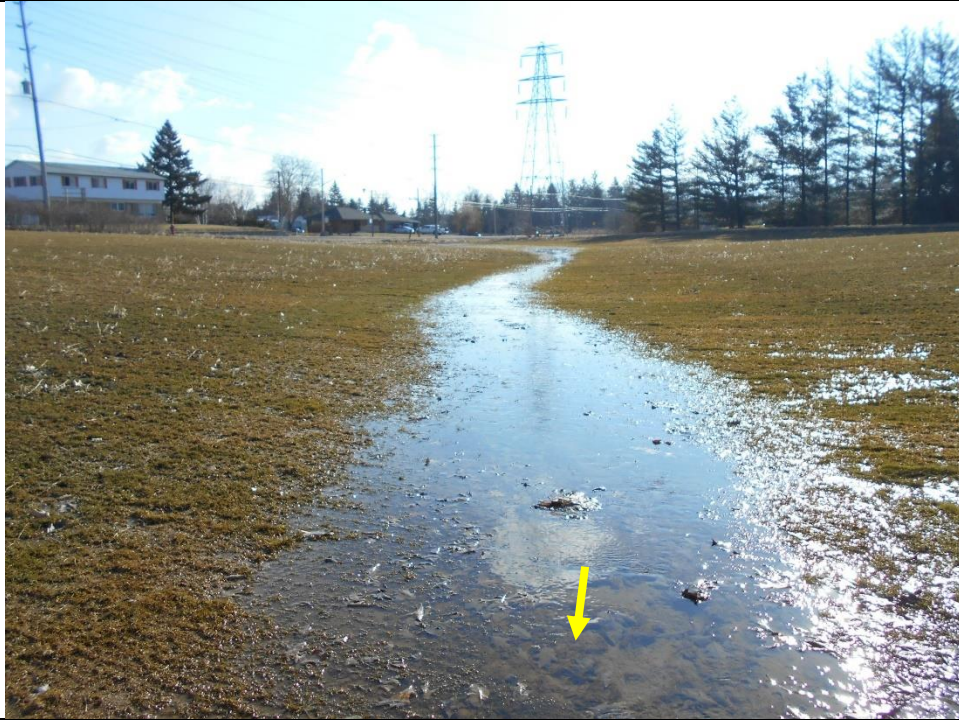
The feature lacked channel definition and conveyed flows through an agricultural field.

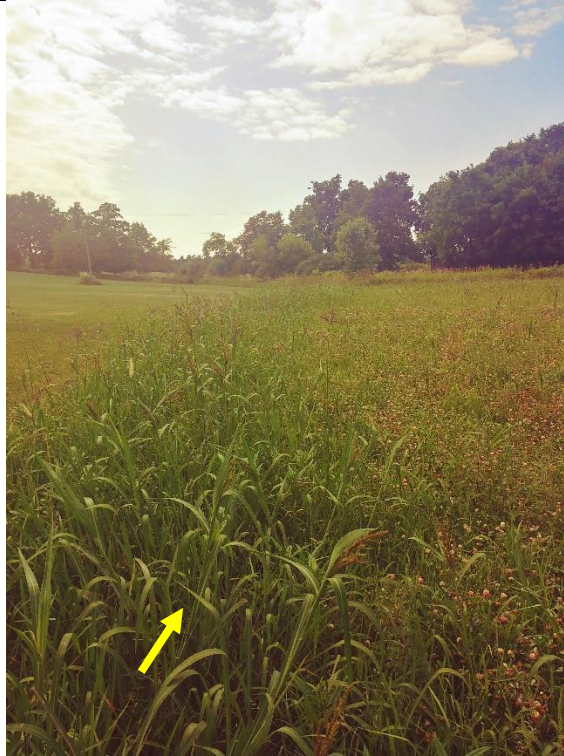
Substrate within the intermittent feature was predominantly clay, silt, and sand. No water was observed during the 3<sup>rd</sup> visit.

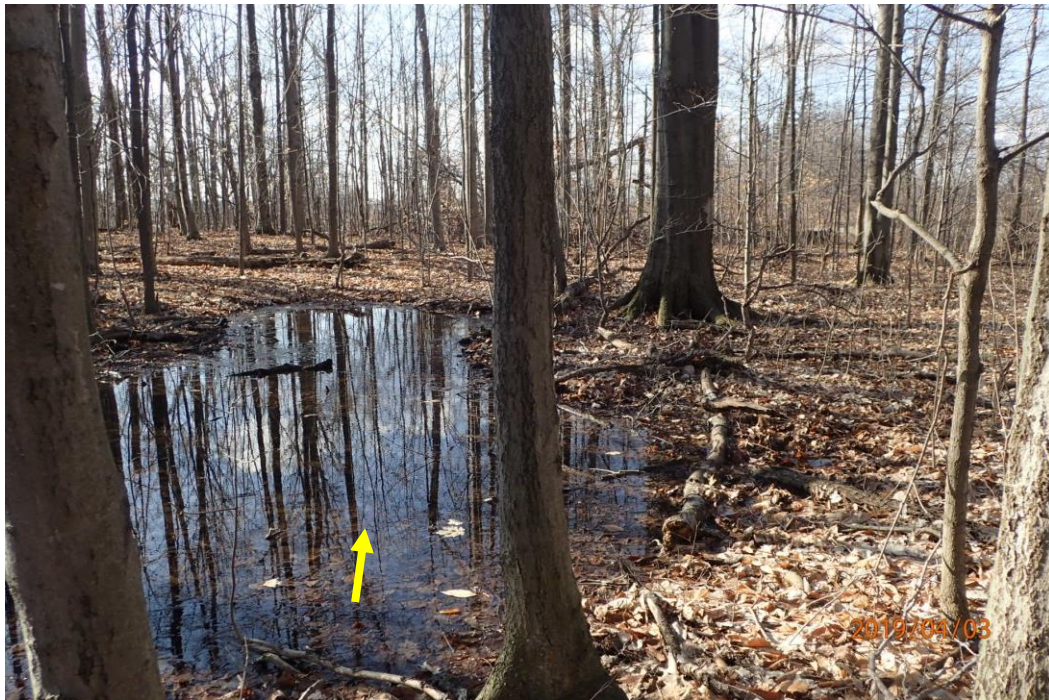
The feature lacked channel definition and conveyed flows through a woodlot.

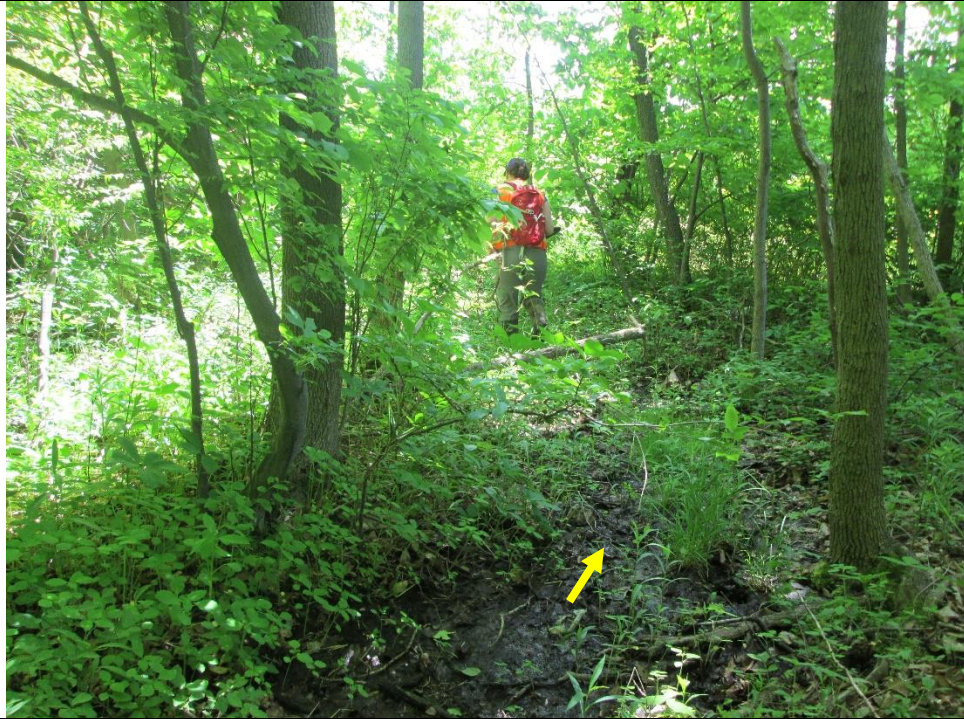
Riparian vegetation adjacent to the feature consisted of deciduous trees. No water was present during the 2<sup>nd</sup> visit.

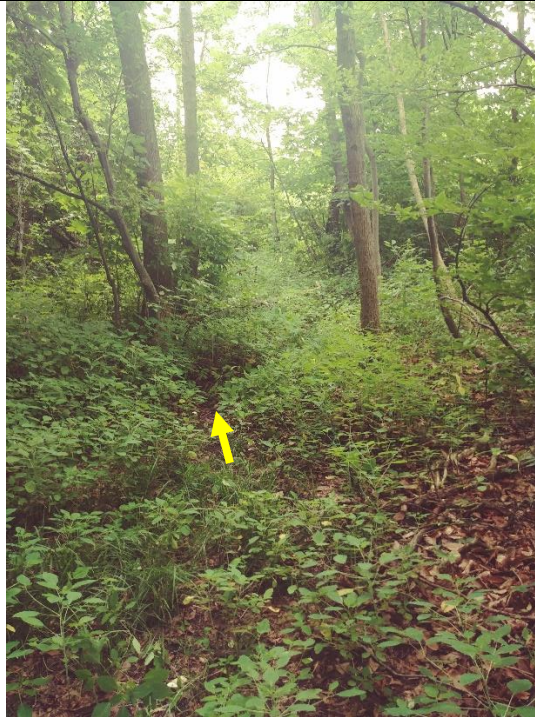
The low gradient feature's substrate was predominantly composed of decomposing organic matter and silt. Water was not observed during the 3<sup>rd</sup> visit.
