Fluvial Geomorphological Assessment and Erosion Hazard Delineation

Sulphur Creek and Tributaries
159 and 163 Sulphur Springs Road
Ancaster, Ontario

Submitted:
November 26, 2024

GEO Morphix Project No. 24108

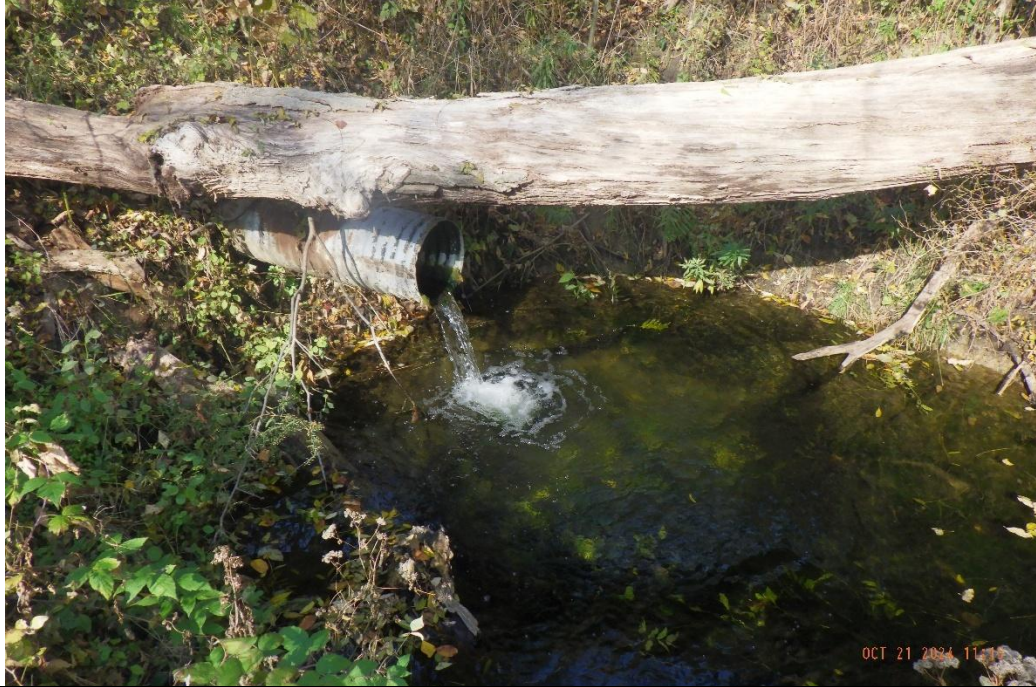
Photo 1
Tributary of Sulphur Creek - Reach SCT1
Ancaster, Ontario

The RGA score of **Reach SCT1** was 0.188, indicating that the reach was in regime. The dominant geomorphic process shaping the channel was determined to be degradation, largely due to the elevated outlet and scouring that is occurring as a result. The RSAT score was 25, indicating that the reach was in good condition. The limiting feature was the physical instream habitat due to the lack of diverse habitat and generally shallow depth of the channel. Under the Downs (1995) model, the channel was determined to be laterally migrating due to the widening that was also occurring as result of leaning and fallen trees and increase in erosion along the channel. Although, overall, observations showed a generally straight channel.

A perched outfall was present in the most upstream section of the reach with a scour pool present measuring up to 0.83 metres deep.

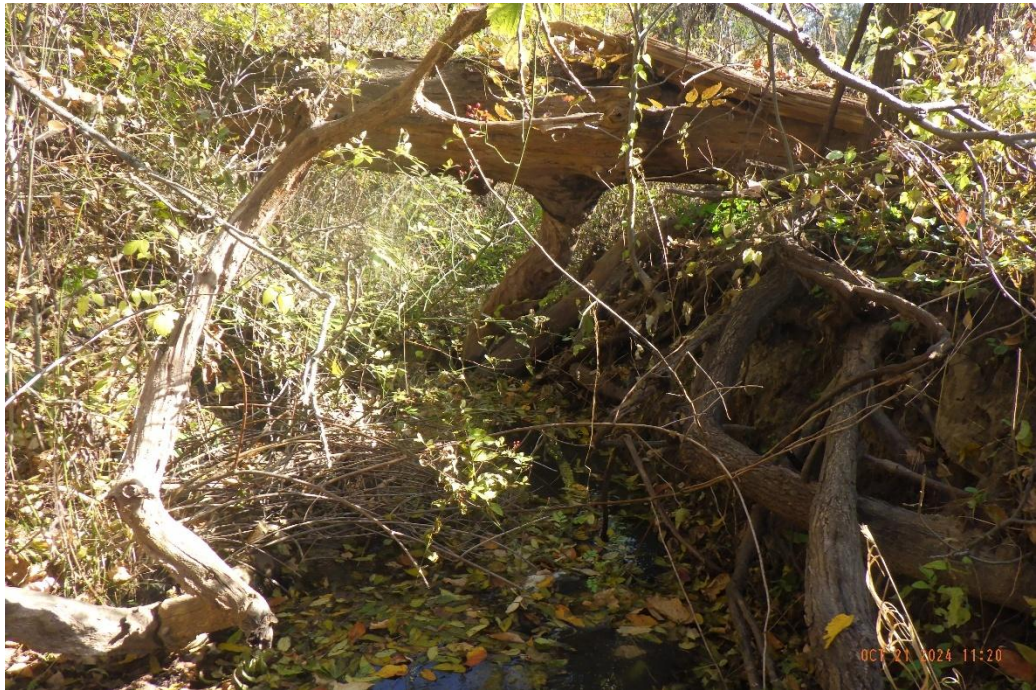
Photo 2
Tributary of Sulphur Creek - Reach SCT1
Ancaster, Ontario

The reach had many exposed roots with some woody debris throughout the reach.

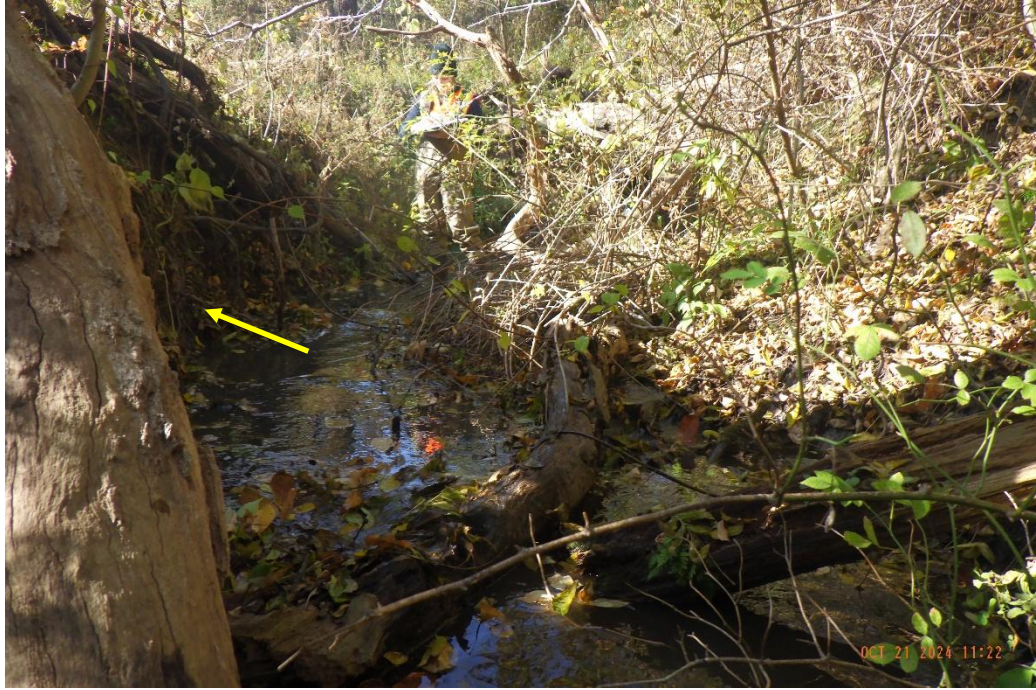
Photo 3
Tributary of Sulphur Creek - Reach SCT1
Ancaster, Ontario

Some erosion was observed along the channel as well as in the scour pool (yellow arrow – general bank erosion).

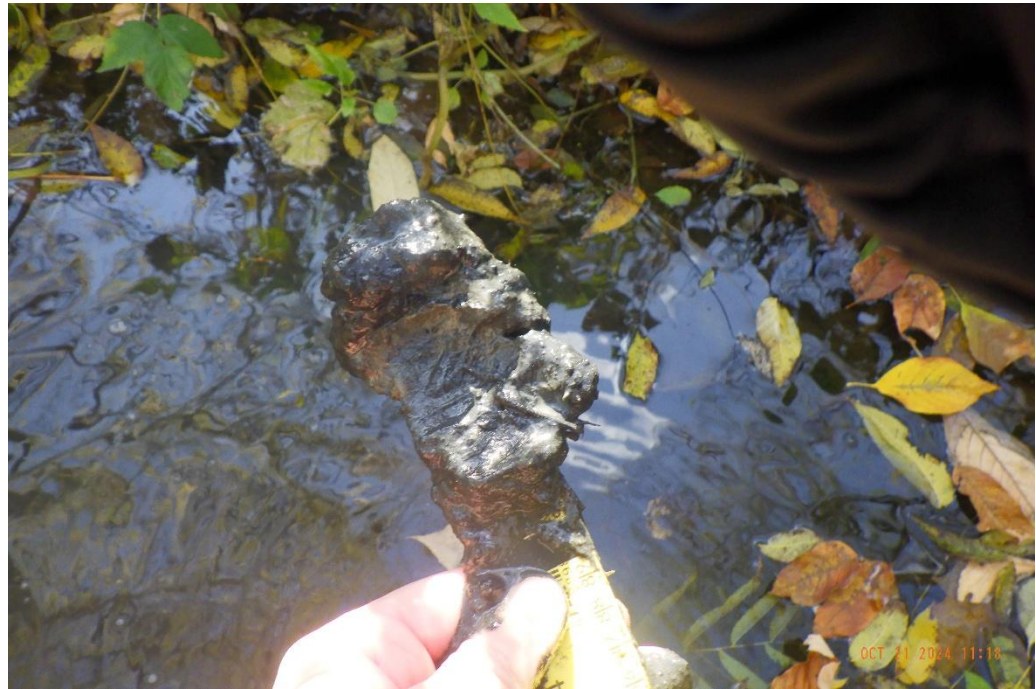
Photo 4
Tributary of Sulphur Creek - Reach SCT1
Ancaster, Ontario

Bed substrate (as shown in photograph 4) consisted of clay, silt, sand, and gravel whilst the bank substrate was observed to consist of clay, silt, and sand.

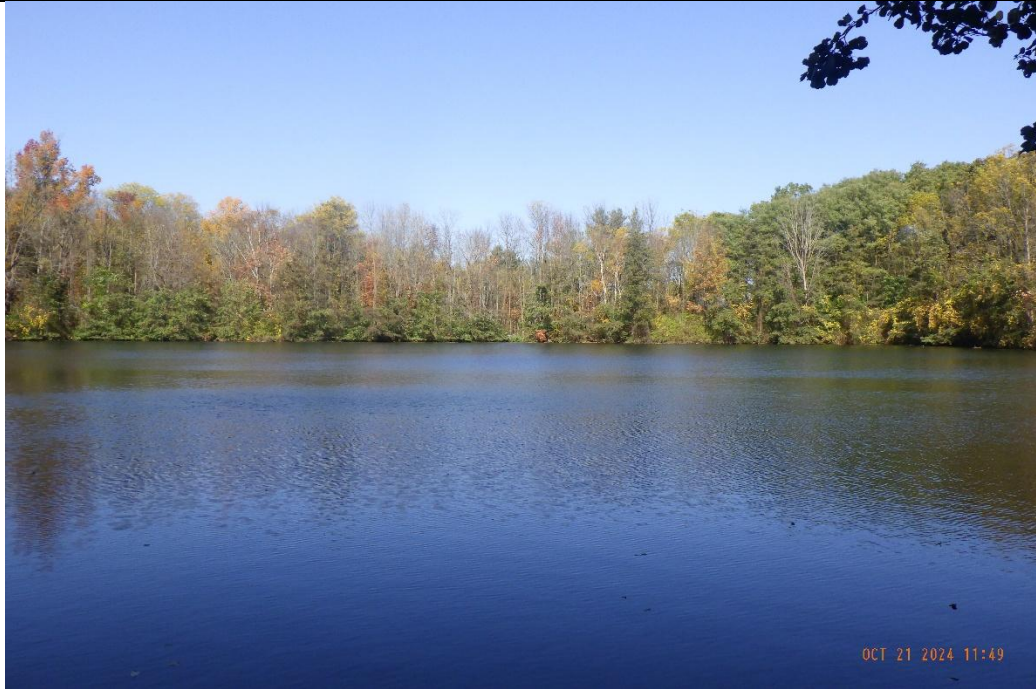
Photo 5
Tributary of Sulphur Creek - Reach SCT2
Ancaster, Ontario

Reach SCT2 was a waterbody along the Sulphur Creek tributary. A wide dense forested buffer was observed around the waterbody. Generally, erosion was not observed around the waterbody however, other observations were limited as the depth of the waterbody was too deep to wade.

This reach consisted of a waterbody with a dense forested buffer surrounding it.

Reach SCT2 consisted of an online pond feature with an adjacent valley wall to the south. Although the pond does not represent a typical erosion hazard due to a lack of channel processes, a 5 m toe erosion allowance is also recommended for this Reach and should be applied from the slope toe.

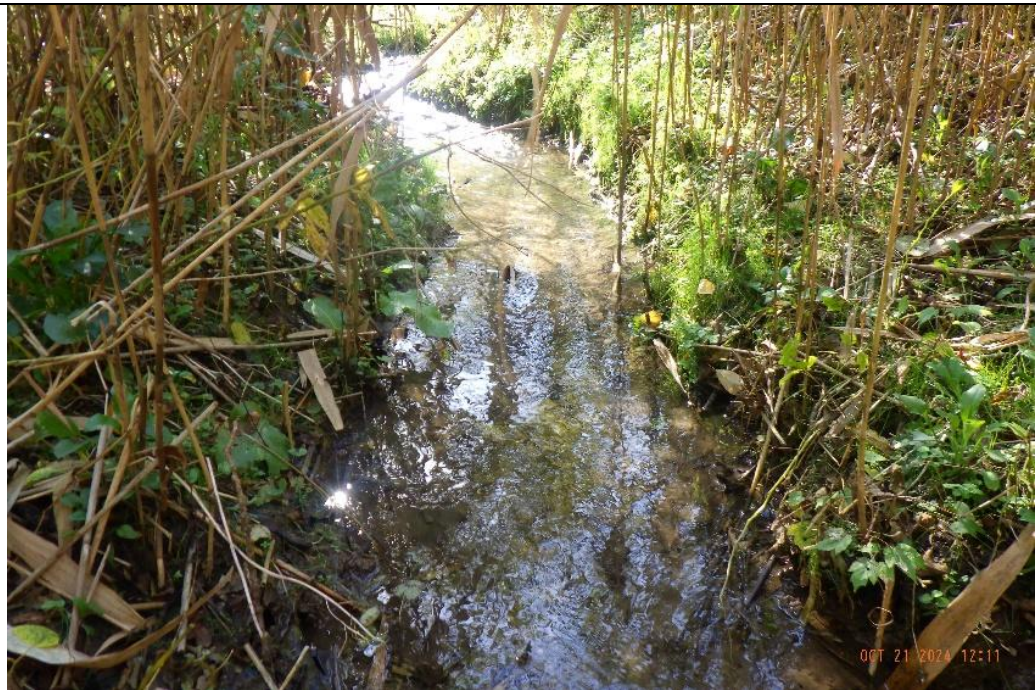
Photo 6
Tributary of Sulphur Creek - Reach SCT3
Ancaster, Ontario

Generally, the banks of the low flow channel were well vegetated with grass and some trees. Some localized phragmites were observed at the most downstream portion of the reach.

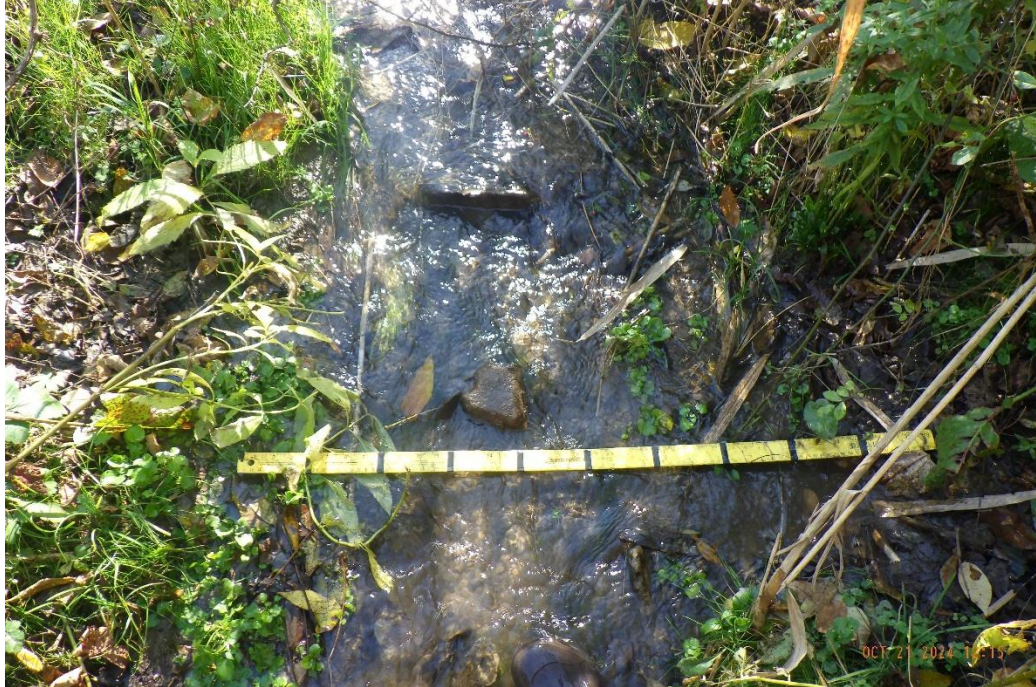
Photo 7
Tributary of Sulphur Creek - Reach SCT3
Ancaster, Ontario

The bed substrate was observed to consist of sand, gravel, and cobbles generally through riffles.

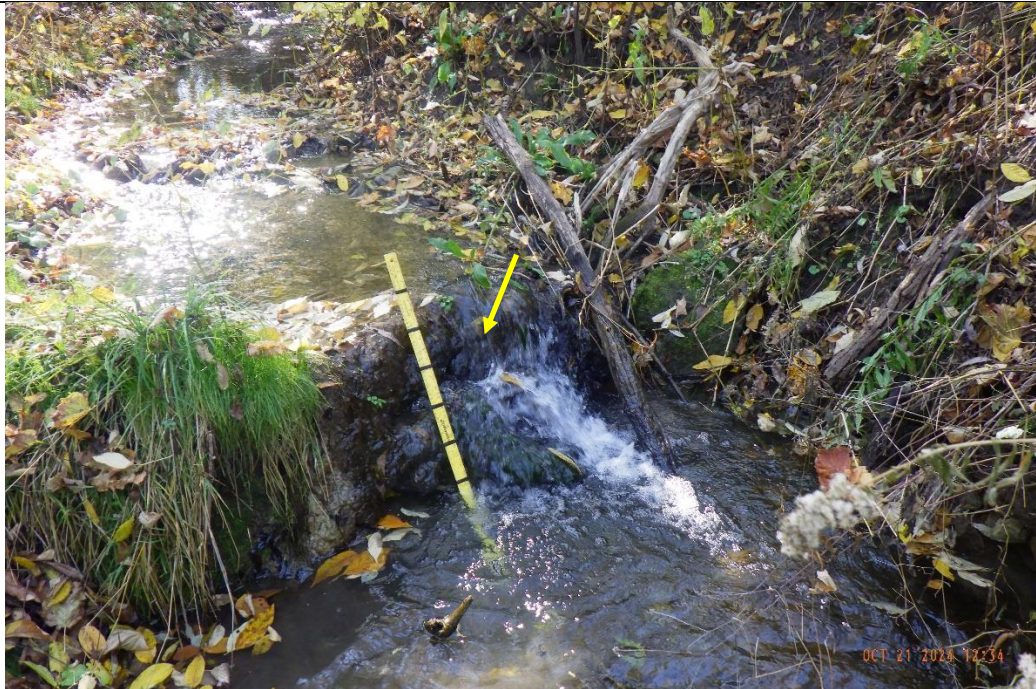
Photo 8
Tributary of Sulphur Creek - Reach SCT3
Ancaster, Ontario

The RGA score of **Reach SCT3** was 0.273, indicating that the reach was in transition. The dominant geomorphic process shaping the channel was determined to be degradation, largely due to the presence of knick points. The RSAT score was 26, indicating that the reach was in good condition. The limiting feature was the physical instream habitat due to the shallow depth of the channel and lack of deep pools. Under the Downs (1995) model, the channel was determined to be in a depositional condition due to the presence of a low flow channel between outer banks.

A couple of knickpoints were present in this reach. In these regions the channel has worn into the undisturbed overburden (yellow arrow).

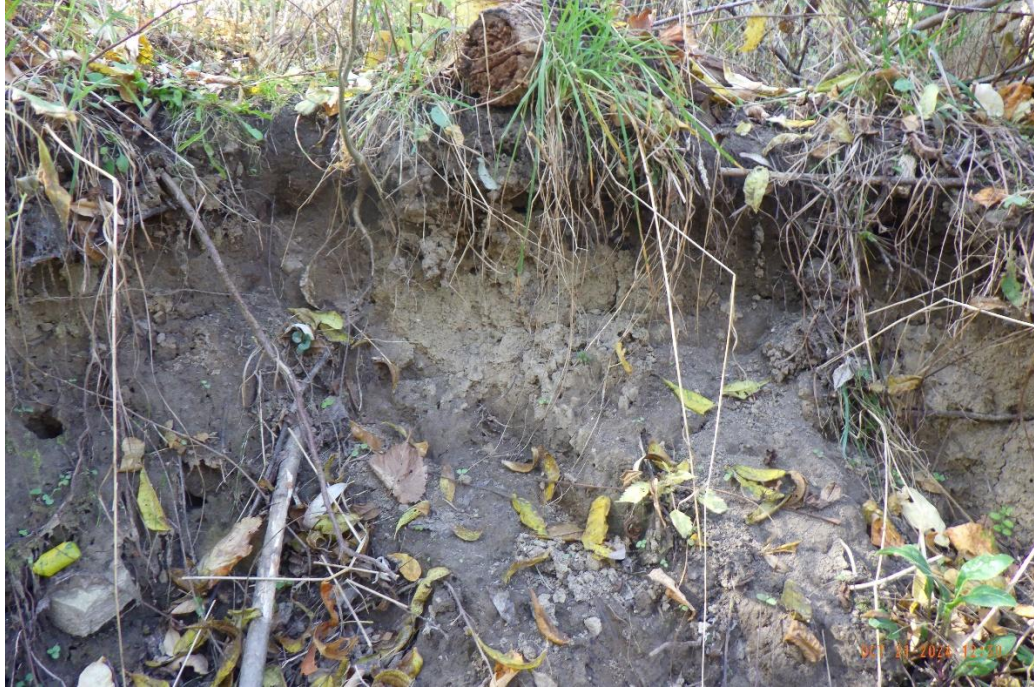
Photo 9
Tributary of Sulphur Creek - Reach SCT3
Ancaster, Ontario

Erosion throughout the reach was generally observed along the outer banks of the channel, whilst minimal erosion was observed through the low flow channel.

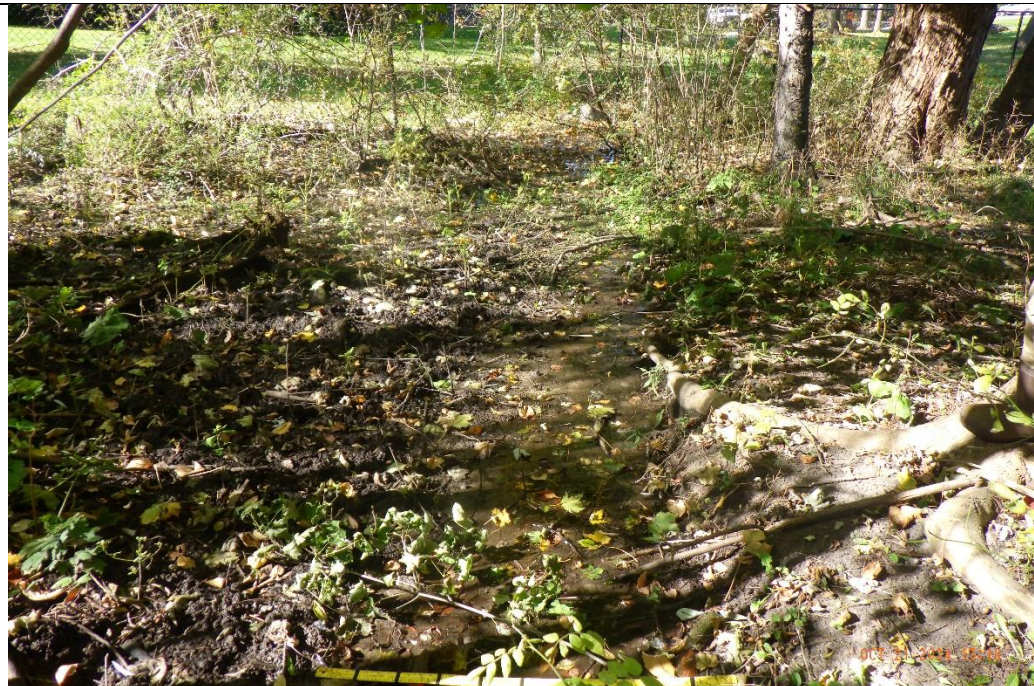
Photo 10
Tributary of Sulphur Creek - Reach SCT6
Ancaster, Ontario

Approximately 20 metres of this reach was present on the subject property. The feature was characteristic of a low order headwater drainage feature with a lack of definition and erosion present. The remainder of the reach was not accessed due to access restrictions.

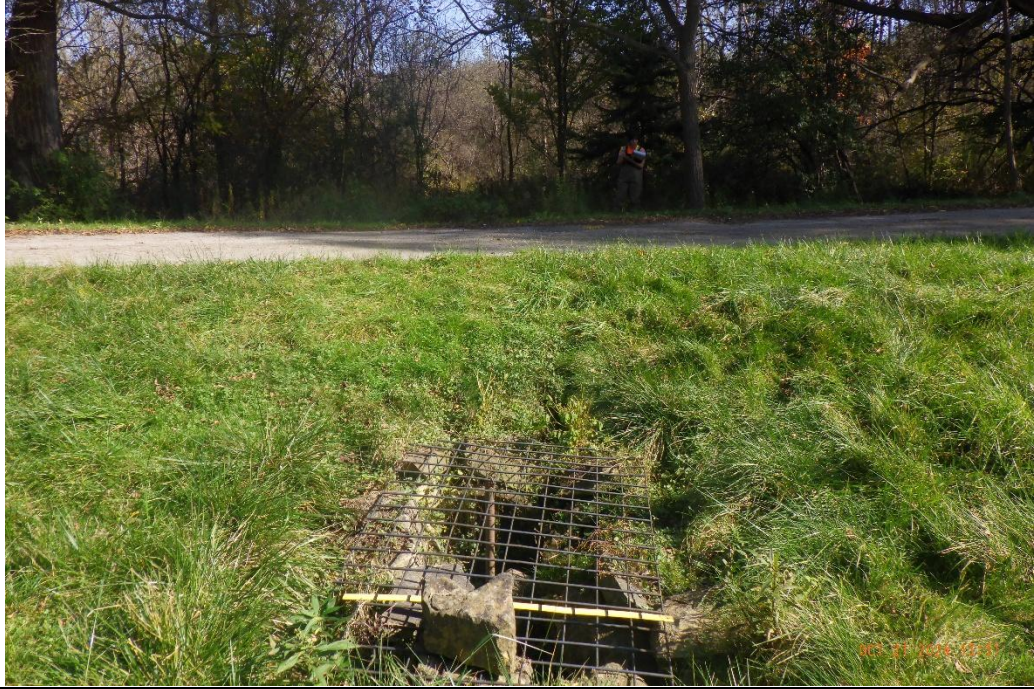
Photo 11
Tributary of Sulphur Creek - Reach SCT1-3
Ancaster, Ontario

Reach SCT1-3 was characterized as a piped drainage feature. The feature carries water from the pond at Reach SCT1-4 to the access road culvert, ultimately discharging flows to the eastern extent of the property. Water was not observed on the day at the culverts or downstream (east) of the property line and access road.

The feature consisted of a tile drain that was identified through the presence of an open grate where a pipe and flowing water was observed.

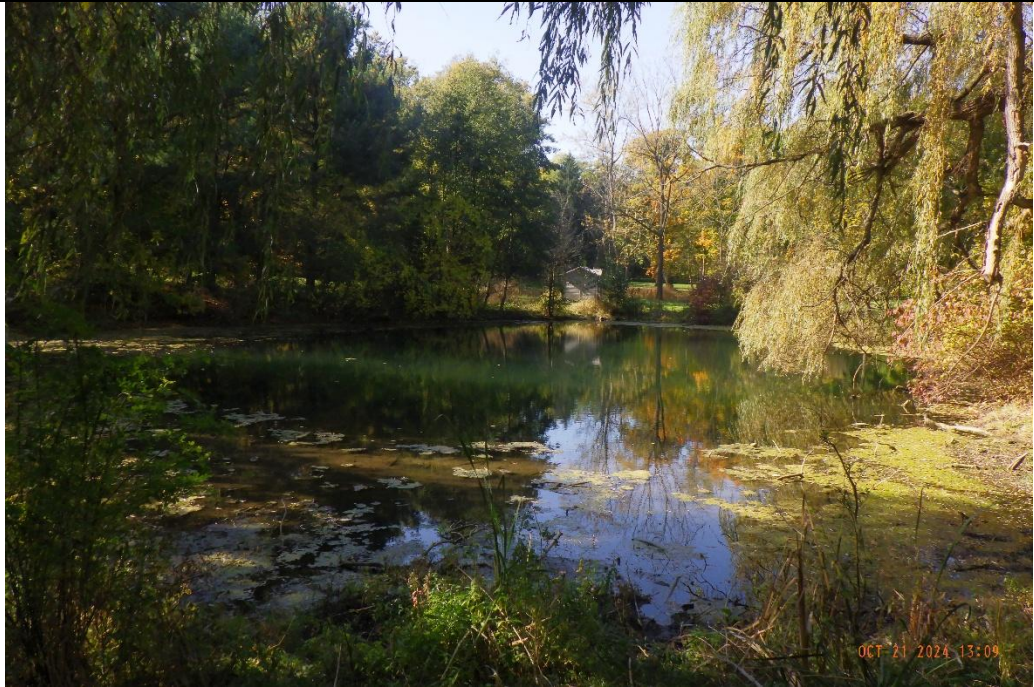
Photo 12
Tributary of Sulphur Creek - Reach SCT1-4
Ancaster, Ontario

Reach SCT1-4 is a small pond in the southern portion of the subject property. The riparian buffer was observed to generally consist of shrubs that were present along the banks, however, immature grasses and some trees were also observed surrounding the waterbody. Generally, erosion was not observed around the waterbody however, other observations were limited as the depth of the waterbody was too deep to wade into.

This reach consisted of a waterbody with grass and trees within the riparian area. Algae was also observed on the pond water surface.

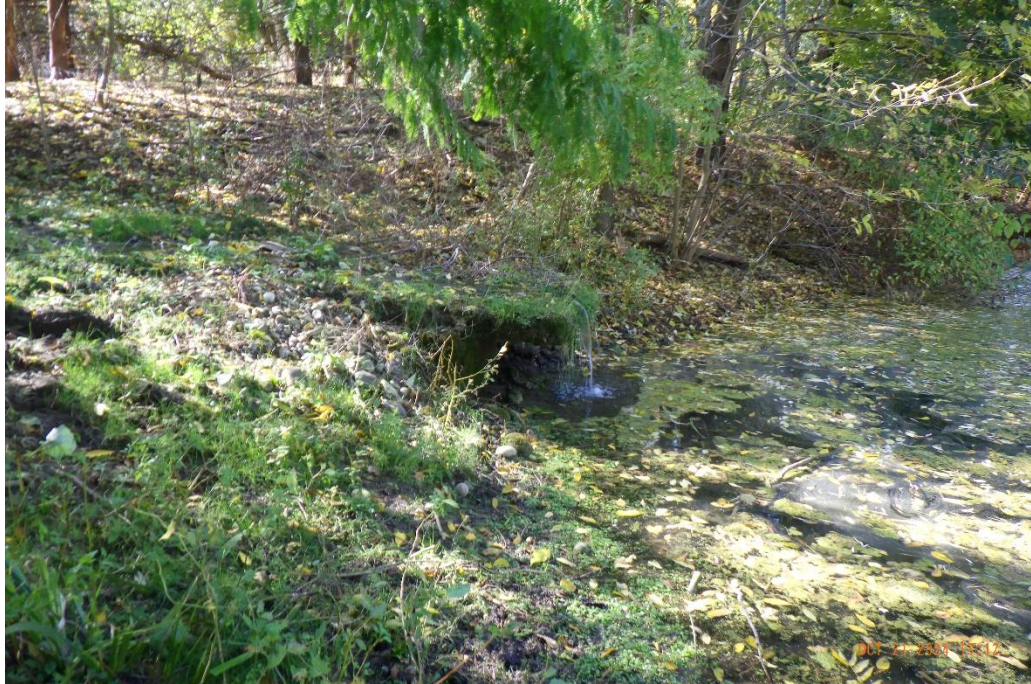
Photo 13
Drainage feature - Reach SCT1-5
Ancaster, Ontario

The drainage feature was observed to enter the pond via overland flow over a concrete slab.

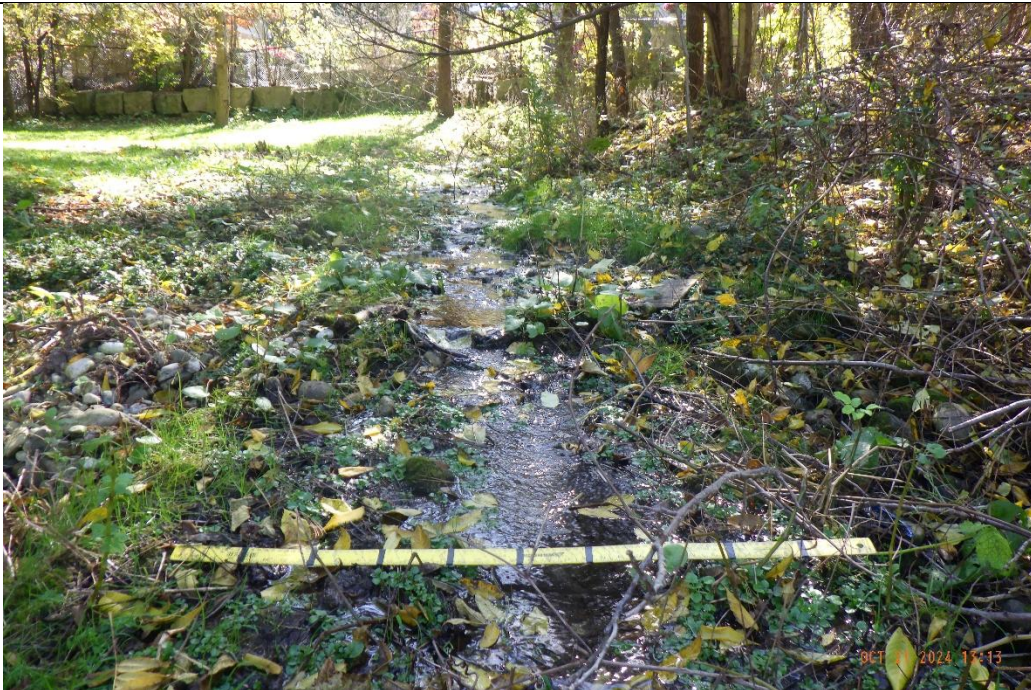
Photo 14
Drainage feature - Reach SCT1-5
Ancaster, Ontario

The drainage feature was observed to be flowing with a lack of defined bed or banks. As a result the bed and bank substrate was observed to consist primarily of rootlets, silt, and sand.

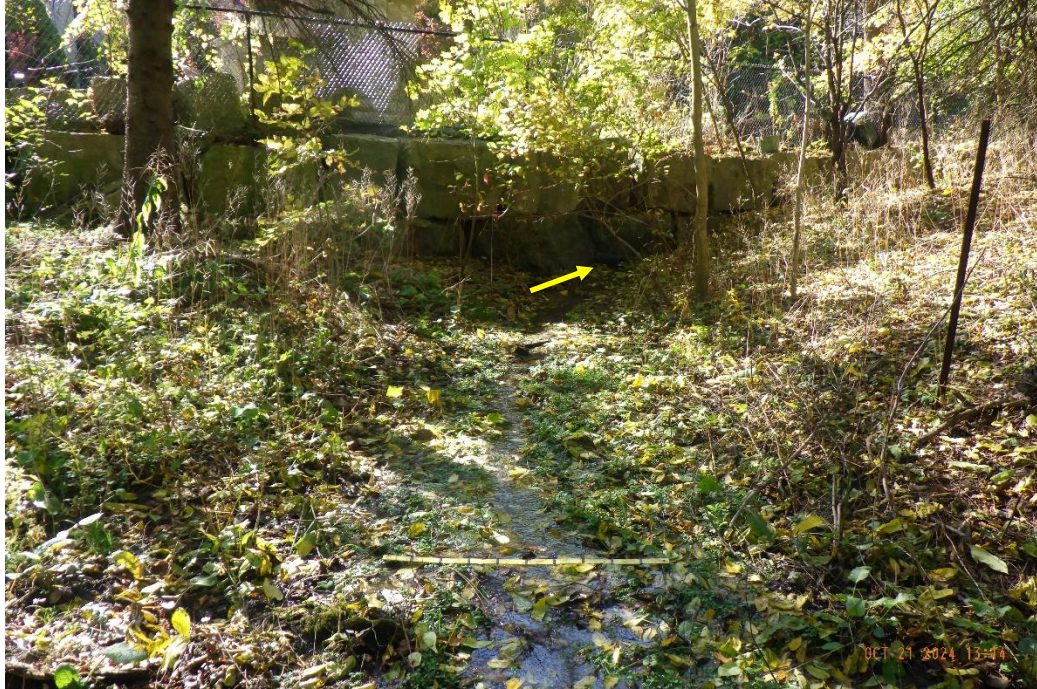
Photo 15
Drainage feature - Reach SCT1-5
Ancaster, Ontario

The source of the flows was observed to be from piped flows discharging from the adjacent properties.

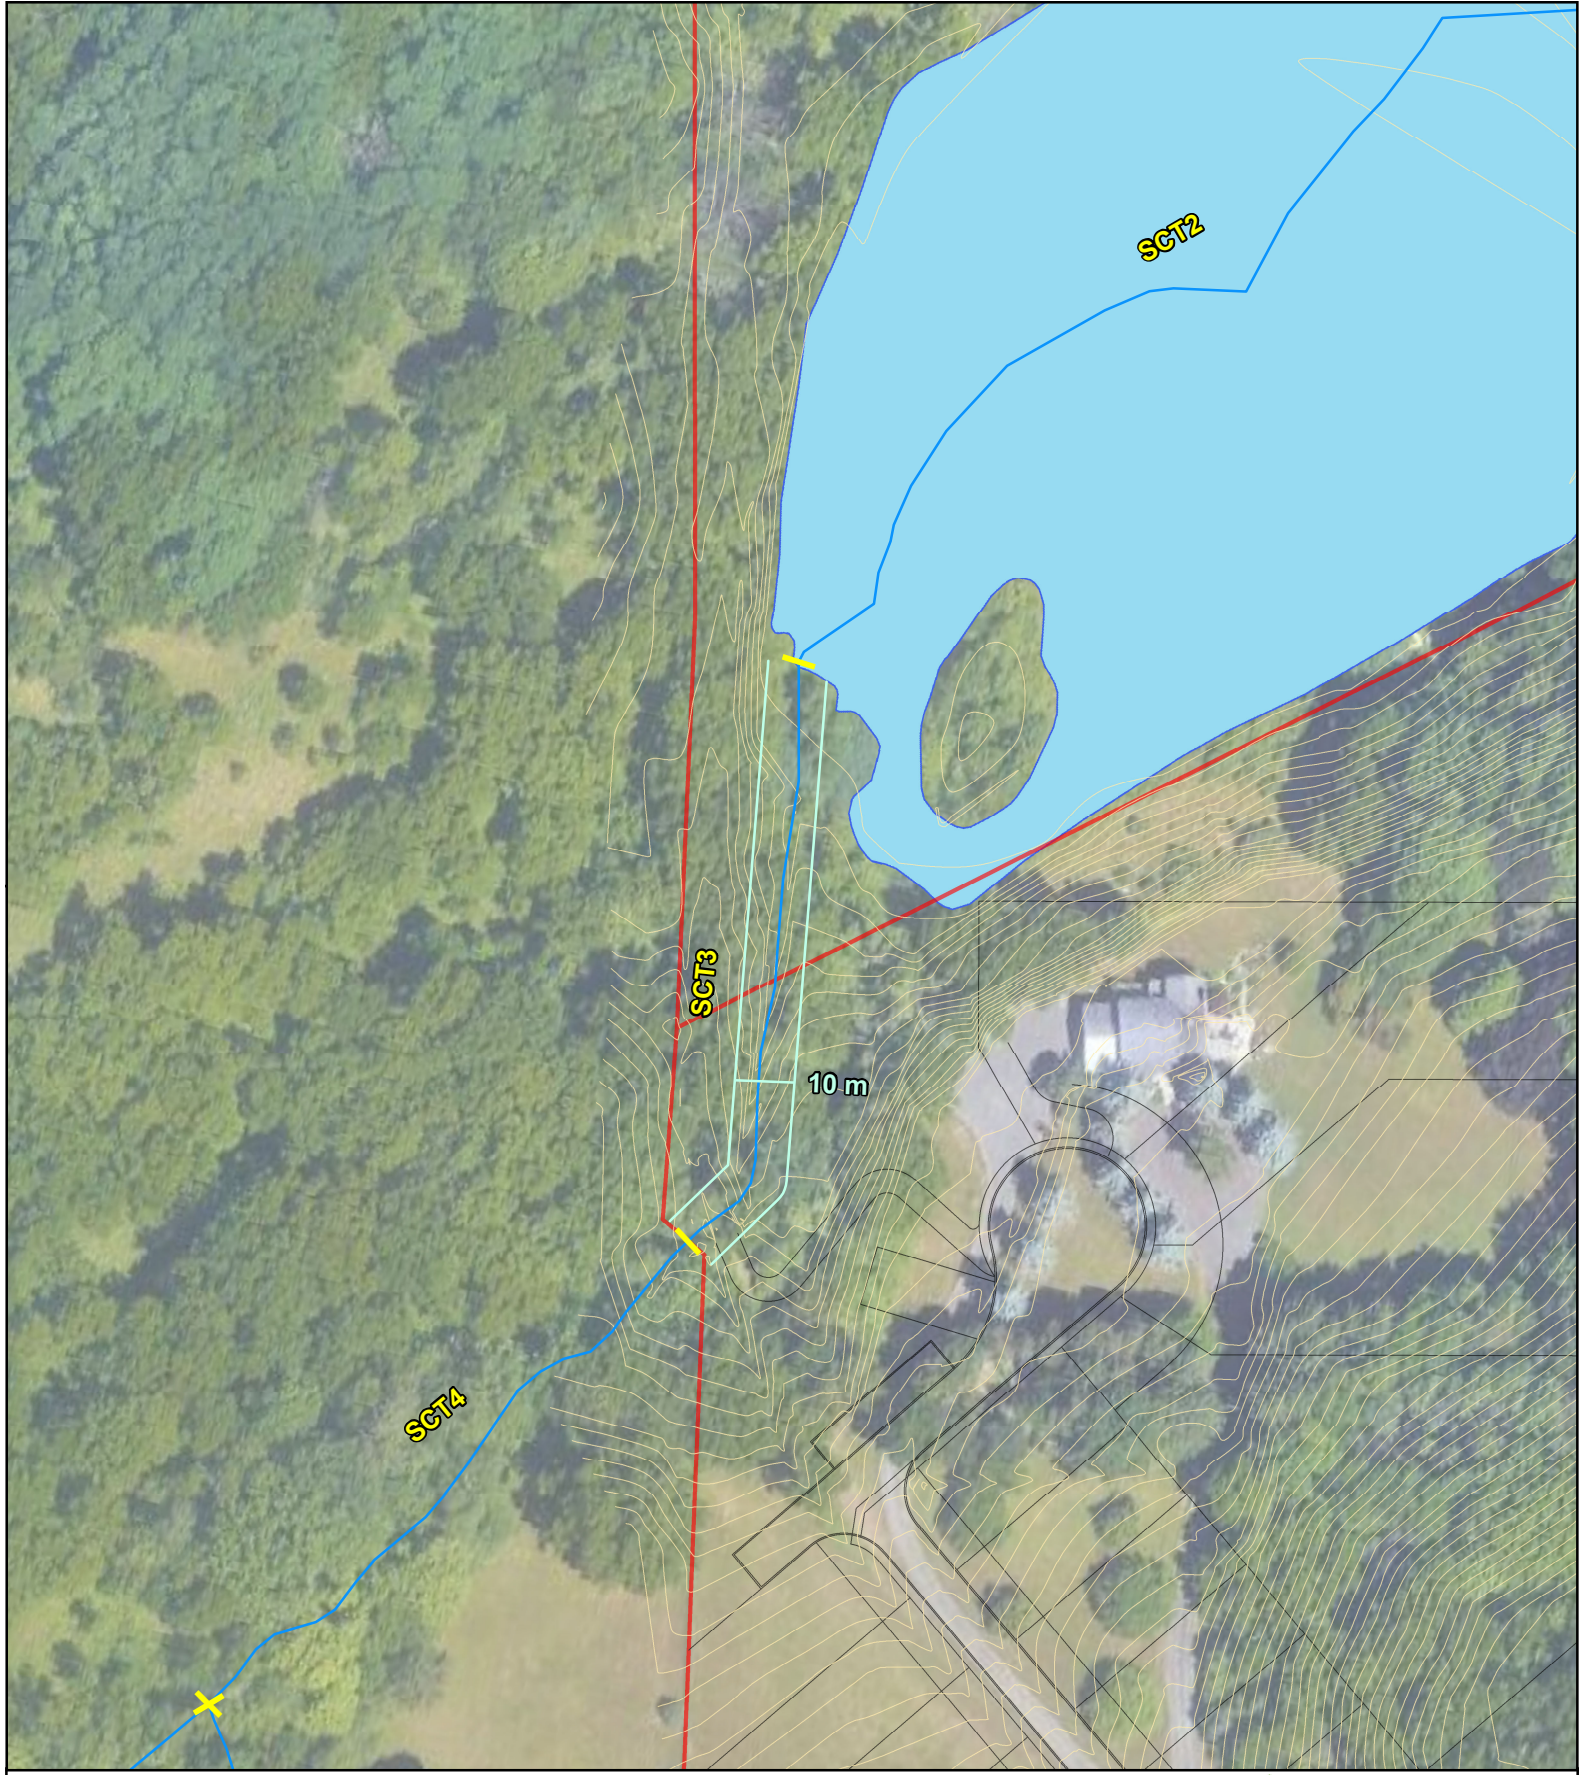
Figure 3
Erosion Hazard Delineation
 Sulphur Creek
 Ancaster, Ontario

The empirical modeling exercise resulted in meander belt widths ranging from 7 m to 8 m for **SCT3**. To be conservative, we recommend a nominal meander belt width of 10 m for **Reach SCT3**. This is an appropriate approach as it is based on site-specific conditions and is considered a conservative value as this reach functions as a straight channel with limited evidence of planform adjustment or active erosion. The final meander belt width is graphically displayed in **Appendix E**.
