APPENDIX C-2: CONTAMINATION OVERVIEW STUDY

Hamilton LRT – Environmental Project Report Addendum

Contamination Overview Study – Final Report

Report
Internal ref. 638045

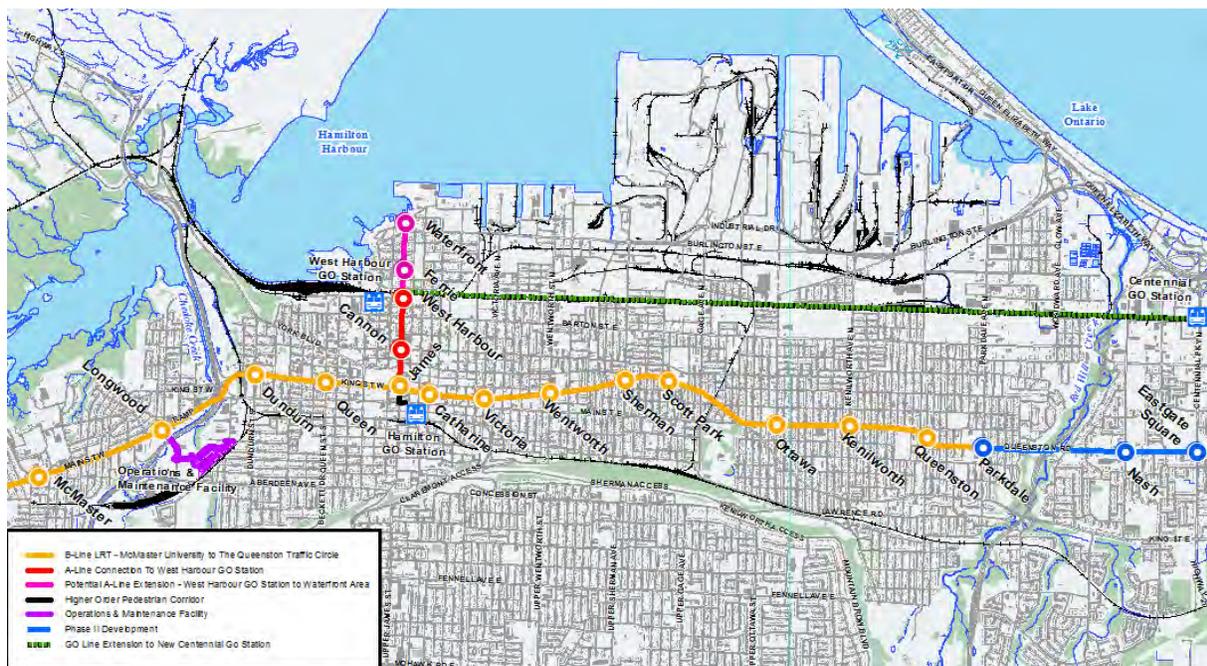
Figure 2.1: Hamilton LRT Project Overview

Below is a general description of the project components. A graphical representation geographical extent of the project and project components is presented on **Figure 2.1** (below). Further design details can be found in the Hamilton LRT Design Workbook 1 (SDG, 2016).

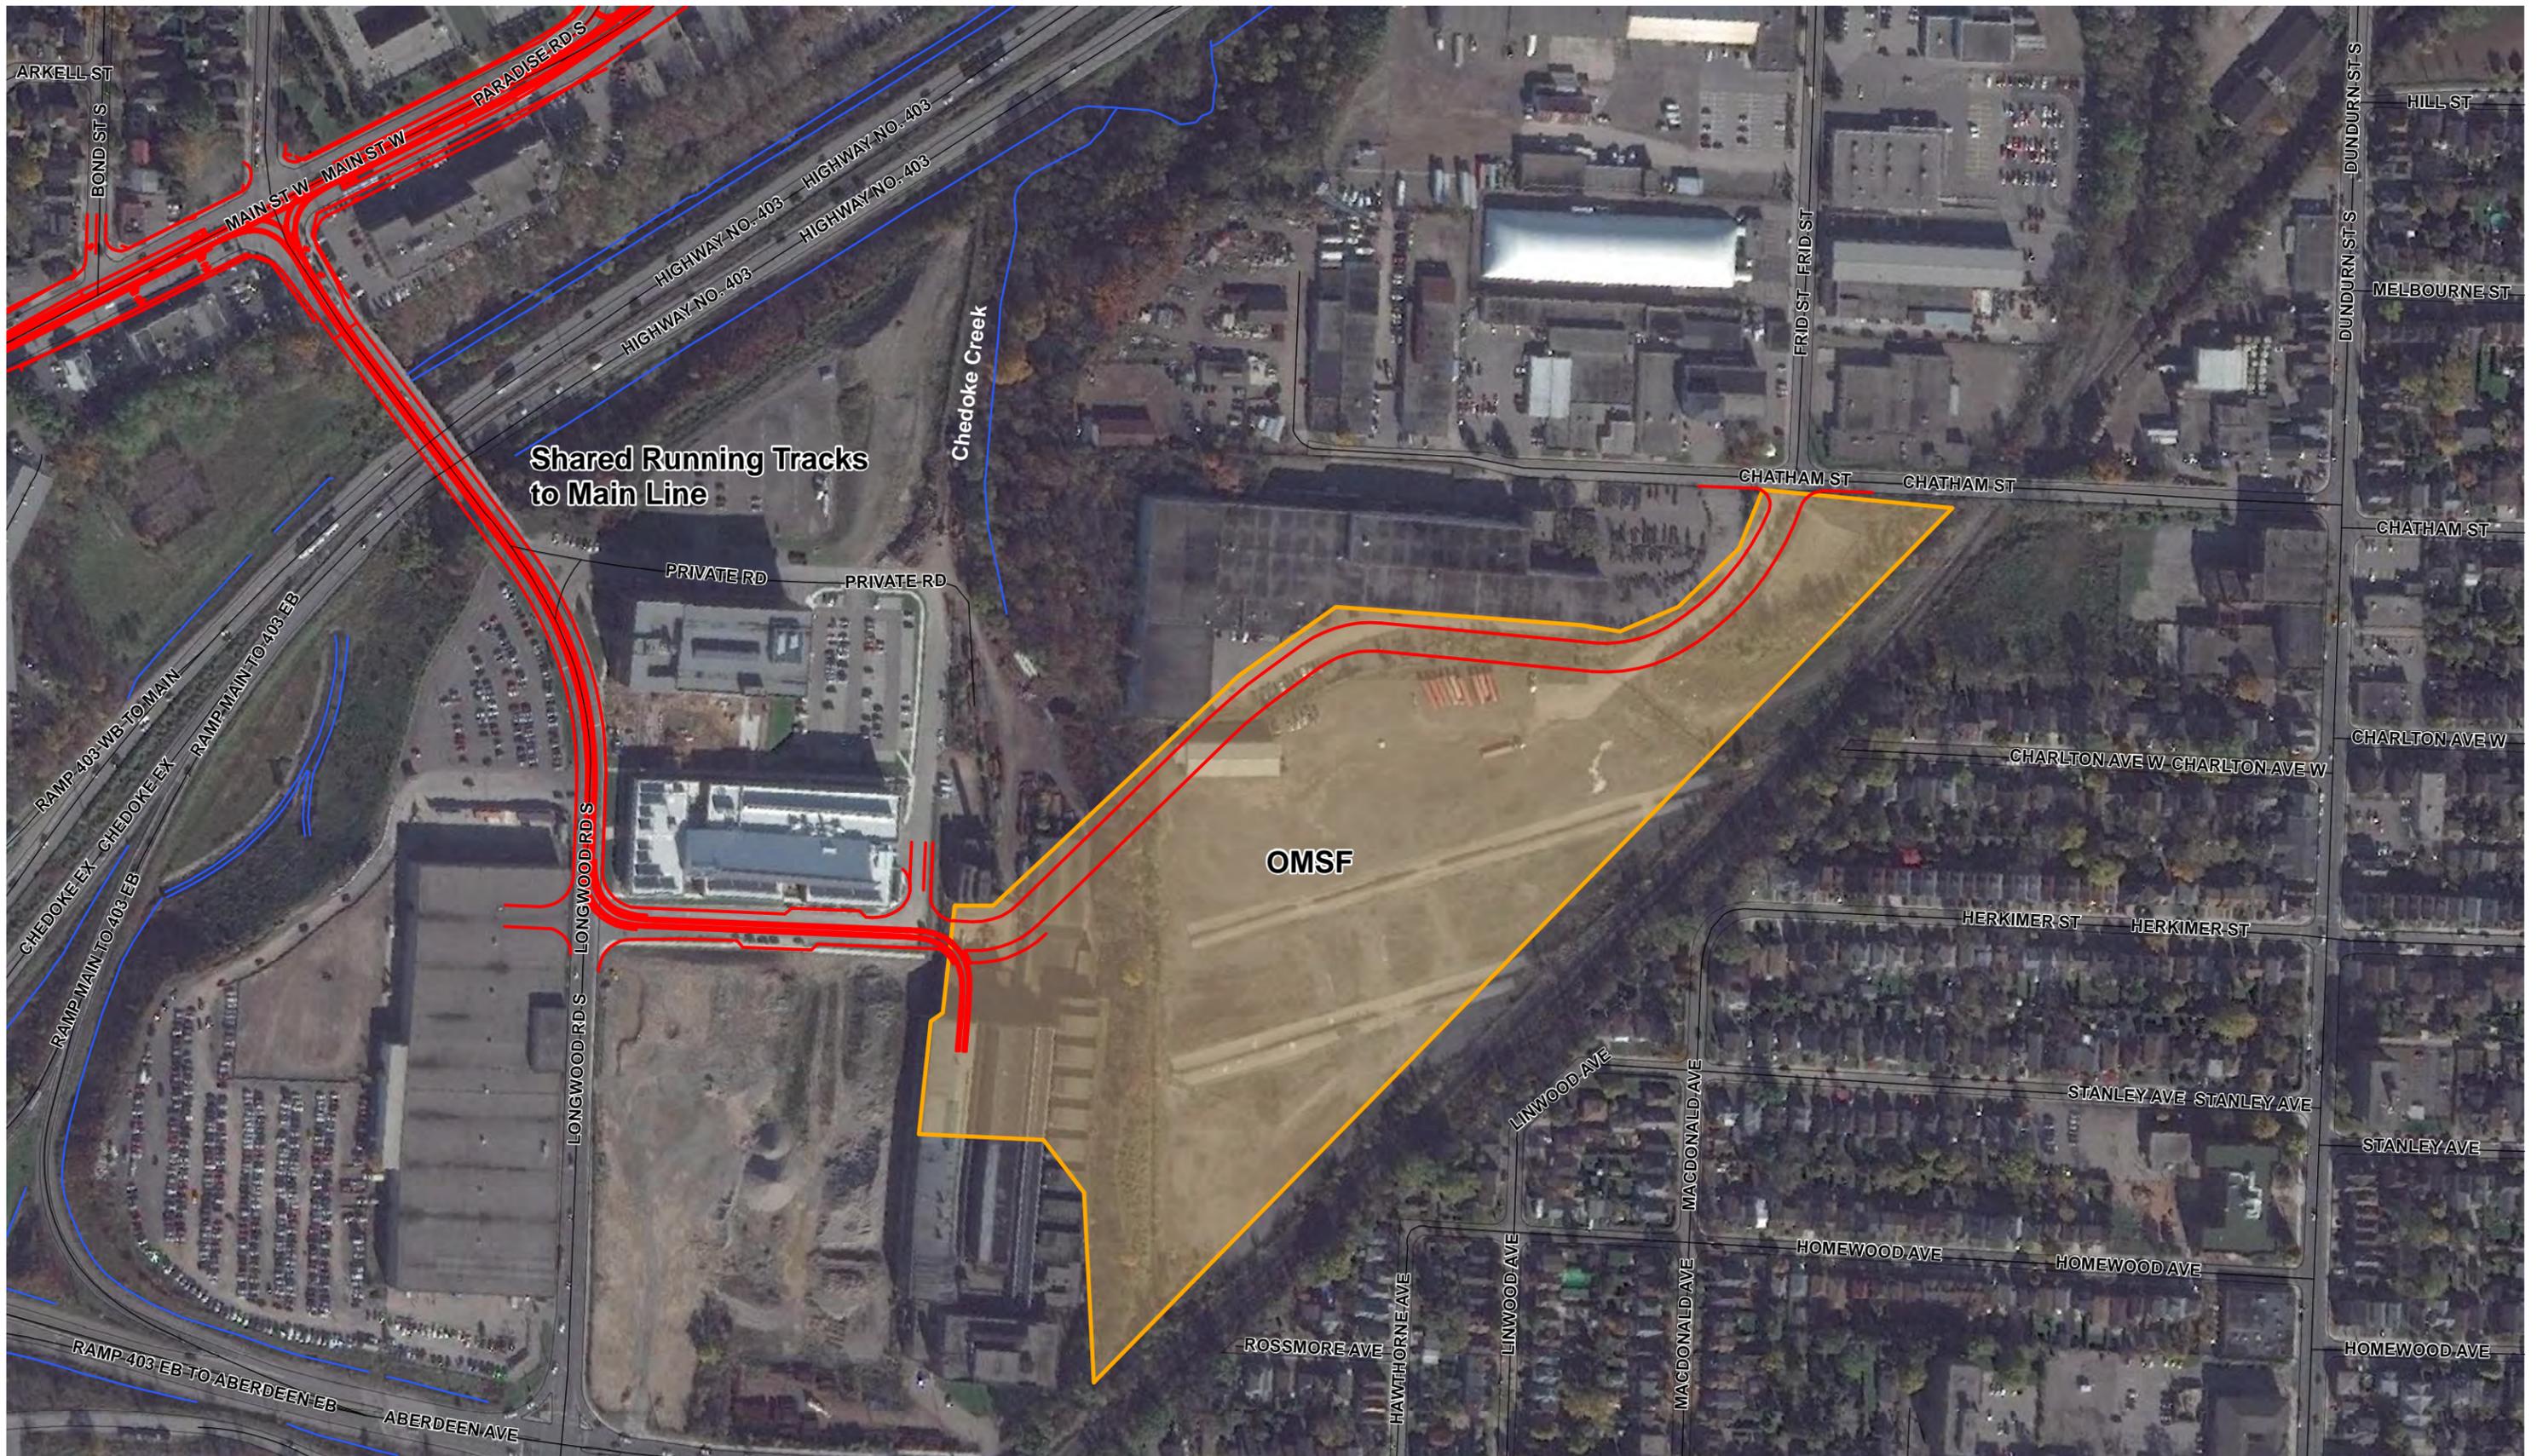
Figure: **2.2** Rev. **0**

This is connected to the B-Line route via shared-running tracks on Frid Street and Longwood Road. A delta junction at the Main Street/Longwood Road intersection allows light rail vehicles to enter and leave service from either direction (see **Figure 2.2**, below).

Operations Maintenance Facility (OMSF)
