**Cootes Paradise: Environmental Impact Evaluation
Hamilton, Ontario**

City of Hamilton

**April 2020
SLR Project No.: 209.40666.00001**

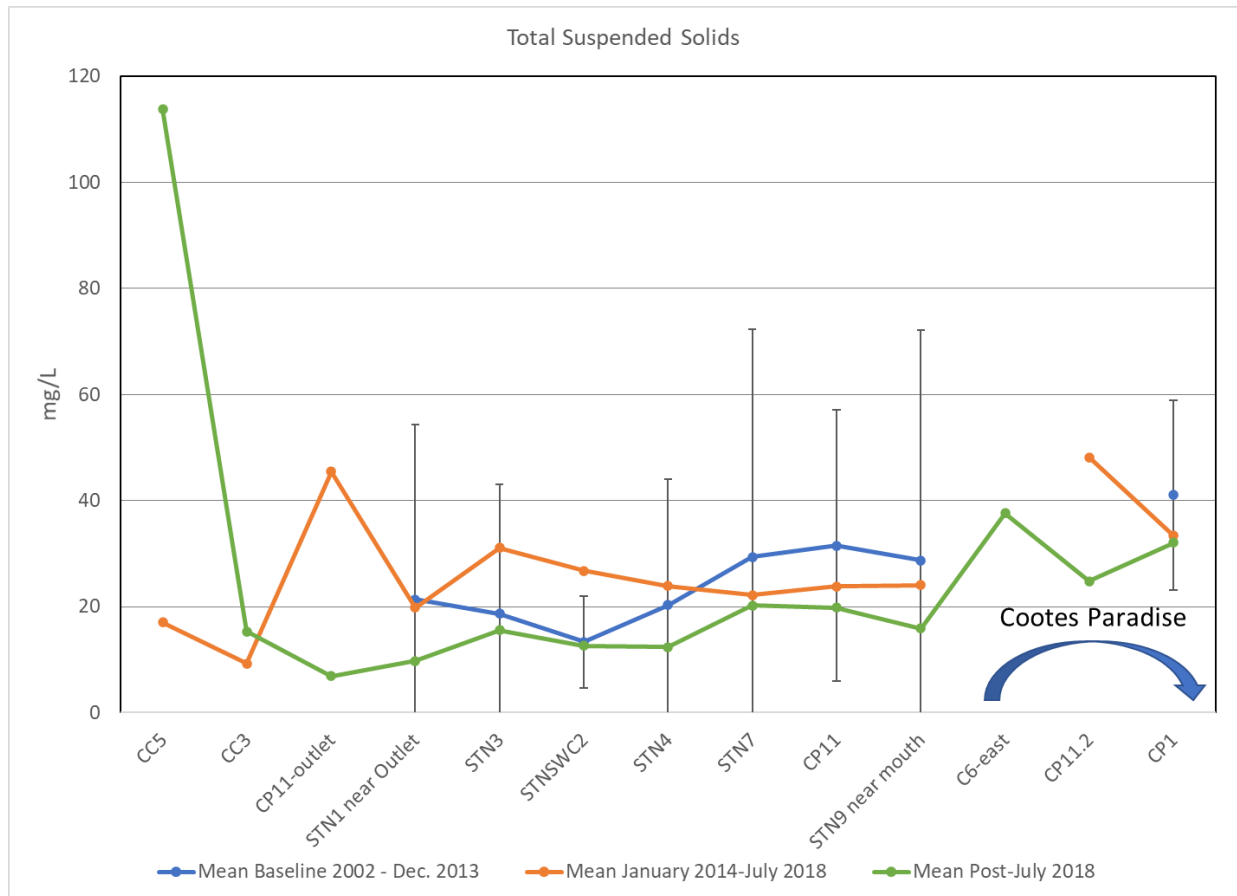
Figure 5-3:
Chedoke Creek and Cootes Paradise total suspended solids concentrations

Average baseline concentrations of TSS (pre-2014) in Chedoke Creek ranged between 15 and 30 mg/L with considerable individual sample variability as evidenced by the 1 standard deviation bars provided in Figure 5-3. Relative to these baseline conditions and the TSS concentrations post-July 2018, the CSO discharge event tended to increase TSS concentration on average by 25 to 40 mg/L. However, this is within the range of the natural variance of TSS at STN1 prior to 2014. Downstream of STN1, TSS ranged from 12 to 31 mg/L through to STN 9 with a high degree of individual sample variability. TSS did rise in Cootes Paradise likely due to factors unrelated to input from Chedoke Creek.

Groundwater carrying leachate will not contain significant concentrations of particles: therefore, the TSS impact of the leachate will be minimal. In summary, while the discharge event did have some direct impact on TSS in Chedoke Creek, this was quickly assimilated downstream and was not outside of the natural variability of TSS within this section of Chedoke Creek.

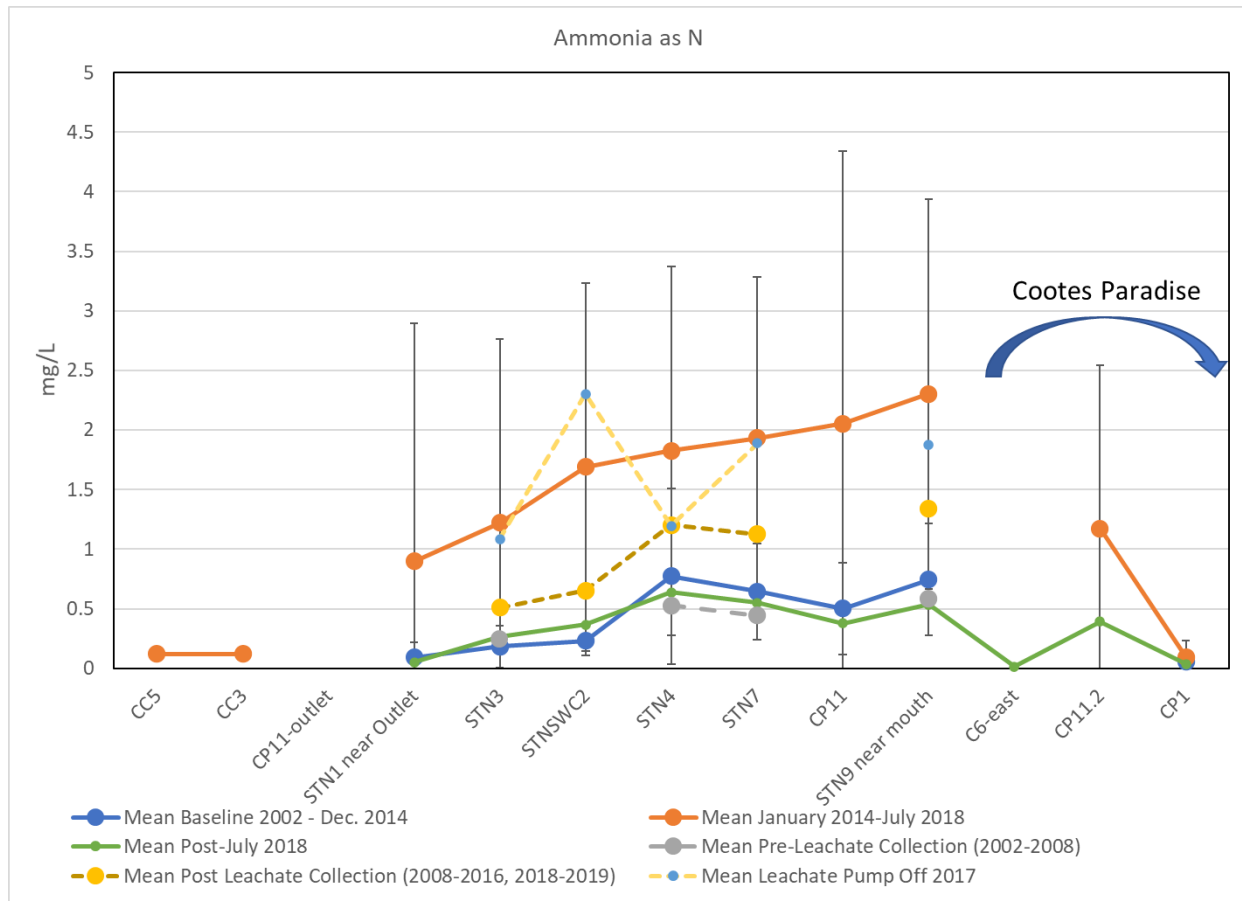
**Figure 5-4:
Chedoke Creek and Cootes Paradise ammonia as N concentrations**

Ammonia measured as N baseline concentrations in Chedoke Creek show low levels at Stn. 1 (0.09 mg/L) but concentrations rise consistently downstream peaking an order of magnitude higher at STN4 and STN9 at 0.77 and 0.75 mg/L, respectively (Figure 5-4). These concentrations

are very similar to concentrations measured after July 2018. When the stream data for post-leachate collection and with the leachate pump off in 2017 are plotted, it is evident that there is a contribution of ammonia from the leachate both when the pump is operating and especially when the pump was not operating in 2017. Unfortunately, there are no data for CP11 – Outlet although the mean concentrations between January 2014 and July 2018 suggest there is a bump of about 1 mg/L at STN1 with a gradual rise through the system to STN9 at 2.3 mg/L. This increase would appear to be primarily attributable to the unquantified impact of leachate reaching Chedoke Creek. Concentrations in Cootes Paradise near the mouth of Chedoke Creek quickly declined to around 0.01 mg/L during the discharge event.

In conclusion, while there appears to have been some impact on ammonia as N concentrations in Chedoke Creek resulting in an increase in ammonia of about 1 mg/L at Stn. 1, there has been an ongoing influence from leachate reaching the watercourse. The natural variability of ammonia concentrations precludes a conclusion regarding a statistically significant impact of either the discharge event or the leachate.

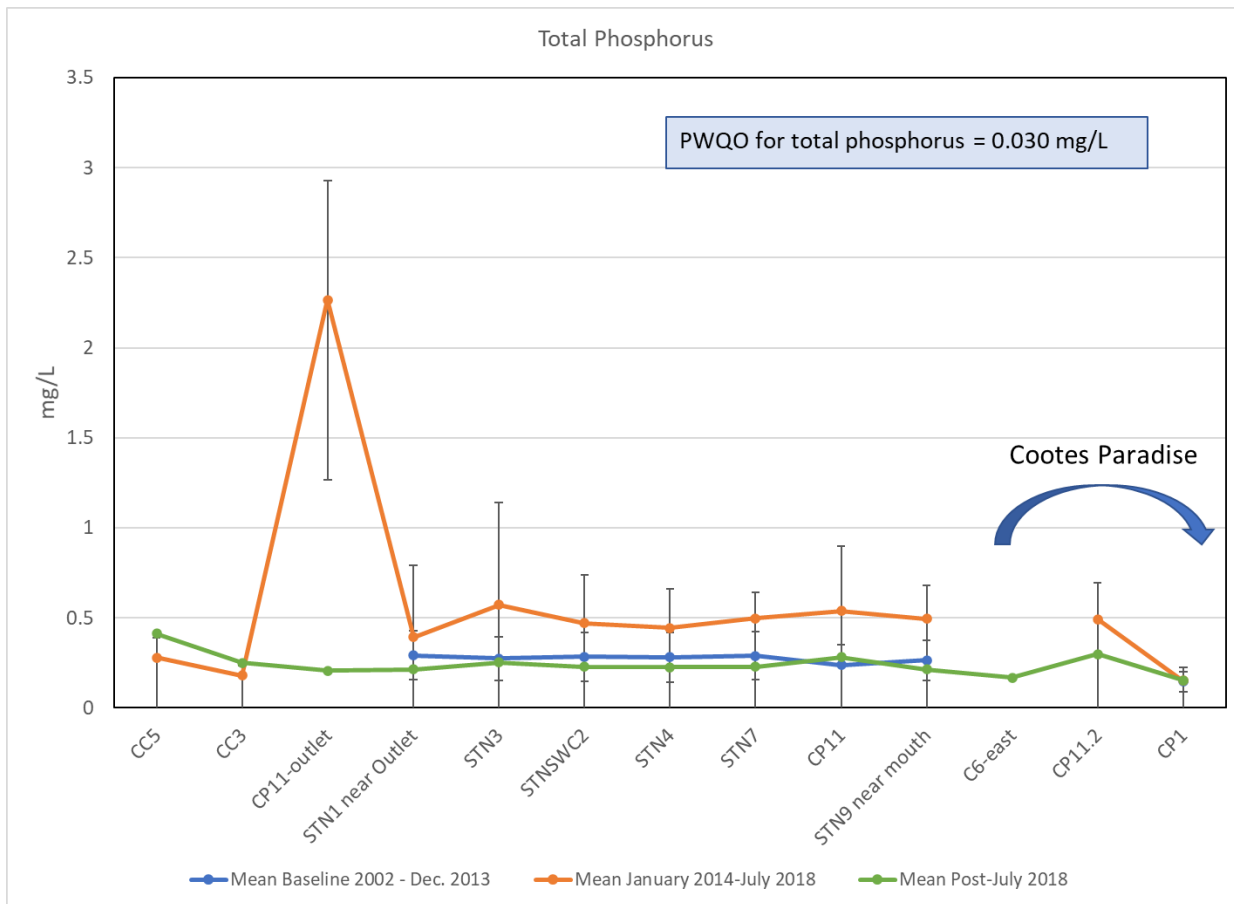
Figure 5-6:
Chedoke Creek and Cootes Paradise total phosphorus concentrations

The discharge event evidently produced elevated TP concentrations at CP11-Outlet averaging 2.3 mg/L and about 2 mg/L above the upstream concentrations and the baseline concentrations in Chedoke Creek. However, TP concentrations were quickly assimilated in the creek returning to concentrations that were about 0.5 mg/L or double the baseline and post discharge event concentrations (Figure 5-6). TP concentrations vary widely and there is no indication that the average in-stream concentration during the 2014 to 2018 period can be statistically differentiated

from background concentrations. TP concentrations in both Chedoke Creek and Cootes Paradise exceed its PWQO (0.03 mg/L).

In summary, the discharge event contributed TP to Chedoke Creek, but elevated concentrations were quickly assimilated in the creek and the inherently variable concentrations in the creek do not indicate a statistically significant increase over baseline conditions.

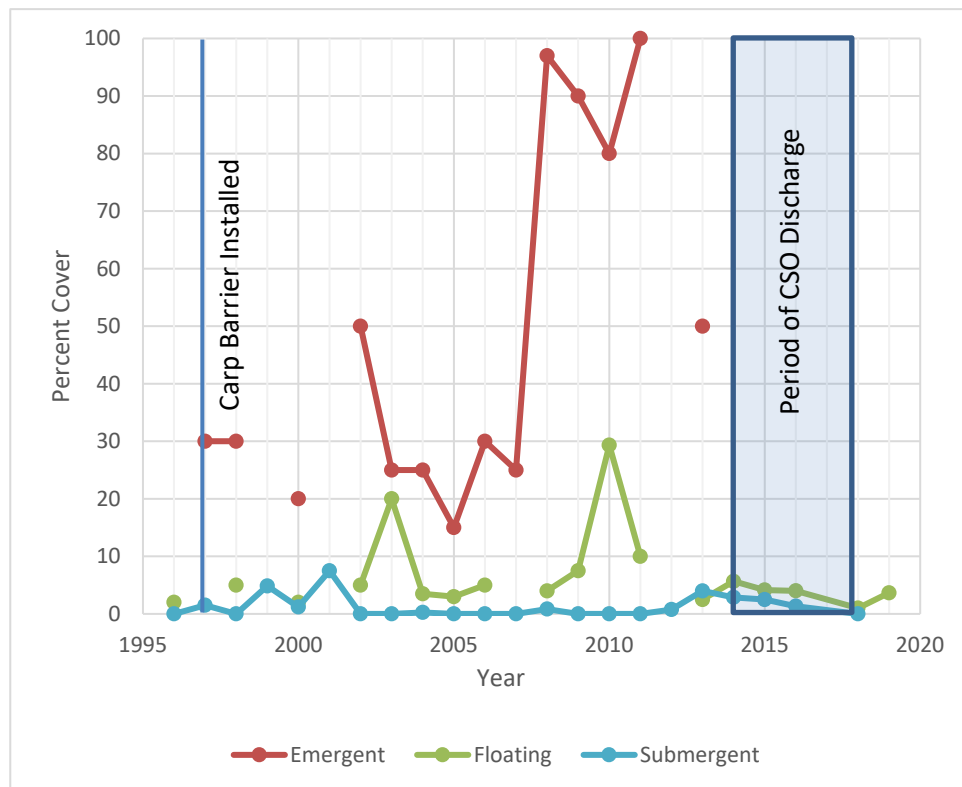
Figure 5-8:
Vegetation Trends for Location in or Near Lower Chedoke Creek

- Magnitude of increases and decreases in percent cover for floating and submergent vegetation types during the CSO discharge were similar to, or smaller than fluctuations prior to the CSO discharge at locations both far from, in or near Lower Chedoke Creek, thus within background variation (Figure 5-9).
- This assessment of available information does not show impacts on aquatic vegetation in Cootes Paradise associated with the CSO discharge, independent from other potential influencing factors.

The observed vegetation trends are generally consistent with previous findings reported for Cootes Paradise by Theysmeÿer et. al (2016) and Leisti et al (2016). In some instances where emergent, submergent and floating vegetation expanded their coverage this was followed with setbacks due to damage as a result of high-water levels, common carp activity, and periods of eutrophic or hypereutrophic conditions which may occur annually (in late summer). Hypereutrophic conditions can result in algae blooms and declines in plant communities (e.g. submergent group). Other factors potentially influencing percent coverage of aquatic vegetation include the regulation of Lake Ontario water levels, resuspension and inputs of sediment from tributaries along with high nutrient levels which may promote algal blooms thus reducing dissolved oxygen (Leisti et al., 2016). These factors influence aquatic vegetation in Cootes Paradise at a much larger scale than the CSO discharge, were occurring before the CSO event and continue as key issues maintaining degraded conditions in Cootes Paradise (Leisti et al., 2016).
