Reference: Valley Inn Bridge Replacement - Natural Environment Technical Memo

VALLEY INN RD BRIDGE No. 457 OVER GRINDSTONE CREEK
BRIDGE REHABILITATION
MISCELLANEOUS DETAILS

VALLEY INN BRIDGE REHABILITATION

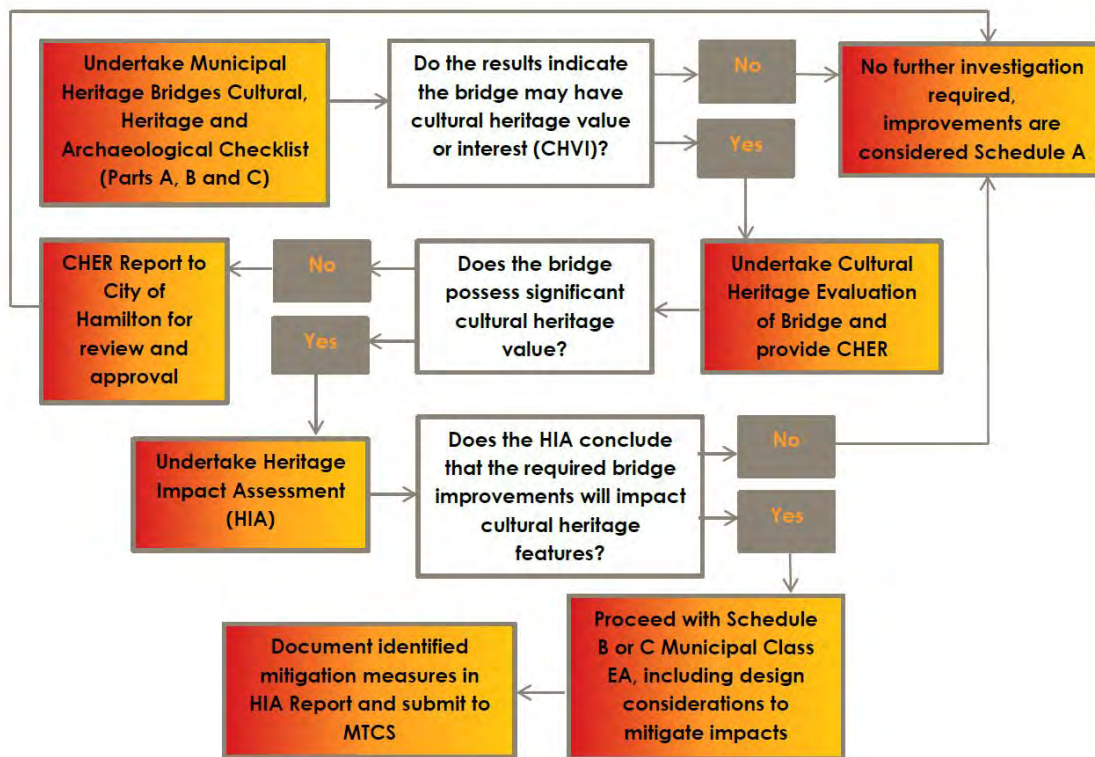
Plate 1: Flowchart of the MCEA Process

This report represents “Step 3” of the MCEA process and the result is a CHIA that identifies impacts and mitigation measures to ensure that the cultural heritage value of the Valley Inn Bridge is conserved. A flowchart depicting the MCEA Process as it pertains to municipal bridges is provided in Plate 1 below.

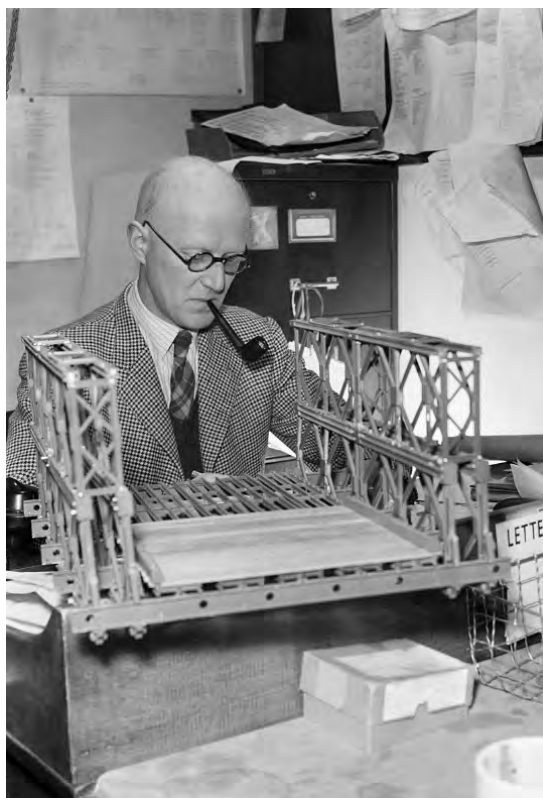
Plate 30: Donald Bailey with a model of the Bailey Truss Bridge in 1944 (Imperial War Museum 1944)
