4 EXISTING SUBWATERSHED CONDITIONS

4.3 Surface Water Resources – Flooding

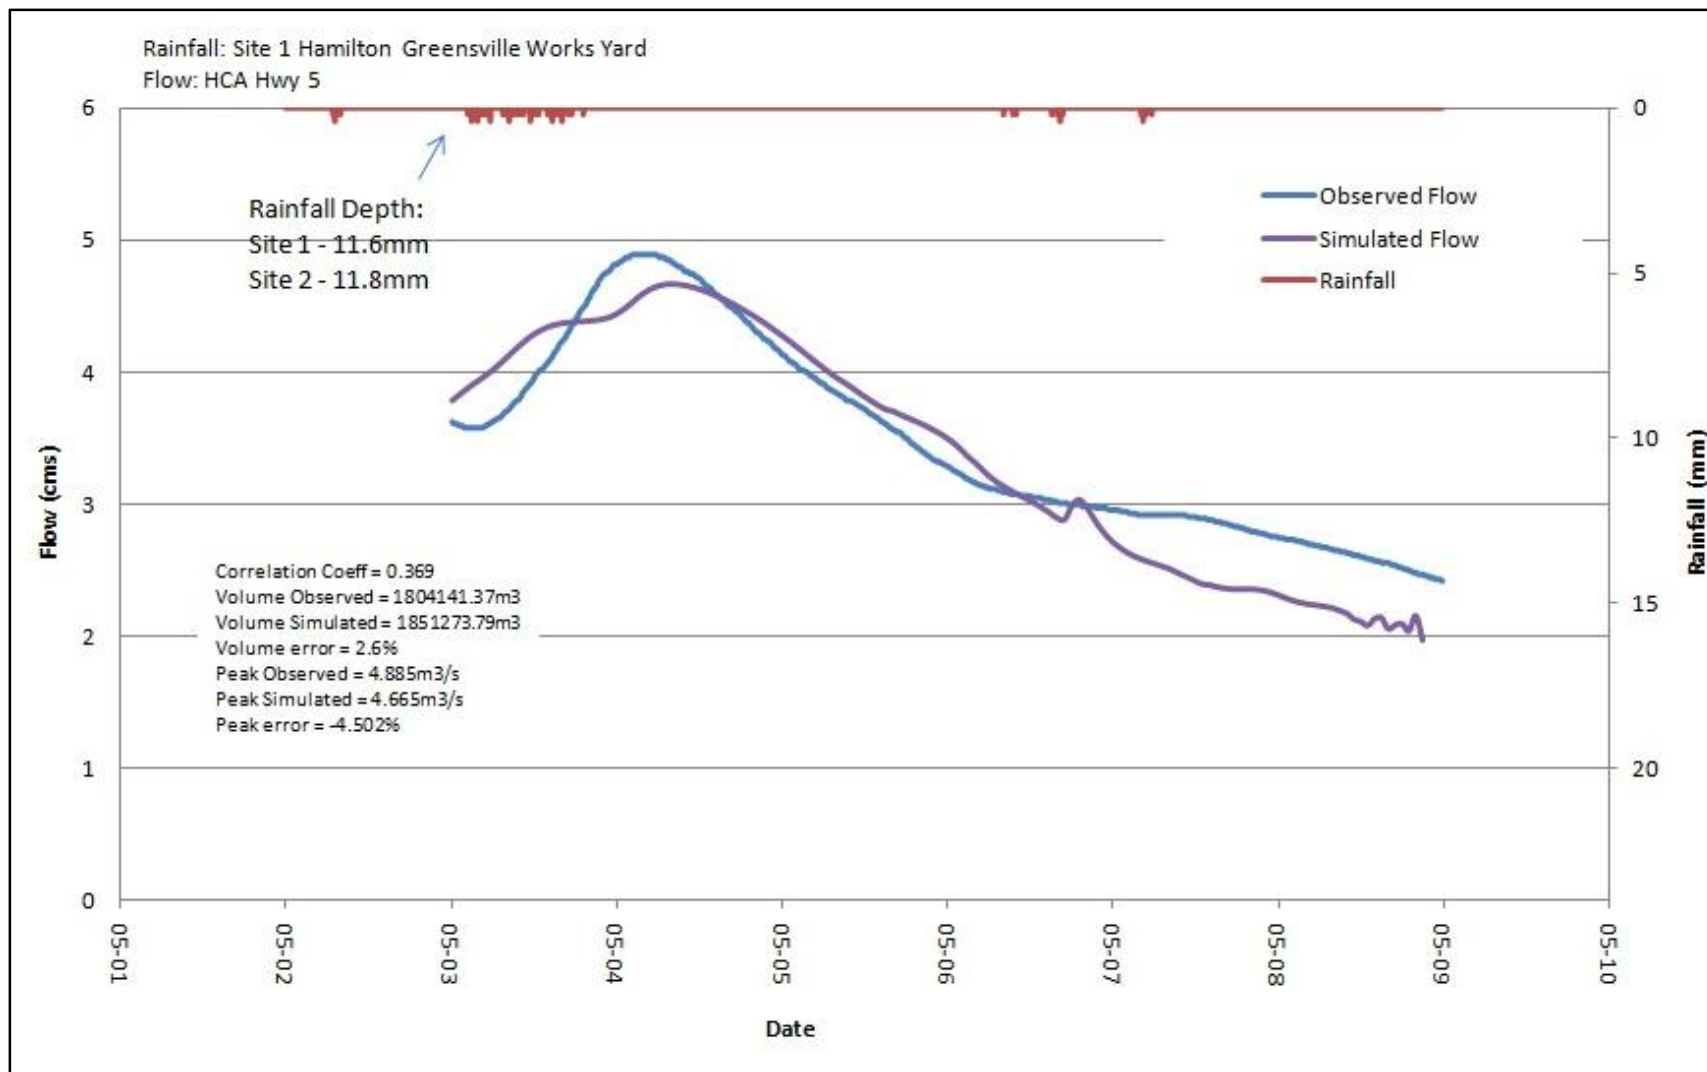
Figure 4.3.8: Calibration May 3rd 2011

The results of the model calibration and validation are shown in **Figures 4.3.5 to 4.3.9**, where simulated and observed flows were plotted and errors in estimating runoff rates and volumes were estimated. Accordingly, for the Hwy 5 gauge, the calibration resulted in a fair to a very good agreement between the simulated and observed runoff volume at the calibration stage, and a good to a very good agreement at the validation stage (**Table 4.3.3**). The validated hydrographs also showed good agreement in hydrograph shapes and baseflows.

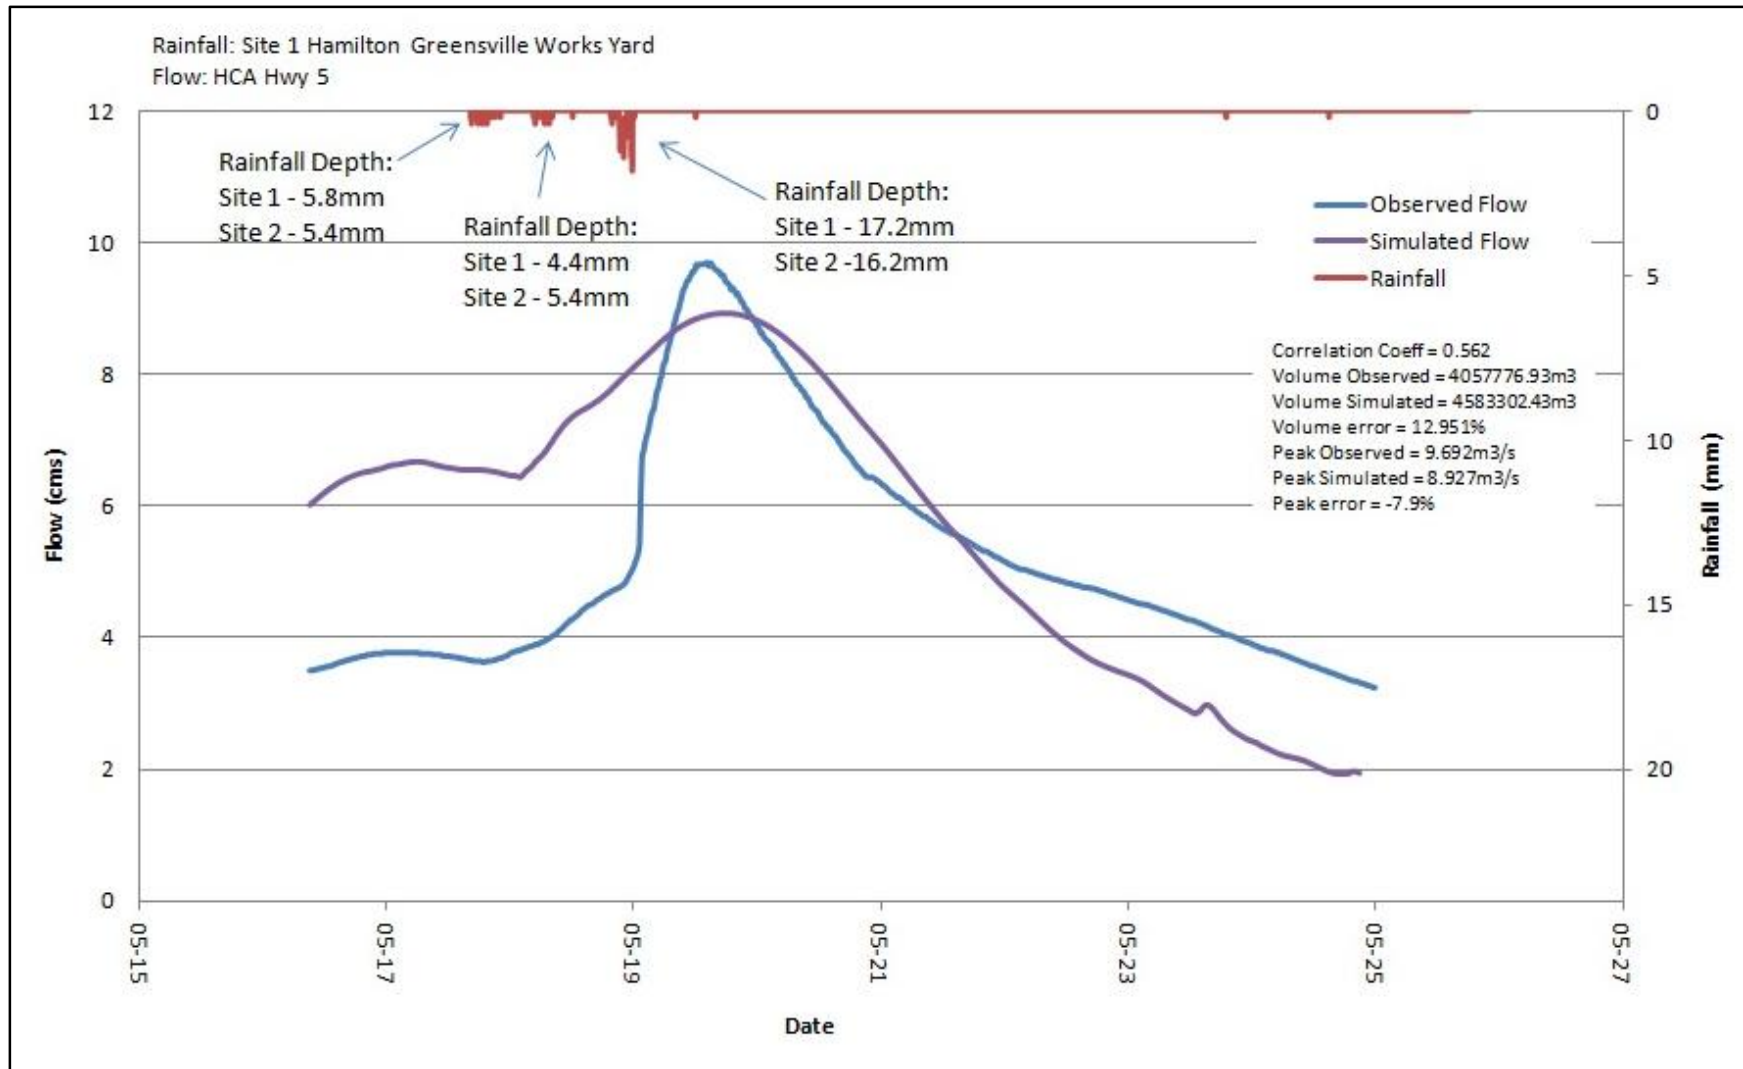
Figure 4.3.9: Calibration May 18th 2011

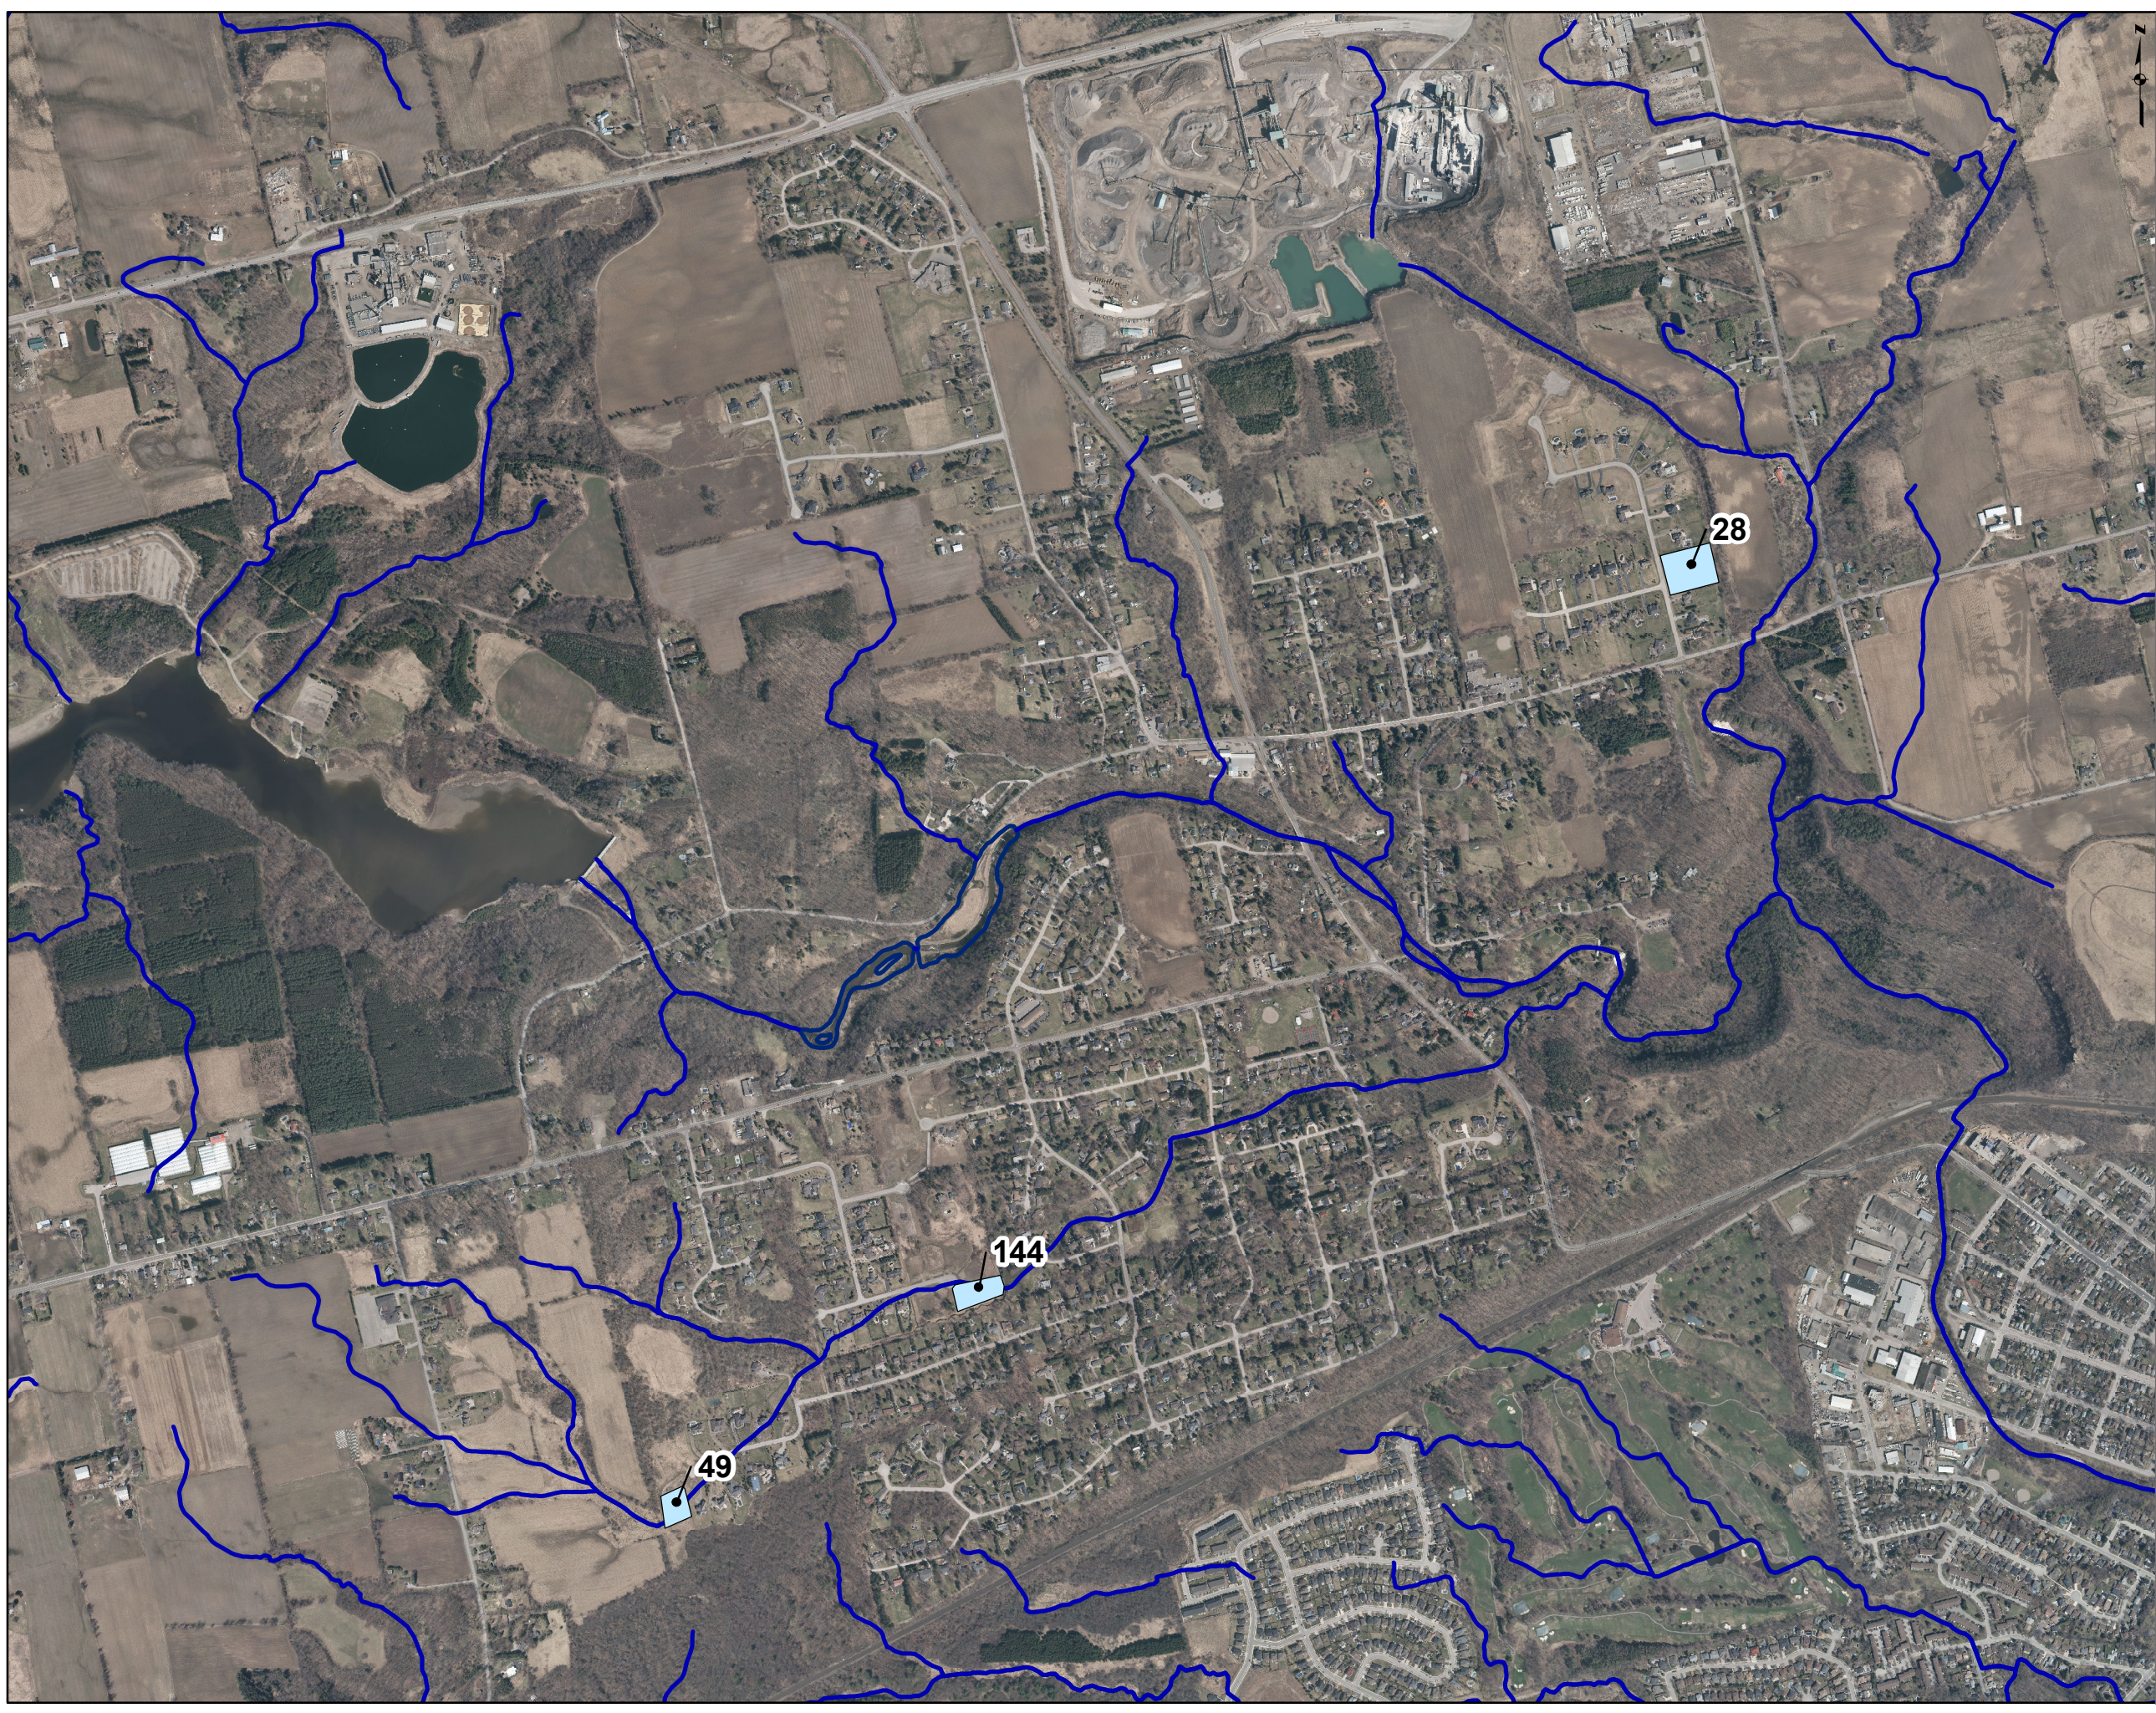
FIGURE 4.3.12
Location of Existing
Stormwater Management
Facilities

Within the RSA there are three existing stormwater management facilities. The locations are shown on **Figure 4.3.12**. Pond #49 is an assumed wetland located at Oak Avenue and Rosebough Street. Pond #144 is an unassumed wet pond located at Mashboro Ave and Herbert Place. Pond #28 is an assumed wetland located at Ofield Road South and Harvest Road.

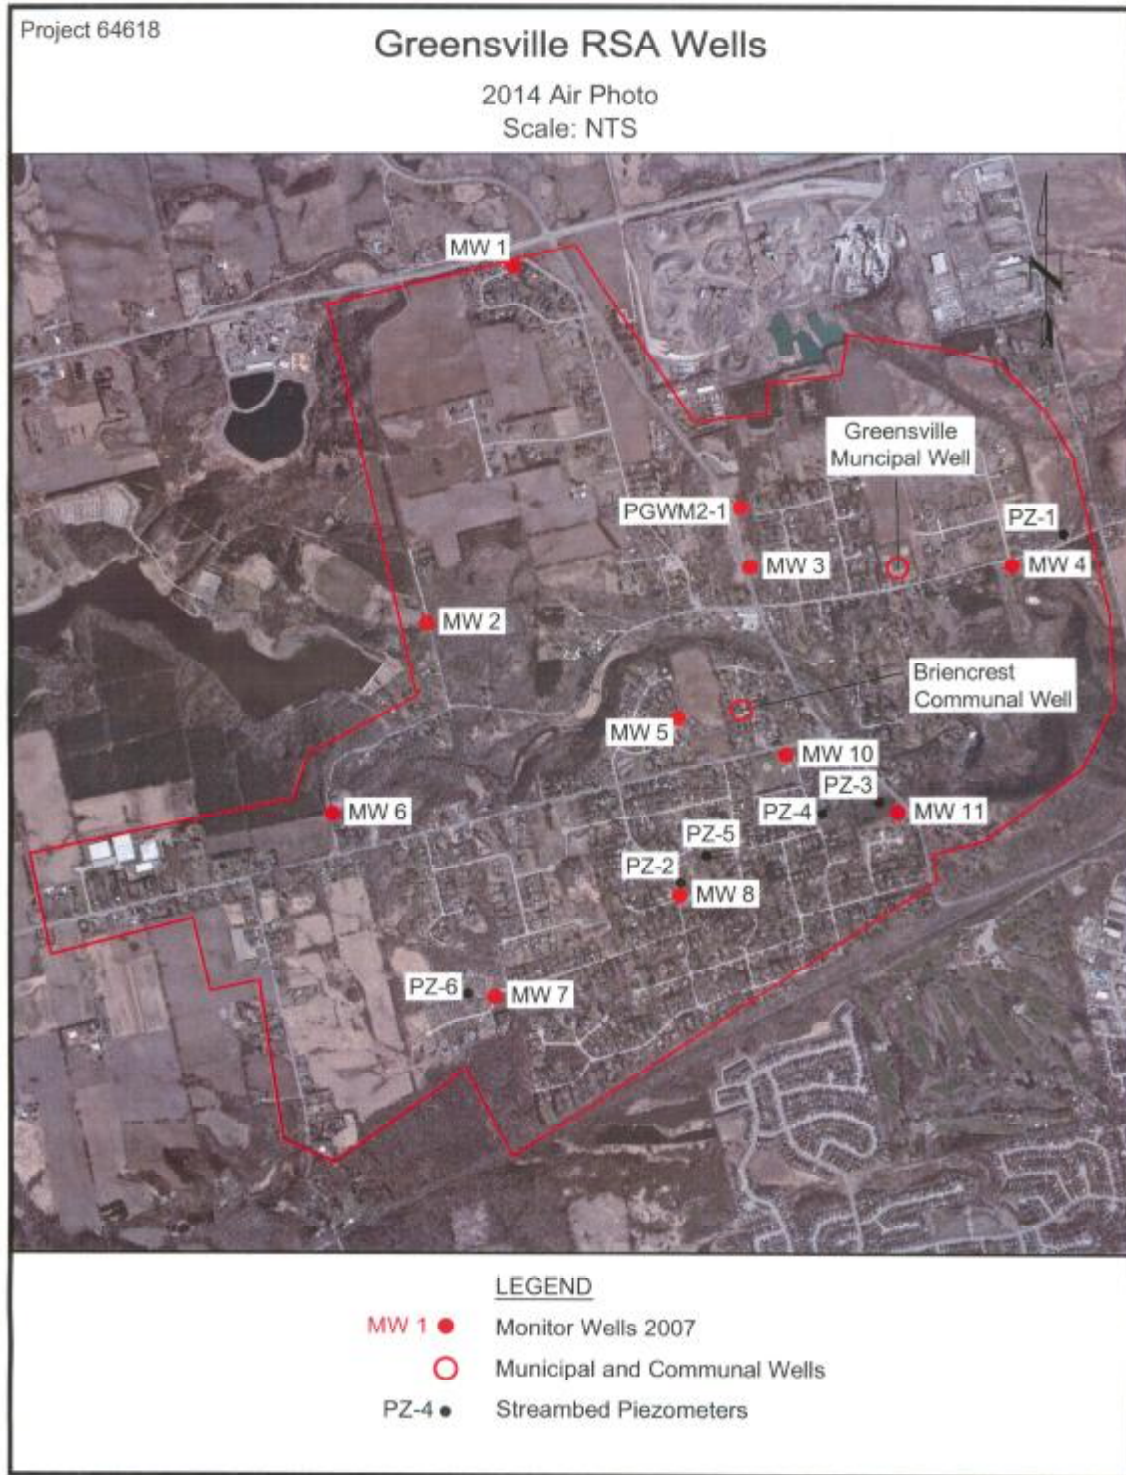
Figure 4.4.8: Locations of 2007 Monitor Wells, Greensville Municipal Well (Drilled 1972, Water Works Approval 1975), the Briencrest Communal Well (1957) and streambed piezometers

The water levels in the nested wells showed a consistent downward gradient from overburden to bedrock between December 2006 and July 2007. These data indicate that the overburden aquifer and the uppermost (weathered) bedrock aquifer are hydraulically connected and that infiltrating water can drain from the overburden into the bedrock.

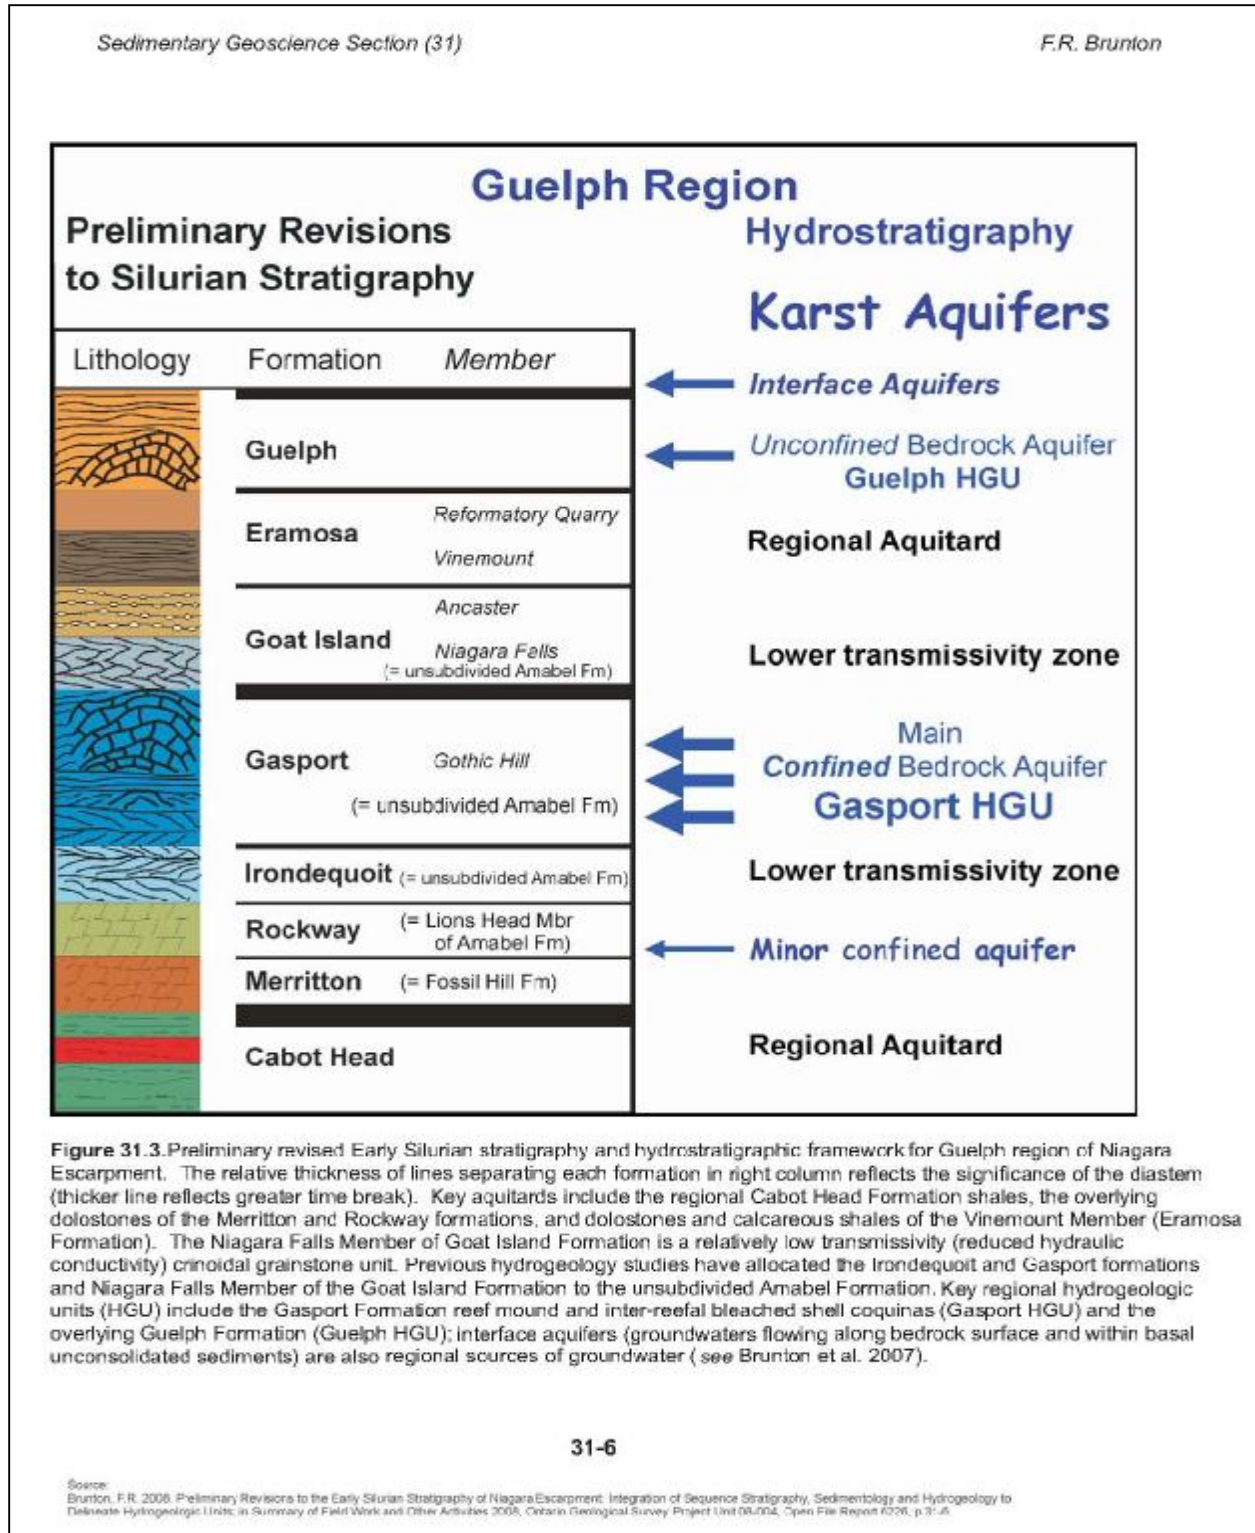
Figure 4.4.12: Bedrock Stratigraphy and Aquifer Sections (from Brunton 2008)

A more detailed examination of the bedrock stratigraphy reveals that the shallow productive aquifer (or hydrogeologic unit – HGU) is found in limestones and dolostones of the Guelph Formation. A second aquifer is associated with the Gasport Formation (aka the Middle Amabel Formation), as illustrated in the section of the Niagara Escarpment in **Figure 4.4.12** (Ontario Geological Survey, from Brunton, 2008). The regional stratigraphic layering is shown in a North-South cross-section that encompasses the Middle Spencer Creek Subwatershed in **Figure 4.4.13** (from Earthfx 2010).

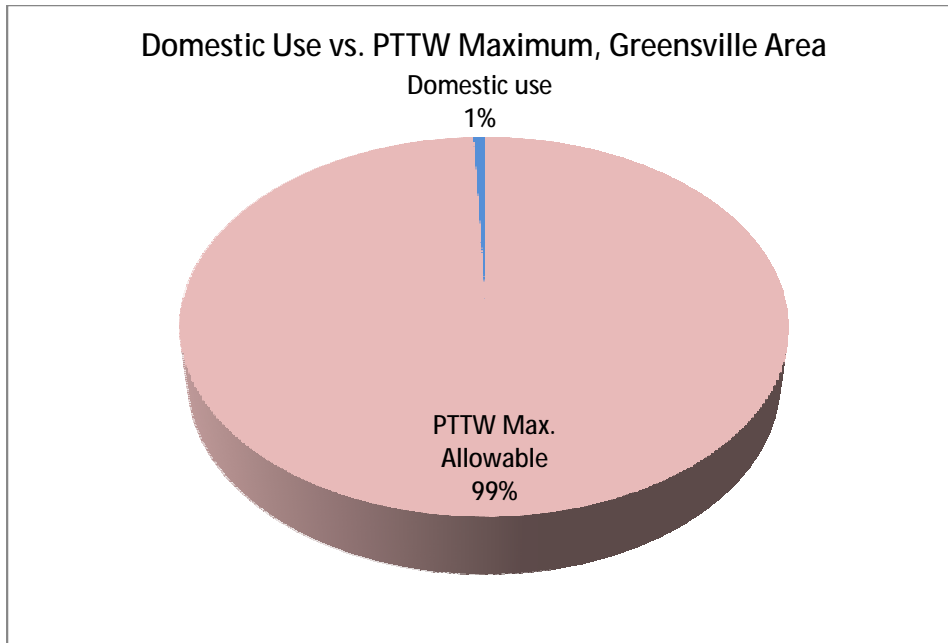
Figure 4.4.17: Groundwater Withdrawals in the Greensville Area PTTW and Domestic Wells

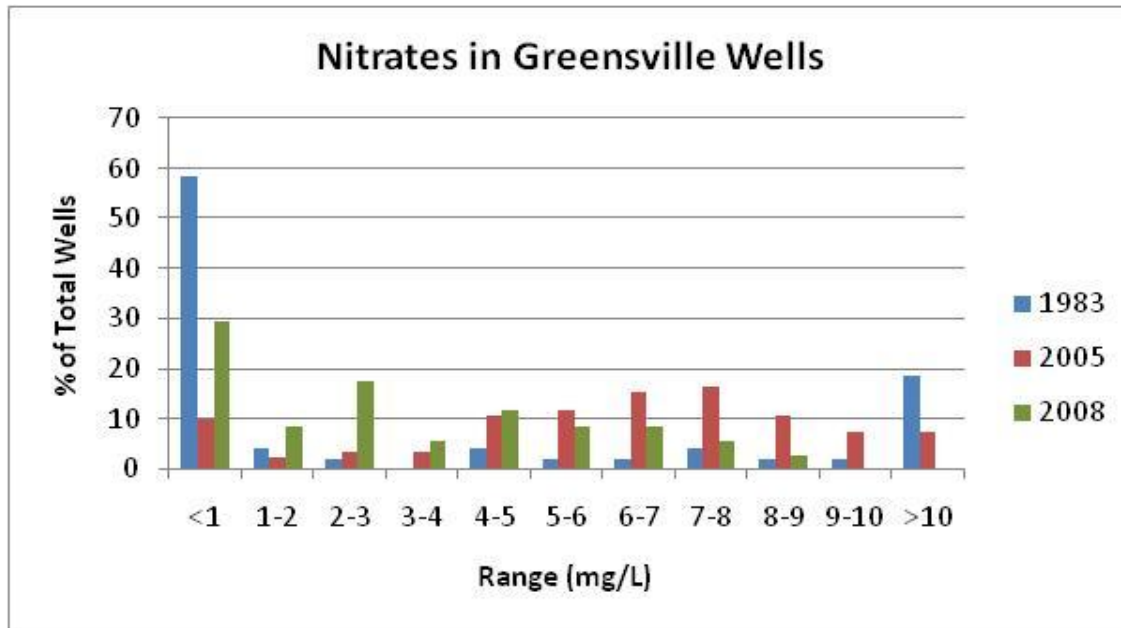
Figure 4.4.19: Nitrate Concentrations in Greensville Well Water (1983 – 2008)

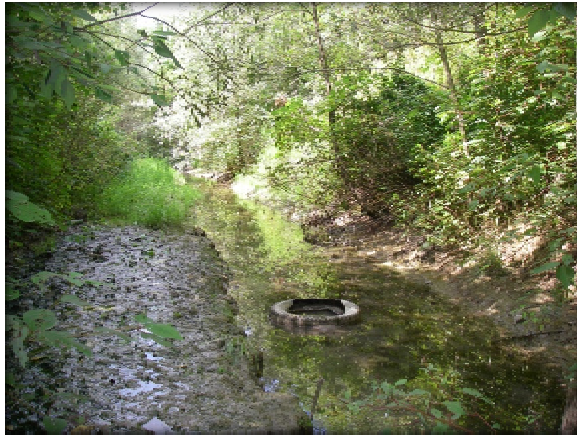
Figure 4.5.8: Logies Creek Reach L-3b

Reach L-3b (**Figure 4.5.8**) of Logies Creek begins within the channelized section and ends downstream of the quarry. This entrenched reach has been channelized and the bed morphology varies from a poorly defined pool-riffle form to low bed relief form. The stream bed composition consists of poorly sorted, unconsolidated fine sediment with few cobbles present. Deposition of unconsolidated fines has been identified within the pools, providing evidence of aggradation. The planimetric form of this channel has been historically altered through the channelization of the watercourse and evidence of adjustment is occurring through poorly formed bars and a thalweg alignment that does not follow the geometry of the channel. The stream banks are composed of fine material with local coarse fill and the riparian vegetation is deciduous and herbaceous vegetation. The Rapid Geomorphic Assessment classifies this reach as ‘stable’, however, the reach exhibits evidence of significant human modification and few natural geomorphic features exist.

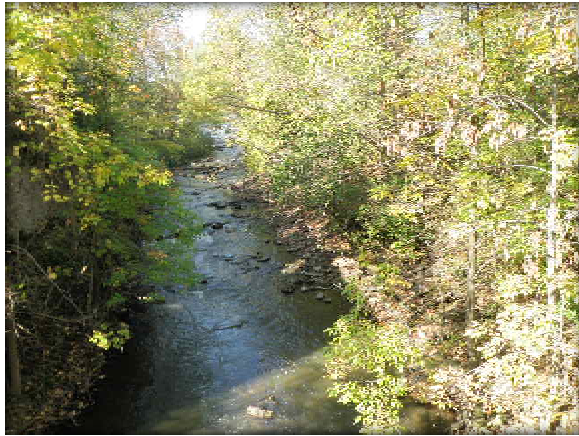
Figure 4.5.19: Middle Spencer Reach MS-5c

Reach MS-5c of Middle Spencer Creek (**Figure 4.5.19**) begins at Crooks Hollow Road and ends at Christie Dam. This is a bedrock channel that has various sizes of coarse material along the bed and multiple knickpoints are present within this reach. No Rapid Geomorphic Assessment was completed at this site due to the bedrock control.
