**DRAFT
MODIFIED PHASE I ENVIRONMENTAL SITE ASSESSMENT
WATERDOWN EAST-WEST BYPASS
HIGHWAY 6 TO BRANT STREET
HAMILTON/BURLINGTON, ONTARIO
for
CITY OF HAMILTON**

PML Ref.: 08HX014
DRAFT Report: 1
March 2009

Draft
Modified Phase I Environmental Site Assessment
Waterdown East-West Bypass
Highway 6 to Brant Street
Hamilton/Burlington, Ontario

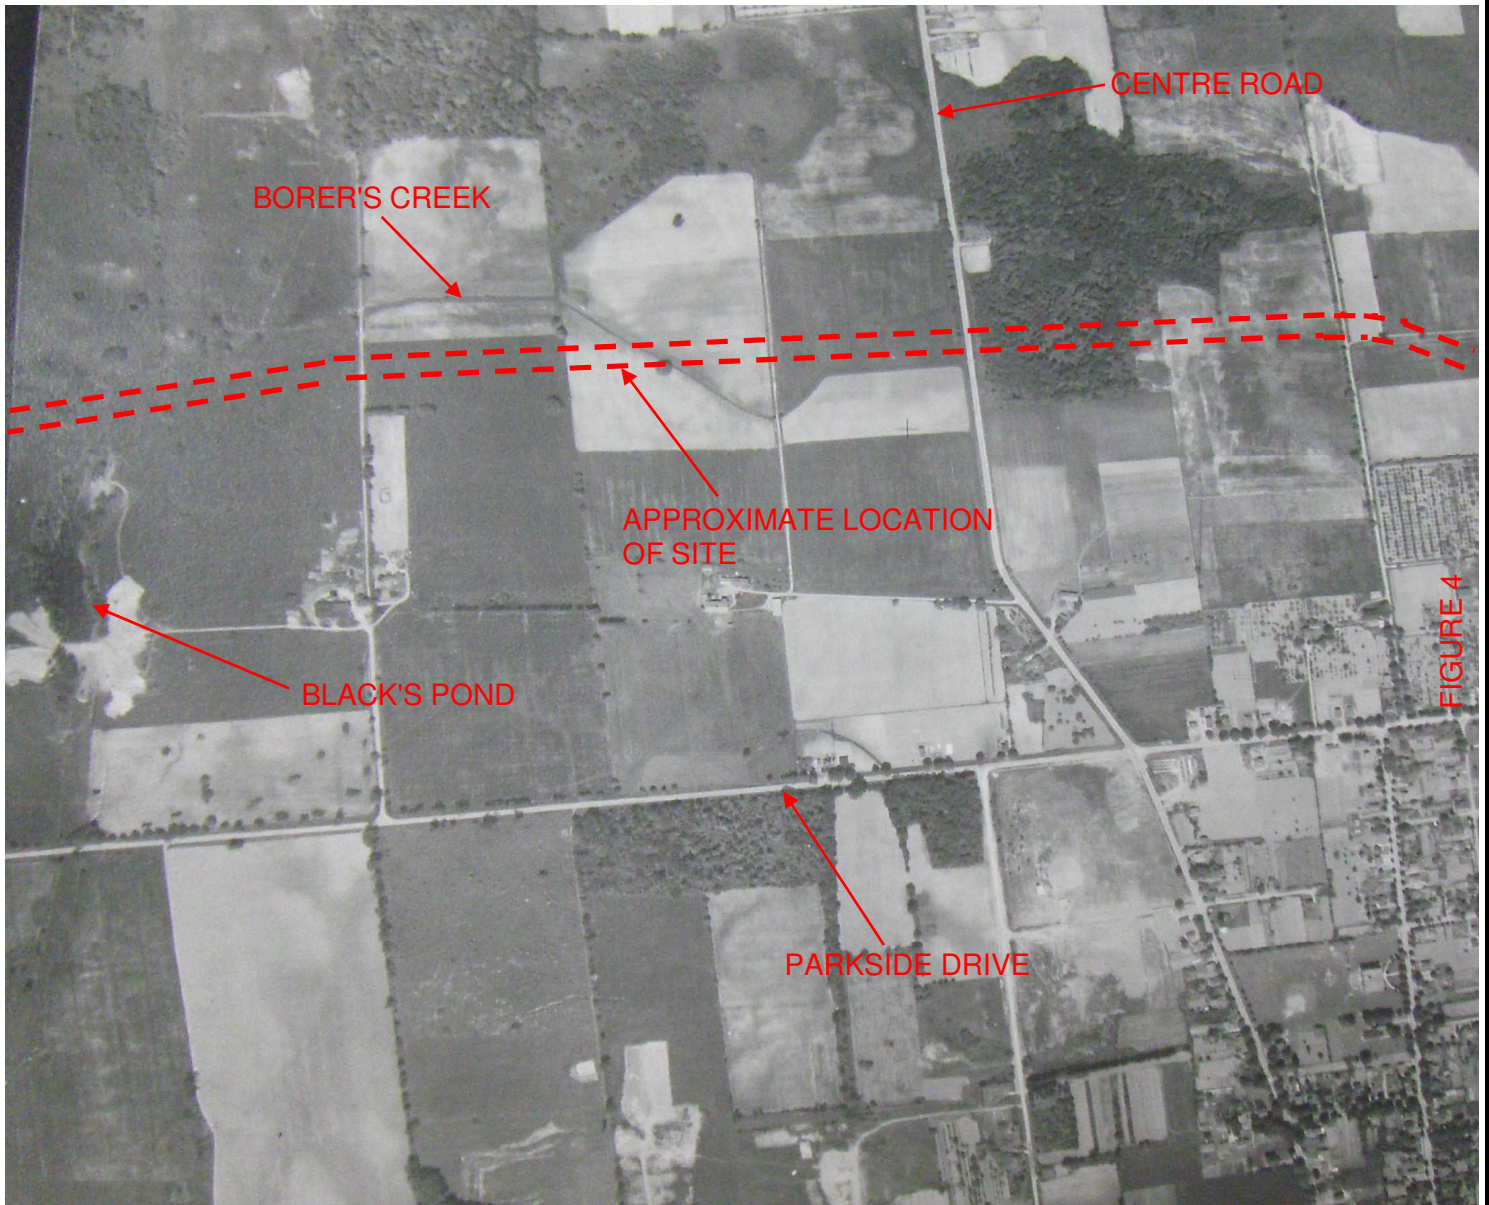
FIGURE 4

Aerial photographs for the year 1950 were available for the entire length of the Site. The aerial photographs indicated the section of the Site, which runs from Highway 6 to Parkside Drive, was used for agricultural purposes, with some wooded areas (Figures 2, 3 and 4). The section of the Site which follows Parkside Drive, was used as a two lane road (Figures 4 and 5). The section of

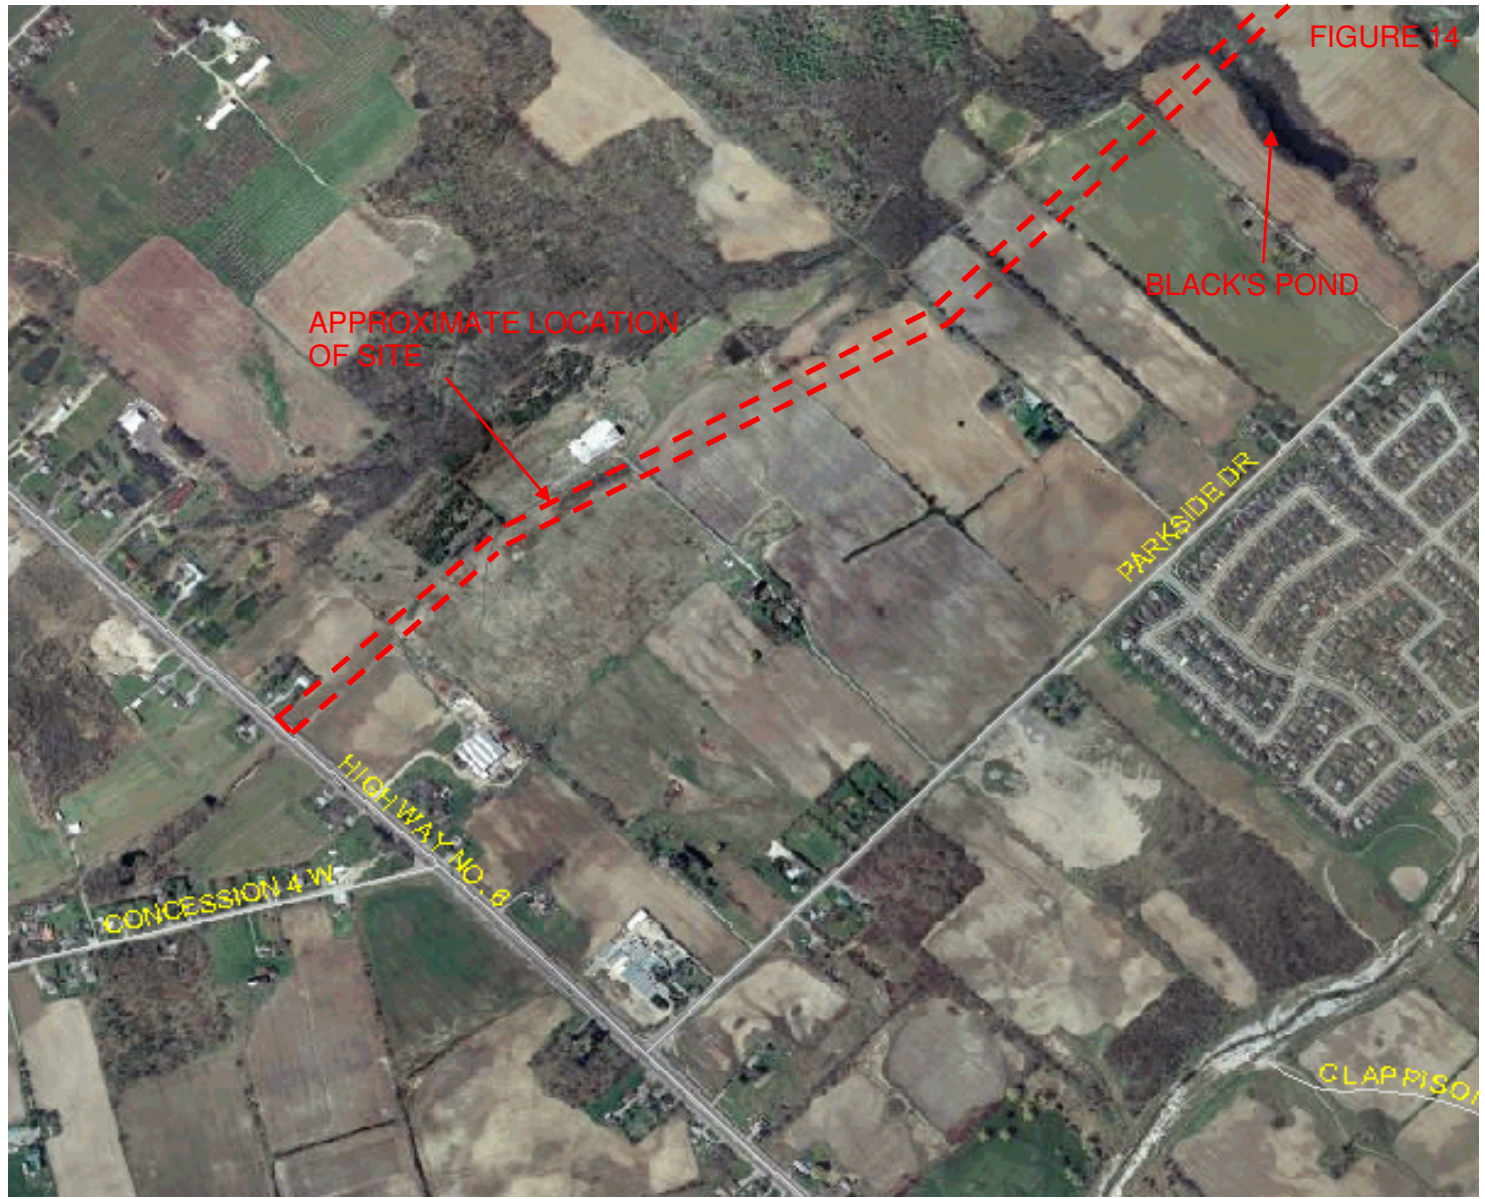
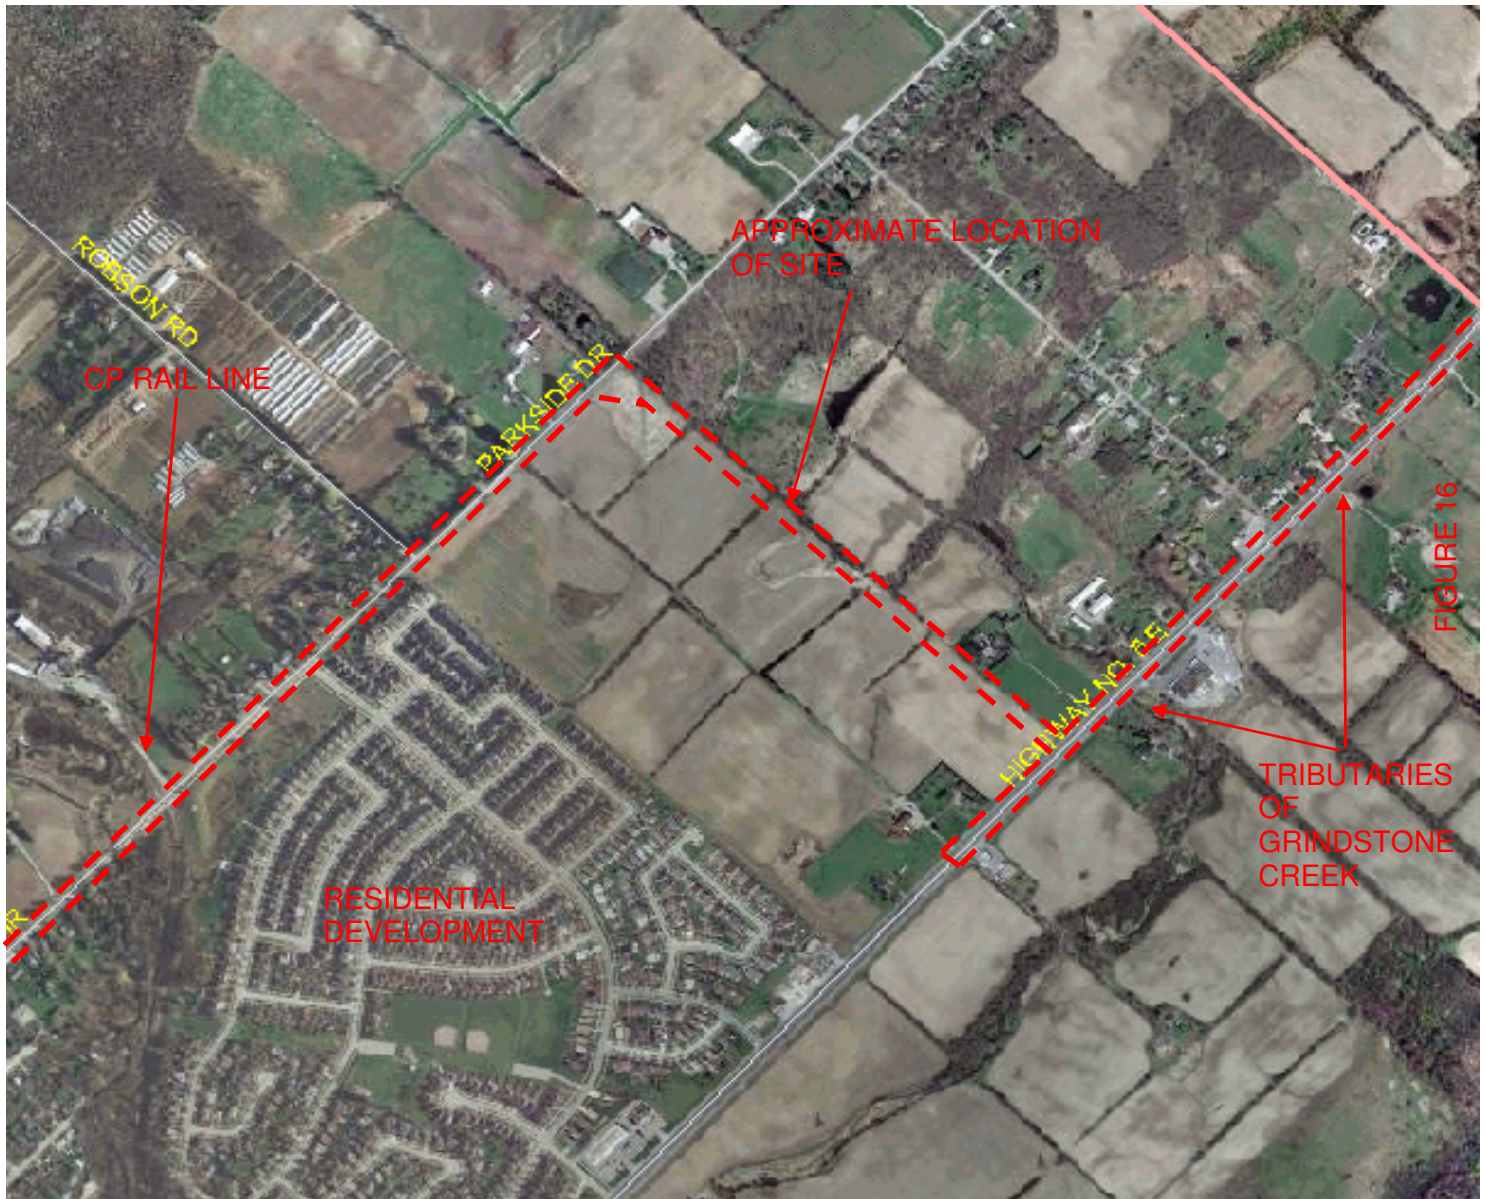
Aerial photographs for the year 2002 were available for the entire length of the Site and indicated similar Site conditions as shown in previous aerial photographs. Borer's Creek is shown crossing the Site at a third location approximately 180 m east of Centre Road. The section of the Site, which follows the Dundas Street East alignment, crossed a tributary of Grindstone Creek approximately 350 m west of Evans Road and approximately 280 m west of Kerns Road. The area of soil stockpiling shown in 1990 was no longer visible. Institutional development, approximately 300 m south of the Site was shown in one location about 680 m west of Centre Road and about 500 m east of Centre Road in another location. Residential development south of the Site was shown just west of Robson Road and just west of Brant Street. What appeared to be a contractors yard was shown immediately north of the Site just east of Kerns Road.

CITY OF HAMILTON
MODIFIED PHASE I ENVIRONMENTAL SITE ASSESSMENT
WATERDOWN EAST-WEST BYPASS HIGHWAY 6 TO BRANT STREET HAMILTON/BURLINGTON, ONTARIO
2002 AERIAL PHOTOGRAPH

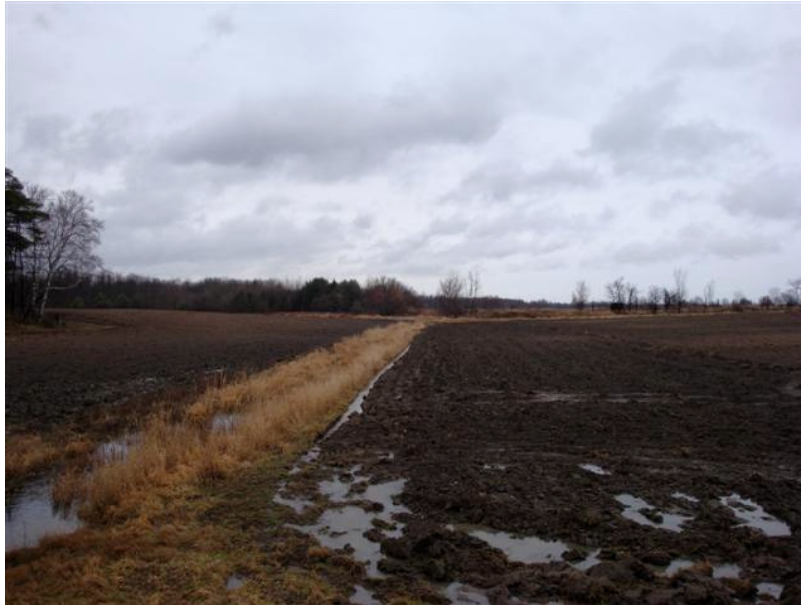
Photograph 1 – View looking east from Highway 6 at typical agricultural Site conditions.

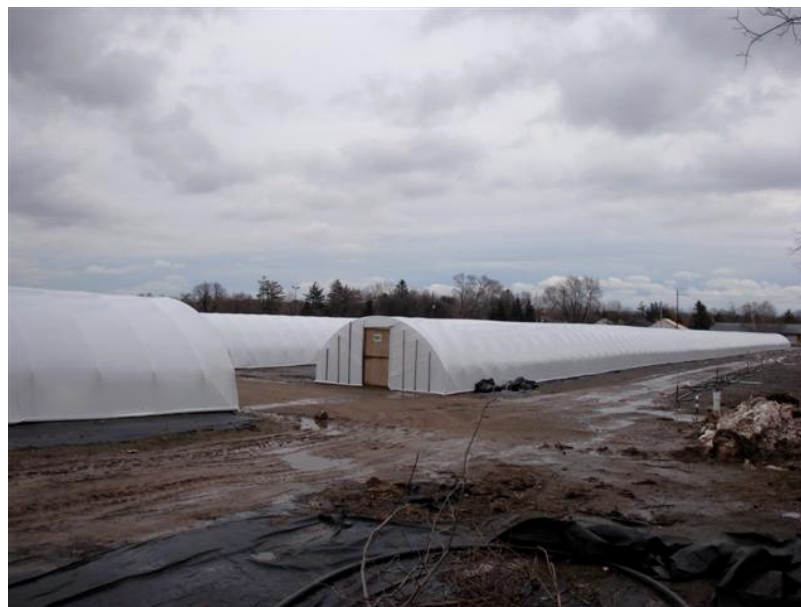
Photograph 2 – View looking southeast at typical Site conditions at the Connon Nursery property located at 383 Parkside Drive.

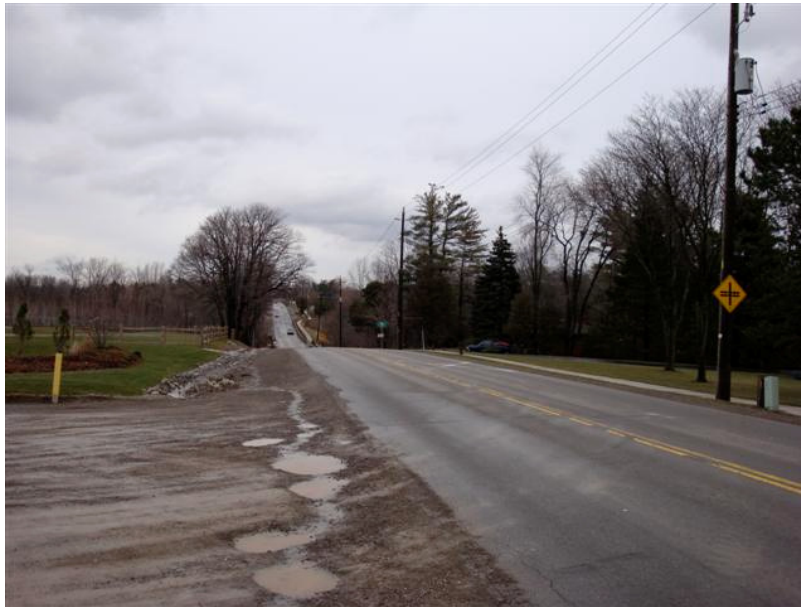
Photograph 3 – View looking west along Parkside Drive including the Grindstone Creek valley.

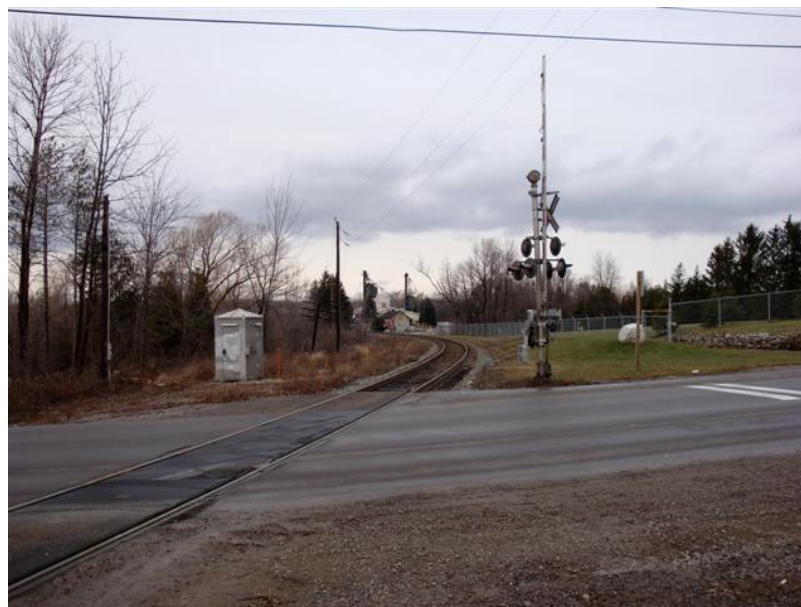
Photograph 4 – View looking north from Parkside Drive at the CP Rail Line. The Opta Minerals property is located beyond the rail line.

The presence of the CP Rail Line that crosses the Parkside Drive alignment east of Grindstone Creek; there is a potential for contamination from the possible use of slag ballast as well as possible spills from rail cars, which may include metals, Volatile Organic Compounds (VOCs), Polycyclic Aromatic Hydrocarbons (PAHs) and Petroleum Hydrocarbons (PHCs).

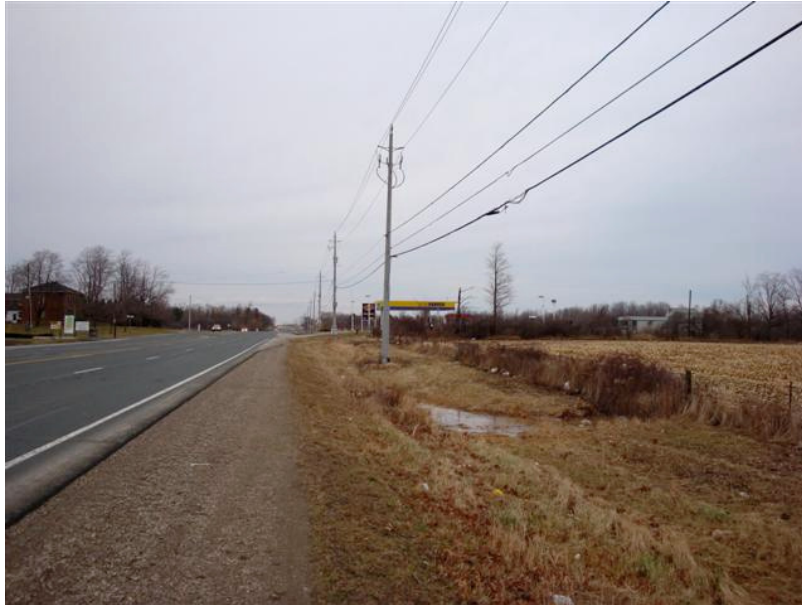
Photograph 5 – View looking east along Dundas Street East including the Sunoco Gas Station located at 490 Dundas Street East.

The operation of at least five former and two current gas stations on Dundas Street East; in the event of spills, leaks or discharges there is a potential for contamination such as metals, VOCs and PHCs.

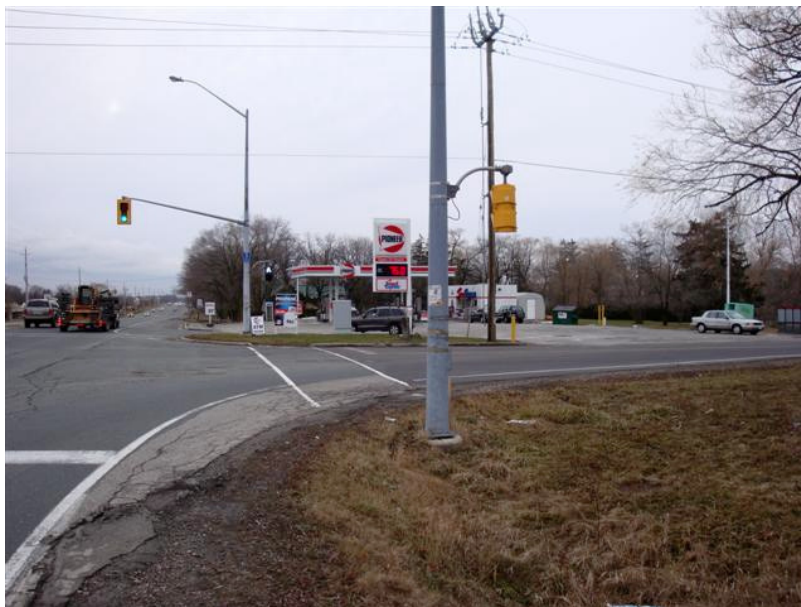
Photograph 6 – View looking west along Dundas Street East including the Pioneer Gas Station located at the northwest corner of the intersection of Evans Road and Dundas Street East.
