**NATURAL HERITAGE CHARACTERIZATION ASSESSMENT
BLOCK 1 LANDS - CITY OF HAMILTON**

Fruitland-Winona Block 1 Owners

Colville Consulting Inc.

File: C18028
Date: April 2024

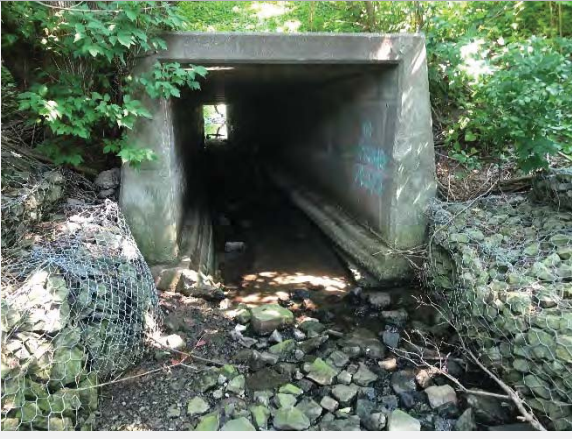
<p>Photo 2: 5 July 2021. Upstream of Highway 8 box culvert with view of structure inlet and gabion bank reinforcement (facing downstream).</p>

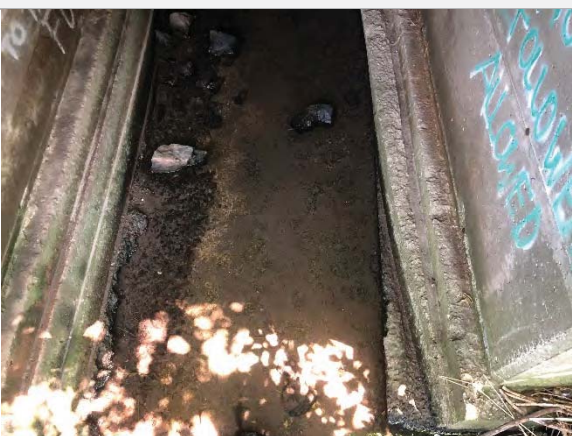
<p>Photo 3: 5 July 2021. Shallow water (3 mm deep) within Highway 8 culvert characteristic of limited aquatic habitat.</p>

The water within the approximately 1.8 m wide box culvert was observed from both ends of the culvert. The observed wetted width of 1.5 to 2.0 m and depth of 0.3 to 3.0 cm (Appendix D Photo 3) are dependent on the distribution of substrates on the culvert floor. Some cobble and gravel were present within the culvert, with a large area being characterized by exposed concrete culvert floor.

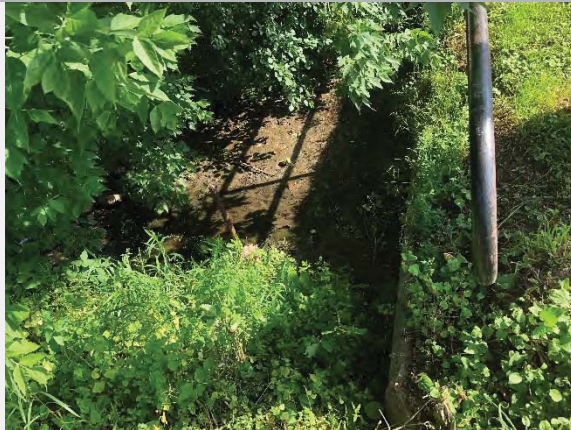
Photo 8: 17 June 2021. Fruitland Road culvert outlet. Standing water conditions (1 mm deep and with no observable flow).

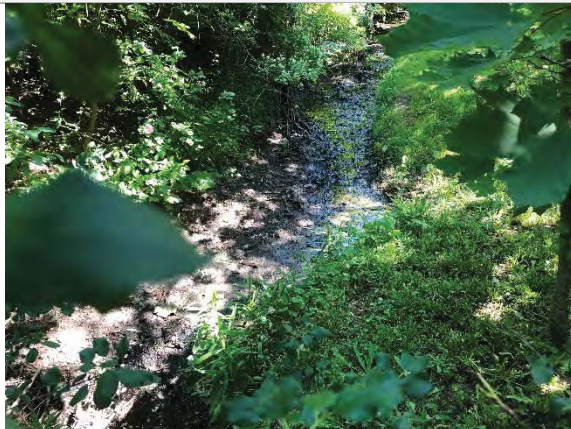
Photo 9: 17 June 2021. Upstream (south) of 212 Fruitland Road culvert inlet. Shallow water (approximately 1 to 2 mm) within the channel. Intermittently distributed dry sections of channel were present.

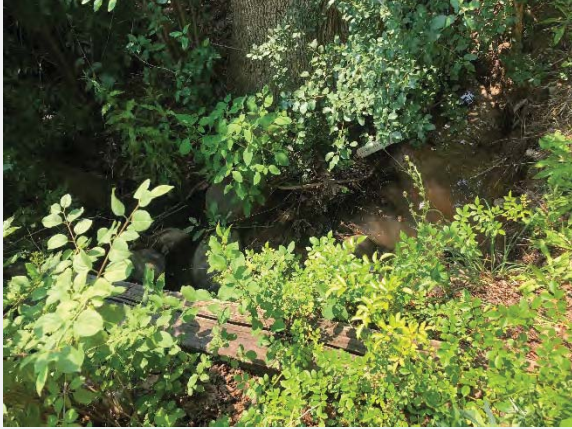
<p>Photo 10: 5 July 2021. Isolated pool immediately upstream (south) of 212 Fruitland Road culvert inlet. Standing water conditions with no observable flow.</p>

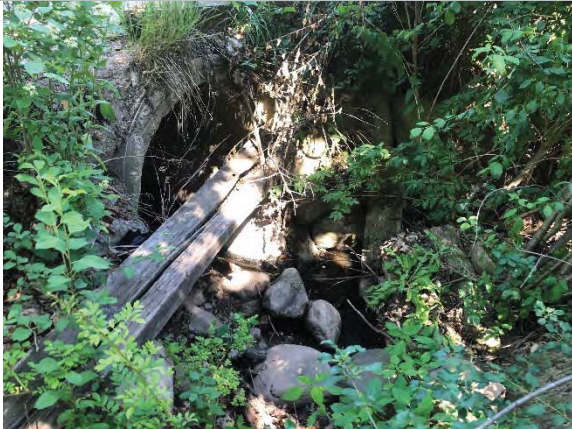
<p>Photo 11: 17 June 2021. Inlet of 212 Fruitland Road culvert. Cobble and wood may provide a barrier to fish movement in event of any higher flows.</p>

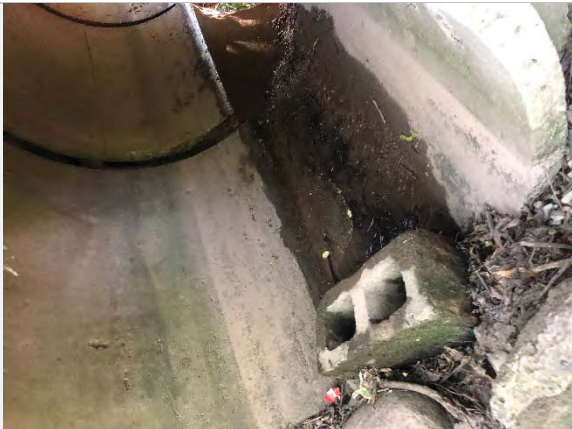
<p>Photo 12: 17 June 2021. Outlet of 212 Fruitland Road culvert. Shallow water (1 to 2 mm) within the culvert.</p>

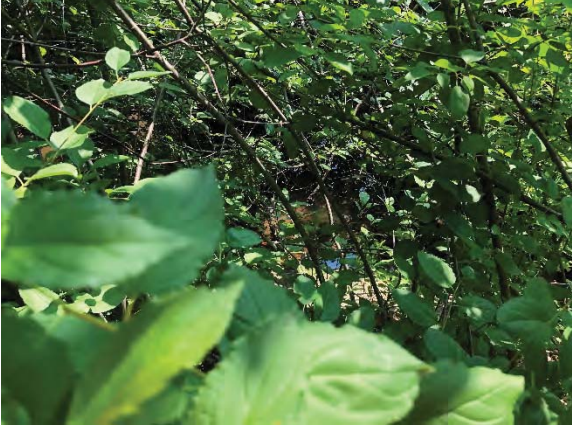
<p>Photo 13: 5 July 2021. Downstream of 212 Fruitland Road culvert outlet. Dense overhanging riparian vegetation. Shallow standing water observed within the channel.</p>

Dense vegetation limited visibility downstream of the culvert, though water could be observed (Appendix D Photo 13).

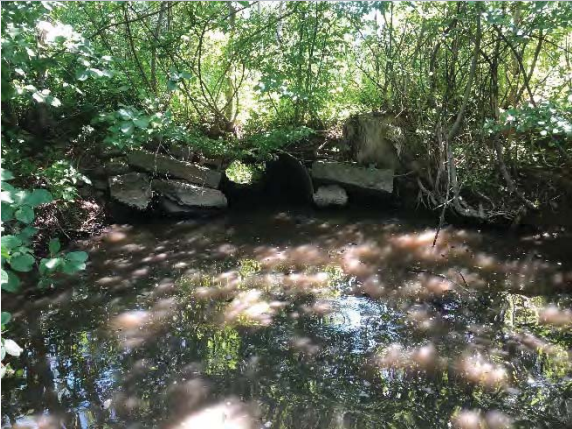
<p>Photo 14: 17 June 2021. Upstream (south) view of watercourse section WC5-A. Pool morphology with a maximum depth of 0.45 m. Outlet of metal culvert at inaccessible private property.</p>

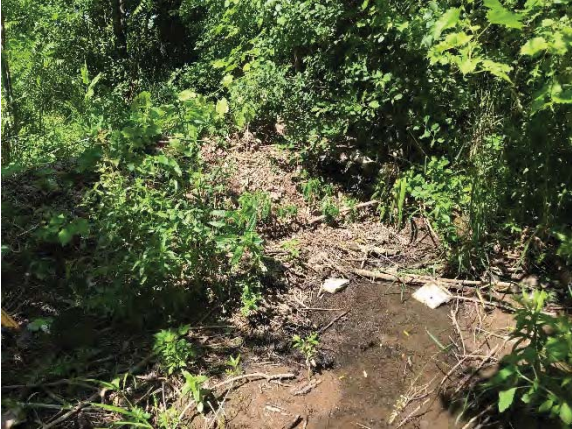
<p>Photo 15: 17 June 2021. Watercourse Section WC5-A. Shallow water (1 mm) and fallen pedestrian bridge with debris blocking channel and aquatic corridor function.</p>

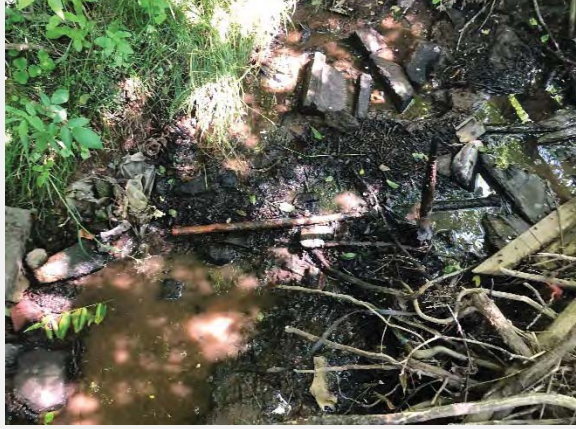
<p>Photo 16: 17 June 2021. Watercourse Section WC5-A. Dry area in channel surrounded by shallow (<2 cm) standing water. Substrates consisting of fines, cobble and assorted debris.</p>

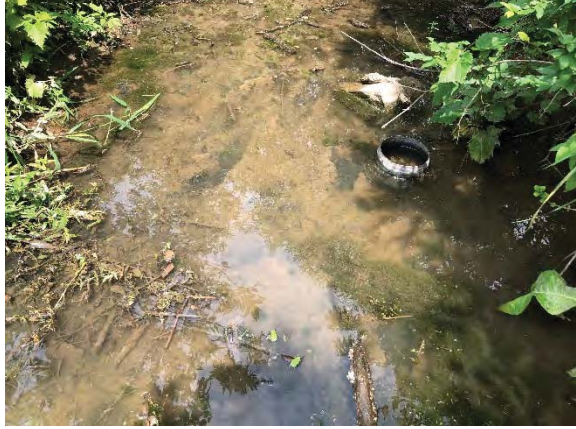
<p>Photo 17: 15 July 2021. Watercourse Section WC5-A. Standing water area of aquatic habitat with no observable flow within the channel. Fine substrates.</p>

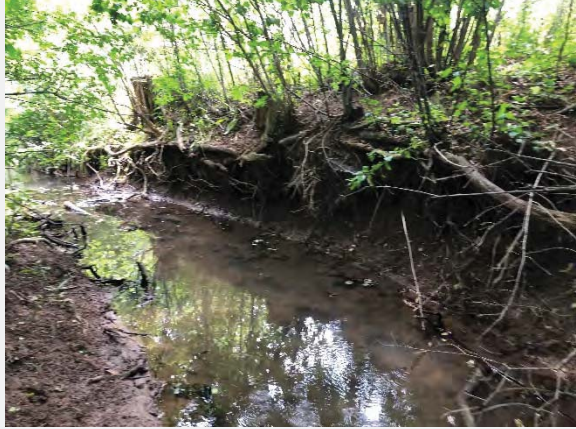
<p>Photo 18: 15 July 2021. Watercourse Section WC5-A, near downstream end of the reach. More defined channel with undercutting on right (west) bank and shallow pool habitat. Riparian vegetation is present along the channel providing overhead shading and cover.</p>

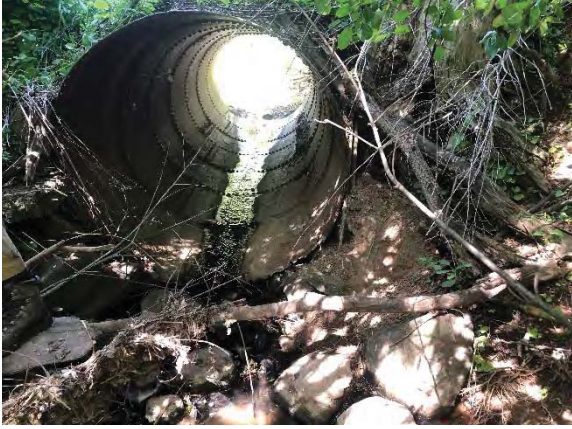
<p>Photo 19: 17 June 2021. Culvert inlet under grass access path between Watercourse sections WC5-A and WC5-B. Water 1 mm deep within the 4.5 m long culvert.</p>

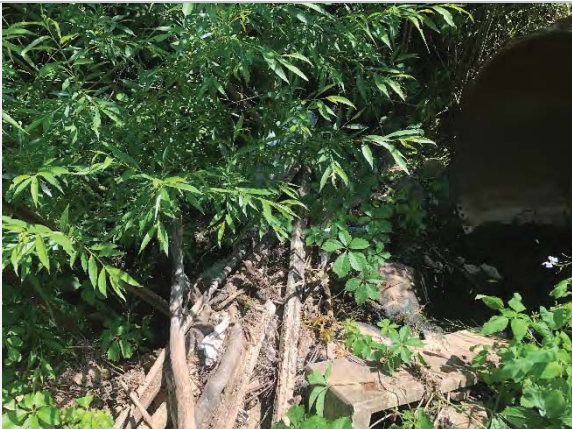
<p>Photo 20: 17 June 2021. Culvert outlet under grass access path between Watercourse sections WC5-A and WC5-B. Debris at culvert outlet extends 55 cm above channel invert partially blocking the flow path. No discernable flow was observed.</p>

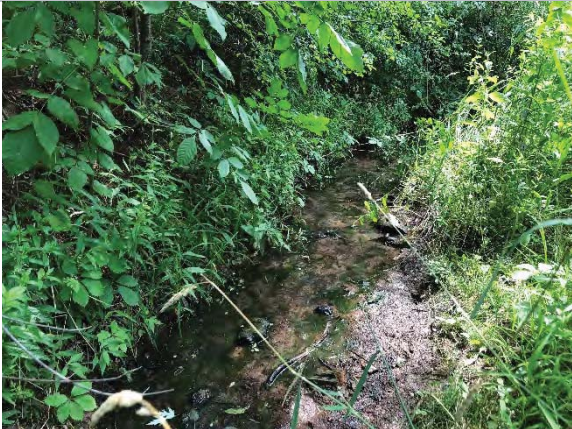
<p>Photo 21: 15 July 2021. Watercourse Section WC5-B exhibiting characteristic intermittent shallow water area with aquatic algae coating a substrate of fines and cobbles. No flow was observed.</p>

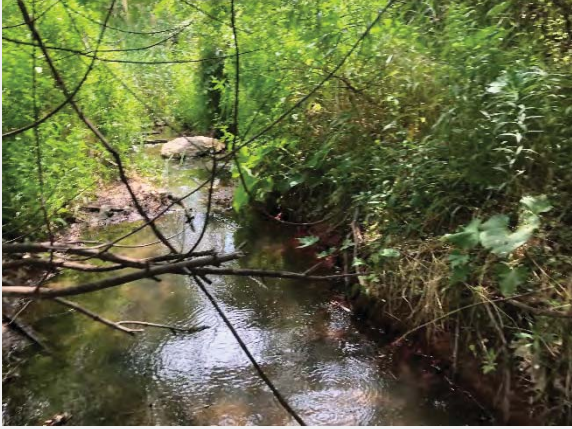
<p>Photo 22: 15 July 2021. Watercourse Section WC5-B exhibiting a shallow standing water pool habitat area.</p>

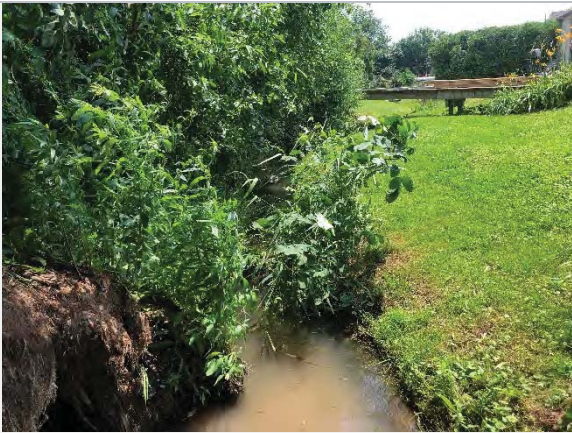
<p>Photo 26: 15 July 2021. Facing upstream from Watercourse Section WC5-C where the defined channel runs through residential properties. Areas beyond this view were not accessed due to private properties. Standing water in scour pool providing some aquatic habitat opportunities.</p>

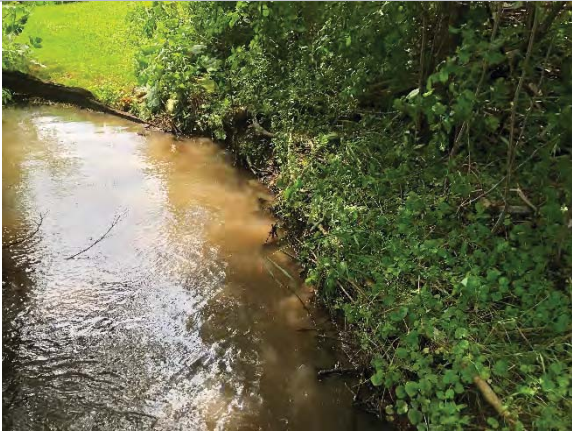
<p>Photo 27: 15 July 2021. Watercourse Section WC5-C upstream view showing mowed lawns, trimmed riparian vegetation leading to unmaintained riparian vegetation on banks of a scour pool providing aquatic habitat opportunities.</p>

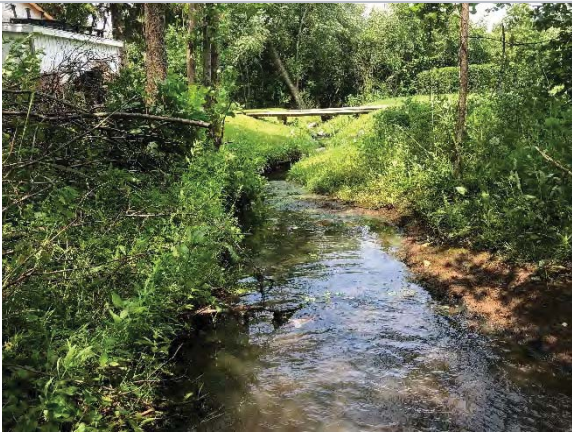
<p>Photo 29: 15 July 2021. Watercourse Section WC5-C, downstream view. Defined channel runs through residential properties immediately downstream (north) which were not accessible.</p>

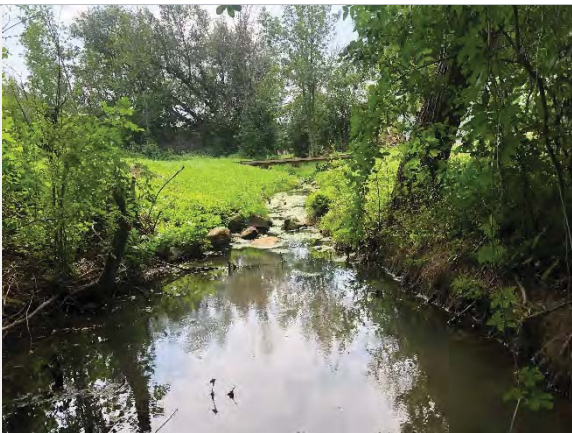
<p>Photo 30: 15 July 2021. Upstream view of Watercourse Section WC5-D. Channel runs through residential properties immediately upstream which were not accessible. Mowed grasses, walkway over the watercourse and placed boulder and stone all observed within this reach of standing water pool habitat.</p>

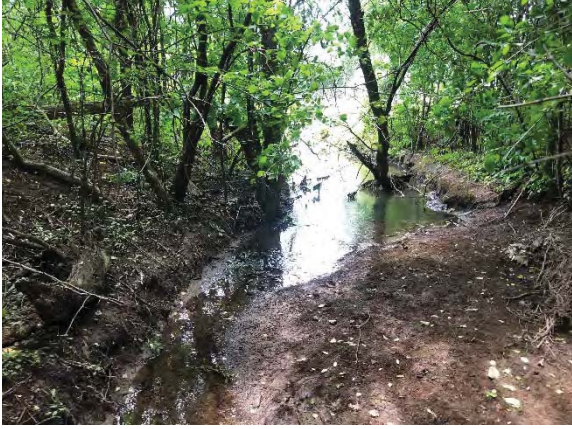
<p>Photo 31: 15 July 2021. Watercourse Section WC5-D. Shallow water pool area and exposed banks and dry channel bed at pool outlet.</p>

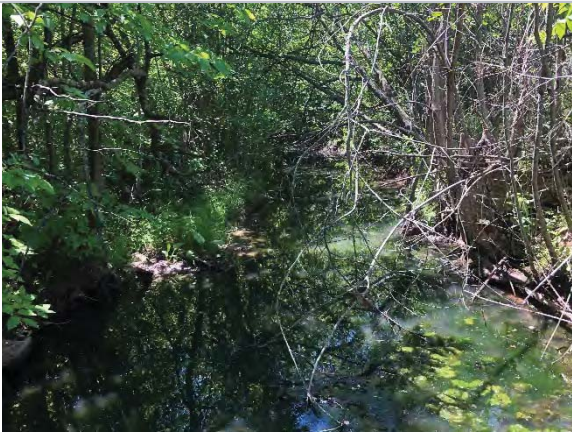
<p>Photo 35: 17 June 2021. Aquatic habitat within Watercourse Section WC5-D. Dense riparian shrub and tree vegetation, standing water pool characterized by a thick growth of aquatic algae across the channel width and length suggesting nutrient inputs.</p>

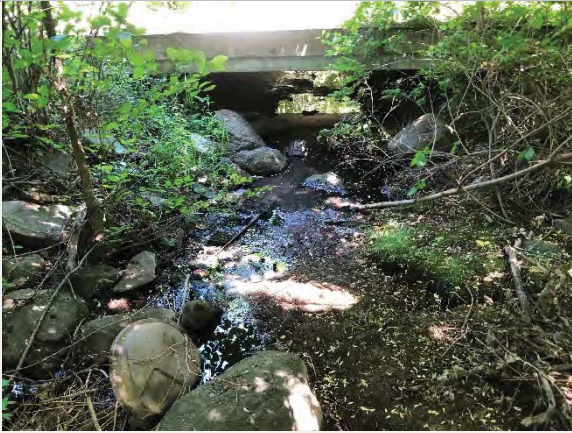
<p>Photo 36: 17 June 2021. Downstream view of Watercourse Section WC5-D toward gravel/dirt path bridge. Dry channel, 0.2 m elevation change over 2 m length. Water present under the bridge. Photos 37 and 38 also show this area.</p>

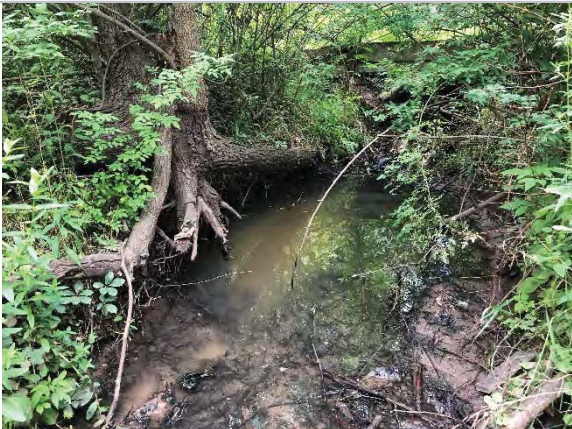
<p>Photo 41: 15 July 2021. Watercourse Section WC5-E. Approximately 10 m downstream of crossing structure.</p>

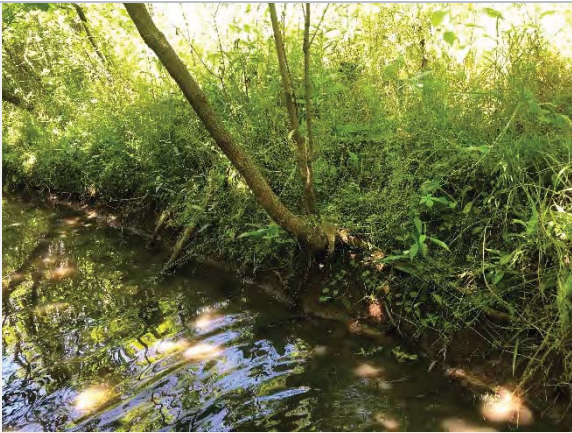
<p>Photo 44: 17 June 2021. Riparian vegetated bank with some exposed soil in Watercourse Section WC5-E. Deeper pool habitat throughout this apparent previously channelized reach.</p>

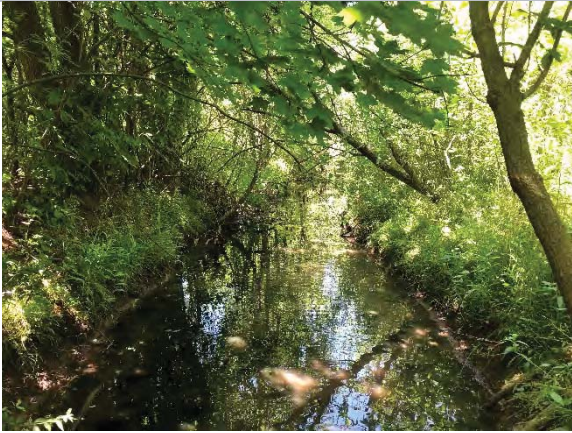
<p>Photo 45: 17 June 2021. Aquatic habitat near downstream end of Watercourse Section WC5-E. Straightened channel reach with standing water pool habitat with notable growths of algae, dense riparian vegetation and overhead shade.</p>

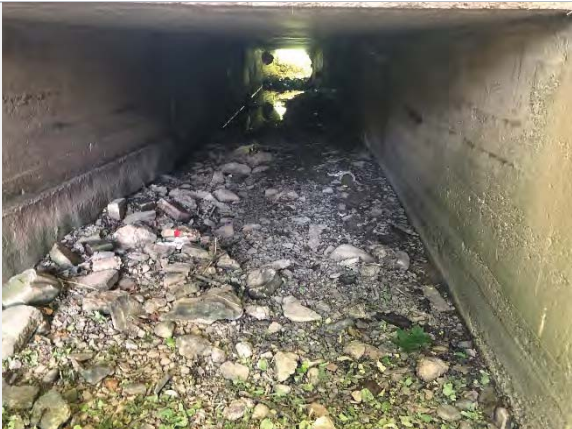
<p>Photo 48: 17 June 2021. View facing upstream through Barton Street concrete box culvert component. Area within the approximately 23 m long culvert was mostly lined with cobble substrates and exhibited dry conditions with no flow.</p>

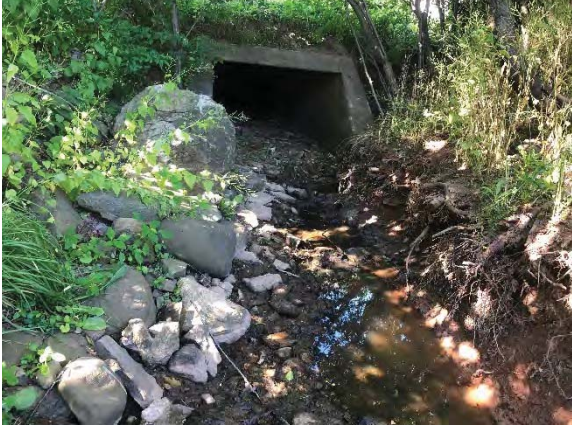
<p>Photo 49: 17 June 2021. Barton Street culvert outlet. Shallow standing water downstream of culvert representing limited habitat. See photo 50 for site conditions in July 2021.</p>

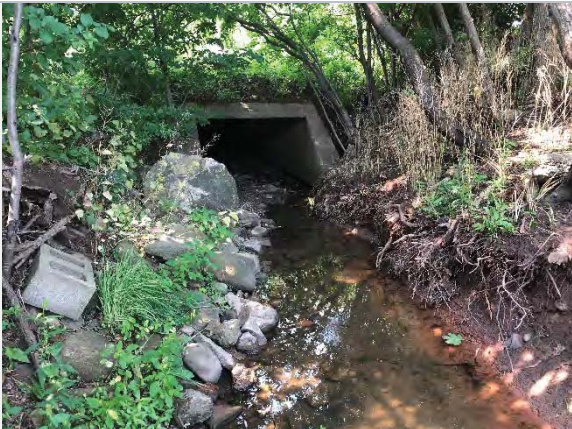
<p>Photo 50: 5 July 2021. Barton Street culvert outlet. Water level slightly higher compared to June due to recent precipitation. Conditions exhibited similar habitat limitations as in June (See photo 49 for site conditions in June 2021).</p>

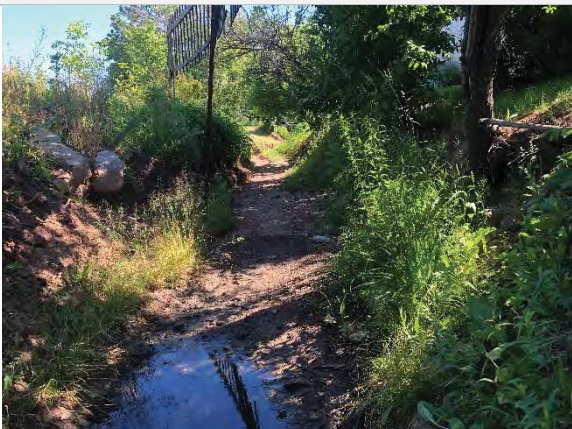
<p>Photo 51: 17 June 2021. Barton Street culvert outlet channel downstream view. Dry channel downstream of isolated shallow standing water area in foreground and vertical grade increase in channel floor. Intermittent nature of standing water areas limits function of aquatic corridor (see photo 52 for site conditions in July 2021).</p>

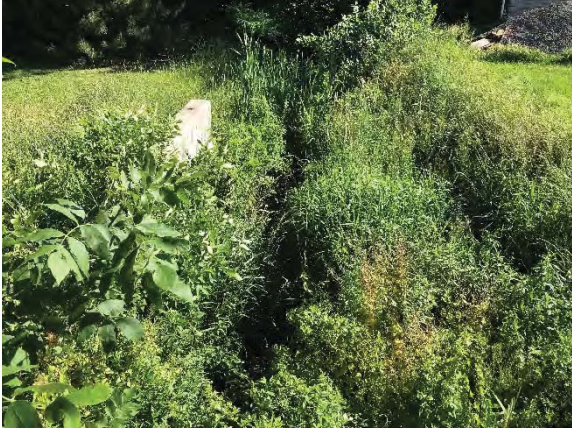
<p>Photo 53: 17 June 2021. Arvin Avenue culvert inlet channel upstream view. Dense vegetation in predominantly dry channel. Very limited aquatic habitat.</p>

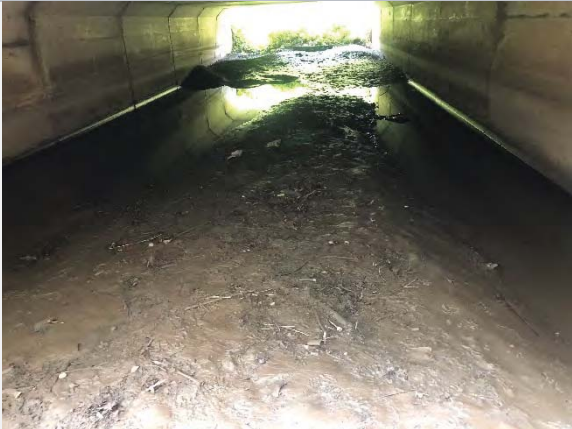
<p>Photo 54: 5 July 2021. Arvin Avenue concrete box culvert inlet area, with view facing downstream within culvert. Predominantly dry channel, limited aquatic habitat represented by standing water area. Impediment to potential fish movement during low flows as observed.</p>

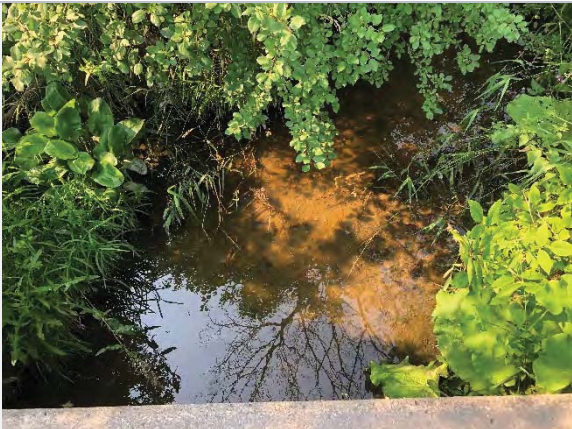
<p>Photo 56: 5 July 2021. South Service Road culvert inlet channel. No observable flows. Very limited aquatic habitat in the form of standing water pool area.</p>

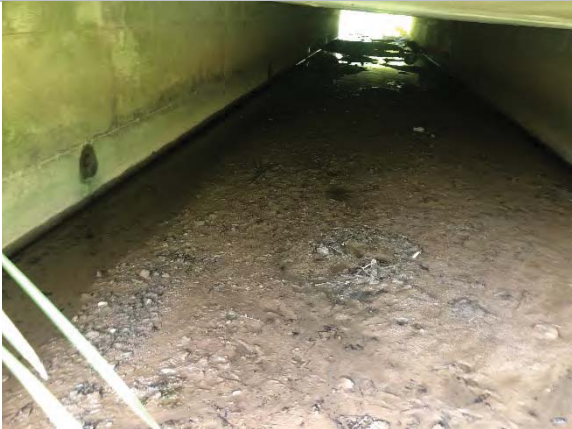
<p>Photo 57: 5 July 2021. South Service Road culvert outlet. Predominantly dry channel with limited aquatic habitat and impediment to potential fish movement under low flow conditions.</p>

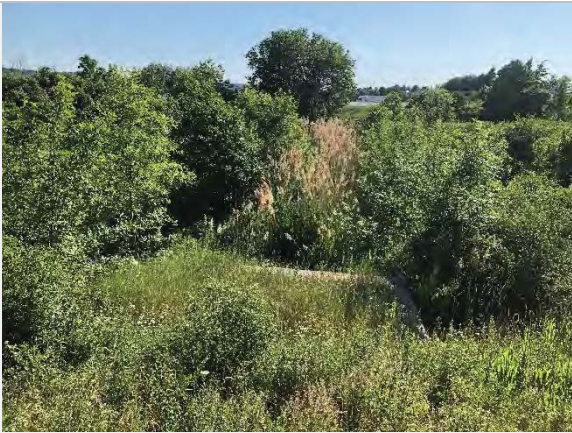
<p>Photo 62: 17 June 2021. Representative overview of North Service Road inlet channel. Dense phragmites in the upstream channel.</p>

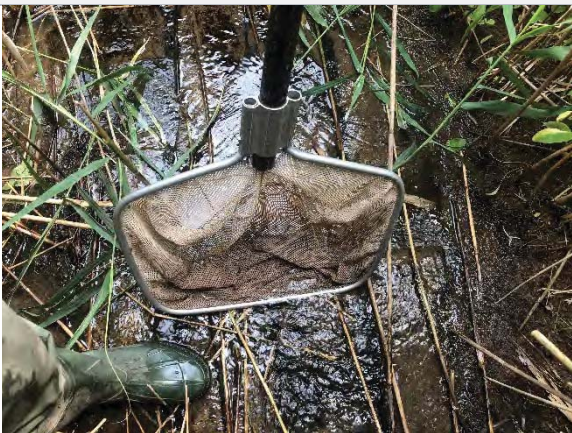
<p>Photo 63: 15 July 2021. Shallow water immediately upstream of North Service Road culvert. Limited aquatic habitat and shallow water levels. Minimal flows were observed in this lower reach of the watercourse.</p>

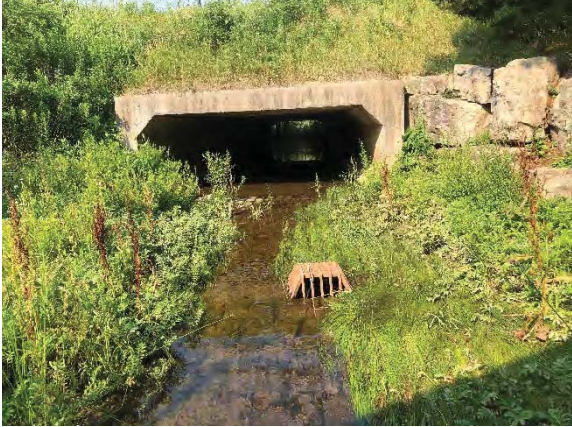
<p>Photo 65: 5 July 2021. North Service Road box culvert outlet channel. Water depth 2 cm downstream of the culvert outlet, with run habitat embedded cobble substrate.</p>

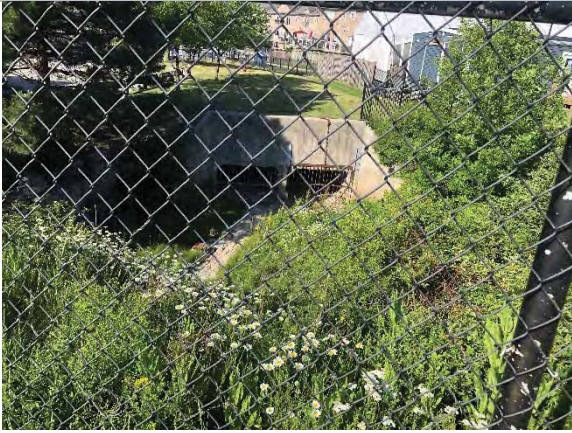
<p>Photo 67: 17 June 2021. Facing downstream from North Service Road. Dry channel upstream of culvert which outlets to Lake Ontario creating a notable impediment to upstream fish movement.</p>

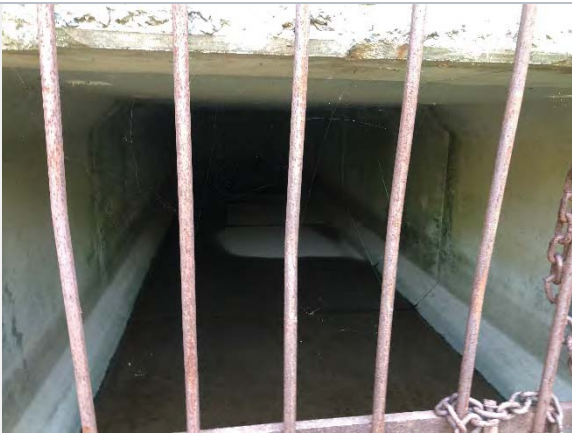
<p>Photo 68: 5 July 2021. Inlet of concrete box culvert structure outletting to Newport Yacht Club and corridor to Lake Ontario. Water level (0 to 1 mm) represents a barrier to fish movement during low flows observed.</p>

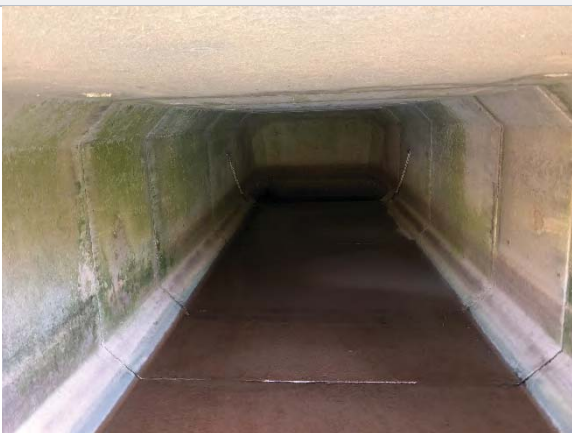
<p>Photo 69: 5 July 2021. Facing downstream into culvert that outlets to Lake Ontario. Opening and associated drop in the culvert floor represents the outlet of Watercourse 5.0 flows to the lake. Outlet drop structure appears to notably impede any upstream fish movement and access from permanent fish habitat in Lake Ontario into the culvert and subsequently Watercourse 5.0.</p>
