# **COMMUNICATION UPDATE**

то:	Mayor and Members City Council	
DATE:	November 8, 2024	
SUBJECT:	July 15 Storm - November 2024 Update - HW2404	
WARD(S) AFFECTED:	City Wide	
SUBMITTED BY:	Shane McCauley Director, Water & Wastewater Operations Public Works Department	
SIGNATURE:	Ahane Mauley

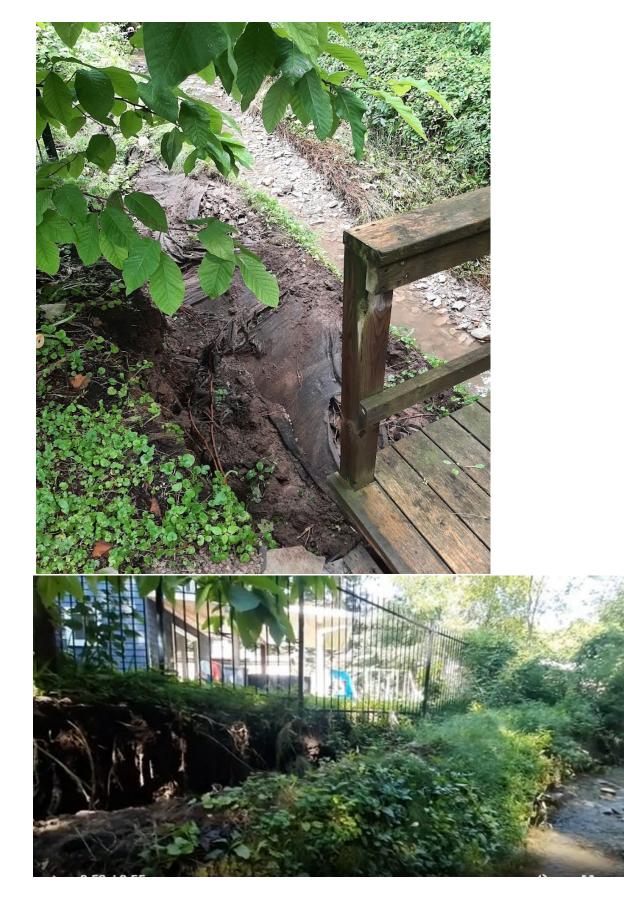
Sydenham Creek Retaining Wall:

Portions of Sydenham Creek in Dundas experienced extreme velocities and flash flooding, resulting in significant deposition of escarpment rock and shale in the creek bed, as well as a partial failure of the gabion basket retaining wall near Park St E. A consultant assignment is currently underway, utilizing Procurement Policy 10 – Emergency Works, to assess the structural integrity of the wall and provide detailed specifications for repair or replacement.

Storm Sewer Outfall	Watson's Lane	Newly reconstructed asset, landscape restoration washed out and requires reinstatement.	In Progress	Sent to Engineering Services for warranty work
Watercourse	Sydenham Creek	Structural assessment underway to determine extent of damage to gabion wall structure and repair requirements	In Progress	Consultant hired; Policy 10 - Emergency Works

Cost estimates for the evaluation and repair of the Sydenham Creek gabion wall are still to be determined. These costs will be allocated to the 2025 budget cycle and can be funded through existing stormwater capital accounts, with no net increase to the overall budget for 2025.

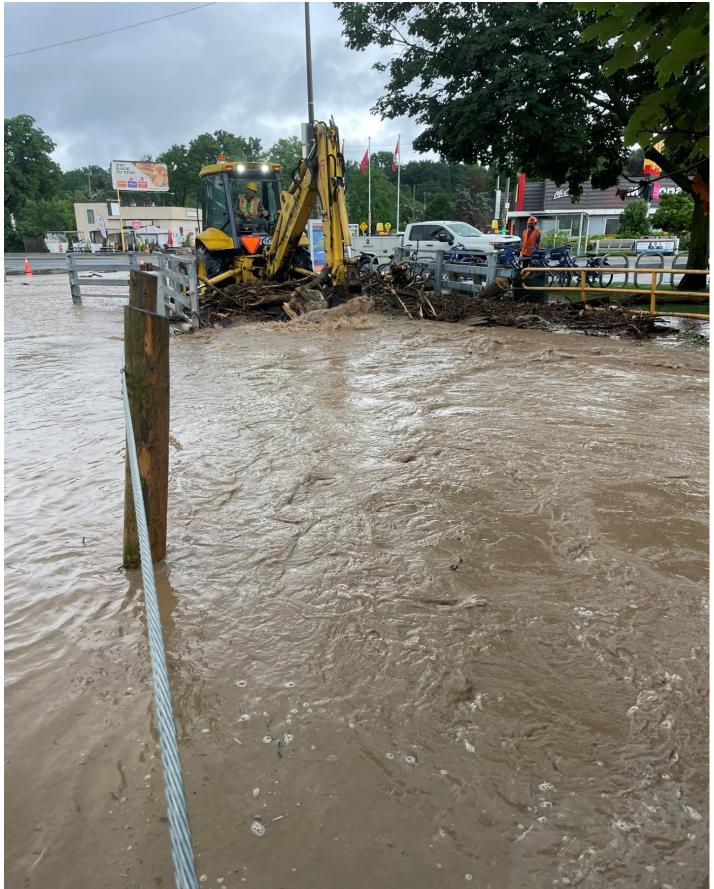
King St (York Road Parkette):

Asset Type	Location	Work Required	Status	Notes
Storm Sewer Inlet	Westoby Crt	Wooded debris blockages removed during storm events and post-storm removal of rock debris from inlet area	Complete	
Storm Sewer Inlet	King St, Dundas (York Rd Parkette)	Wooded debris blockage removal during storm event	Complete	
Storm Sewer Inlet	Chedoke Golf Course (East)	Wooded debris blockages removed during storm events and post-storm removal of rock debris from inlet area	Complete	100m2 area near inlet excavated of rock debris
Storm Sewer Inlet	Chedoke Golf Course (West)	Wooded debris blockage removal during storm events and post-storm removal of rock debris from inlet area	Complete	70m2 area near inlet excavated of rock debris
Storm Sewer Inlet	Highway 403	Post-storm removal of rock debris from inlet area	Complete	90m2 area near inlet excavated of rock debris
Storm Sewer Inlet	Sanatorium	Wooded debris blockages removed during storm events and encroaching vegetation removal in upstream watercourse	Complete	Strictly minor watercourse maintenance
