TECHNICAL MEMORANDUM

Project No. 19125764-M01-Rev1

CULTURAL HERITAGE SCREENING REPORT – TWENTY ROAD WEST PLAN OF SUBDIVISION, GLANBROOK, CITY OF HAMILTON, ONTARIO

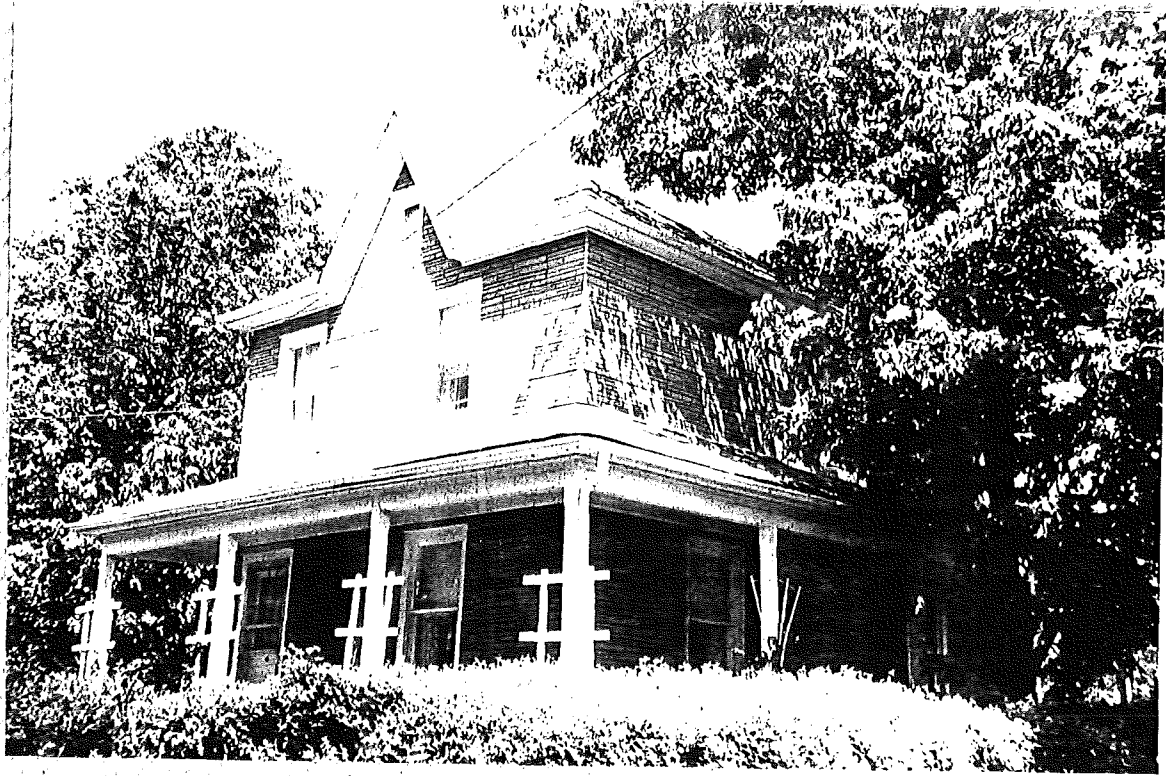
WEST (FRONT) & SOUTH (SIDE) VIEWS ↑

- wall dormer
- porch on west and south sides

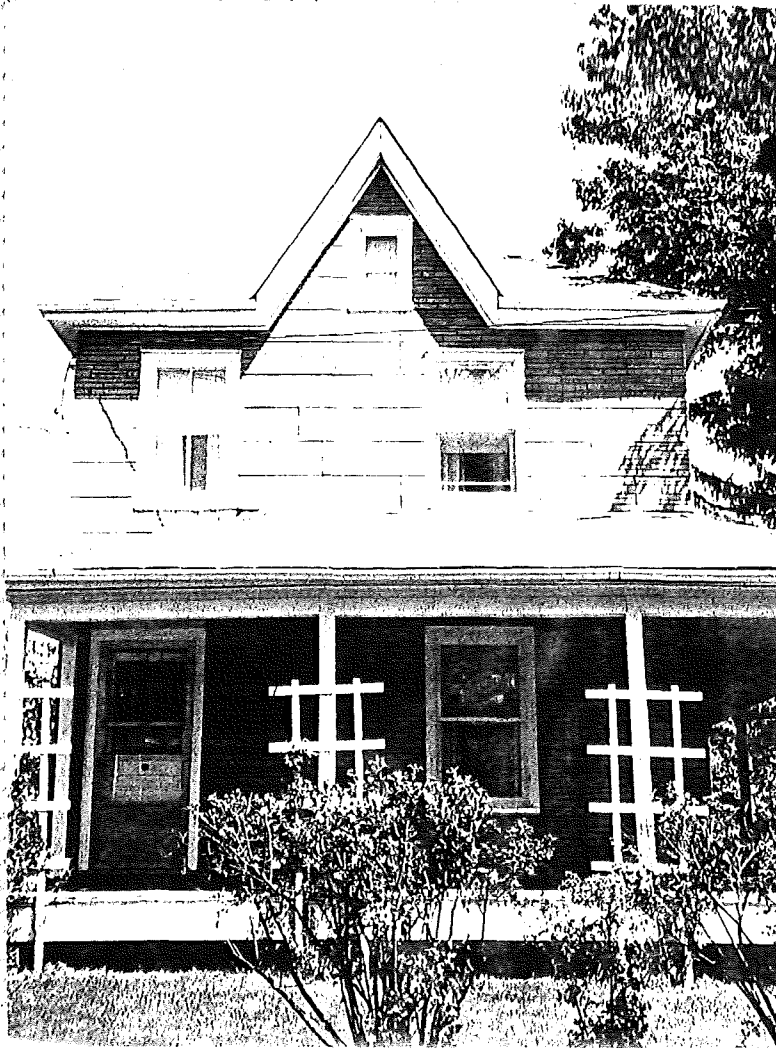
WEST (FRONT) VIEW ←

- gable roof

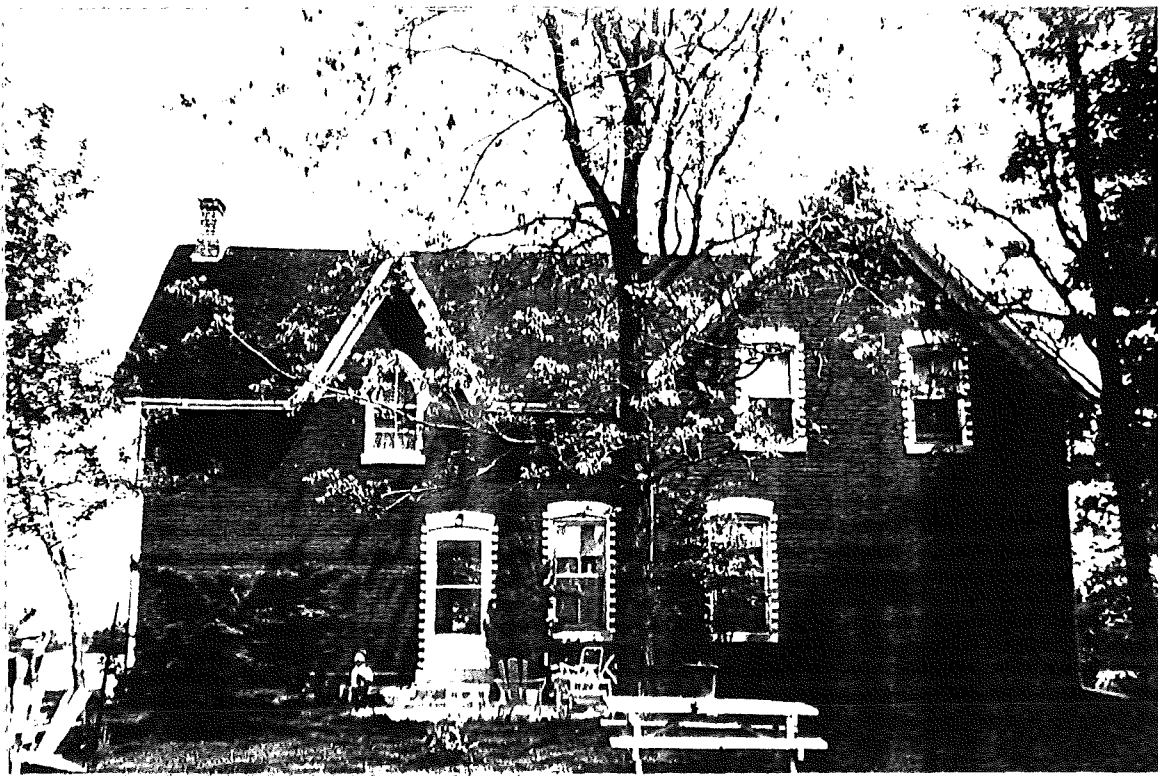
WEST VIEW ↑

- brick relieving arches over windows and doors
- wall dormer with pointed arch window

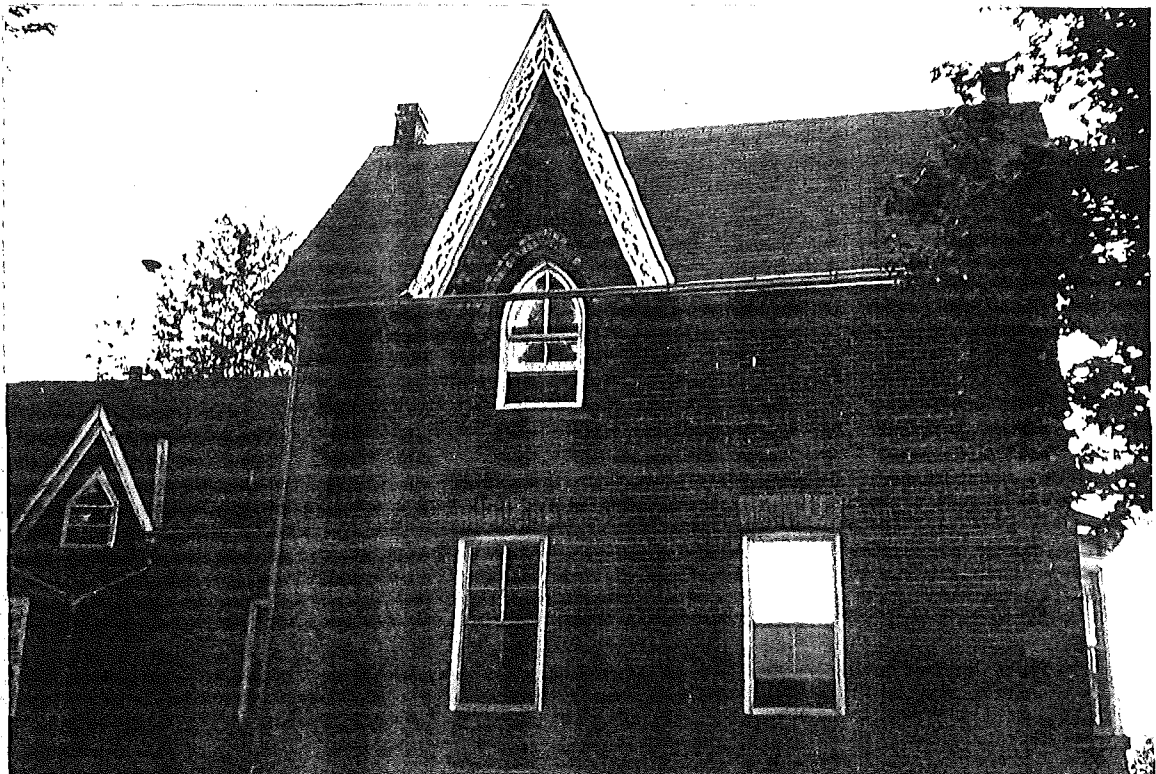
EAST (SIDE) VIEW ↑

- wall dormers
- pointed arch window in one dormer
and a triangular window in the other
dormer

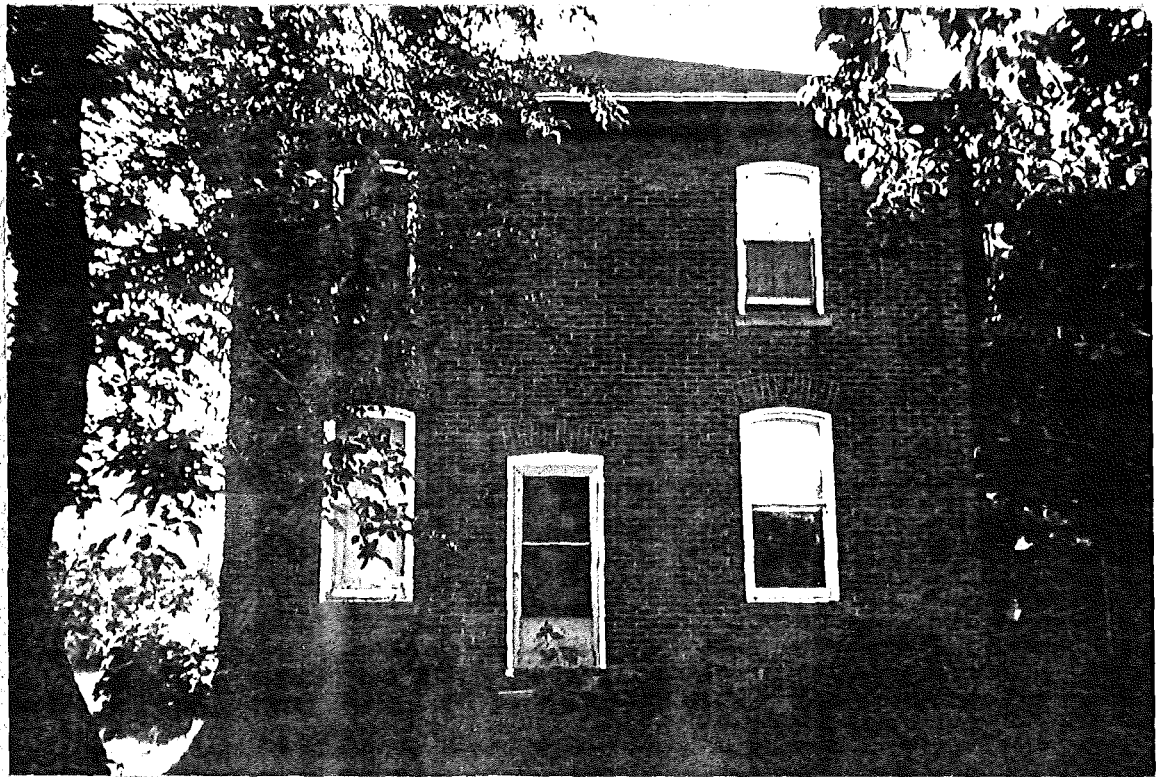
EAST VIEW ↑

- hip roof

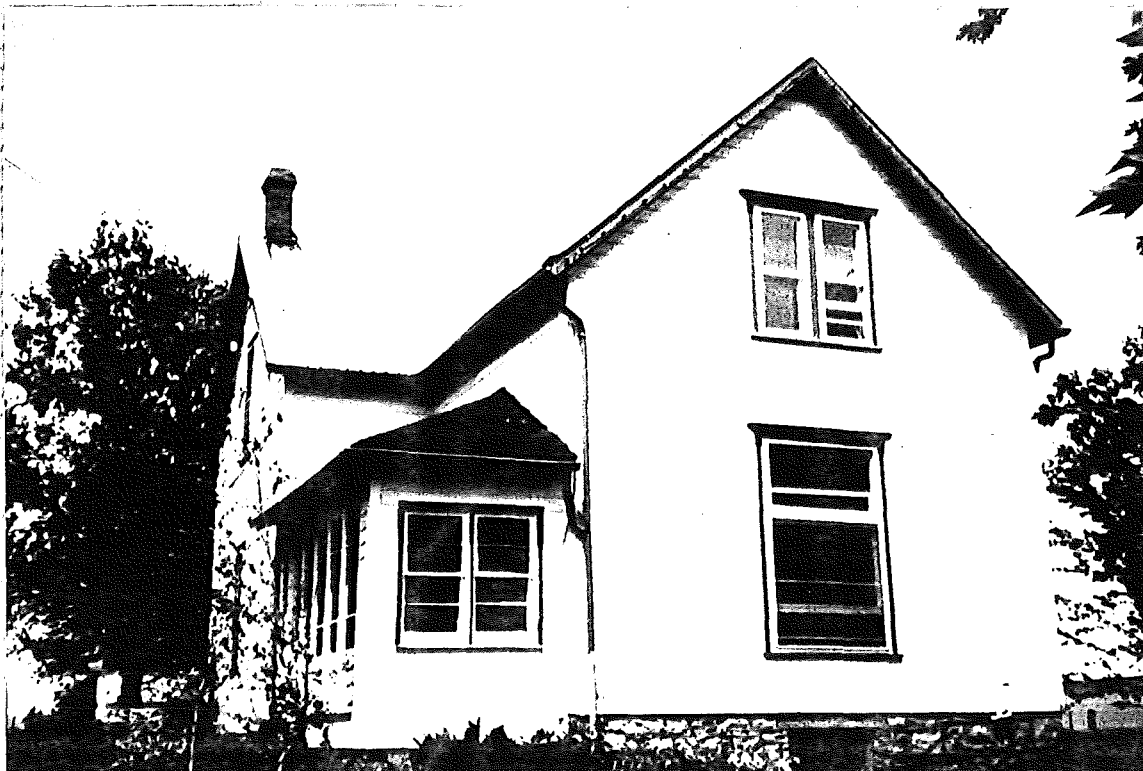
SOUTH (FRONT) VIEW ↑

- corbeled chimney caps

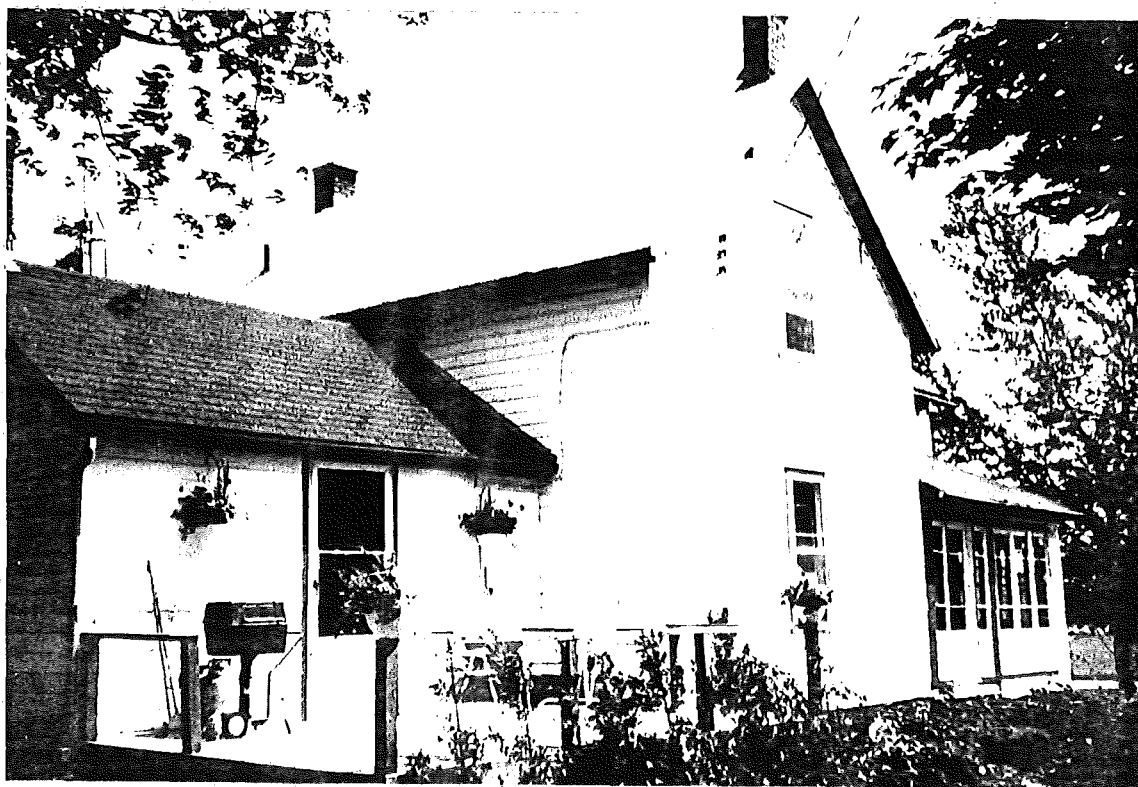
WEST (SIDE) VIEW ↑

- gable roof

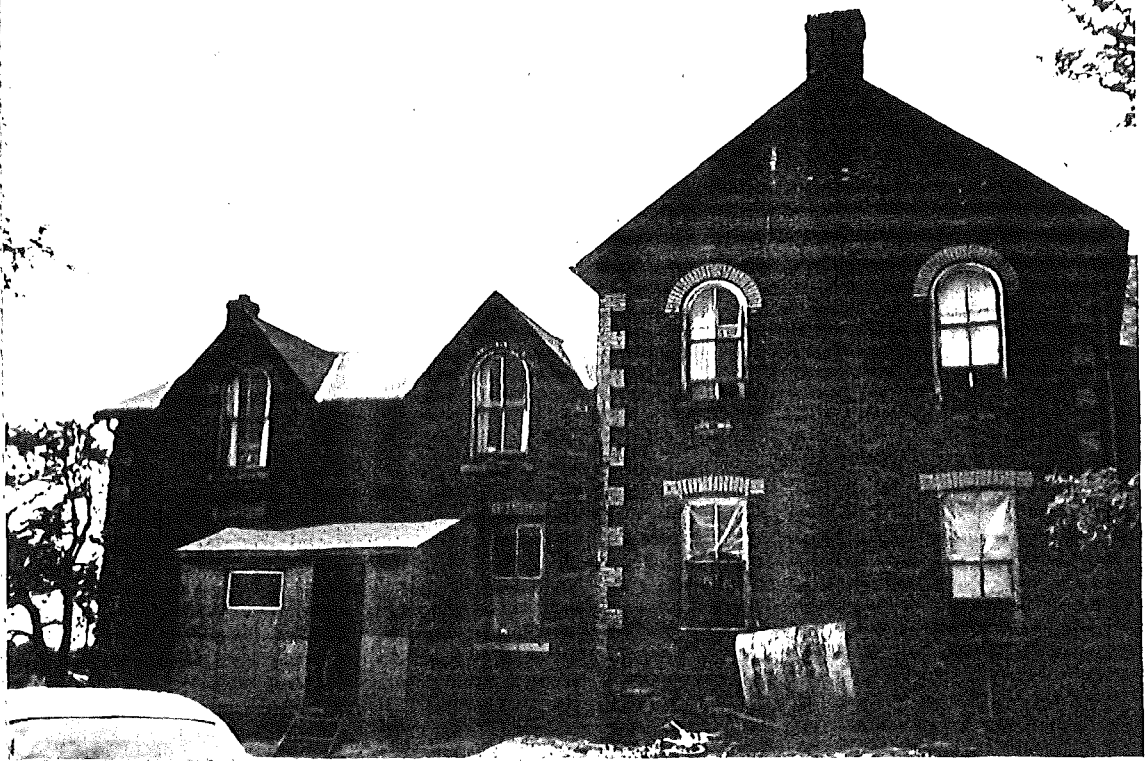
EAST (SIDE) VIEW ↑

- brick relieving arches over windows on first floor and full arch windows in second storey
- two wall dormers

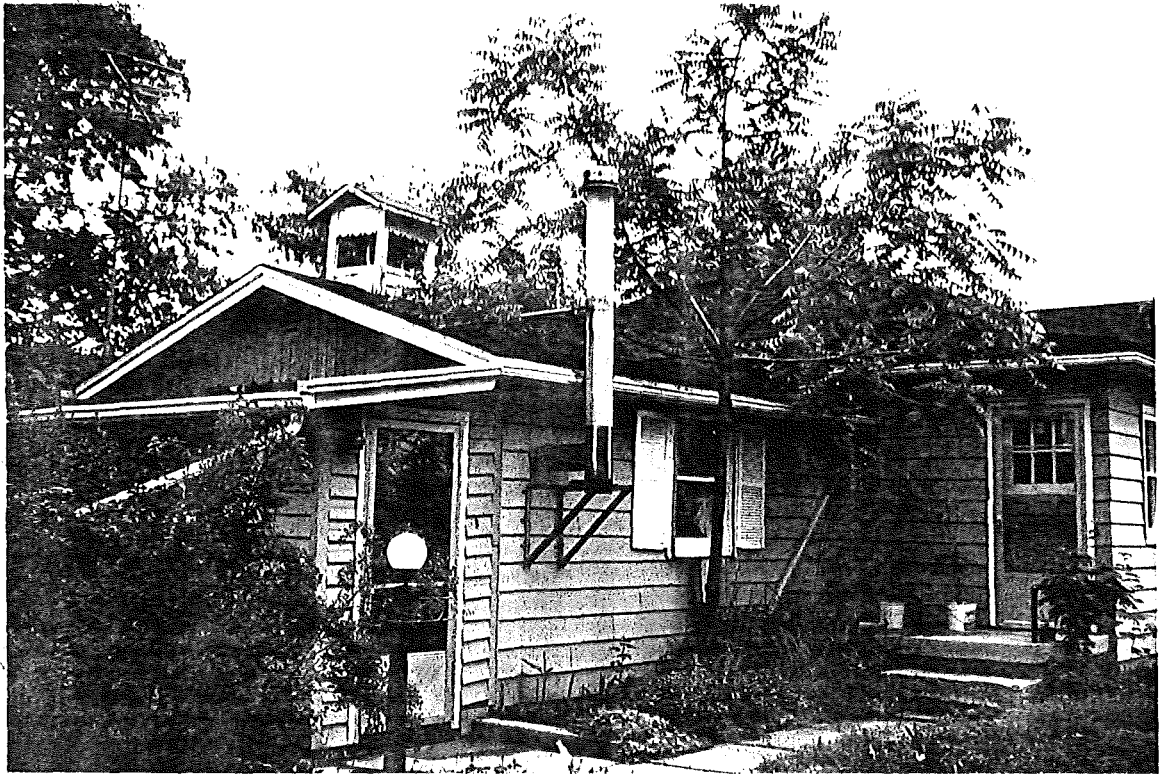
SOUTH (SIDE) & WEST (BACK) VIEWS ↑

* little tower on the roof once
was equipped with a bell which
was used to call people in from
the fields for meals

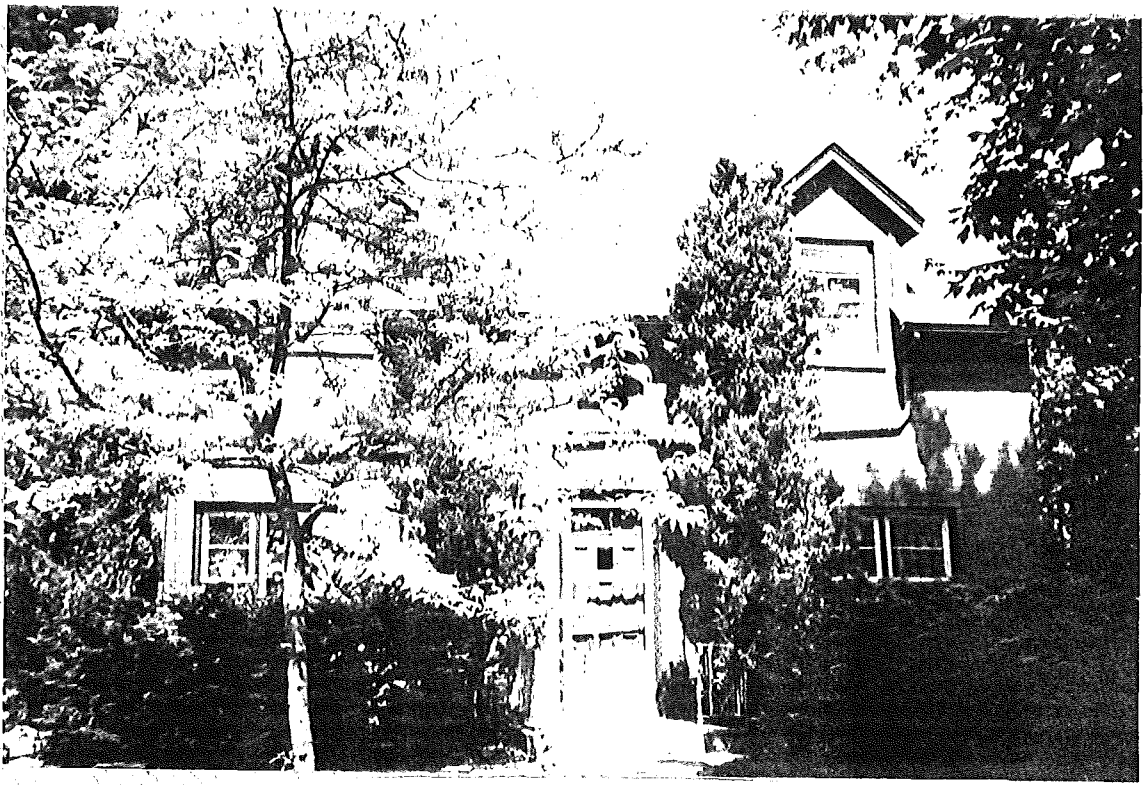
EAST (FRONT) VIEW ↑

- wall dormers
- gable roof

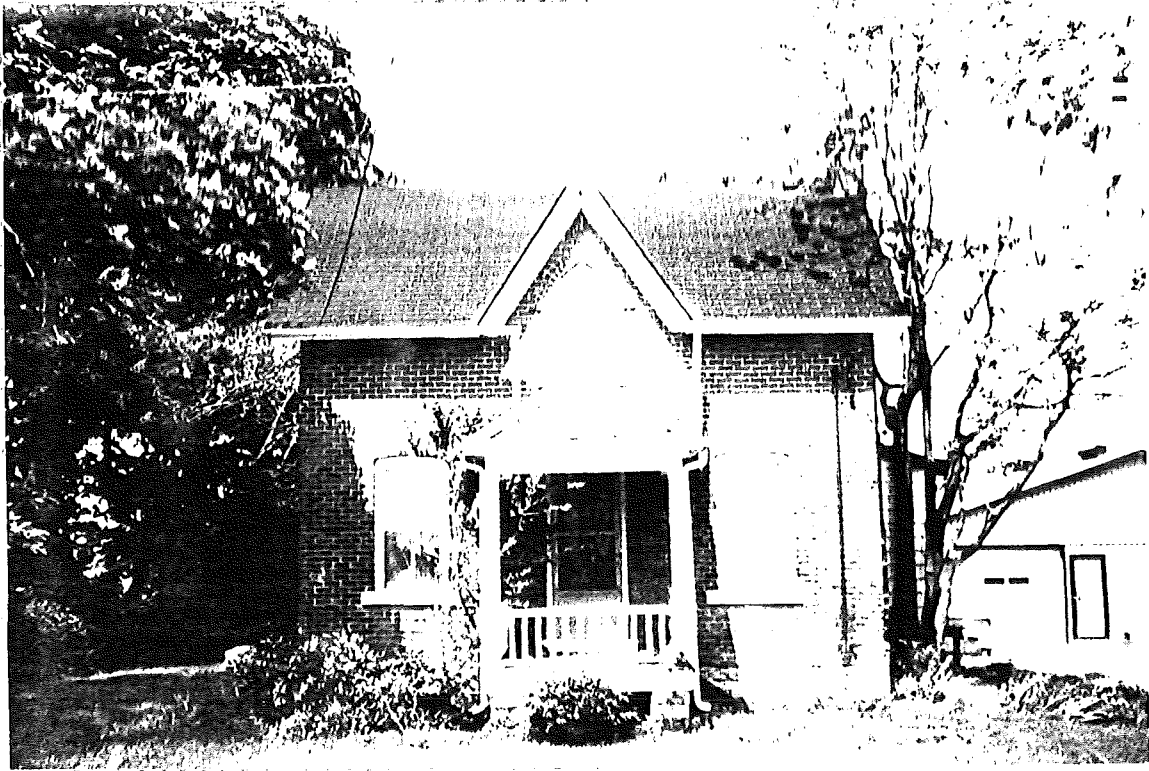
SOUTH (FRONT) VIEW ↑

- pedimented front porch
- brick relieving arches over windows and doors
- wall dormer with pointed arch window and label mold
- bevel brick detail

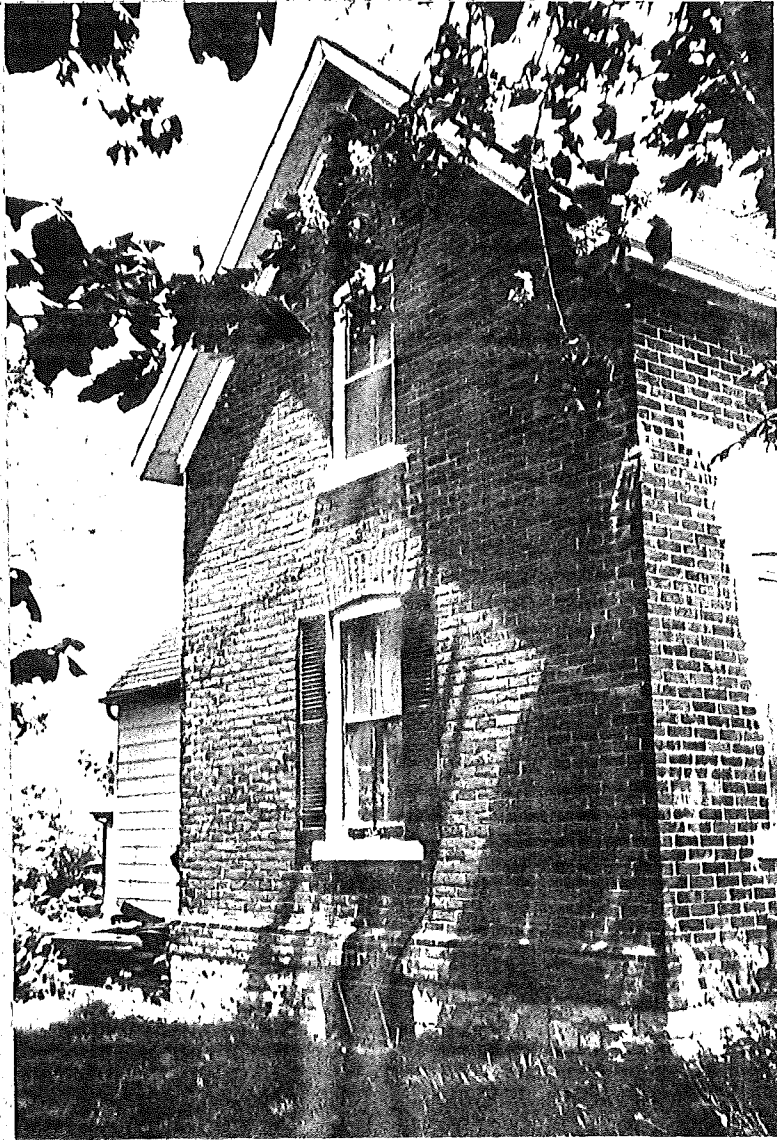
WEST (SIDE) VIEW ↑

- flat top brick relieving arches
over windows

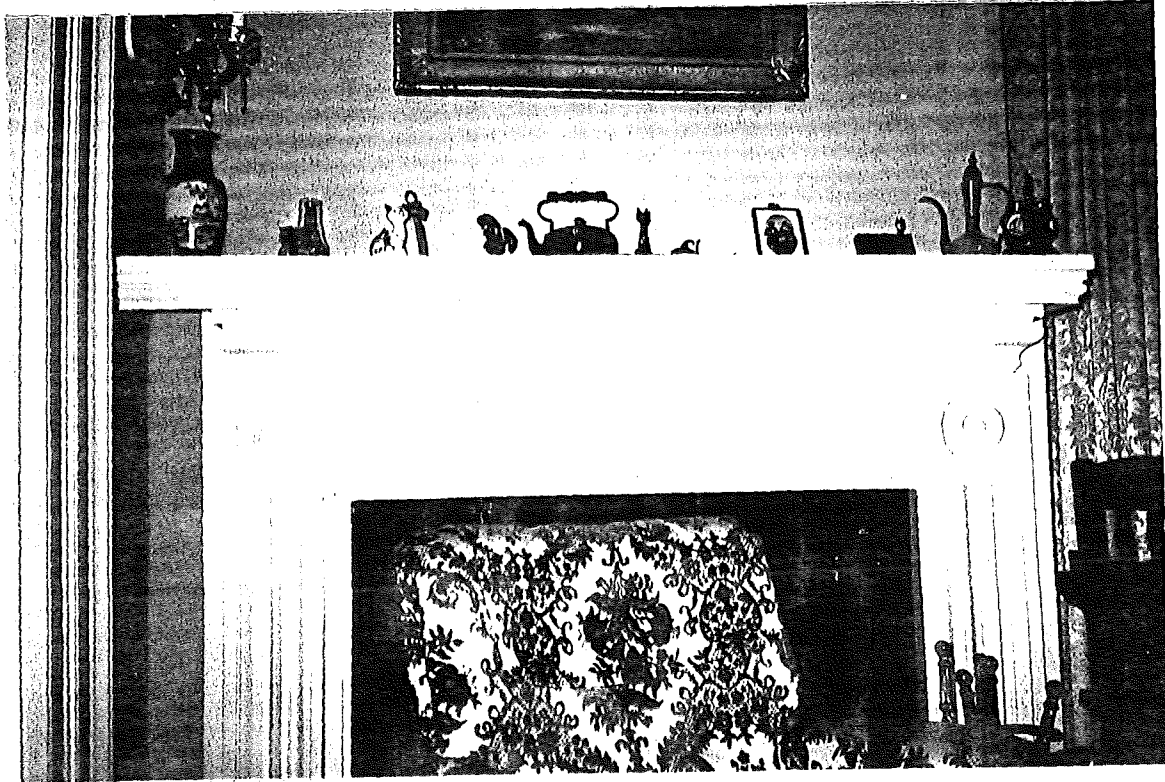
ORIGINAL ↑
- fireplace mantle

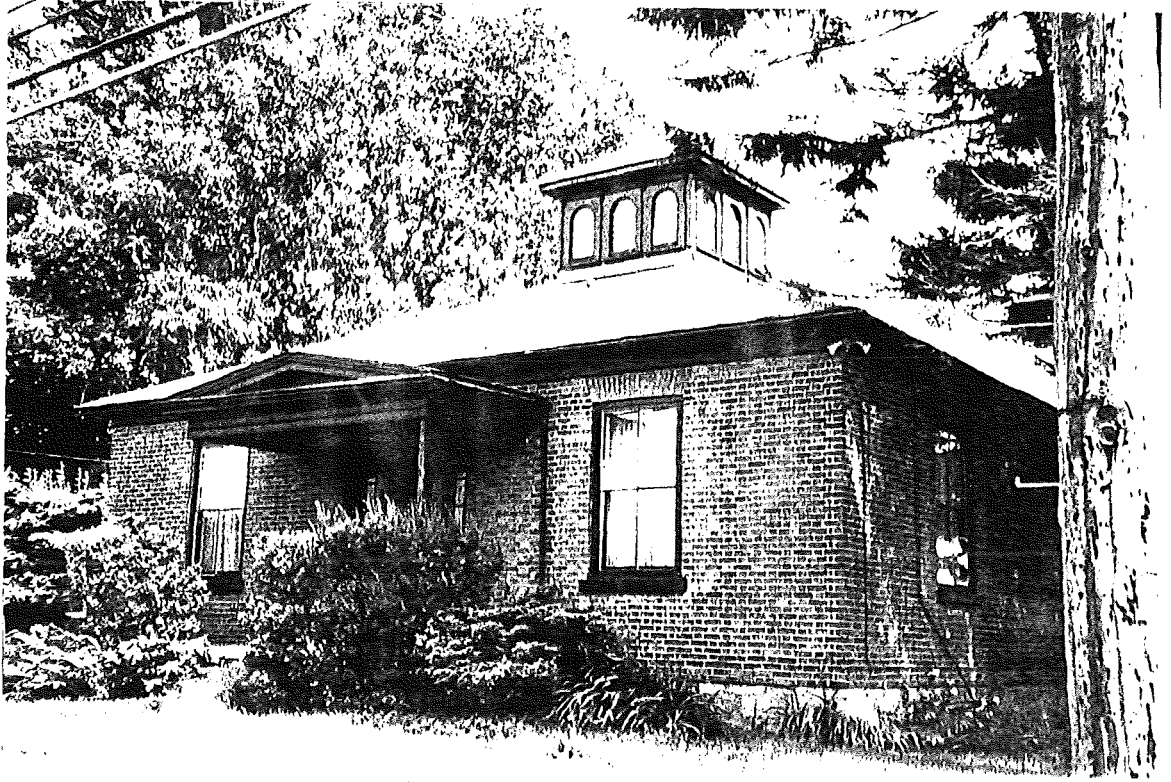
WEST (FRONT) VIEW ↑

- cupola
- flat top arches over windows
- front porch

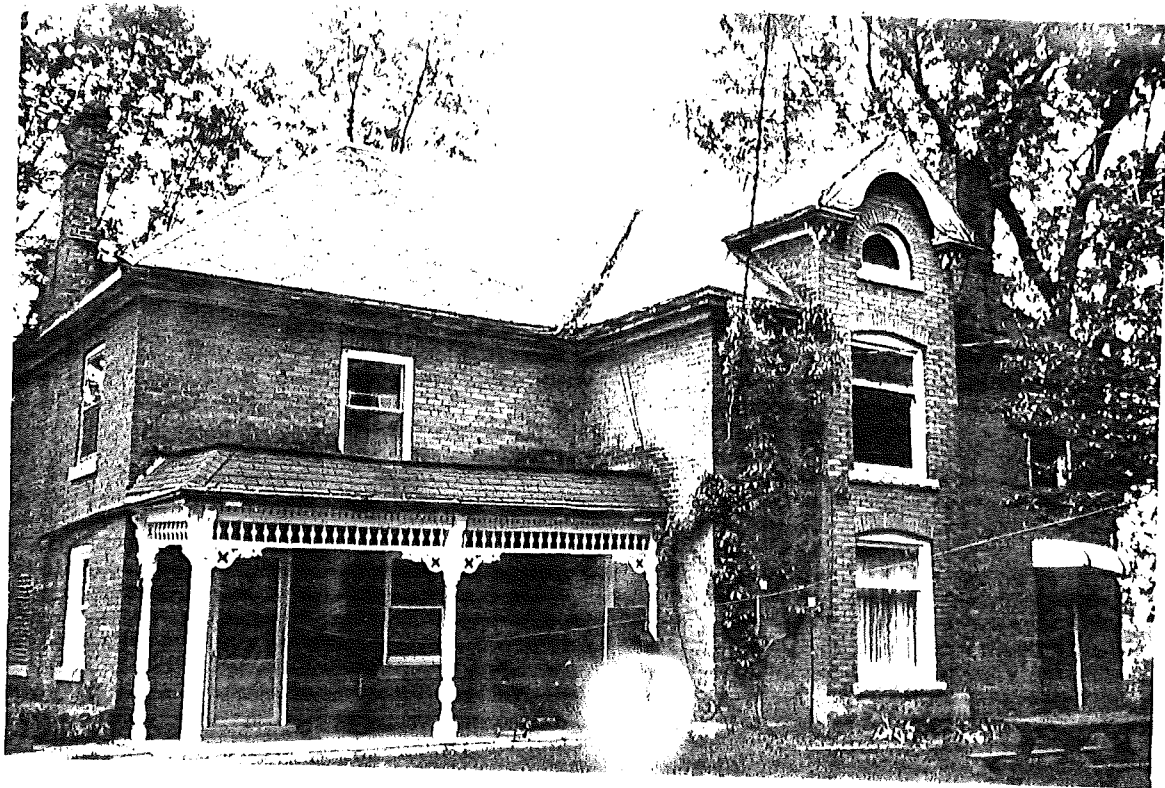
EAST (SIDE) VIEW ↑

- brick relieving arches over windows and doors
- side porch
- original gingerbread trim
- hip roof
- semi circular window

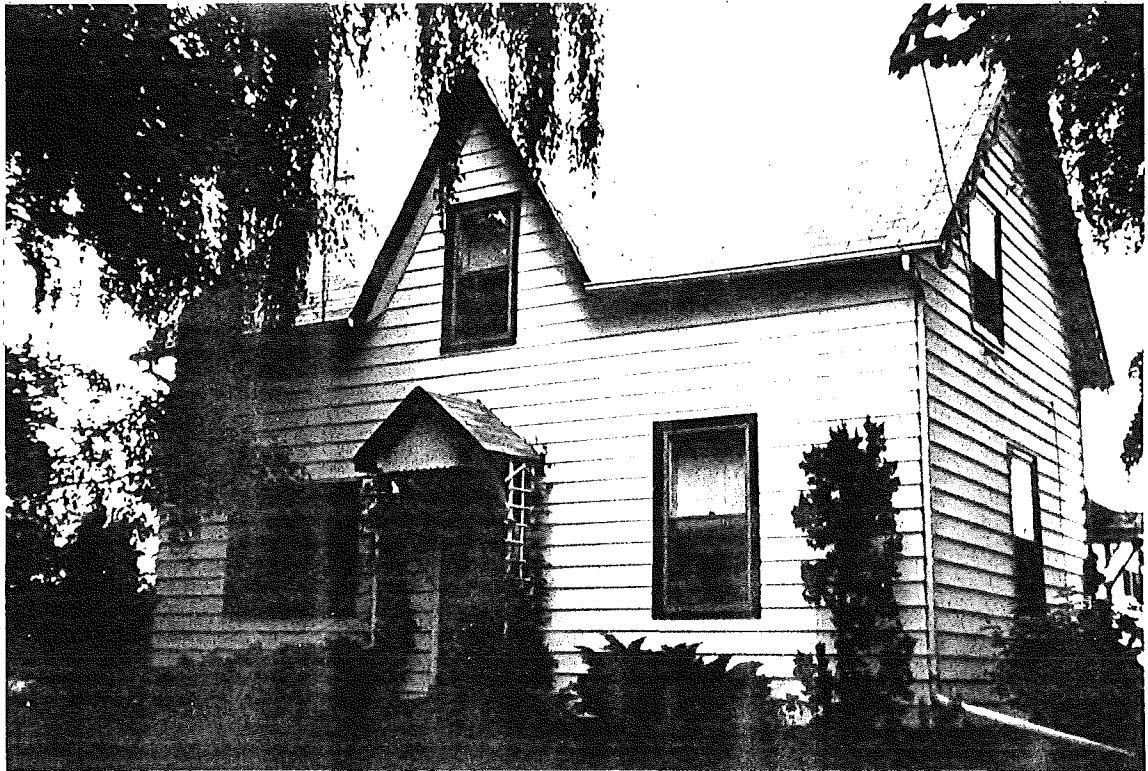
SOUTH (FRONT) VIEW ↑

- wall dormer
- original gingerbread trim

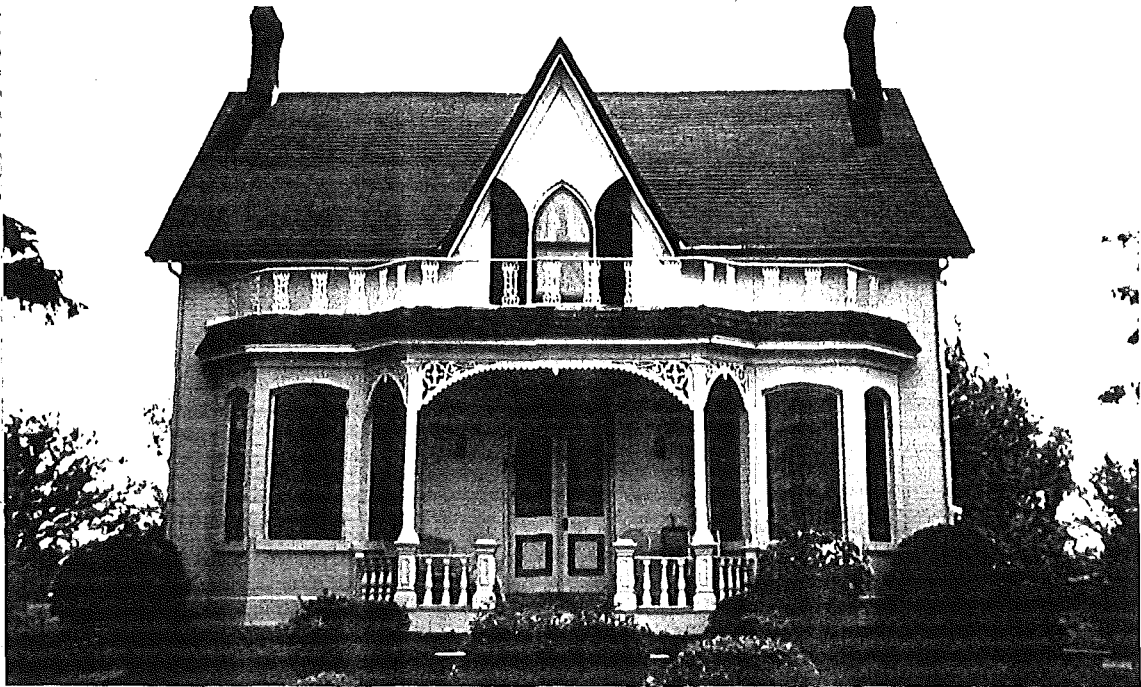
NORTH (FRONT) VIEW ↑

- bay windows
- brick relieving arches over windows and doors
- double front doors with a transom
- wall dormer with pointed arch window

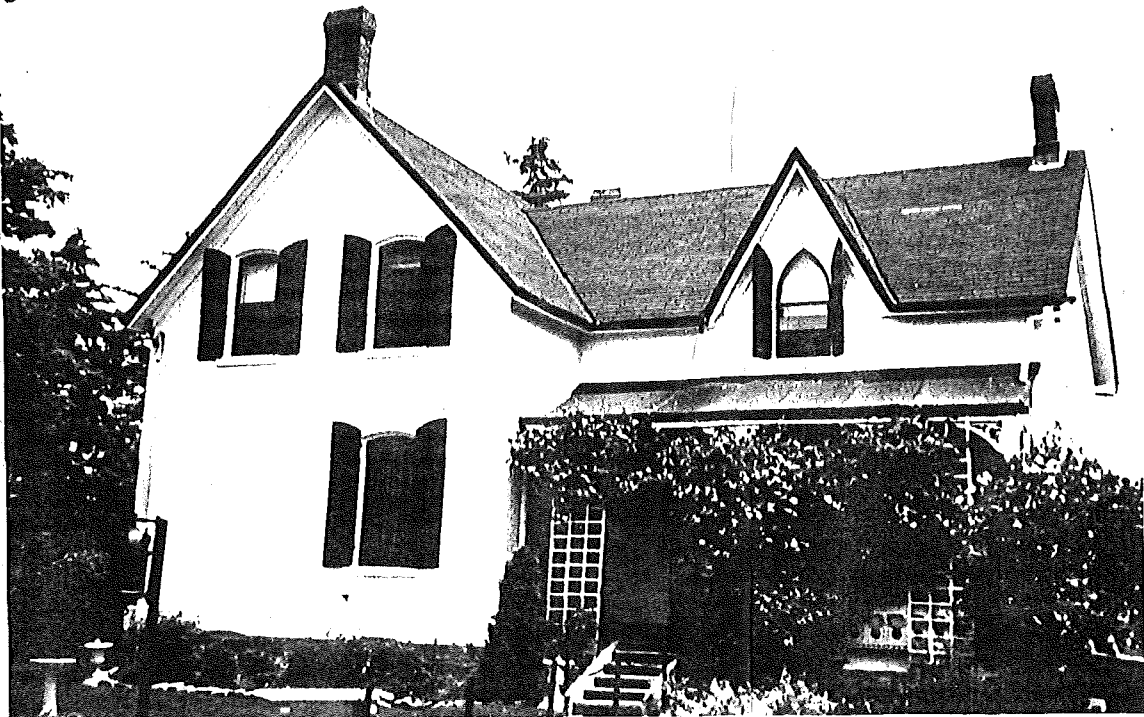
WEST (SIDE) VIEW ↑

- wall dormer with a pointed arch window
- corbeled chimney caps
- side veranda

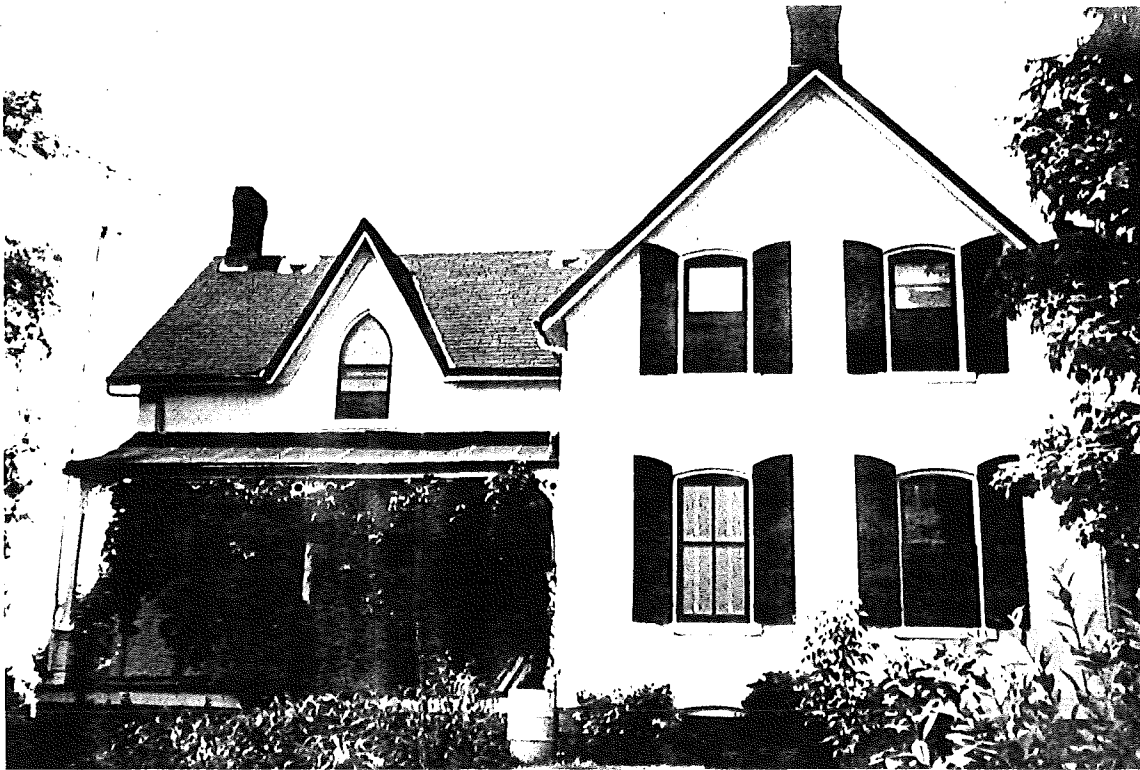
EAST (SIDE) VIEW ↑

- wall dormer with pointed arch window
- gable roof
- side veranda

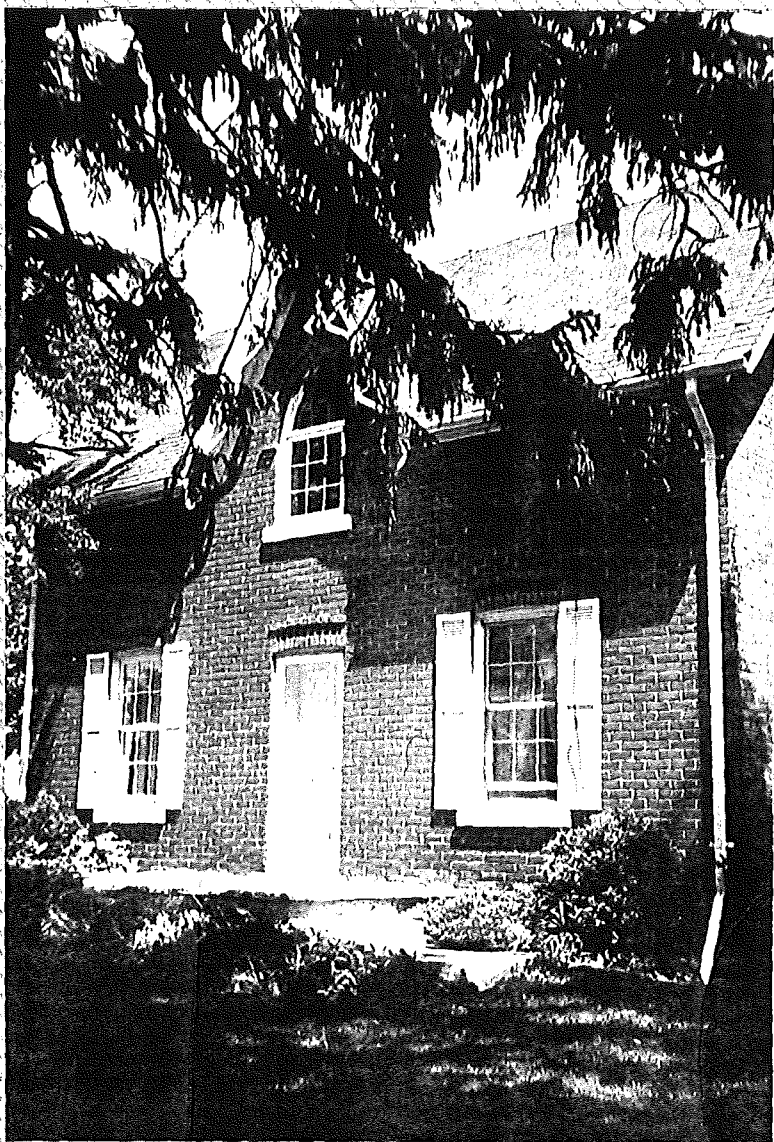
WEST (FRONT) VIEW ←

- brick relieving arches over windows and doors
- wall dormer with pointed arch window
- window in wall dormer has a label mold
- original trim

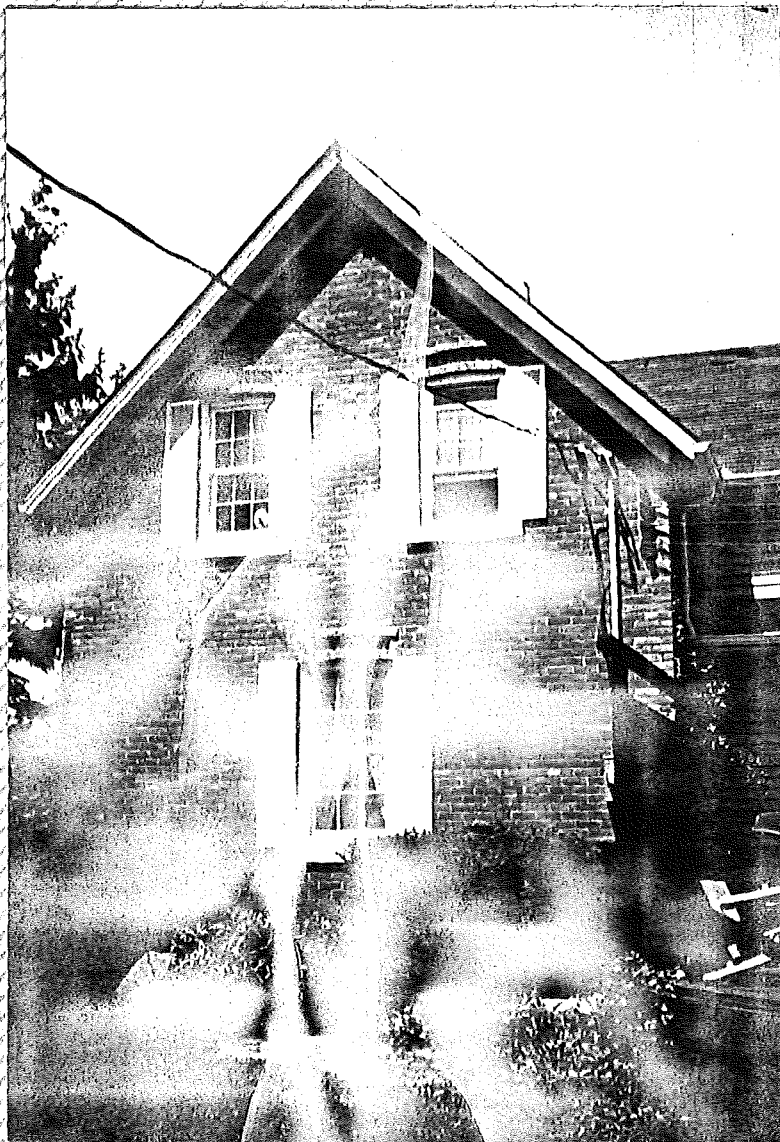
SOUTH (SIDE) VIEW ↑

- gable roof

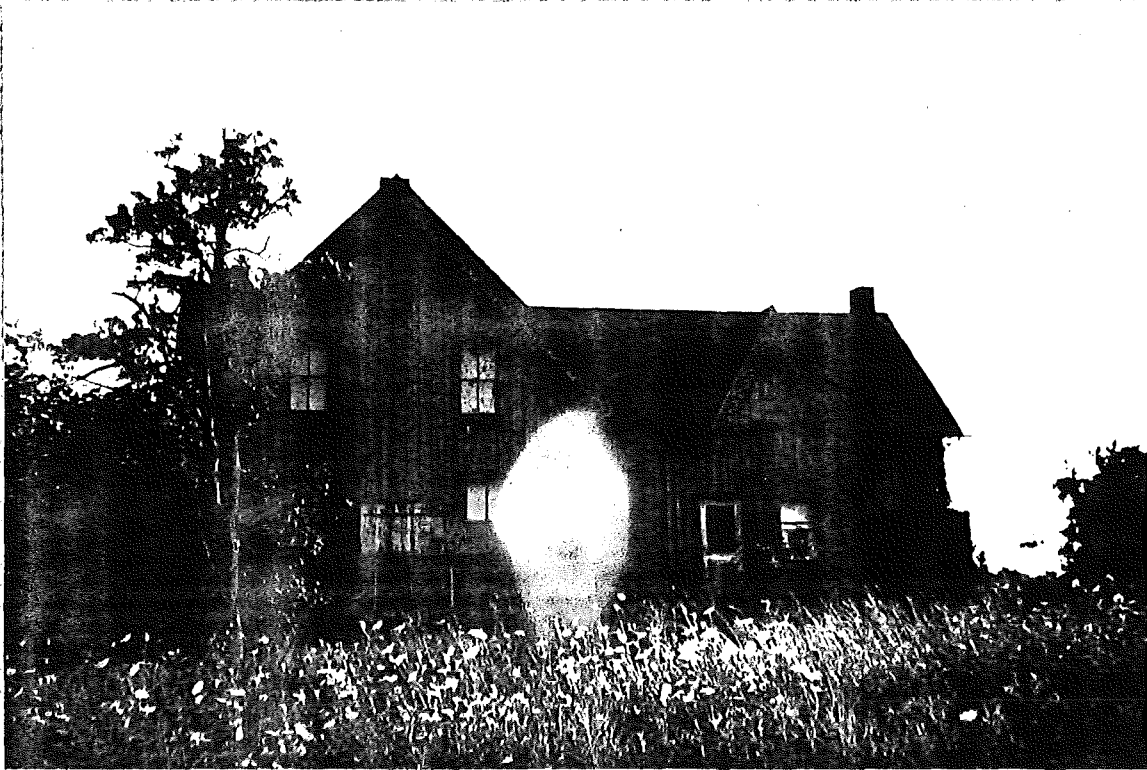
NORTH (FRONT) VIEW ↑

- wall dormer
- original gingerbread trim
- pedimented window and door heads

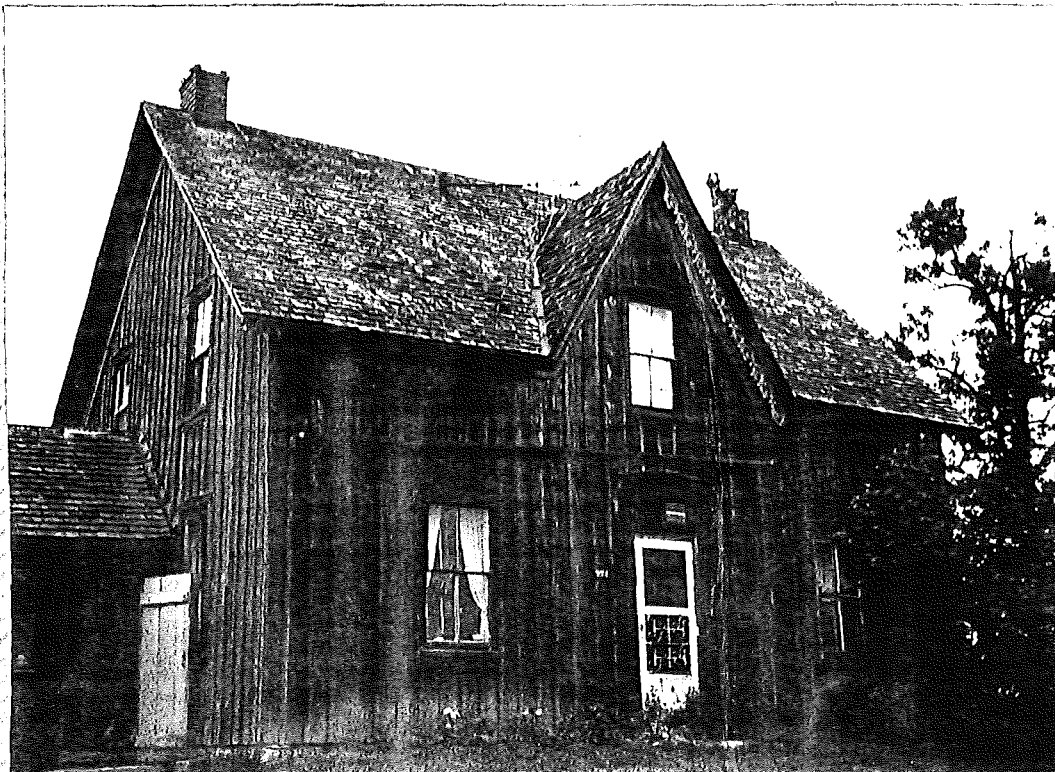
EAST (SIDE) VIEW ↑

- wall dormer with original gingerbread trim
- original boards and batten siding
- pedimented window and door heads

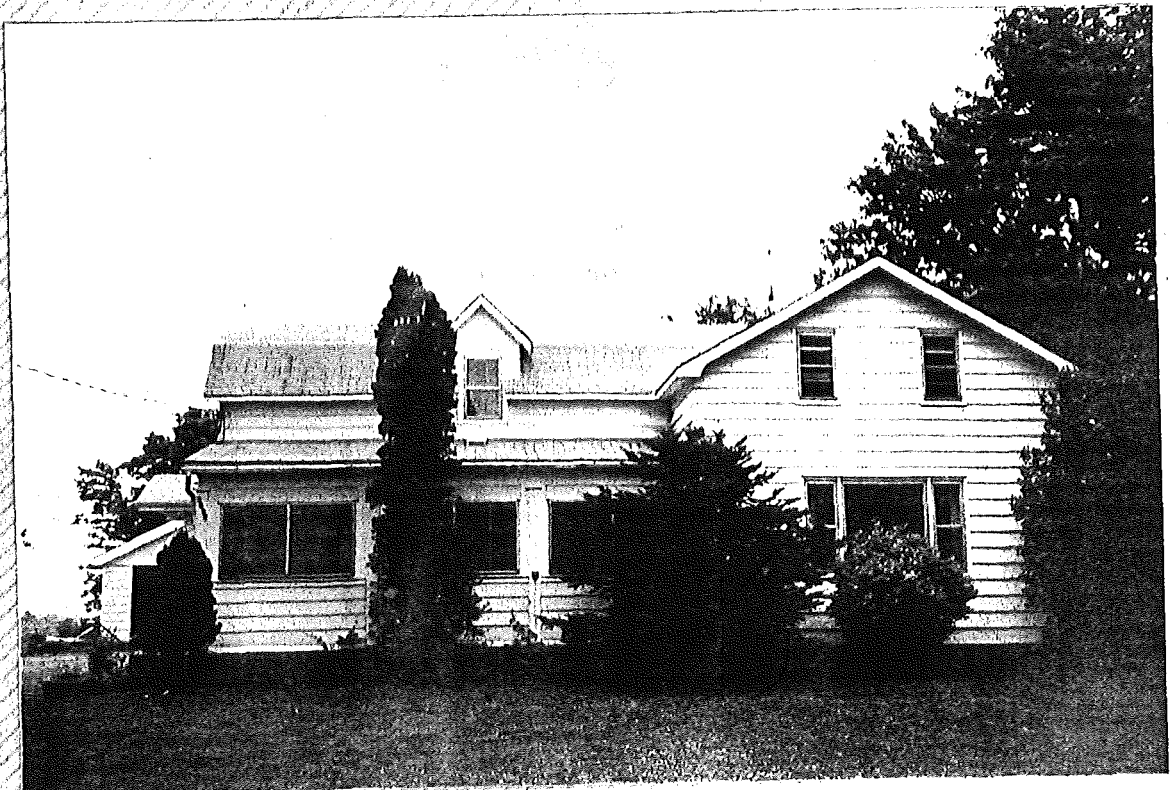
NORTH (FRONT) VIEW

- dormer

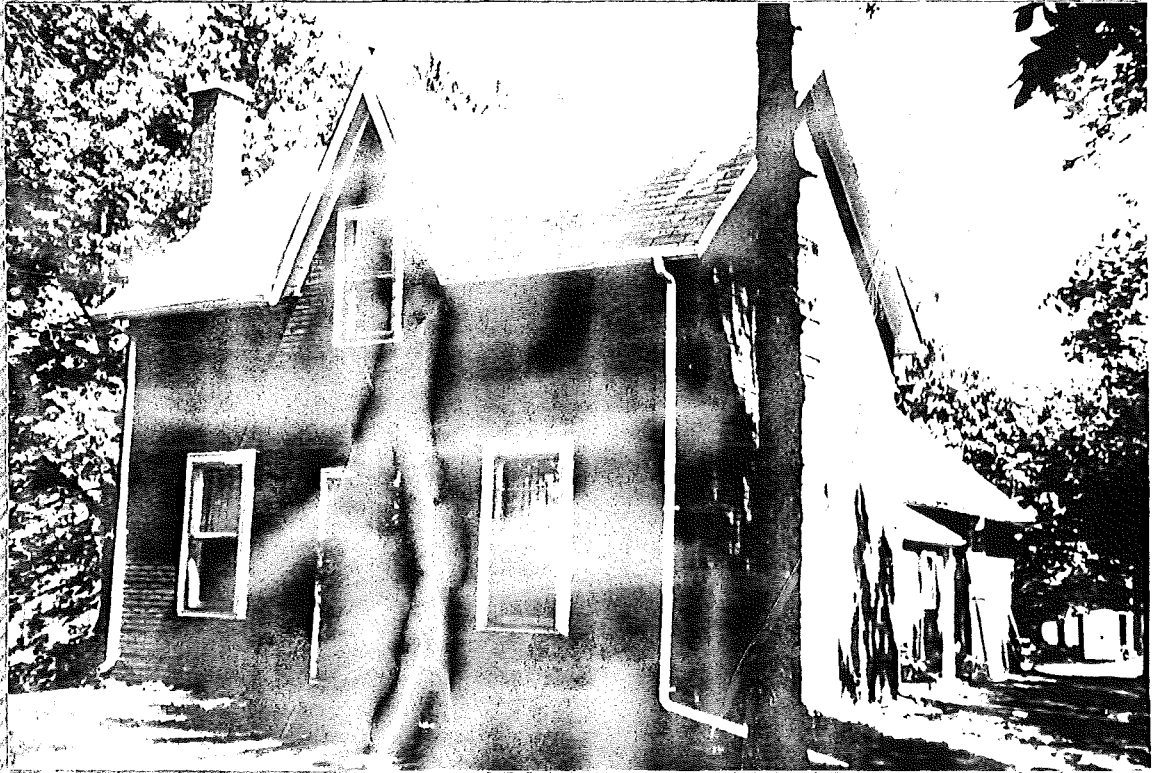
WEST (FRONT) & SOUTH (SIDE) VIEWS↑

- wall corner
- gable roof
