TECHNICAL MEMORANDUM

Project No. 19125764-M01-Rev1

CULTURAL HERITAGE SCREENING REPORT – TWENTY ROAD WEST PLAN OF SUBDIVISION, GLANBROOK, CITY OF HAMILTON, ONTARIO

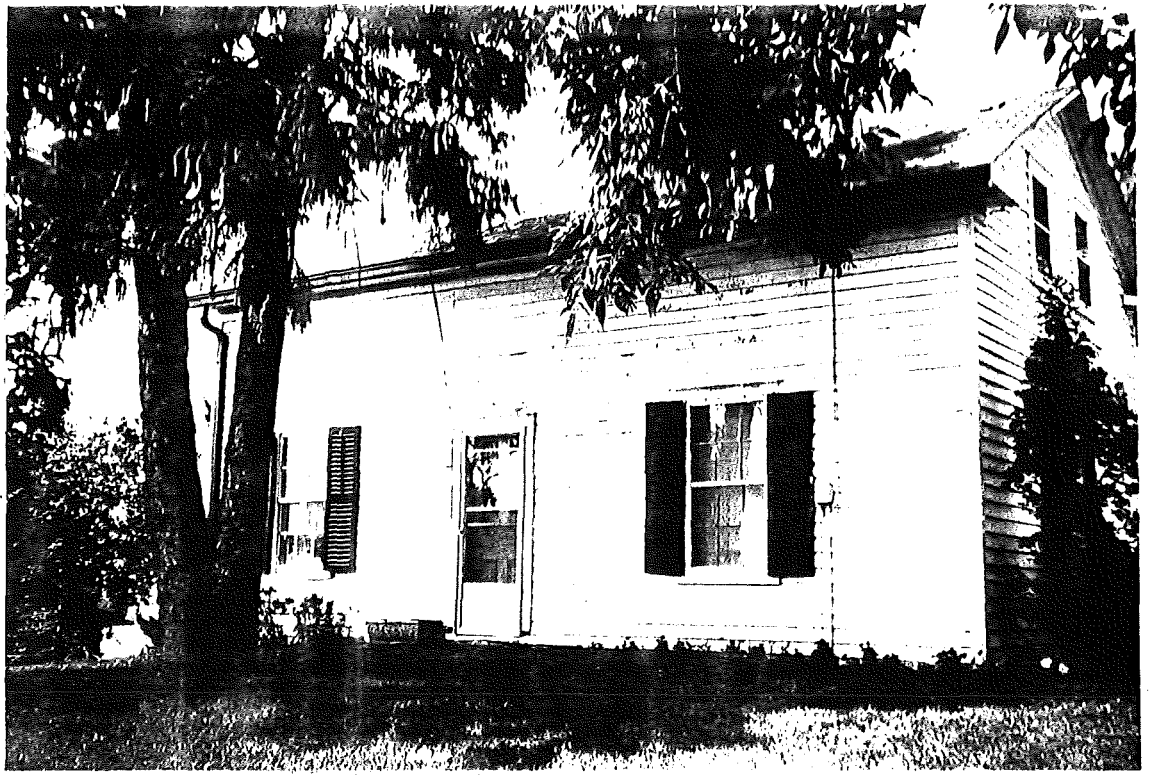
NORTH (SIDE) VIEW ↑

- gable roof

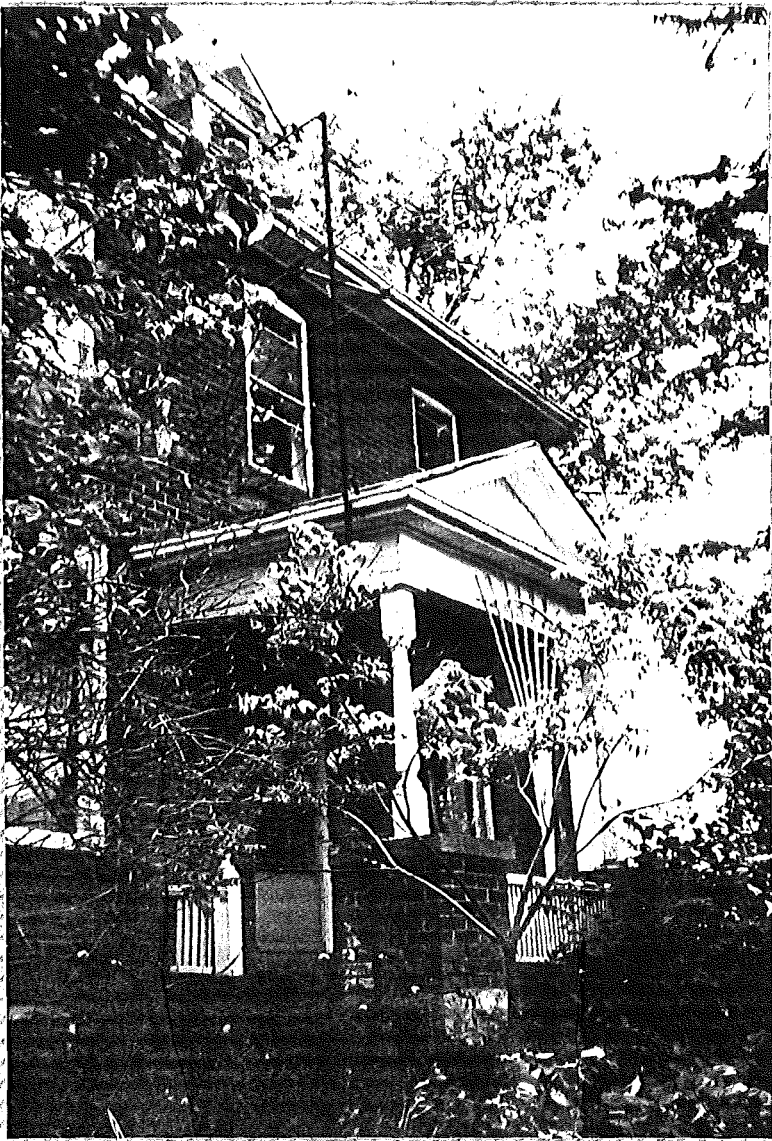
NORTH (FRONT) VIEW ←

- pedimented front porch
- dormer

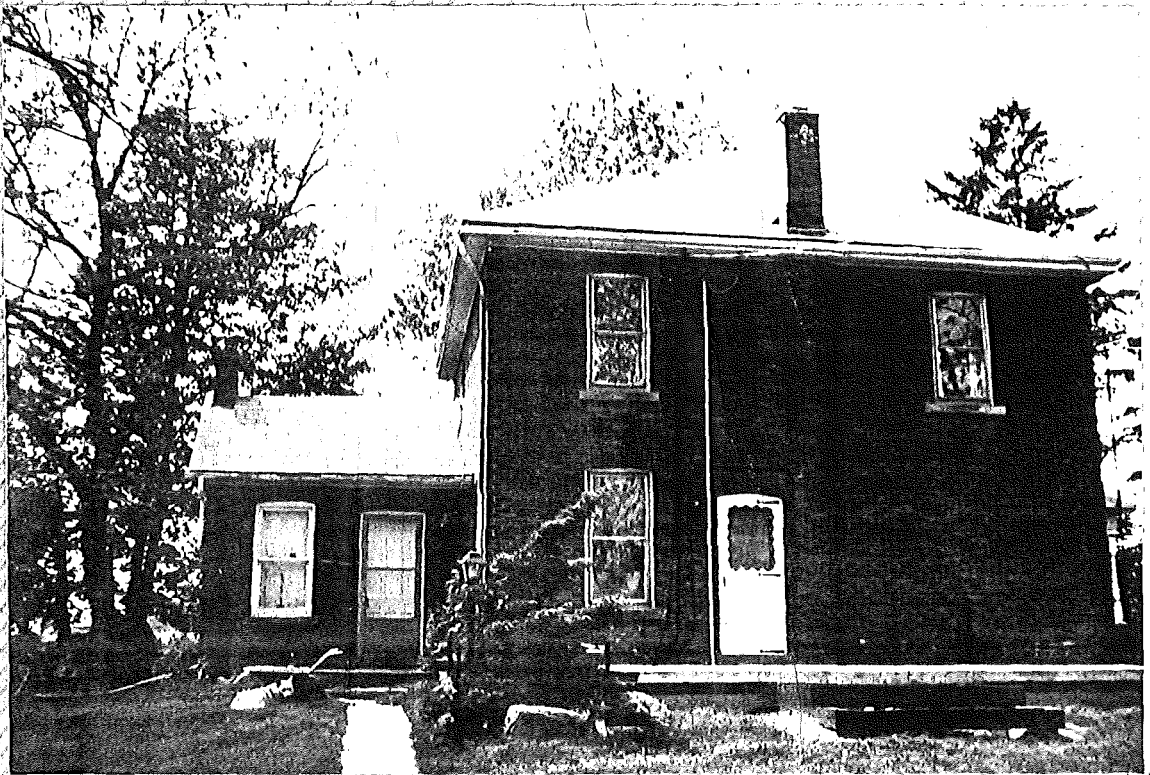
EAST (SIDE) VIEW ↑

- * flat top brick relieving arch over door

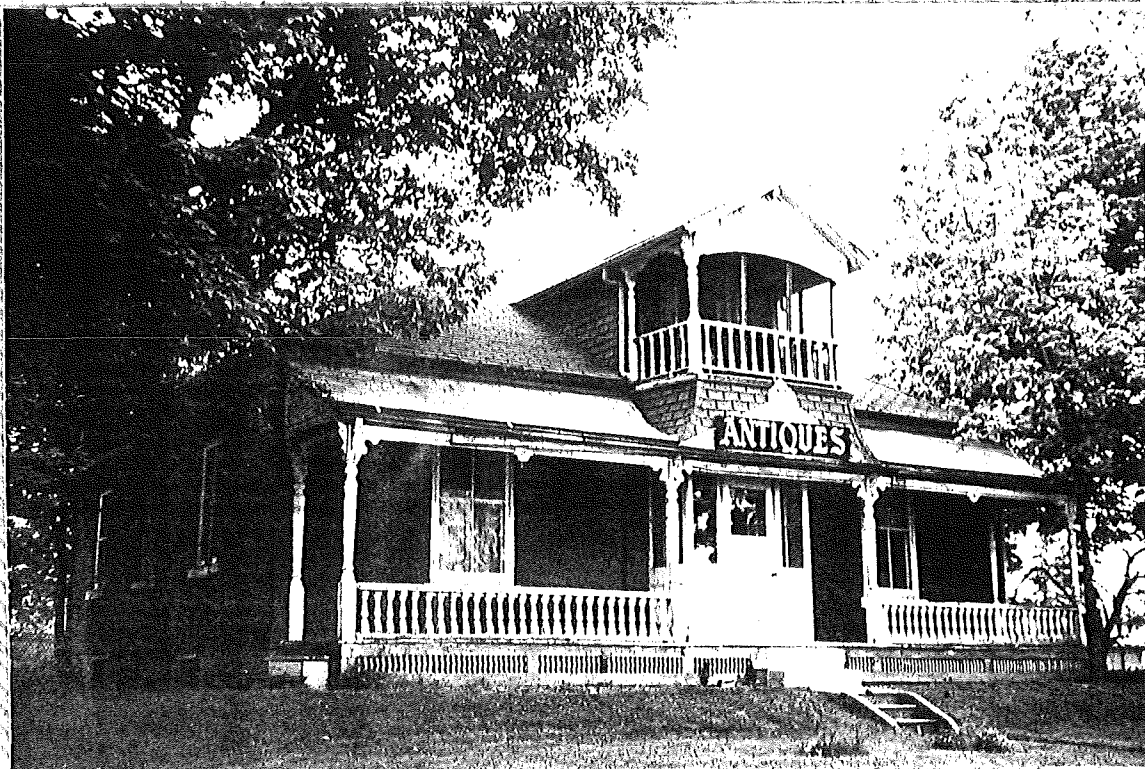
EAST (FRONT) & SOUTH (SIDE) VIEWS ↑

- wall dormer with porch
- front veranda
- side lights

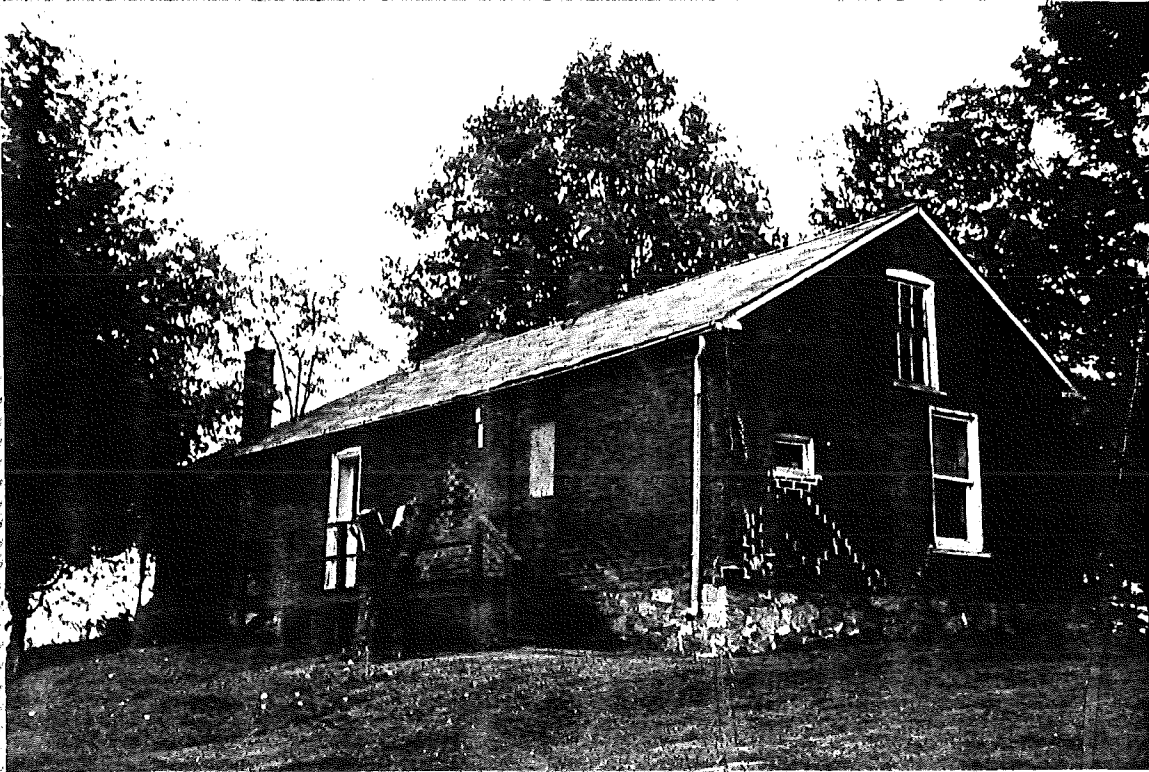
WEST (BACK) & NORTH (SIDE) VIEWS ↑

- brick relieving arches over
doors and windows

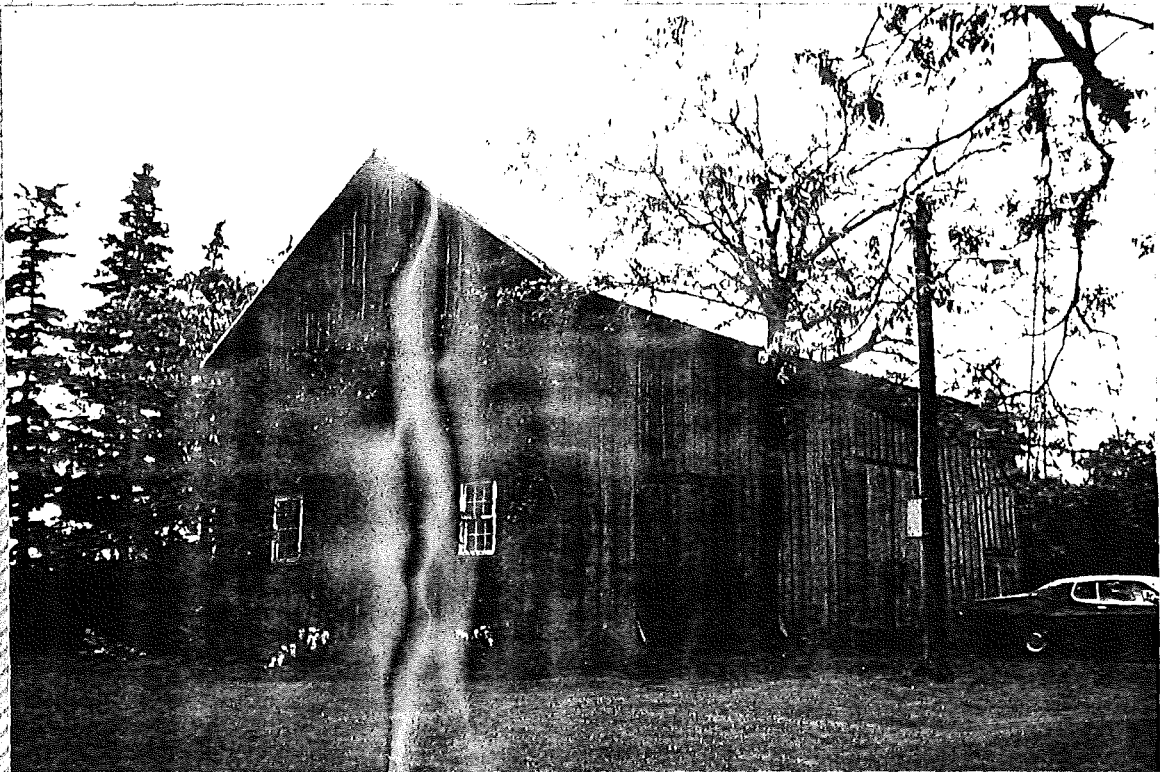
EAST & NORTH VIEWS ↑

- gable roof

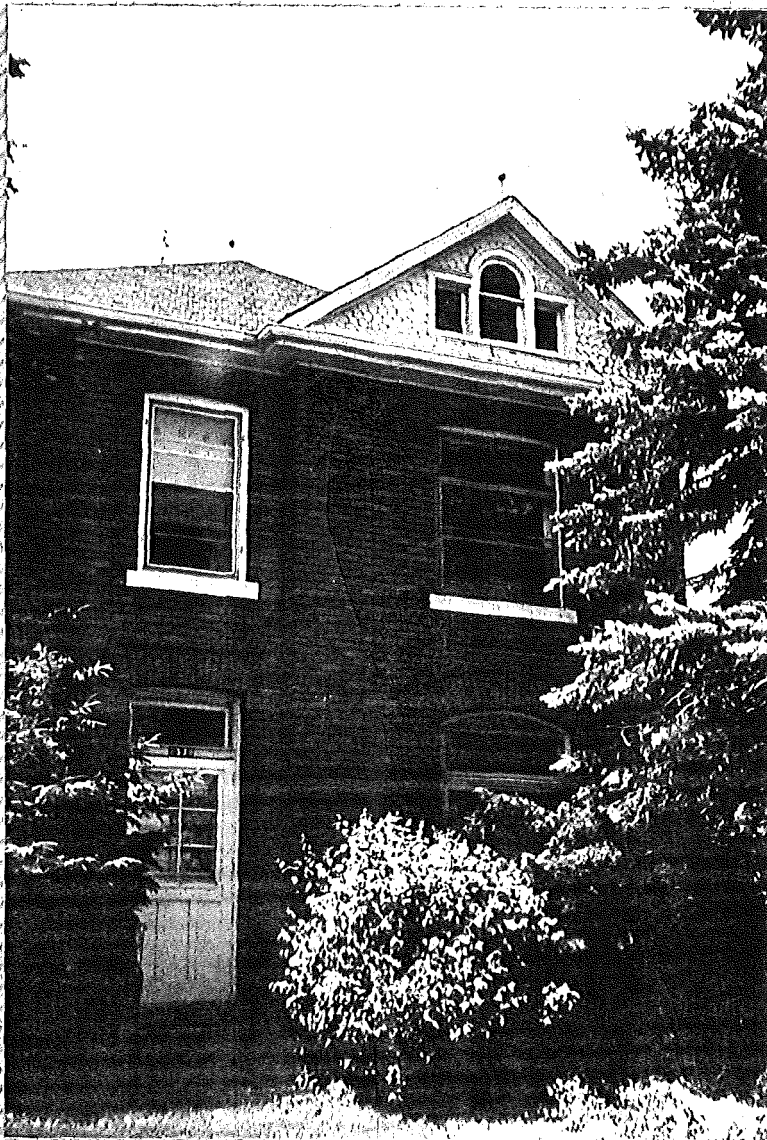
EAST (FRONT) VIEW ↑

- * flat top brick relieving arches over doors on first floor and on the East and South sides only
- label mold over doors and windows on East and South sides only
- brick relieving arches over windows in second storey and over windows on first floor on West and North sides
- * palladian window in third floor
- original patterned glass in transom and front windows

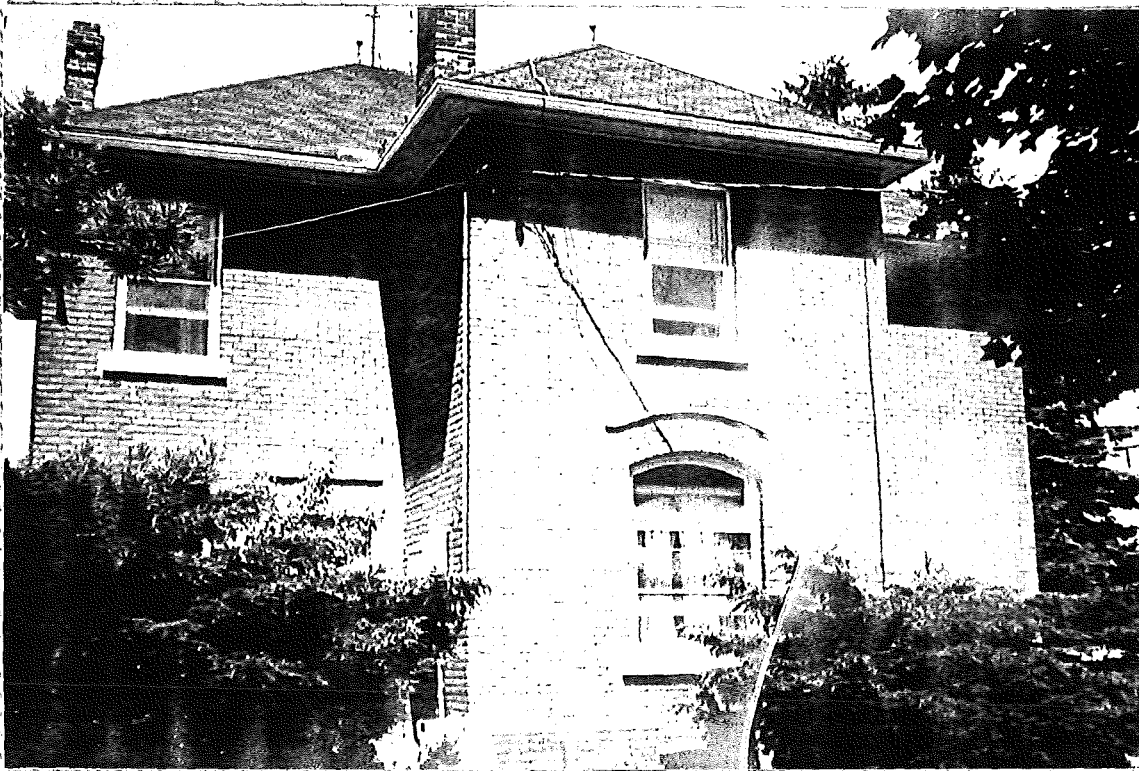
SOUTH (SIDE) VIEW ↑

- bevel brick detail
- corbeled chimney cap
- hip roof

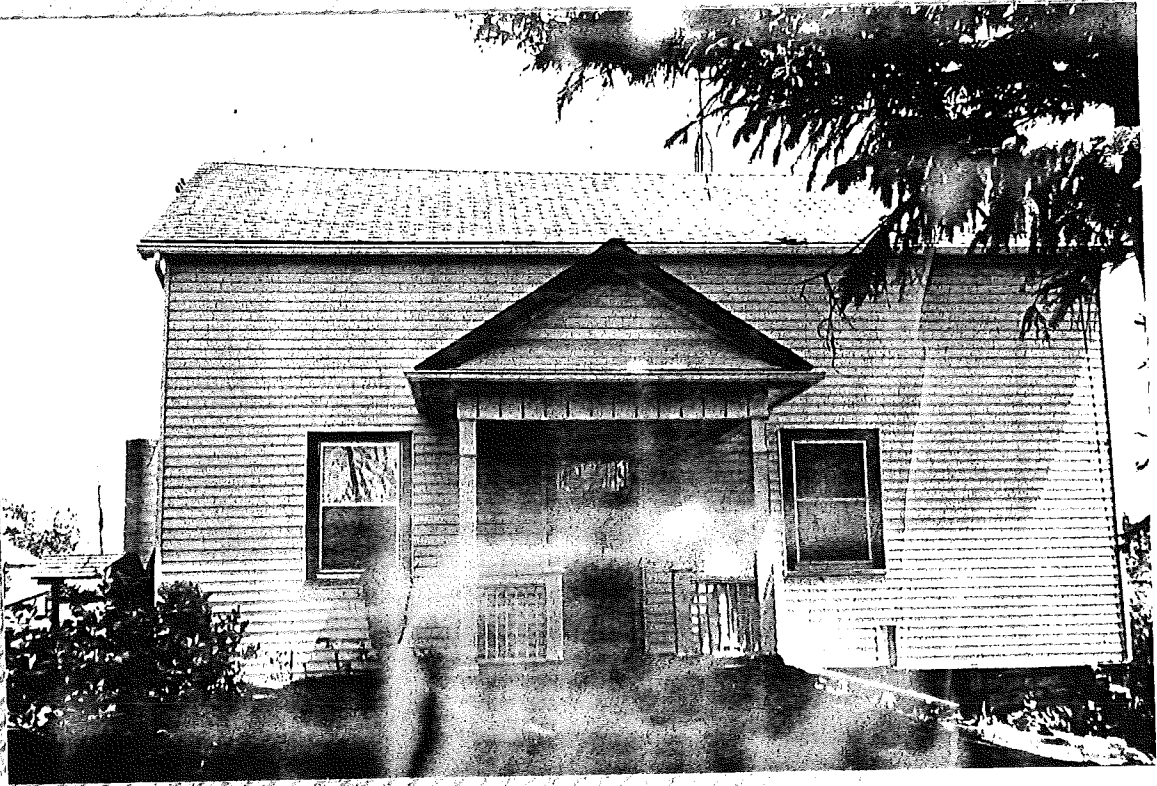
WEST (FRONT) VIEW ↑

- gable roof

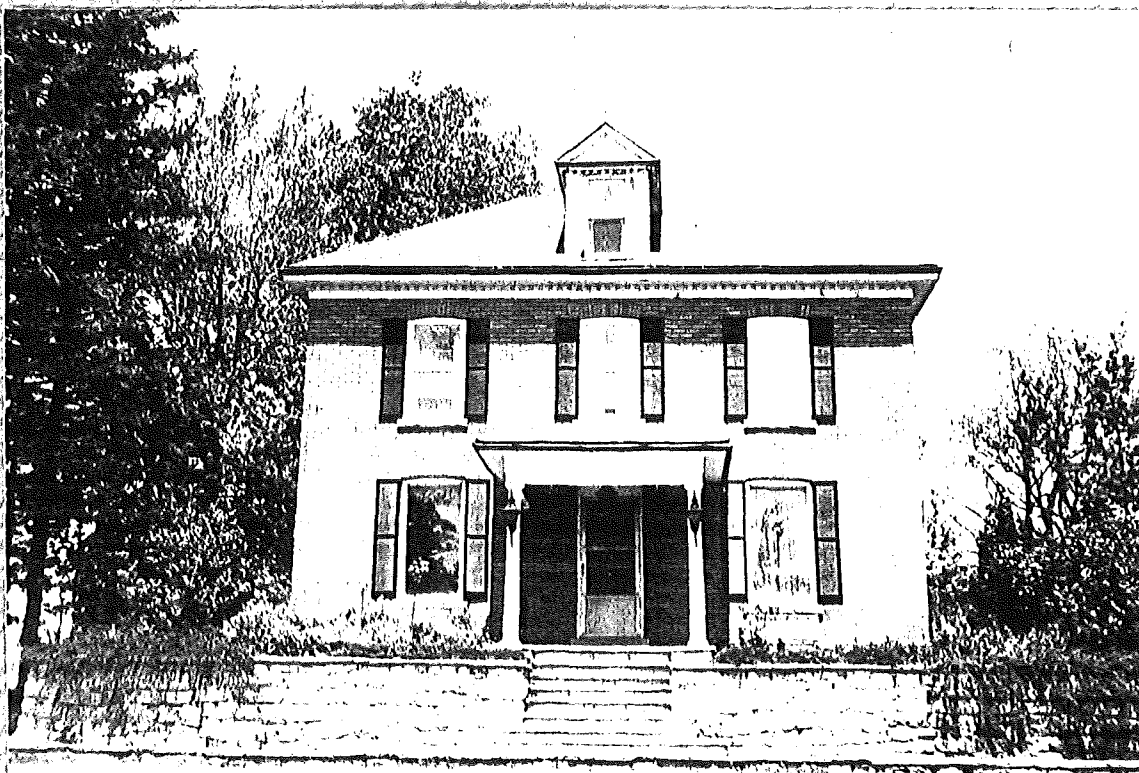
SOUTH (FRONT) VIEW ↑

- dormer

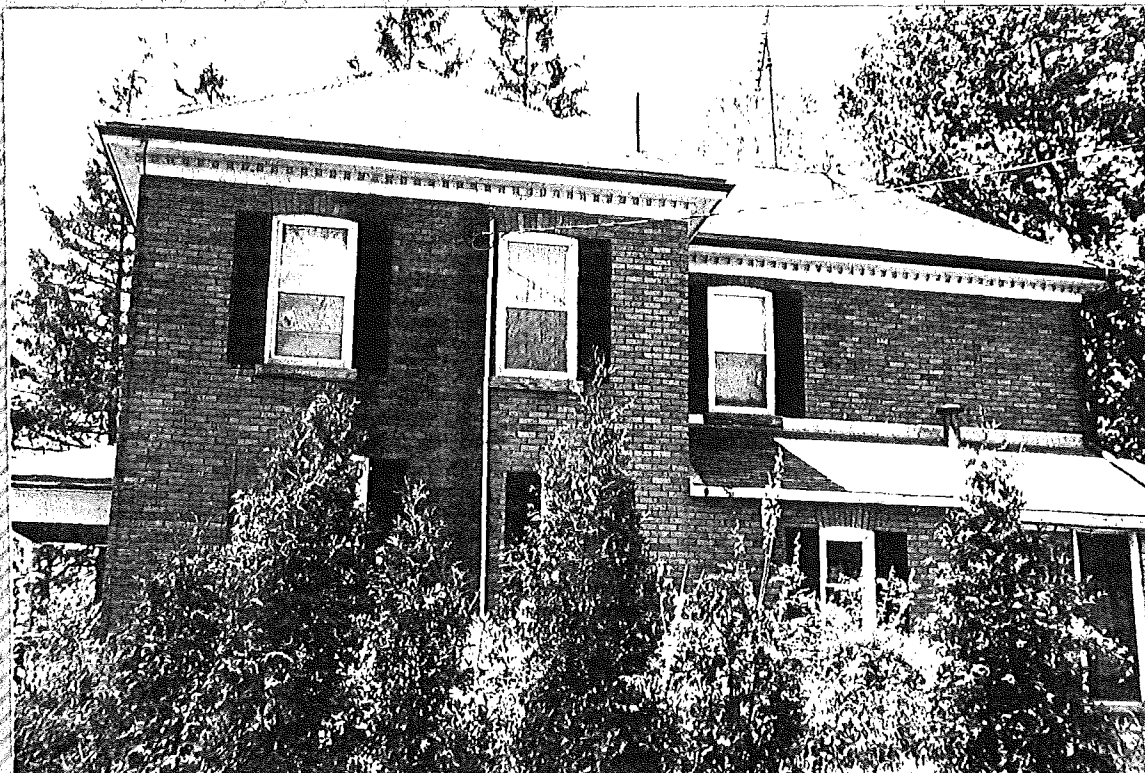
EAST (SIDE) VIEW ↑

- brick relieving arches over windows
- dentils running along overhang
- hip roof

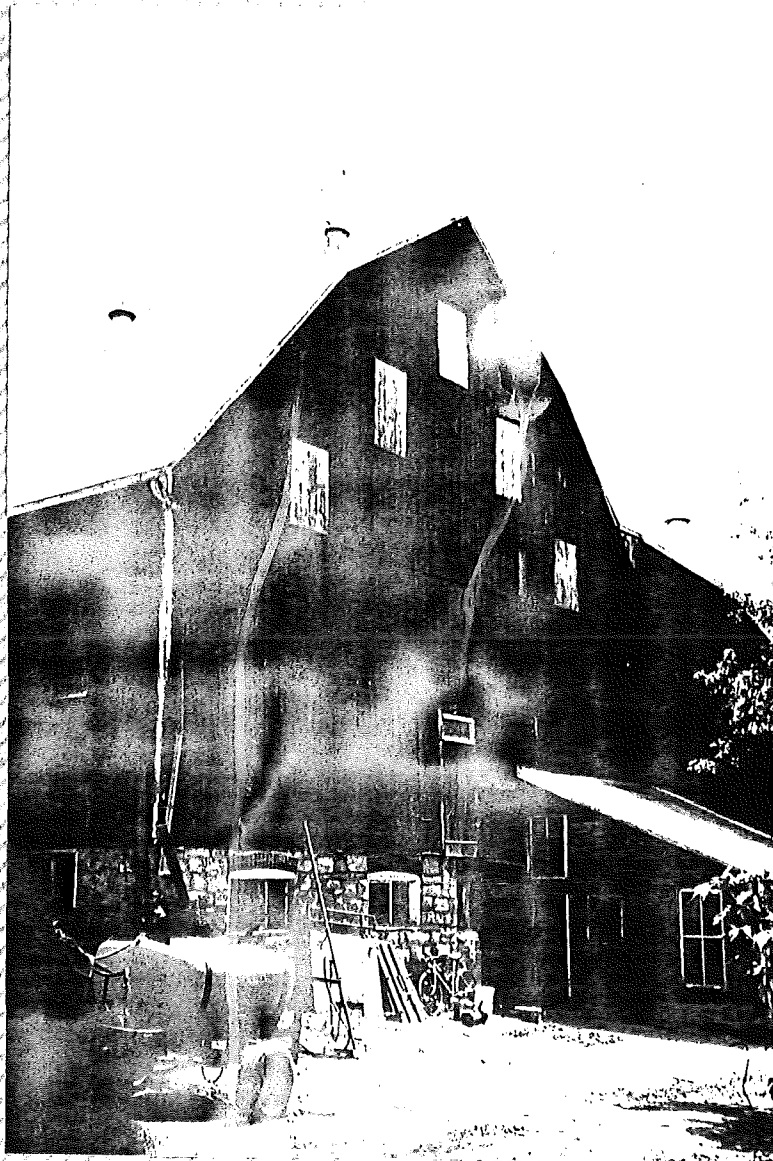
WEST VIEW ↑

- hip roof
- brick relieving arches over windows and doors

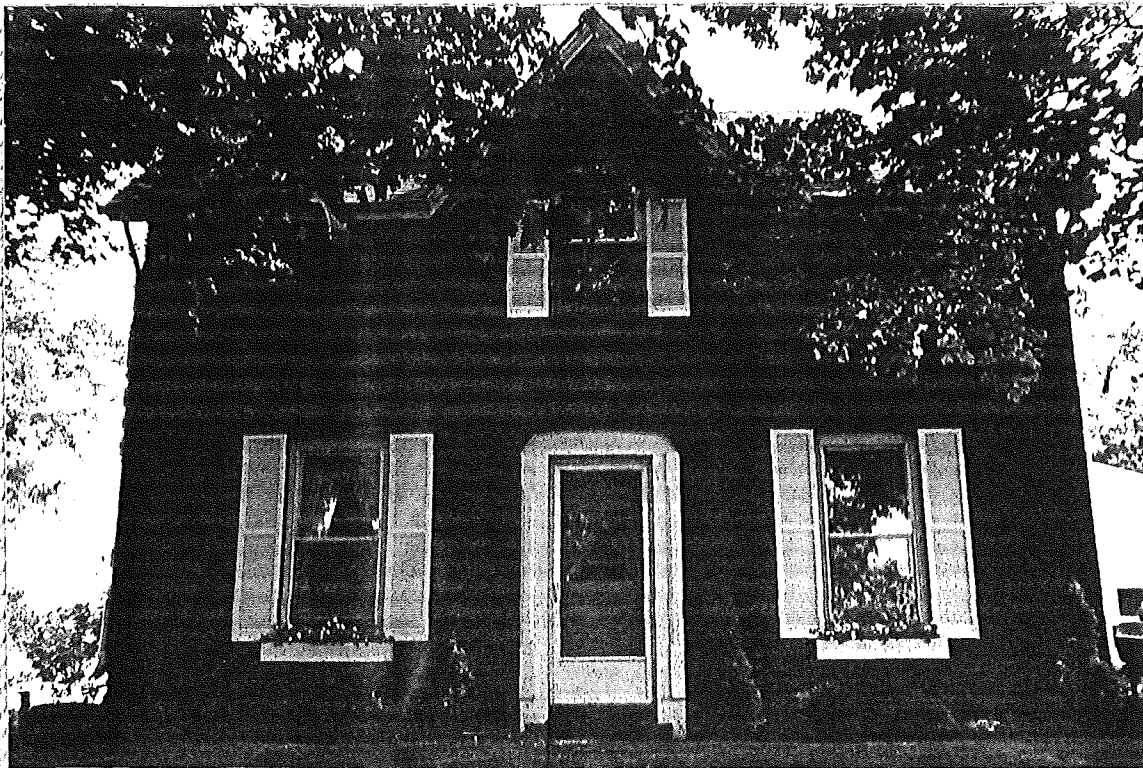
SOUTH (FRONT) VIEW ↑

- wall dormer with semi-circular window
- brick relieving arches over windows

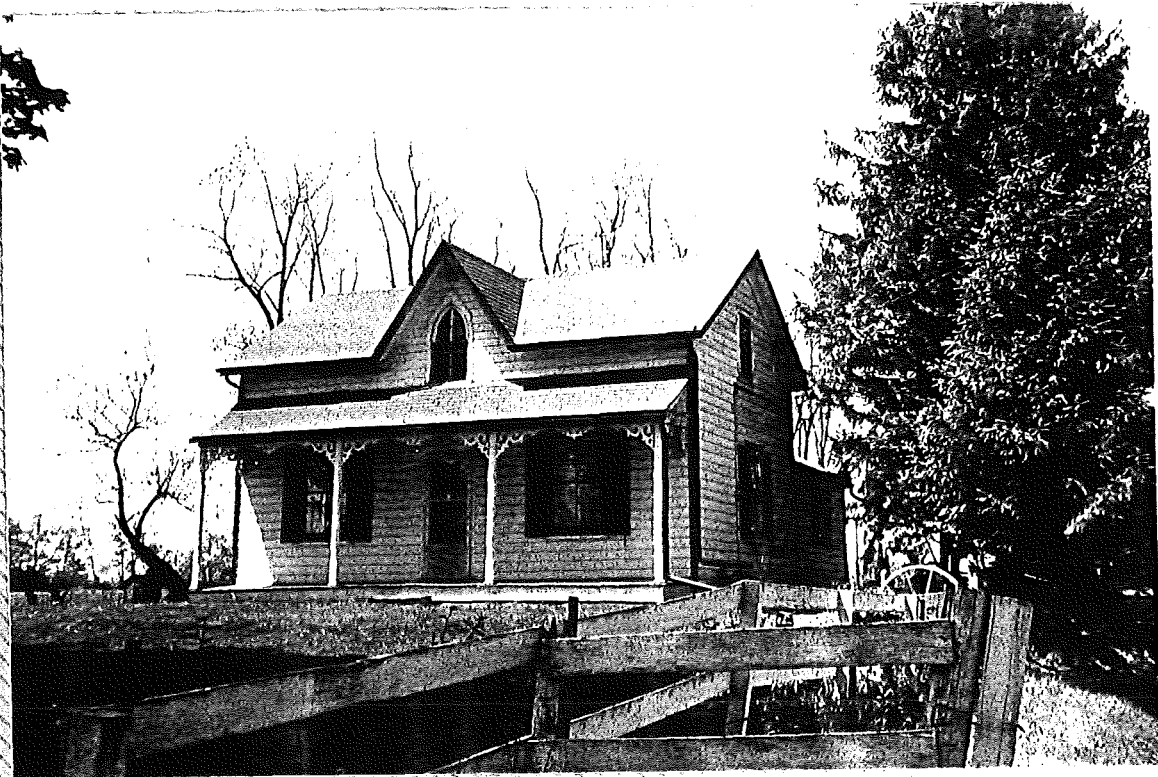
EAST (FRONT) & NORTH (SIDE) VIEWS ↑

- wall dormer with pointed arch window
- front porch with original trim

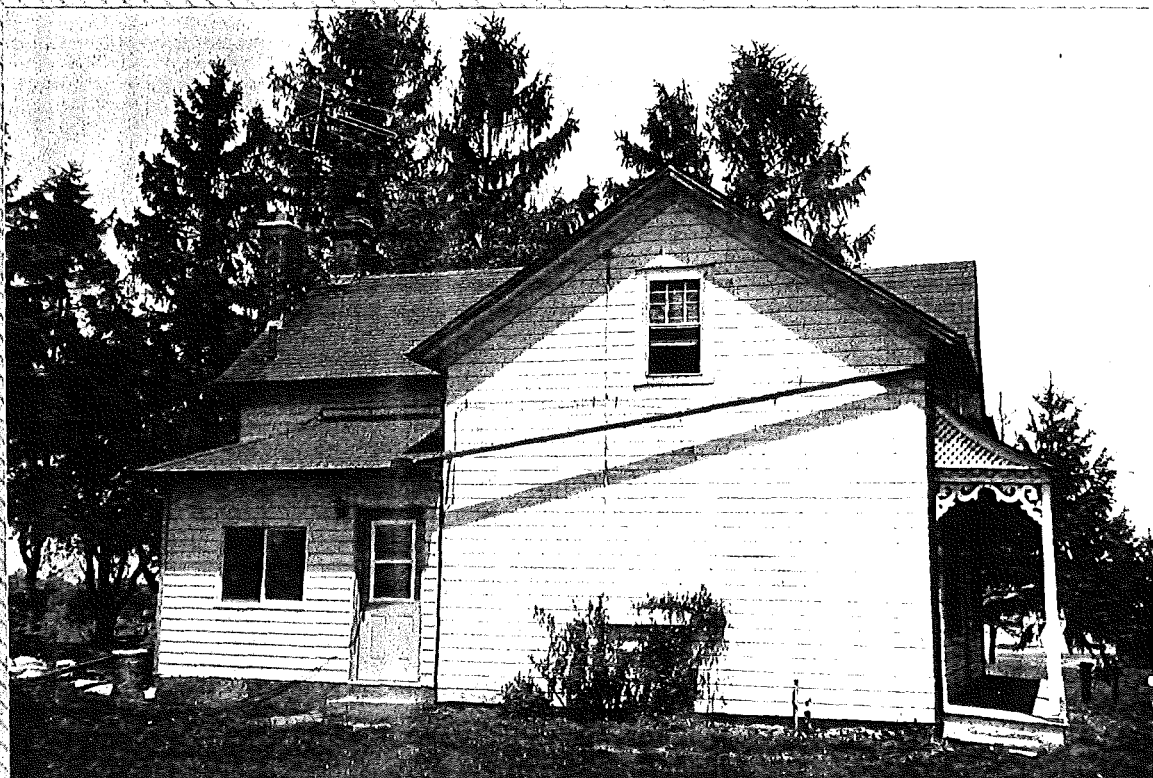
SOUTH (SIDE) VIEW ↑

- gable roof
- corbeled chimney cap

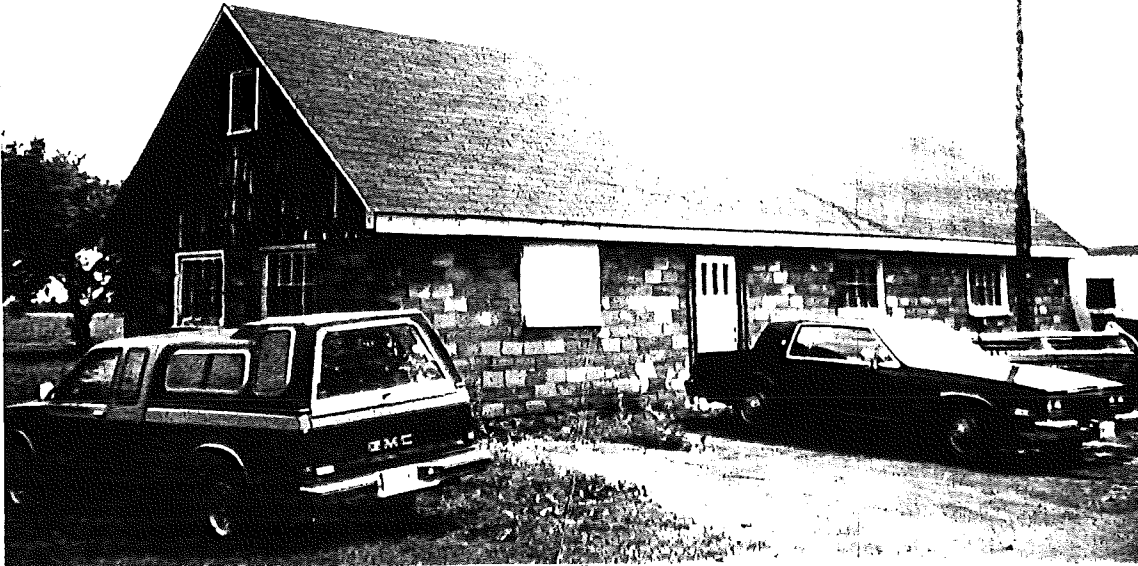
WEST & NORTH VIEWS ↑

- clay brick tile walls
- gable roof

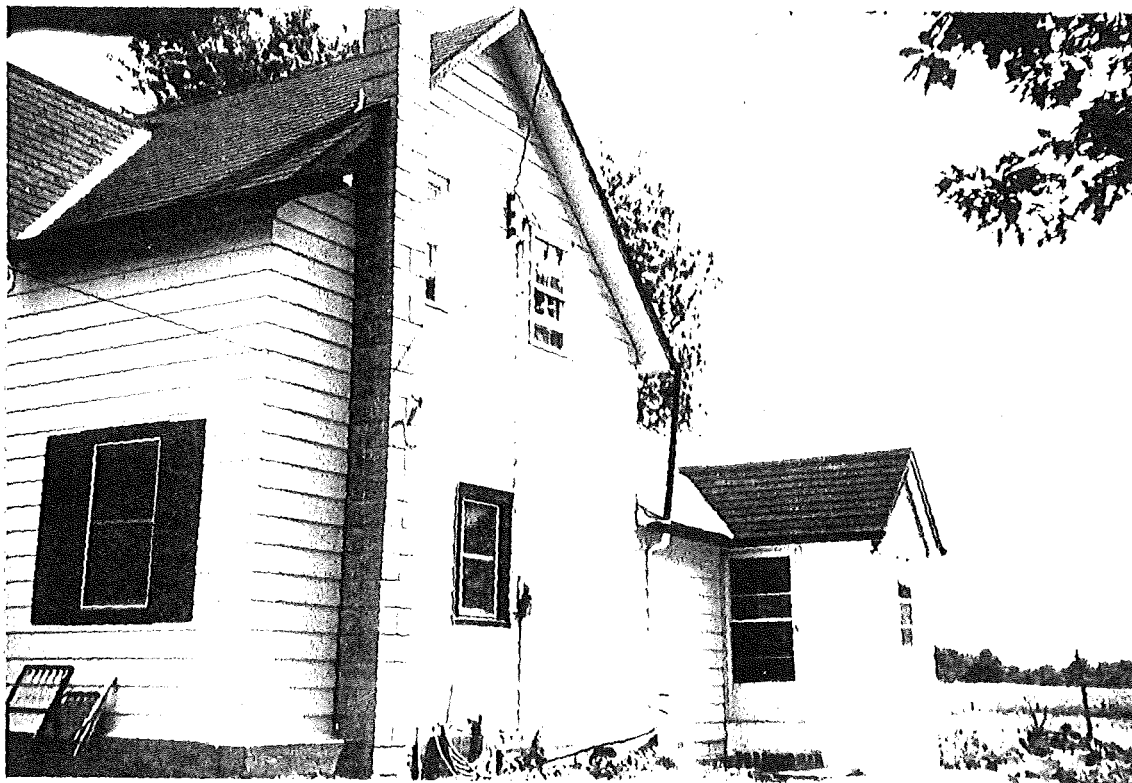
WEST (SIDE) VIEW ↑

- gable roof

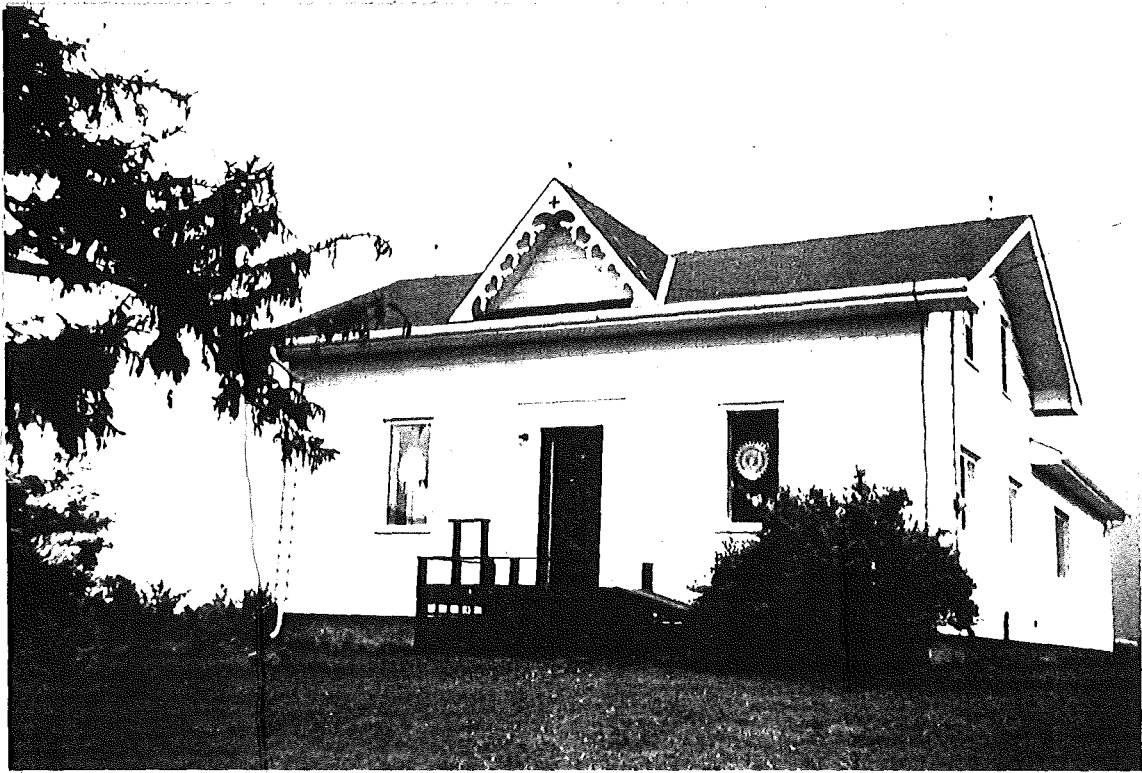
NORTH (FRONT) VIEW ↗

- wall dormer with
original gingerbread
trim

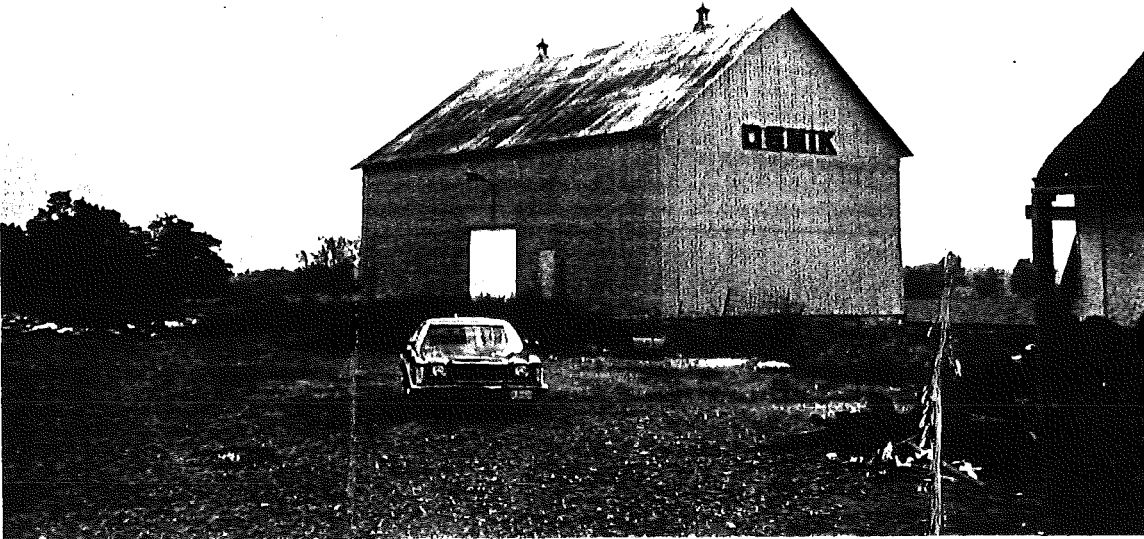
EAST & NORTH VIEWS ↑

- gable roof

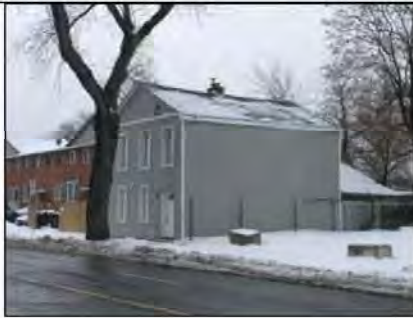
SgA2	BHR Residence	577 James Street North	This two storey frame dwelling dates to the second half of the nineteenth century. It features a gable roof and a central (interior) chimney. This structure is remarkable for the lack of window openings on the north elevation. This may indicate that this structure was part of a row of similar structures or may suggest renovations which took place subsequent to construction. The gable end faces James Street North and features three windows on the upper storey and a door and two windows on the lower storey. This structure is similar to others seen in a row and found within the landscape making up SgA12 and may be an example of a multi-occupancy residence/ commercial property and is an important example of the type of vernacular architecture which would have been typical of the port area of the city.	Identified during field review

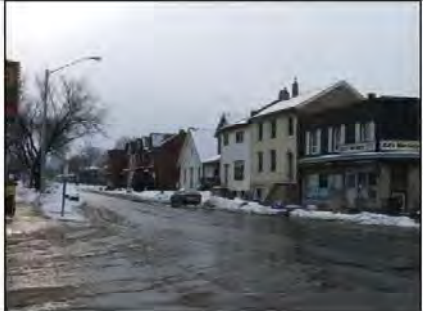
SgA9	CHL Streetscape	James Street North - Port of Hamilton, Ferrie Street to Picton Street	This feature consists of a split commercial and residential streetscape dating from the late nineteenth to the mid twentieth century. This streetscape is later than those noted below (e.g. SgA12 and SgA11) and represents the transition of the neighbourhood at the north end of James Street North from a largely residential area to mixed residential and commercial. In general, the commercial structures—although many are two storeys—are of much smaller scale than their counterparts to the north. Residences tend to be vernacular frame structures with some brick structures interspersed. This streetscape is less densely occupied than those to the south.	Identified by the City of Hamilton (CHL) Mapping (2009) Identified during field review

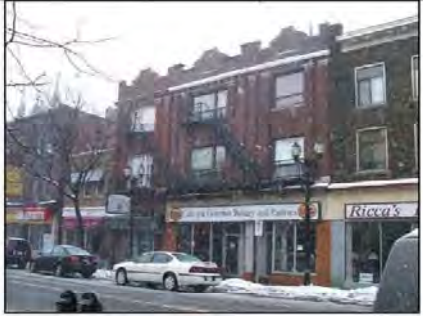
Identifier	Feature Category and Type	Address	Description/Comment	Recognition and References	Photo
SgA11	CHL Streetscape	James Street North, York Boulevard/Wilson Street to Murray Street.	This feature consists of a commercial streetscape dating to the nineteenth and twentieth centuries. This streetscape, like SgA12, is an important example of the type of commercial structures which populated James Street North in the late nineteenth and into the twentieth century. Like SgA12, these structures are important as individual buildings but even more so for their unbroken stretch along James Street North. Like SgA12 and the other streetscapes, these structures have been notably altered at street level; however, nearly all of the character defining elements have been retained on the upper stories. The massing, scale and variety of formal and informal styles seen within this cultural heritage landscape provide notable information about the nineteenth and early-twentieth-century commercial district of the historic settlement of 'Jamesville'.	Identified by the City of Hamilton (CHL) Mapping (2009) Hamilton's Heritage Vol. 2 Identified during field review

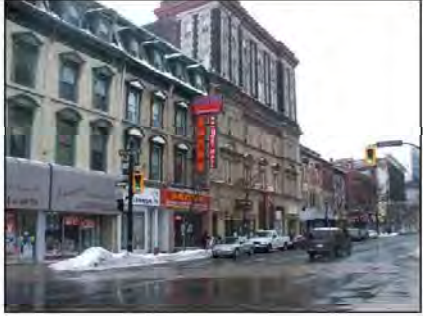
SgA12	CHL Streetscape	James Street North south of Rebecca Street to York Boulevard/Wilson Street	This feature consists of a commercial streetscape dating to the nineteenth century. This example of commercial architecture is typical of a late-nineteenth-century urban landscape. Within this cultural heritage landscape there are a variety of commercial buildings. Ranging from two-and-a-half storeys to larger-scale three storey structures, these properties appear to have been in use since their construction in the late nineteenth and early twentieth centuries. At street level, many of the individual shops have been altered with large plate glass windows and modern signage; nonetheless, many of the original/ early features are retained at this level and nearly all of the features retained in the upper levels. These structures front directly onto the sidewalk and are in close proximity to the road right-of-way. These structures—both individually and as part of a connected streetscape—offer important insight to the nature of the nineteenth-century commercial development in the downtown core of Hamilton.	Identified by the City of Hamilton (CHL) Mapping (2009) Hamilton's Heritage Vol. 2 Identified during field review

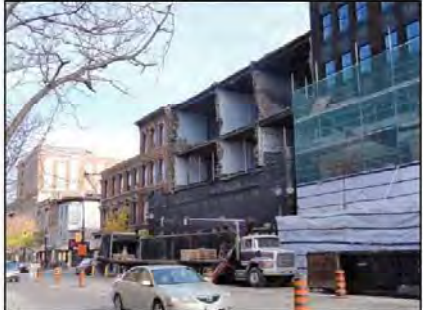
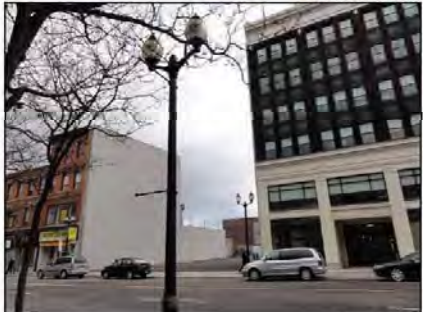
Identifier	Feature Category and Type	Address	Description/Comment	Recognition and References	Photo
SgA13	BHR Commercial Structure	46-52 James Street North	This structure, the William Thomas Building, was located adjacent to the Lister Block (SgA7). Dating to c. 1855 this commercial structure housed a number of businesses throughout the nineteenth and twentieth centuries. It occupied a prominent position on the James Street North streetscape. This building was under demolition at the time of the field review in November 2010 and was a vacant lot on a site visit in March 2012. The exterior front panels and other elements have been designated under Part IV of the <i>Ontario Heritage Act</i> . The se components are, at time of writing, in storage.	Designated Part IV of the <i>Ontario Heritage Act</i> Hamilton's Heritage Vol. 1

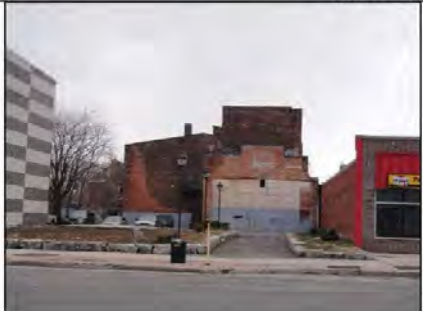
<p>March 2012</p>
SgA14	BHR Entertainment Complex	108 James Street North	The Tivoli Theatre was used as a theatre since 1908 and, originally fronted onto James Street North. Built in 1875, the James Street portion of the building served first as a carriage factory (until c. 1901) and later was a succession of theatres including the 'Wonderland Theatre' reputedly Hamilton's first cinema. With the construction of a large auditorium on Hughson Street the building was principally used as the Tivoli Theatre. Although the Hughson Street portion of the structure remains, the building(s) on James Street North were demolished sometime after 2004. Today, the James Street site is a largely empty lot backed by the west elevation of the Tivoli auditorium.	Designated Part IV of the <i>Ontario Heritage Act</i> Hamilton's Heritage Vol. 1

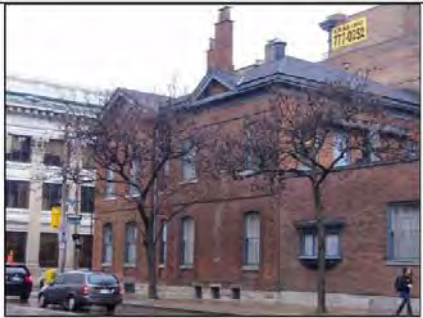
SgB2	BHR Commercial Building	47 James Street South	Located at the nexus of the city's historic financial centre, this building was constructed in 1908 for the Landed Banking and Loan Company. This structure is an exceptional example of Classical Revival architecture. It is in the oldest bank building still standing in the city's original financial centre.	Designated under Part IV of the <i>Ontario Heritage Act</i> Hamilton's Heritage Vol. 1

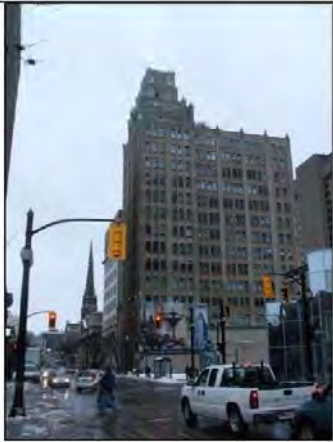
SgB4	BHR Commercial Building	42 James Street South	This building was constructed in 1905-1906 for the Federal Life Assurance Company and design by Montreal Architects Finley and Spencer. Its significance is tied to its material innovations as the city's first building featuring modern steel skeleton construction. Its association with: the Federal Life Assurance Company; Hamilton's function as a major city centre in the early twentieth century; and its contextual contribution to this prominent intersection are also of local significance.	Designated under Part IV of the <i>Ontario Heritage Act</i> Hamilton's Heritage Vol. 1

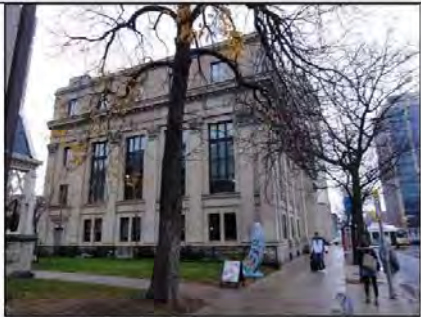
Table 2: Identified Built Heritage Resources (BHR) and Cultural Heritage Landscapes (CHL) Along James Street South, James Mountain Road, West 5 th Street, and Fennel Avenue West					
Identifier	Feature Category and Type	Address	Description/Comment	Recognition and References	Photo
SgB5	BHR Commercial Building	1 Main Street West	This structure was built in 1928 for the Bank of Montreal. It was designed by Montreal architect Kenneth G. Rea and Pigott Construction of Hamilton was retained to execute the building contract. Its significance is tied to its material and design, as one of the best types of Bank Architecture in the city and its association with prominent and notable architectural and construction firms. It is also tied to its wider surroundings at the Main Street and James Street intersection, the heart of the city's original financial district.	Designated under Part IV of the <i>Ontario Heritage Act</i> Hamilton's Heritage Vol. 1

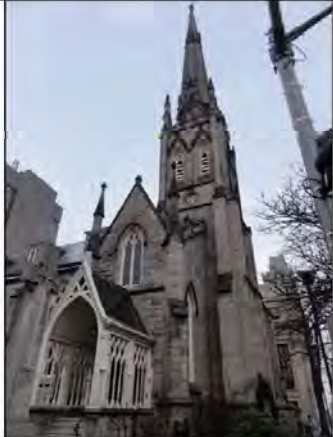
SgB6	BHR Church	64 James Street South	St. Paul's Church was completed in 1857 and was designed by architect William Thomas. It is an excellent example of the Gothic Revival style and reflects design and aesthetic associations with the English Medieval parish church. The site is framed by mature trees on its east elevation and monuments along its south elevation. The church's magnificent spire makes it a landmark and contributes to the visual quality of the downtown.	National Historic Site Designated under Part IV of the <i>Ontario Heritage Act</i> Subject to an Ontario Heritage Trust (OHT) easement Hamilton's Heritage Vol. 1 and 6

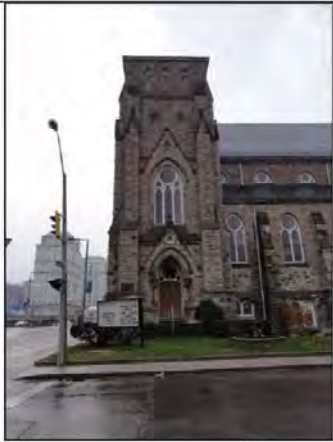
Table 2: Identified Built Heritage Resources (BHR) and Cultural Heritage Landscapes (CHL) Along James Street South, James Mountain Road, West 5 th Street, and Fennel Avenue West					
Identifier	Feature Category and Type	Address	Description/Comment	Recognition and References	Photo
SgB7	BHR Church	96 James Street South	James Street Baptist Church was constructed between 1878 and 1882. It reflects the Gothic Revival style and is noted for its use of rock-faced masonry walls. The subject building is associated with the Baptist congregation, a religious organization that has played a role in the city since at least the mid-nineteenth century. The Baptist Congregation is also notable for having financially contributed to the establishment of McMaster University in the City of Hamilton.	Designated under Part IV of the <i>Ontario Heritage Act</i> Hamilton's Heritage Vol. 1

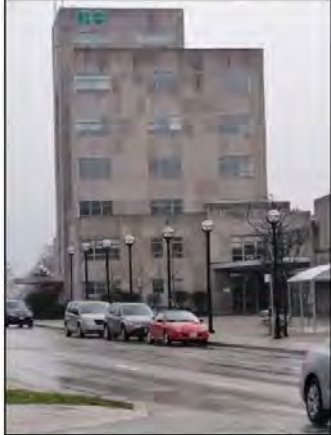
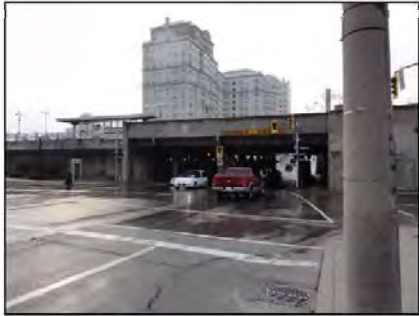
Table 2: Identified Built Heritage Resources (BHR) and Cultural Heritage Landscapes (CHL) Along James Street South, James Mountain Road, West 5 th Street, and Fennel Avenue West					
Identifier	Feature Category and Type	Address	Description/Comment	Recognition and References	Photo
SgB8	CHL Transportation Complex	36 Hunter Street East	The Toronto Hamilton and Buffalo Railway company constructed tracks along Hunter Street circa 1890. During this time, a brick and stone station was located at the northeast corner of Hunter Street East and James Street South. Today, a plaque commemorates the building that once stood at this corner. The present Go Station, centered at the base of Hughson Street was constructed in 1933 of buff stone material, indicative of both the Art Deco and International styles popular in the first half of the twentieth century. The rail line is carried into the station by a concrete and steel bridge, featuring two spans, and which carries the tracks over Hunter Street.	Designated under Part IV of the <i>Ontario Heritage Act</i> Identified by the City of Hamilton's Cultural Heritage Landscapes (CHL) Mapping (2009) Identified during field review Hamilton's Heritage Vol. 1

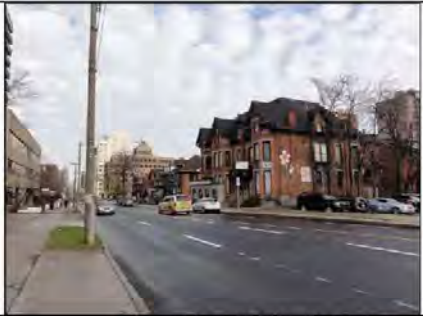
Table 2: Identified Built Heritage Resources (BHR) and Cultural Heritage Landscapes (CHL) Along James Street South, James Mountain Road, West 5 th Street, and Fennel Avenue West					
Identifier	Feature Category and Type	Address	Description/Comment	Recognition and References	Photo
SgB9	CHL Transitional Nineteenth and Early- Twentieth-Century Streetscape	East and west sides of James Street South, Hunter Street East to Freeman Place	This portion of James Street South is defined by clusters of residential buildings dating to various periods of the nineteenth century. The streetscape is defined by groupings of buildings that have similar set backs, massing, and scale. Additionally, extant nineteenth-century residences function together to provide excellent examples of period designs and construction techniques, including pre-confederation stone terrace construction, Richardsonian Romanesque, Queen Anne, and High Victorian styles. In places the streetscape has been fractured through the introduction of modern infill development. Nonetheless, the streetscape retains excellent examples of mid-nineteenth century stone construction (clustered between Bold Street and Duke Street, some of which have been designated under the <i>Ontario Heritage Act</i>) and High Victorian residences as well as more common Edwardian-inspired residences. Of additional note are circa 1930s introductions into the streetscape, including the Medical Arts Building at the northeast corner of Young Street and James Street South, and an apartment building at James Street South and Freeman Place.	Identified by the City of Hamilton (CHL) Mapping (2009) Identified during field review Hamilton's Heritage Vol. 2 and 3

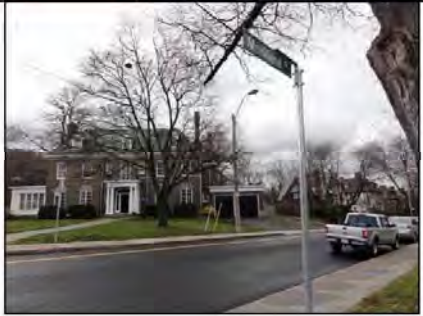
SgB10	CHL Durand–Markland Heritage Conservation District	Markland Street and James Street South	This heritage conservation district extends westerly from James Street South on the north and south sides of Markland Street. This district contains residential properties of an early-twentieth-century vintage with some dating to the nineteenth century set within a park setting.	Designated under Part V of the <i>Ontario Heritage Act</i> Hamilton's Heritage Vol. 1
