TECHNICAL MEMORANDUM

Project No. 19125764-M01-Rev1

CULTURAL HERITAGE SCREENING REPORT – TWENTY ROAD WEST PLAN OF SUBDIVISION, GLANBROOK, CITY OF HAMILTON, ONTARIO

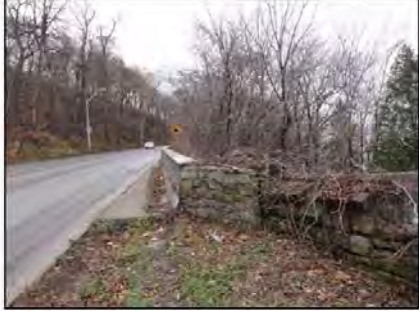
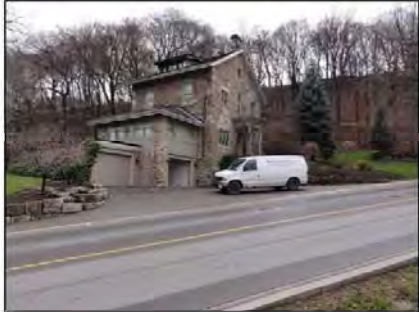
Table 2: Identified Built Heritage Resources (BHR) and Cultural Heritage Landscapes (CHL) Along James Street South, James Mountain Road, West 5 th Street, and Fennel Avenue West					
Identifier	Feature Category and Type	Address	Description/Comment	Recognition and References	Photo
SgB11	CHL Scenic Corridor	North and south sides of James Mountain Road, St. Joseph's Place to Gateview Drive	This scenic corridor traces a historic alignment that provided access between the downtown city centre and the escarpment since at least the mid-to-late nineteenth century. It is framed by notable estates to the north and two nineteenth-century residences on the south side; features vegetation on either side of the road right-of-way as well as stone foot walls on the north side, and may retain elements of the former Hamilton and Barton Incline Railway that extended up the mountain from the southern terminus of James Street South in the first half of the twentieth century. Vehicular use of this corridor provides exceptional views of the city in all directions.	Identified by the City of Hamilton (CHL) Mapping (2009) Identified during field review

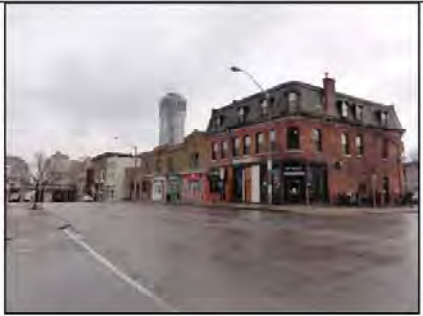
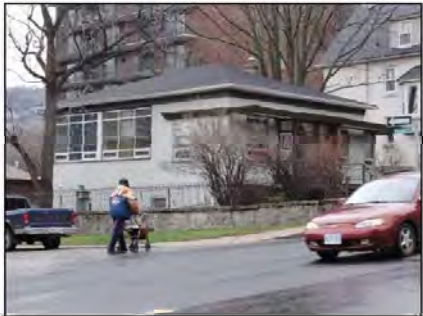
Table 2: Identified Built Heritage Resources (BHR) and Cultural Heritage Landscapes (CHL) Along James Street South, James Mountain Road, West 5 th Street, and Fennel Avenue West					
Identifier	Feature Category and Type	Address	Description/Comment	Recognition and References	Photo
SgB12	CHL Nineteenth-century commercial/residential streetscape	East and west sides of John Street South, Hunter Street East to Charlton Avenue East	This streetscape is historically associated with mid-to-late nineteenth-century commercial and residential development patterns in the original urban core of the city. Southerly from Hunter Street East, the streetscape is generally defined by two and three storey brick commercial structures that would have clustered in this area due to proximity of the rail line along Hunter Street East. Southerly, towards Augusta Street and Charlton Avenue East, the streetscape transitions to a smaller scale with two-and-a-half storey residential structures, generally with brick exteriors, clustered in groupings and illustrative of 'market town' architecture that would have emerged towards the end of the nineteenth century in this area of the city. Of particular note and sensitivity is a residential structure located at the southeast corner of Forest Avenue and John Street South. This structure is of a one storey scale and is therefore unique or rare within the context of remaining nineteenth century residential building stock in the city, which generally consists of a one-and-a-half, two, or two-and-a-half storey scale. This structure is indicative of the Regency style which dates to the first half of the nineteenth century. Additionally, a stone foot wall surrounds the north and west elevations of the property line and which may be susceptible to vibration effects or removal should encroachment on to the property be required.	Hamilton's Heritage Vol. 2 Identified during field review

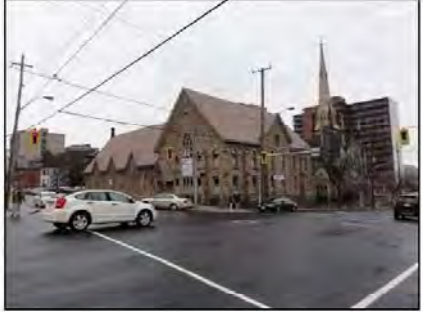
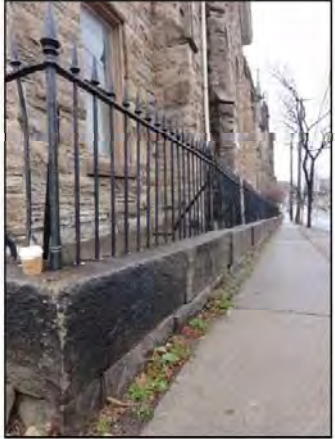
Table 2: Identified Built Heritage Resources (BHR) and Cultural Heritage Landscapes (CHL) Along James Street South, James Mountain Road, West 5 th Street, and Fennel Avenue West					
Identifier	Feature Category and Type	Address	Description/Comment	Recognition and References	Photo
SgB13	BHR Church	65 Charlton Avenue East	The Church of the Ascension sits at the northwest corner of John Street South and Charlton Avenue East. It was the second Anglican Church to be built in the city in 1850 with opening services held in 1851. Land for the church was donated by Richard Juson, a prominent merchant in the city. The structure is valued for its design merits as a good example of Gothic Church architecture using limestone materials, which were likely readily available locally. Of particular note and sensitivity is the stone and wrought iron fencing that surrounds the structure on its east and south elevations. This element is purported to date to 1867.	Designated under Part IV of the <i>Ontario Heritage Act</i> Hamilton's Heritage Vol. 1

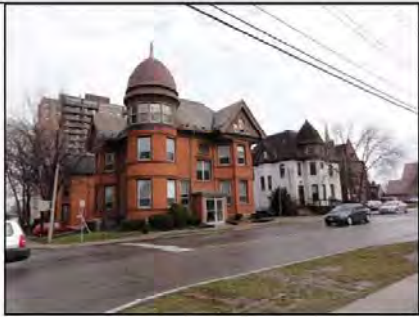
Table 2: Identified Built Heritage Resources (BHR) and Cultural Heritage Landscapes (CHL) Along James Street South, James Mountain Road, West 5 th Street, and Fennel Avenue West					
Identifier	Feature Category and Type	Address	Description/Comment	Recognition and References	Photo
SgB14	CHL Nineteenth-century residential cluster	Charlton Avenue East, north side, east of Hughson Street South	This residential cluster is located within an evolved portion of the southern area of the downtown core. These three residences likely date to the last quarter of the nineteenth century and are valued for their illustration of Victorian, high style elements such as domes and drums and Flemish dormers. This cluster of houses helps trace residential development patterns in this increasingly changed area of the downtown that is increasingly defined by its health care related facilities.	Hamilton's Heritage Vol. 2 Identified during field review

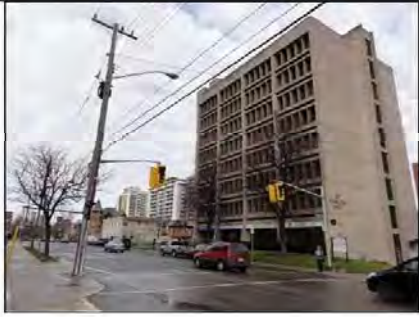
SgB15	BHR: Mid-Twentieth century high rise	25 Charlton Avenue East	This concrete tower sits at the northwest corner of Hughson Street South and Charlton Avenue East and is one of very few mid-twentieth century structures located in the area that exhibits design adherence to a particular architectural style. The subject structure may be described as an example of Brutalist architecture. Although distinct from its surroundings, the scale and detailing of this building is very similar to mid-twentieth century buildings constructed within the McMaster University campus and therefore, further research may reveal historical or design associations between the two.	Identified during field review

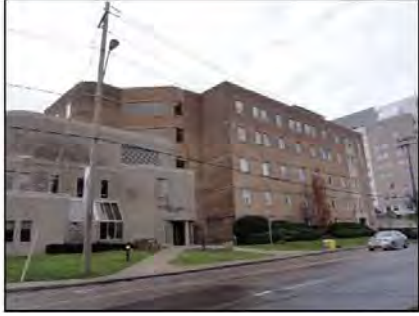
SgB16	BHR Hospital	50 Charlton Avenue East	St. Joseph's Hospital is situated at the southeast corner of James Street South and Charlton Avenue East. The subject site has housed the St. Joseph's hospital since 1890 when the Sister's of St. Joseph established a 25-bed hospital. The hospital underwent a major reconstruction program after World War II. The northeast corner of the complex, including the property's northerly frontage contains buildings that appear to date to the first half of the twentieth century. There is also potential that within the complex, older buildings may be extant given that health care services were delivered from this site as early as 1890. The subject site retains associative value with: the Sister's of St. Joseph; the development of institutionalized medical services in the early twentieth century; and the local neighbourhood as other buildings with related uses, particularly the Medical Arts Buildings on James Street South, developed in the area as a result.	Identified during field review

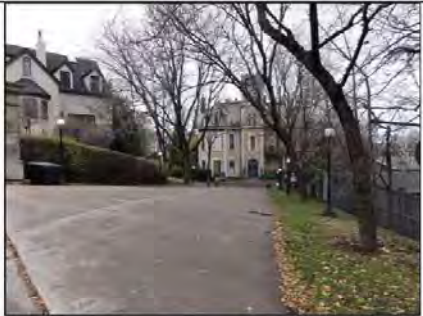
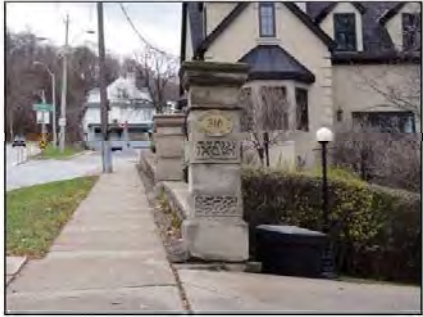
Table 2: Identified Built Heritage Resources (BHR) and Cultural Heritage Landscapes (CHL) Along James Street South, James Mountain Road, West 5 th Street, and Fennel Avenue West					
Identifier	Feature Category and Type	Address	Description/Comment	Recognition and References	Photo
SgB17	BHR Estate	316 James Street South	This property, known as Ballinahinch, was constructed between 1849 and 1850 for Aeneas Sage Kennedy, a Scottish dry goods merchant. It is valued for its architectural excellence as an outstanding example of the country villa style and demonstration of Italianate and Gothic-inspired architectural detailing. The subject property was subsequently owned by Edward Martin, publisher William Southam, and industrialist Frank McKune. It also contributes to the streetscape that lines the northern side of James Mountain Road and which combine together to create a picturesque streetscape of estate homes that date to the nineteenth century and which would have been sited at the base of mountain to offer an ideal setting while still maintaining a close distance to the commercial centre of the city. Of particular sensitivity to operations within the road of right-of-way are the ornately carved entrance gates situated at the beginning of the drive way.	Designated under Part IV of the <i>Ontario Heritage Act</i> Hamilton's Heritage Vol. 1

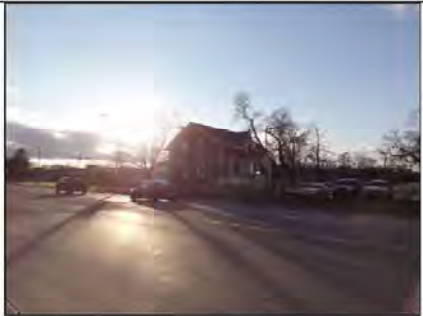
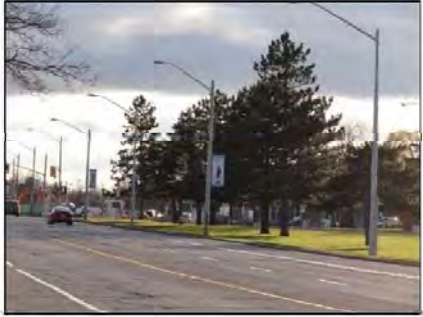
Table 2: Identified Built Heritage Resources (BHR) and Cultural Heritage Landscapes (CHL) Along James Street South, James Mountain Road, West 5 th Street, and Fennel Avenue West					
Identifier	Feature Category and Type	Address	Description/Comment	Recognition and References	Photo
SgB18	CHL: St. Joseph's Mountain Hospital	100 West 5 th Street	St. Joseph's Mountain Hospital complex is an evolved cultural heritage landscape. The grounds were first established in the 1870s as the Hamilton Asylum for Inebriates and contains several buildings of known heritage value, such as Grove Hall (1931), Hickory House (1929), Gateview (1877), the Claremont Building (1960), the Auchmar Complex (1960), and Century Manor (City of Hamilton 2009). A Heritage Impact Assessment completed for the subject site in 2008 by Unterman McPhail Associates confirmed that the site retains numerous significant buildings and that any new development should be sympathetic to the site's character, which might include maintenance of mature trees, the curvilinear road system, the open lawns, and the central green. As such, sensitivities associated with the site and in relation to road right-of-way improvements are present along the property's eastern elevation where mature trees and open space are situated.	Designated Under Part IV of the <i>Ontario Heritage Act</i> City of Hamilton Register of Property of Cultural Heritage Value or Interest Hamilton's Heritage Vol. 1, 2, and 3

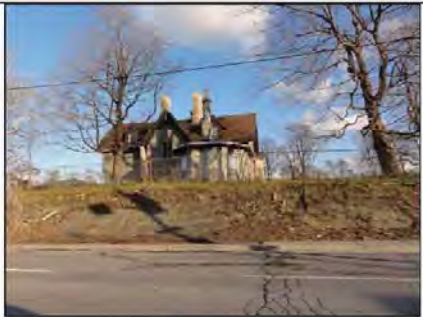
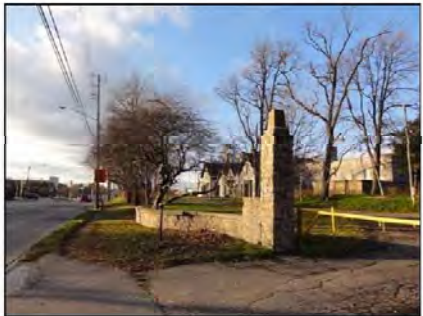
Table 2: Identified Built Heritage Resources (BHR) and Cultural Heritage Landscapes (CHL) Along James Street South, James Mountain Road, West 5 th Street, and Fennel Avenue West					
Identifier	Feature Category and Type	Address	Description/Comment	Recognition and References	Photo
SgB19	CHL Auchmar Estate	88 Fennel Avenue West	The Auchmar Estate is a recognized designed cultural heritage landscape in the City of Hamilton. It sits at the northerly part of the escarpment and once occupied lands extending northerly from Fennel Avenue to the brow of the mountain. A plaque located at the Claremont Drive and Arcade Crescent intersection identifies the 'Claremont Lodge' that was built for the Honourable Isaac Buchanan and notes that the Buchanan Estate located at Fennel Avenue West and West 5 th Street was established in 1855. Buchanan subdivided his lands, explaining the concentration of the Auchmar Estate buildings at Fennel Avenue West and West 5 th Street and the Claremont Lodge located much further north. The Auchmar Estate buildings are concentrated close to the Fennel Avenue West right-of-way and overall, the entire property is an excellent and outstanding example of the Picturesque country estate set within a designed landscape that was popular among the wealthy in the nineteenth century. Features sensitive to road right-of-way improvements include mature tree lines and hedgerows located along the property's western and southern elevations, as well as: stone entrance gates located along Fennel Avenue West; mature trees that line West 5 th Street; and road-side slopes along Fennel Avenue West that have been reinforced with stone materials.	Designated under Part IV of the <i>Ontario Heritage Act</i> Hamilton's Heritage Vol. 1, 2, and 3

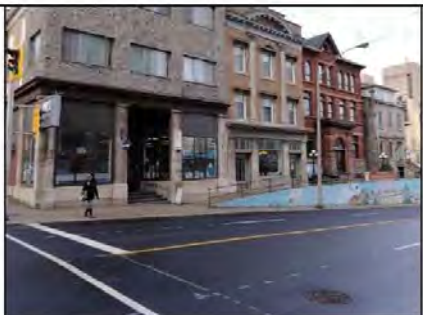
SgB20	BHR Professional Building	126 James Street South	This building was constructed in 1905 to house the Hamilton Conservatory of Music. Its location just south of Hunter Street and prominent position in an elevated portion of the James Street South streetscape, as well as its three-storey massing and brick and stone construction materials make it an important contextual feature within this historic corridor. Architect A. W. Peene designed the subject building as well as the Carnegie Library on Main Street West.	Designated under Part IV of the <i>Ontario Heritage Act</i> Hamilton's Heritage Vol. 1

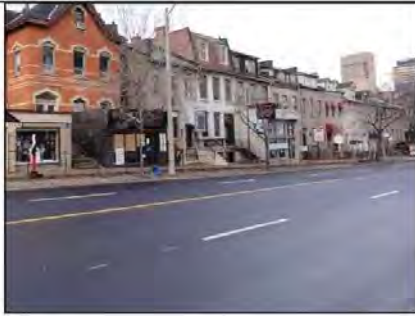
SgB22	BHR Residence	250 James Street South	The subject structure is located at the northwest corner of Herkimer Street and James Street South and is noted as one of the city's finest examples of a Second Empire residence. The subject residence was designed by James Balfour, a local architect who was also responsible for designing the Detroit Art Museum and Hamilton City Hall. In addition to its design significance as an outstanding example of the Second Empire style, the subject residence is contextually important within the James Street South streetscape and is also associated, through long-term occupancy, with two noted Hamiltonians: merchant William J. Maugh, active in the Y.M.C.A., and physician John F. Houston.	Designated under Part IV of the <i>Ontario Heritage Act</i> Hamilton's Heritage Vol. 1

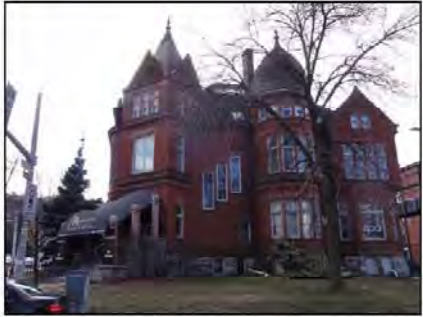
Table 2: Identified Built Heritage Resources (BHR) and Cultural Heritage Landscapes (CHL) Along James Street South, James Mountain Road, West 5 th Street, and Fennel Avenue West					
Identifier	Feature Category and Type	Address	Description/Comment	Recognition and References	Photo
SgB23	BHR Residence	252 James Street South	Located at the southwest corner of Herkimer Street and James Street South, the subject residence was built in 1891 for business magnate Tunis B. Griffith who managed the Hamilton Street Railway. It is valued as a superb example of the Richardsonian Romanesque style that was popular in the late nineteenth century as a bold representation of Victorian architecture. The property is also associated with prominent businessmen who contributed to nineteenth-century urban development in the city. Owners of the home have included: Sir John S. Hendrie, businessman and politician and former Lieutenant Governor of Ontario; and his son, Major William Ian S. Hendrie, a military officer and president of the Hamilton Bridge Works Company. The subject residence also contributes to the visual and historical character of the James Street South streetscape.	Designated under Part IV of the <i>Ontario Heritage Act</i> Hamilton's Heritage Vol. 1

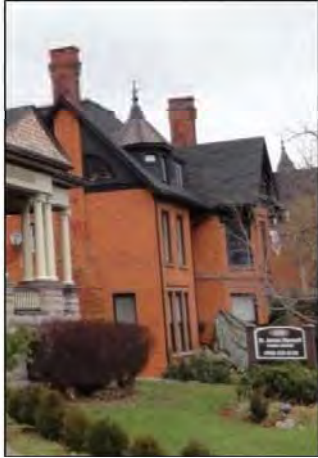
SgB24	BHR Residence	262 James Street South	This structure is located between Herkimer Street and Markland Street. Built between 1892 and 1893, this residence is valued as a very good example of the Queen Anne architectural style. It is associated with Henry P. Coburn, president and manager of one of the city's important nineteenth-century industries, and who commissioned construction of the residence. It is also valued as a contributory element of the James Street South streetscape.	Designated under Part IV of the <i>Ontario Heritage Act</i> Hamilton's Heritage Vol. 1

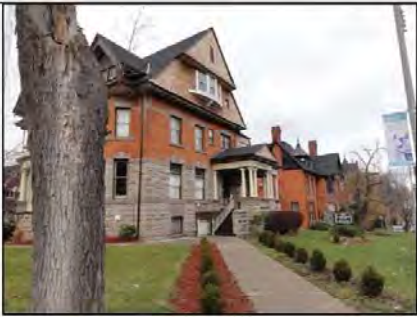
SgB26	CHL Residences	209-211 James Street South	These three houses are characteristic of the nineteenth-century streetscape of James Street South. Constructed 1888-89, they were the part of a trend of speculative building in Hamilton at the end of the nineteenth century. Owned by Andrew Rutherford a businessman, these three residences were built by James Philips. The red-brick structure feature high-style Gothic Revival architecture with steeply pitched roofs a narrow footprint. Many early/original elements including decorative bargeboard and exterior fire breaks/walls remain in place. Operating as commercial business there has been some alteration—particularly the two southernmost structures. —however, most of the character of the two designated structures (209 and 211) have been retained	Designated under Part IV of the <i>Ontario Heritage Act</i> Hamilton's Heritage Vol. 1

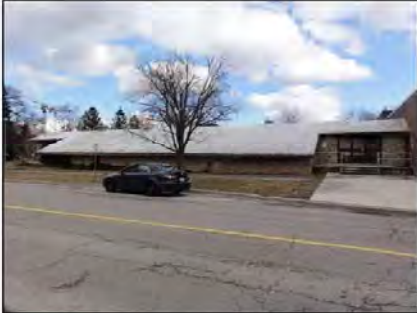
SgB27	BHR Storage	135 Fennell Ave	'Known as 'The Cellar' this stone structure was originally constructed c. 1891 and was likely part of the Andrews farm complex that was part of the Hamilton Asylum for the Insane (later Hamilton Psychiatric Hospital). This stone structure is presently operating as a student centre and pub. Part of the farm complex, this structure is now just one of two remaining farm buildings on the property.	Designated under Part IV of the <i>Ontario Heritage Act</i> Hamilton's Heritage Vol. 1

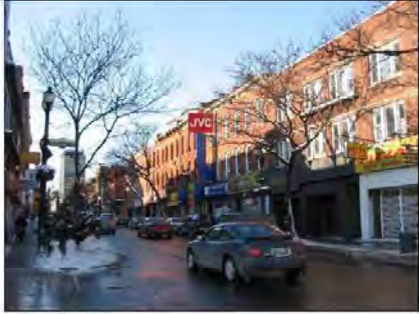
SgC2	BHR Commercial Building	35-41 King Street East	The Right House is situated at the southwest corner of Hughson Street North and King Street East across from the Gore Park. It was constructed between 1890 and 1893 by Hamilton merchant Thomas C. Watkins. The building's significance is tied to its architectural value as an excellent example of 'modern' late-nineteenth-century commercial architecture emphasizing running arcades, columns and stone arches. It is historically associated with and illustrative of commercial development patterns in the downtown core as this building functioned as one of the first examples of large-scale retail space in the downtown. Finally, its location at this intersection and particularly across from the Gore Park is notable. Its design and scale contributes to the visual experience of the streetscape and is sympathetic to pedestrian uses and circulation routes along the King Street corridor and through the Gore Park.	Designated under the Part IV of the <i>Ontario Heritage Act</i> . Hamilton's Heritage Vol. 1

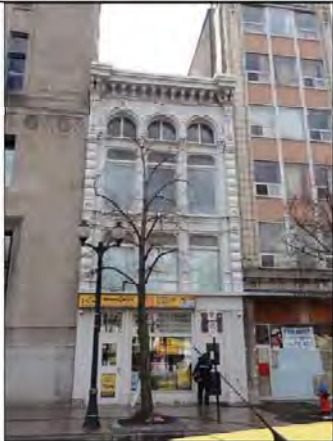
SgC4	BHR Commercial Building	66 King Street East	This building, known as Victoria Hall, was designed by Williams Stewart and built between 1887 and 1888 for local barrister, Alexander Bruce. It was originally known as Victoria Hall and is notable in the downtown as the only building dating to the 1880s to feature an applied metal façade; its design value is also linked with its High Victorian features such as ornate stone carving and for its metal front which mimic carved stone. It is historically associated with late-nineteenth-century commercial development within the original commercial centre of Hamilton. It contributes to and maintains the visual and physical experience of one's the city's most important commercial streetscapes.	National Historic Site of Canada Designated under the Part IV of the <i>Ontario Heritage Act</i> . Hamilton's Heritage Vol. 1

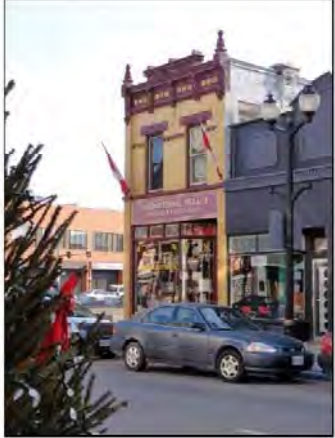
SgC6	BHR Commercial Building	320 King Street East	The subject structure likely dates to the late nineteenth century as commercial building stock developed along either side of King Street through the downtown core. It is characterized by brick construction materials, decorative dentil bands between the upper storey windows and an ornate frieze adorning the flat roofline. This property is associated with late-nineteenth-century commercial development in the downtown core and likely dates to the 1870 to 1900 period. It is illustrated on 1911 mapping and is identified as the Smart Tea Company. This structure contributes to and maintains the visual and physical character of the King Street streetscape between James Street and Wellington Street.	Designated under Part IV of the <i>Ontario Heritage Act</i> . Hamilton's Heritage Vol. 1

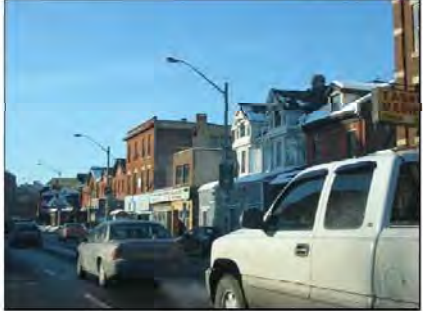
SgC9	BHR Semi-Detached Residence	12-14 Wellington Street South	This two-and-a-half storey semi-detached residence is clad in red brick and sits on stone foundations. It features matching frontispieces on its eastern elevation which are defined by arched window openings and gable dormers with scalloped shingles. The structure is a remnant of late-nineteenth-century residential development on the east side of the downtown core, now situated between a Tim Hortons and parking lot.	Identified during field review

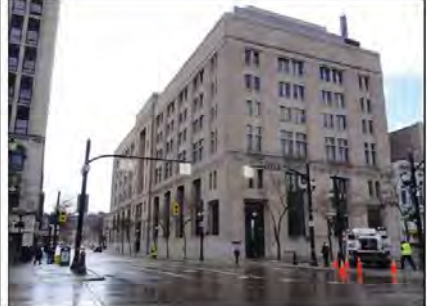
SgC13	BHR Public Institution	10 John Street	<p>The John Sopinka Courthouse, located at the corner of King and John Streets. Built as the Dominion Public Building it served as a post office and housed several other Federal departments including customs and excise building; health, immigration. This building was typical of a number of public buildings constructed in the 1920s and 1930s and was part of a Depression-era work project. Constructed by the local firm of Hutton and Souter this structure is considered to have the finest interior of any of the other Federal block buildings of the era. With its front façade on John Street and full occupying the west end of the block between King Street and Main Street, the Court House occupies a prominent position on the downtown streetscapes. The building now operates as the John Sopinka Federal Courthouse.</p>	<p>Designated under the Part IV of the <i>Ontario Heritage Act</i>.</p> <p>Hamilton's Heritage Vol. 1</p>

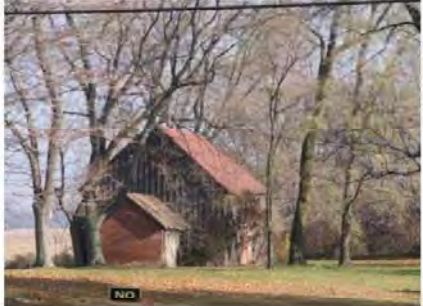
SgD8	BHR Barn	2543 Upper James Street	This small barn and brick extension no doubt represents the remains of a farm complex. A small silo is located to the rear and the south of the barn. The barn features a gable roof clad with metal roofing materials and has a large opening on the south elevation. The small brick extension also features a gable roof—clad in asphalt shingles—also has an opening to the south. The structure is located near a line of mature deciduous trees that appear to demarcate the line between farm yard and field. A small wood lot appears to be located behind the barn.	Hamilton's Heritage Vol. 2 Identified during field review

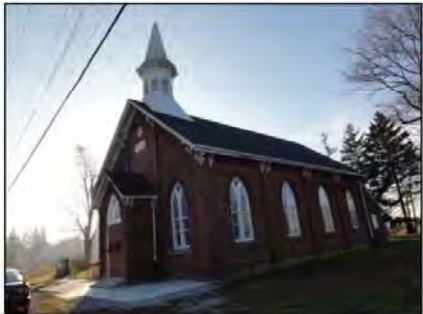
Identifier	Feature Category and Type	Address	Description/Comment	Recognition and References	Photo
SgD9	BHR Church	3076 Homestead Drive	Now known as Mount Hope United Church, this was previously known as Mount Hope Methodist Episcopal Church. Built in 1876 by local builders, the 'Places of Worship' inventory notes that the bricks were made in the builders' yards at the southeast corner of Upper James and Twenty Road. This church has a twentieth-century hall attached to it but the property consists only of church buildings; there is no associated cemetery.	Hamilton's Heritage Vol. 7A

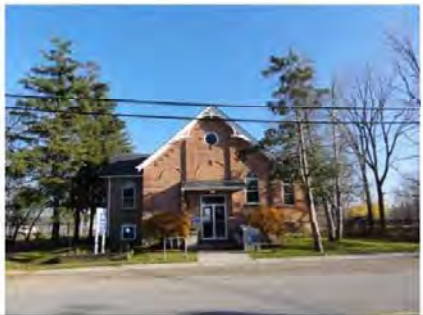
SgD10	BHR Institutional	3027 Homestead Drive	A cornerstone dates this two storey structure to 1904. Currently it serves as the Mount Hope branch of the Hamilton Public Library. Originally this structure was built as the Glanford Community (Township) Hall and served as the township centre for Glanford Township (established 1849) until the 1970s. This dark buff coloured building features a gable roof and two projecting side bays. The front elevation features decorative brick pillars and arches across the front and around the windows and doors. A small round window sits underneath the eaves. There is decorative vergeboard on the ends of the projecting eaves on the front elevation.	City of Hamilton Register of Property of Cultural Heritage Value and/or Interest Hamilton's Heritage Vol. 2 and 3

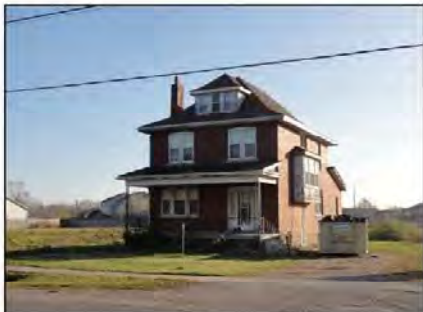
SgD11	BHR Residence	9075 (also 9089) Airport Rd West	This large-scale, two-and-a-half storey red brick house is located on a corner lot. At the time of the field review, the house was isolated and appears to have been a remnant of an older streetscape of early-twentieth-century residences. Featuring a roof with a dormer on the north (front) elevation, this house presents with a single external brick chimney on the east elevation. Window openings appear to be largely contemporary with the house construction. This house is slightly earlier than the frame bungalows located on the north side of the street. It likely dates to the inter-war period. This large-scale, single family residence may be typical of a more affluent neighbourhood than that represented by the bungalows within SgD34.	Identified during field review

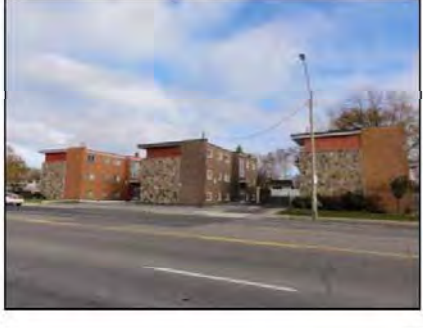
SgD 13	CHL Streetscape	721-725 Upper James Street	These three low-rise, mid-twentieth century are distinguished by higher density property use (than those properties in SgD12) and by design elements that were particular to the mid-twentieth century. These resources are located between the postwar bungalows to the north and a similar but distinct set of three low-rise apartments to the south.	Identified during field review

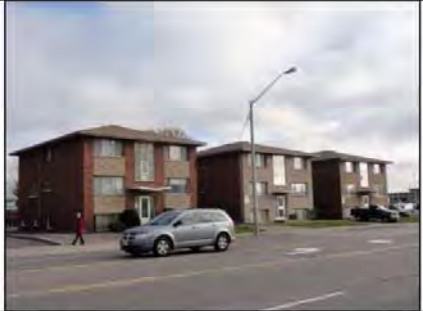
Identifier	Feature Category and Type	Address	Description/Comment	Recognition and References	Photo
SgD 14	CHL Streetscape	727-731 Upper James Street	This streetscape is defined by low-rise apartment buildings. Like their counterparts to the north, these three low-rise apartment buildings are typical of a mid-twentieth-century building style. These structures are distinct from the more common small postwar family homes which line much of this section of Upper James Street. The style of these apartments suggests that they were constructed after those which make up SgD13.	Identified during field review

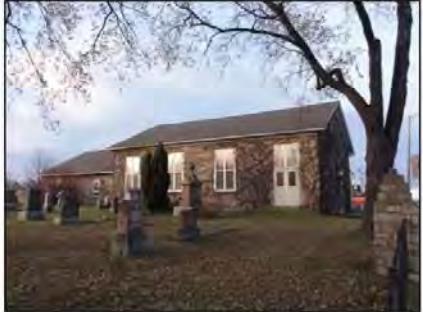
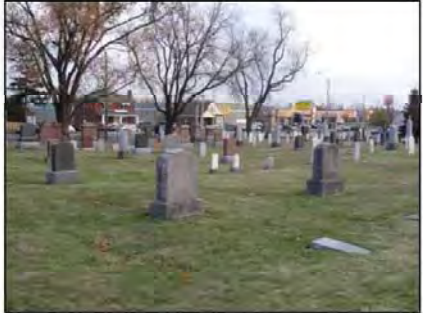
Identifier	Feature Category and Type	Address	Description/Comment	Recognition and References	Photo
SgD17	CHL Church and Cemetery	21 Stone Church Road	Barton Stone United Church is located at the corner of Upper James Street and Stone Church Road. This landscape takes up the entire corner and extends some distance down both its frontages. This early Gothic Revival church features a gable roof and four sets of double gothic arched windows on each side. The lower half of one set of windows on the south elevation has been adapted as a modern entrance. Those on the north elevation are unchanged, although all feature modern storms. The windows feature decorative wooden 'frames'. The stone extension on the east elevation was added in the 1970s. The cemetery is of considerable local importance as a number of early settlers and prominent landowners including Ira Rymal, Jacob Hess and Jacob Terryberry publican of a large inn are buried here. The cemetery is fronted (on Upper James Street) by a stone and wrought iron fence. The date of this fence is unknown; however, it may postdate the construction of the church.	Hamilton's Heritage Vol. 2 and 5 Intent to designate under the <i>Ontario Heritage Act</i>

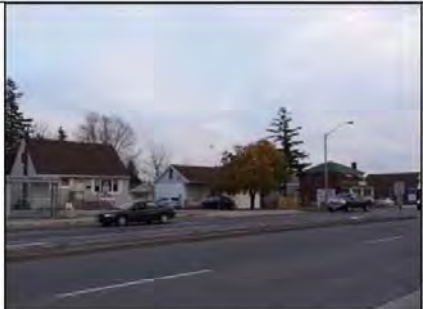
SgD 18	CHL Streetscape	North of 1367 Upper James	This streetscape is comprised of small-scale, postwar bungalows intermixed with larger storey brick houses. These properties are set back from the road but differ from the properties in SgD12 with larger back yards and somewhat small areas in the front. All of these properties contain mature plantings and a woodlot at the rear. The ground level shows variation suggesting that rather than flat urban lots, these parcels retain elements of their earlier topography.	Identified during field review

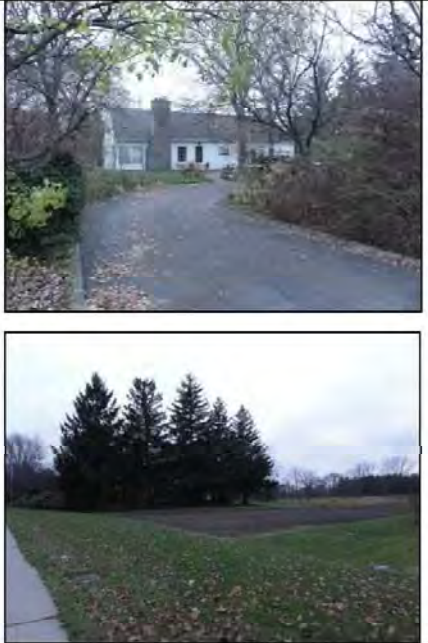
Identifier	Feature Category and Type	Address	Description/Comment	Recognition and References	Photo
SgD 19	CHL Farm Complex	1452 Upper James Street	<p>The property at 1452 Upper James sits on a large tract of land that includes fields and pastures to the west and a field which has been under recent cultivation to the south. An orchard borders the southern edge of this field and a small watercourse lies to the north. The field and orchard sit below the grade of the road right-of-way and extend east to a line of trees. Another, smaller line of mature ornamental conifers sits on the high ground to the south of the field and acts as a visual block and/or wind break for a small house. This house, a small bungalow with external chimney stack appears to date to the mid-twentieth century. A few small outbuildings are located to the rear of the residence. The southern property line is marked by a fence line and trees which block the view to the late-twentieth-century mall which has been built adjacent to the property. It appears that a new(er) twentieth-century residence has been built on a much older lot, no doubt part of a farm complex which may date as far back as the nineteenth century.</p>	Identified during field review

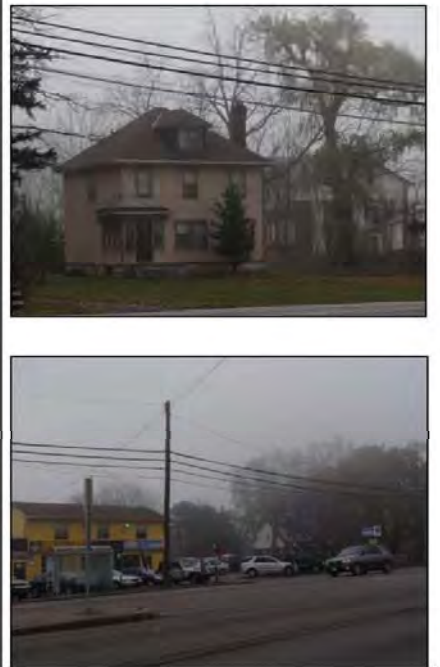
Identifier	Feature Category and Type	Address	Description/Comment	Recognition and References	Photo
SgD20	CHL Streetscape	1699-1719 & 1694 Upper James Street	<p>This streetscape exists on both the east and west sides of Upper James Street with the bulk of it located on the east side. This streetscape is characterised by late-nineteenth and early-twentieth-century structures. Structures of both dates are intermixed with a late-nineteenth/early-twentieth-century farmhouse (see 1719 Upper James Street) sitting adjacent to postwar bungalows. The smaller residences are set back from the road and the properties contain very large, mature deciduous trees along the lot lines and in the rear of the property. A large brick farm house, currently used as part of Corpus Christi Church (SgD6), and the corner lot upon which it and a school sits are also typical of this evolved nineteenth and twentieth century-streetscape.</p>	Identified during field review.

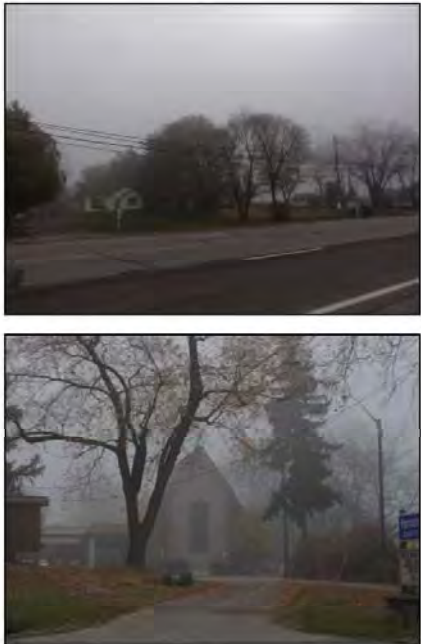
Identifier	Feature Category and Type	Address	Description/Comment	Recognition and References	Photo
SgD21	CHL Streetscape	1749-1755 Upper James Street	This streetscape is situated between SgD20 with its late-nineteenth to early-twentieth-century structures to the north and a large field and Alderlea Avenue to the south. The structures making up this streetscape more likely date to the 1950s and 1960s. The properties all possess large, mature deciduous trees in many of the front yards and along the property lines. This streetscape includes Harmony Baptist Church which was built on its current site in the 1960s and a small vernacular structure located to the north of the driveway. This small structure appears to be made in part from log or log siding and appears to sit on high cinderblock foundations. Harmony Baptist Church is noted in Hamilton's Heritage Vol. 2	Hamilton's Heritage Vol. 2 and 7A Identified during field review.

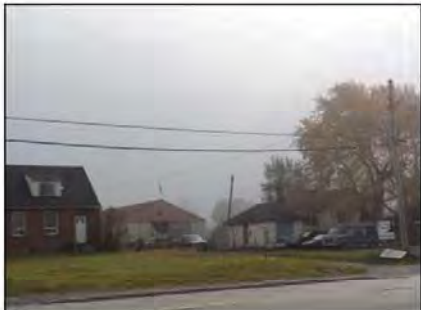
SgD22	CHL Streetscape	1899 & 1915 Upper James Street	This small cluster of houses is located to the south of SgD21 and is also part of postwar settlement and occupation of Upper James Street. The properties are large—some containing sizable outbuildings—and many possess large, mature deciduous plantings. Both these houses are accessed via paved driveways. Principal buildings include garages and large metal clad storage buildings.	Identified during field review

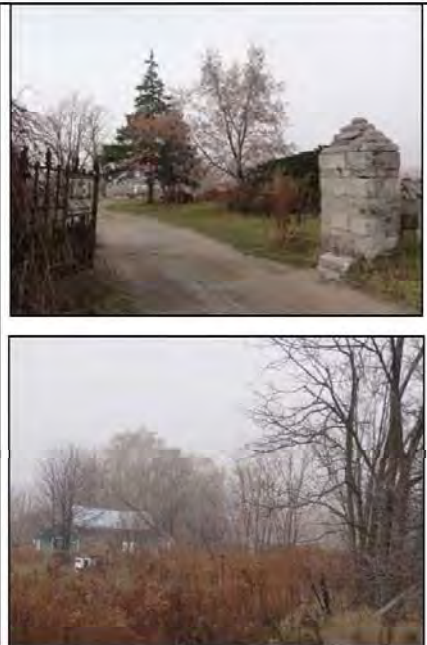
Identifier	Feature Category and Type	Address	Description/Comment	Recognition and References	Photo
SgD23	CHL Farm Complex	1980 Upper James Street	<p>This is a large property which consists of a number of barns and large outbuildings. No house was visible at the time of the visit. The property is bounded along the road by a post and wire fence. Two substantial stone gate posts sit at either side of the driveway which retains half of a large wrought iron gate in place. A length of stone fencing runs southward where it is picked up by a post and wire fence; the point of transition between the two fences roughly marks the transition from front yard or workspace to the fields to the south. The ground dips slightly to the south towards a small watercourse that runs behind the property and curves somewhat to an east-west orientation and runs under Twenty Road. There are mature plantings near the drive and around the house and the field areas are divided up by a series of internal fences</p>	Identified during field review

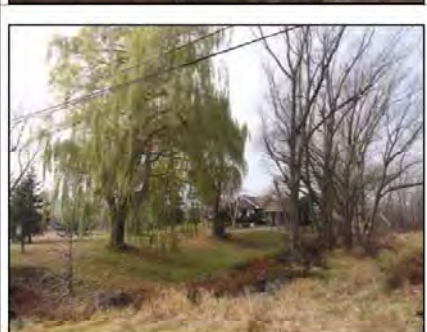
SgD24	CHL 13 Farm Complex	2028 Upper James Street	<p>This one-storey twentieth-century frame house sits on a small rise of land south of a small stream which runs roughly east-west. Mature plantings border the stream with very large willows located on the south side. This section of the property—and the area comprising the front yard—retains much of its natural topography and early character. The fields to the south retain some of their early character; however, this land has been notably altered by the placement of hydro pylons.</p>	Identified during field review

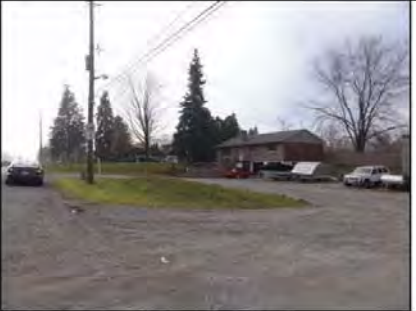
Identifier	Feature Category and Type	Address	Description/Comment	Recognition and References	Photo
SgD25	CHL 14 Streetscape	2072-2084 Upper James Street	A small cluster of post-war residences this section is typical of the land use which occurred during and after the initial post war construction. These houses are likely remnants of the development of this area as it transitioned from rural properties and farm complexes to a peri-urban landscape with commercial enterprises. These residences would have been typical of this area before that transition.	Identified during field review

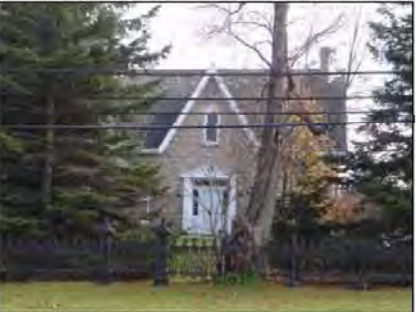
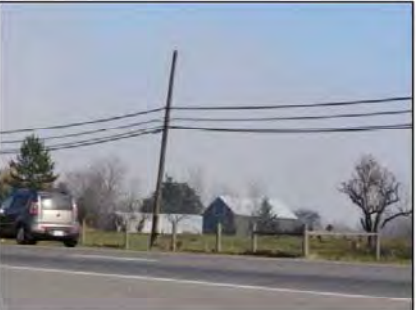
SgD26	CHL Residence	2081 Upper James Street	This property is known as Stoneholm Farm. This farm complex consists of at least two large barns with gable roofs and a smaller barn or drive shed. The frontage is planted with large conifers and some mature deciduous trees which partially block the view from the street to the house. The property is fronted with a highly decorative wrought iron fence and gate. The house itself is a one-and-a-half storey stone block Ontario Gothic cottage with a centrally placed window in the dormer located above the main door. The dormer window is bordered with a six-over-six sash window with a small wood vent making up the point of the gothic arched window. A small amount of gingerbread trim remains on the dormer. The door, sidelights and transom all appear to be original as does the pediment above; however, marks on the stone wall suggests that there was a larger porch located on this elevation. There are two internal chimneys located at either gable end, both are located on the front roof, slightly below the ridge. The landscape of this farm complex appears to have retained many of its original/ early features and topography.	Hamilton's Heritage Vol. 2 and 3

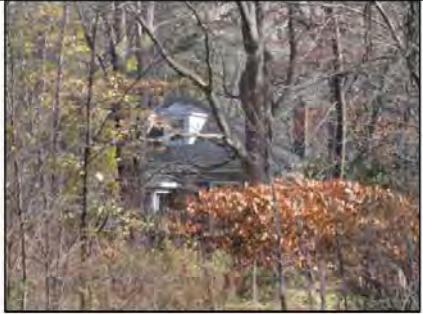
Identifier	Feature Category and Type	Address	Description/Comment	Recognition and References	Photo
SgD27	CHL Residence	2173 Upper James Street	This small stone house sits in a low spot on a heavily wooded property and is, therefore, almost completely obscured from view from the street. The property is accessed via a long dirt driveway and is separated from the street by a set of decorative iron gates with a sign which reads, in part, 'Insane Asylum'; these gates may have been removed from another location. It appears that there is at least one other structure on this property. The property is heavily wooded with deciduous trees and has a small watercourse near the northwest corner of the property.	Hamilton's Heritage Vol. 2 and 3

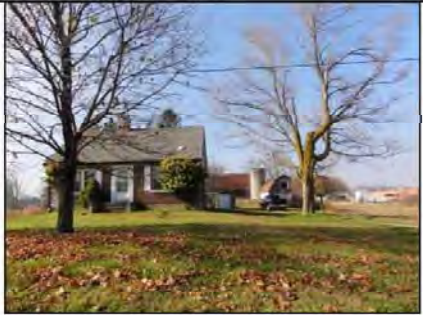
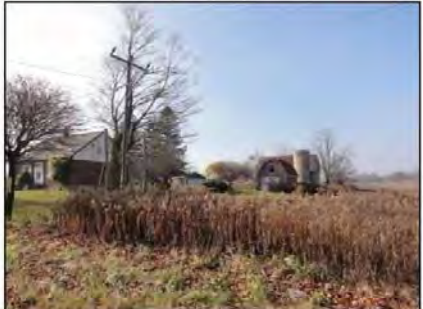
SgD28	CHL Farm Complex	2240 Upper James Street	This property consists of a small one storey house, a modern frame garage, a larger shed with double doors and gambrel roof and a large gambrel roofed barn and silo to the rear. The property is bounded by fields on the north and the east sides. The residence is a small one storey brick house with gable roof and synthetic siding on the upper portion of the gable ends. This property is listed on the City of Hamilton Heritage Inventory as containing a 1820s residence. Although this structure is not immediately apparent, the scale, the location and nature of a brick central chimney on the extant house and the relationship with the barn all suggest that the early structure may have been heavily altered. Slight indicators in the brick work of window alterations and a parged foundation lend further evidence to this idea. Large fields under cultivation are located to the north.	Hamilton's Heritage Vol. 3

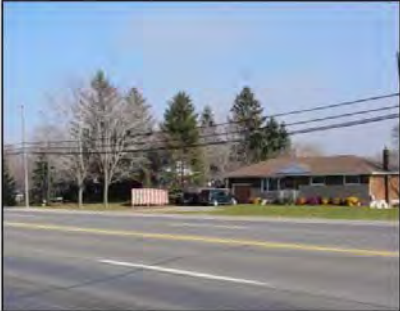
Identifier	Feature Category and Type	Address	Description/Comment	Recognition and References	Photo
SgD29	CHL 18 Streetscape	2285 Upper James Street	This streetscape is made up of small to medium scale residences which date to the mid-to-late twentieth century. These are located on both the east and west sides of the road. Most sit in middle proximity to the road and many possess large front yards. In general, these houses sit at grade with Upper James Street. Many of these properties contain mature plantings near the house and along the frontage.	Identified during field review

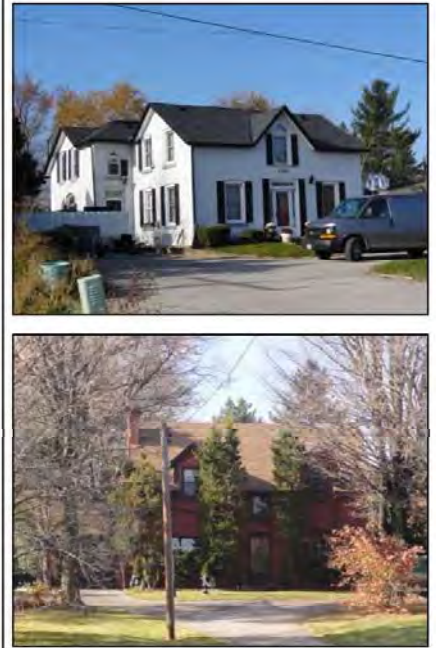
Identifier	Feature Category and Type	Address	Description/Comment	Recognition and References	Photo
SgD30	CHL Cluster	2332 & 2340 Upper James Street	<p>These two 1860s houses are listed on the City of Hamilton's Heritage Inventory Vol. 2 and, together with four frame structures, once formed a streetscape between Talbot Lane and Dickenson Road. Both these properties and the two to the north are made up of long, narrow parcels of land which are typical of the original eighteenth or nineteenth-century lots. The residence at 2332 Upper James is located in close proximity to the road, at the head of a small semi-circular drive. This one-and-a-half storey brick structure sits on what appears to be stone foundations. Its counterpart at 2340 Upper James is also a brick structure with projecting bay and gable. These two houses are typical of a mid-nineteenth-century rural/village streetscape</p>	Hamilton's Heritage Vol. 2

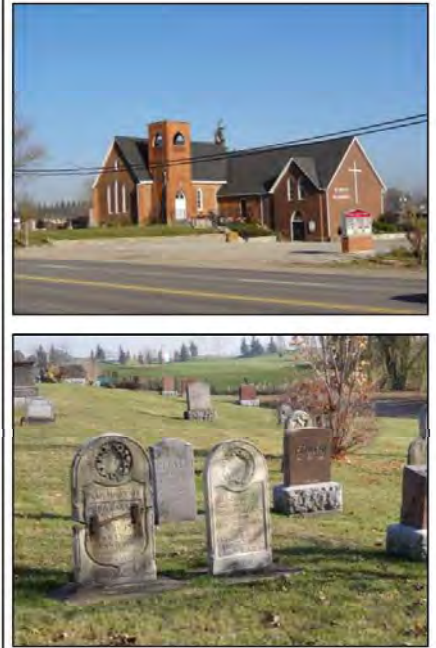
Identifier	Feature Category and Type	Address	Description/Comment	Recognition and References	Photo
SgD31	CHL Church and Cemetery	2869 Upper James Street	<p>St Paul's Glanford Anglican Church was constructed circa 1851 as a small brick church in the Early Gothic style. The property consists of the church and cemetery sitting on 1¼ acre of land. Later additions to the nineteenth-century structure include a tower (1926) and a parish hall added in the 1950s. The original church building sits on fieldstone foundations. The original acre of land was added to in 1943 when the church purchased additional land to bury RAF servicemen who had died in training exercises. This property sits on a rise of land above a water course to the north and is accessed via a gravel drive and parking lot. The church yard at the front contains a small number of stones and sits above the roadway and the parking lot. The church itself is accessed via a flight of modern concrete steps. At the rear, the land slopes to the south giving the property a slightly rolling appearance.</p>	Hamilton's Heritage Vol. 3 and 7A

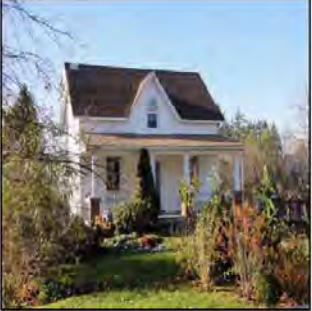
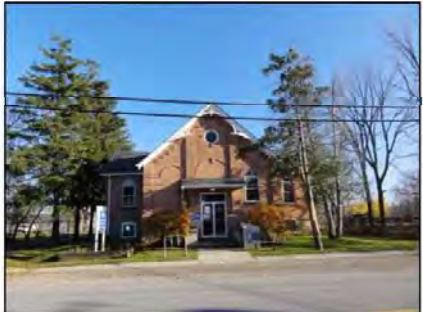
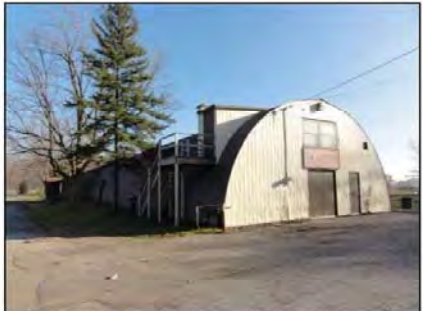
Identifier	Feature Category and Type	Address	Description/Comment	Recognition and References	Photo
SgD32	CHL Settlement	Homestead Drive	<p>This feature is known as the settlement of Mount Hope. This landscape derives its character from three main periods: (1) an intact rural nineteenth-century landscape containing farmhouses and extant fields as well as village settlement along both sides of Homestead Drive; (2) strong evidence of structures and landscapes related to the RAF and RCAF navigation school and associated activities and ancillary structures which led to the development of the John C. Munro International Airport; and (3) an evolved early to mid-twentieth-century landscape of a small village. This landscape retains notable features associated with each of these periods and, together, represents an unique evolved landscape. Although there are individually significant structures which have been previously identified in Hamilton's Heritage volumes—among them SgD9 and SgD10—others, including the Quonset huts and a number of farmhouses also contribute to the significance of this landscape as a whole. Many of the properties on the west side retain their original house/field alignments. In some cases historic barns are extant. Many of these fields which sit at the end of the runway are under active cultivation. The properties on the east side of the street back onto Upper James Street and most of these do not have fields but do sit on sizable lots. Mature plantings are found on both sides of the street.</p>	<p>Identified during field review Hamilton's Heritage Vol. 7A, 2 and 3.</p>

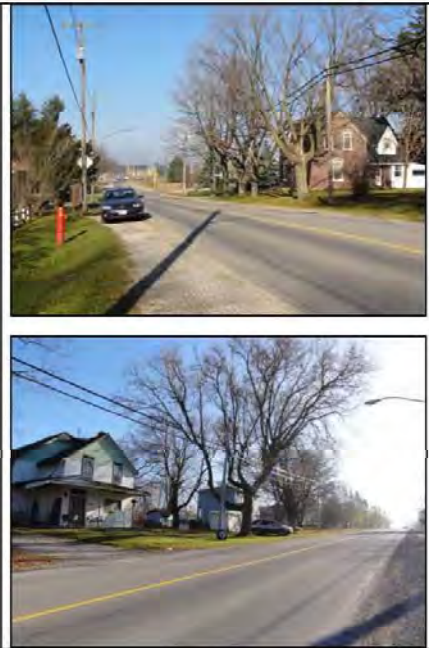
Identifier	Feature Category and Type	Address	Description/Comment	Recognition and References	Photo
SgD33	CHL Roadscape	Homestead Drive	<p>This historic roadscape spans the curve of Upper James Street, creating a crescent-shaped property to the east. Homestead Drive consists of a two lane paved road with gravel and dirt shoulders. Large, mature deciduous trees line both sides of the road. The road is at grade with the surrounding landscapes and follows the natural topography. This road is a narrow thoroughfare with little room for widening. The viewshed to the north focuses upon St Paul's Glanford. The south portion which has evolved into a mid-twentieth-century roadscape likewise maintains its character. A large nineteenth century inn known as Homestead house sits at the southeast corner of the intersection between Airport Road and Homestead Drive. This cultural heritage landscape includes a number of structures noted in Hamilton's Heritage Vol. 2</p>	<p>Identified during field review Hamilton's Heritage Vol. 2</p>

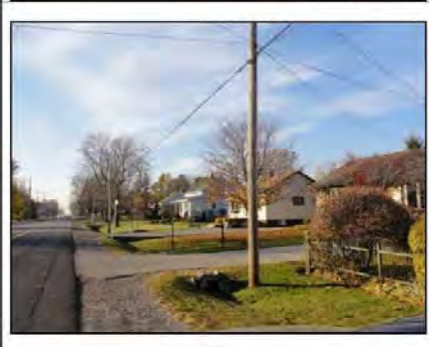
SgD34	CHL Streetscape	Airport Road	<p>This streetscape of small bungalows dating to the post-war period is representative of a mid-twentieth-century neighbourhood. This streetscape is typical of a neighbourhood of workers houses and may be associated with the John C. Munro International Airport. These houses all sit on large lots and are set back from the road right-of-way suggesting that the extant structures may have been constructed on earlier lots and evidences an early-twentieth-century land use. Together with this stretch of Airport Road, this streetscape retains much of its original character.</p>	<p>Identified during field review</p>

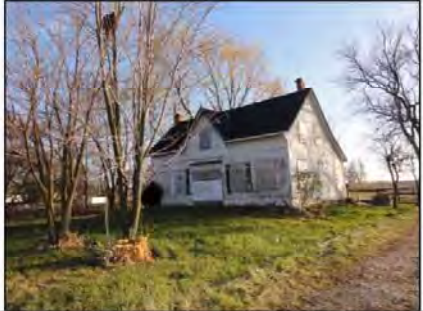
Identifier	Feature Category and Type	Address	Description/Comment	Recognition and References	Photo
SgD35	CHL 24 Farm Complex	9255 Airport Road West	<p>This small nineteenth-century frame house is in the Ontario Gothic cottage style. Currently abandoned, this property is accessed from Airport Road via a gravel driveway. The subject property is comprised of agricultural fields, the residence and possibly a pond to the rear. The front of the property contains plantings in the front yard and towards the east side of the house. The house is boarded up and is in poor shape; however, it retains a number of original features including remnants of decorative gingerbread trim and a finial about the dormer. Portions of shutters remain and may be original to the house. There are two internal chimneys each located at the gable ends. It appears that this structure sits on fieldstone foundations.</p>	Hamilton's Heritage Vol. 3

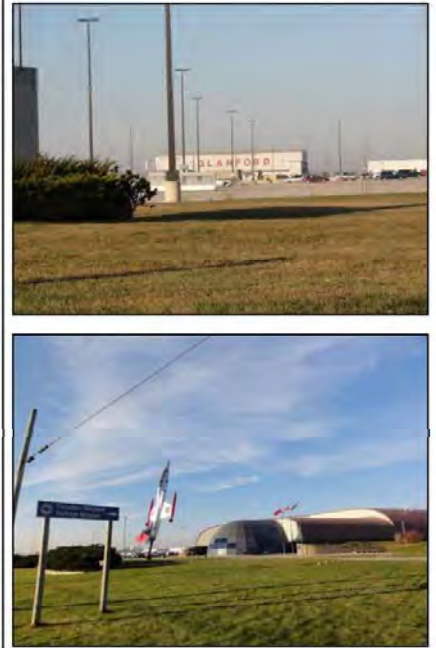
Identifier	Feature Category and Type	Address	Description/Comment	Recognition and References	Photo
SgD36	CHL Commercial and Public	Airport Road West	<p>John C. Munro International Airport. This landscape includes all airport-related lands and structures apart from 9500 Airport Road. It includes the War Plane Heritage Museum at 9280 Airport Road. An airport was first built on this site in 1940 to meet military needs during the war, only becoming a civilian airport after 1963. Much of the landscape has since been altered but the subject property does retain a number of older hanger buildings. The War Plane Heritage Museum was originally housed in one of these older structures. The Airport Road property may also include a property listed in the Hamilton's Heritage Vol. 3 at 9500 Airport Road West. At the time of the field review, the property was occupied by an hanger/ factory.</p>	Hamilton's Heritage Vol. 3

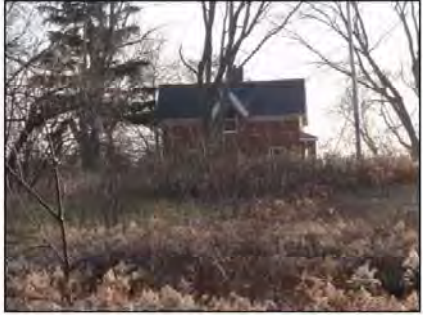
Identifier	Feature Category and Type	Address	Description/Comment	Recognition and References	Photo
SgD37	CHL Farm Complex	9705 Airport Road West	This farm complex consists of a house sited well back from the road on a rise of land. The main structure is a one-and-a-half storey brick Ontario Gothic style farmhouse dating to the late nineteenth century. The property has been abandoned. The structure features a brick central chimney and gable roof with projecting eaves. A small bay has been added to the west elevation. A decorative soffit runs beneath the eaves. The window openings all appear to be original with intact brick arches. The nature of the foundations is unknown. The house sits amid large fields and the property contains some large, mature plantings near the house.	Hamilton's Heritage Vol. 2
