Final Preliminary Hydrogeological Investigation

Upper West Side Draft Plan of Industrial Sub-
Division
Twenty Road West,
Hamilton, Ontario

Client:
Corbett Land Strategies Inc.

Project Number:
BRM-00801363—B0

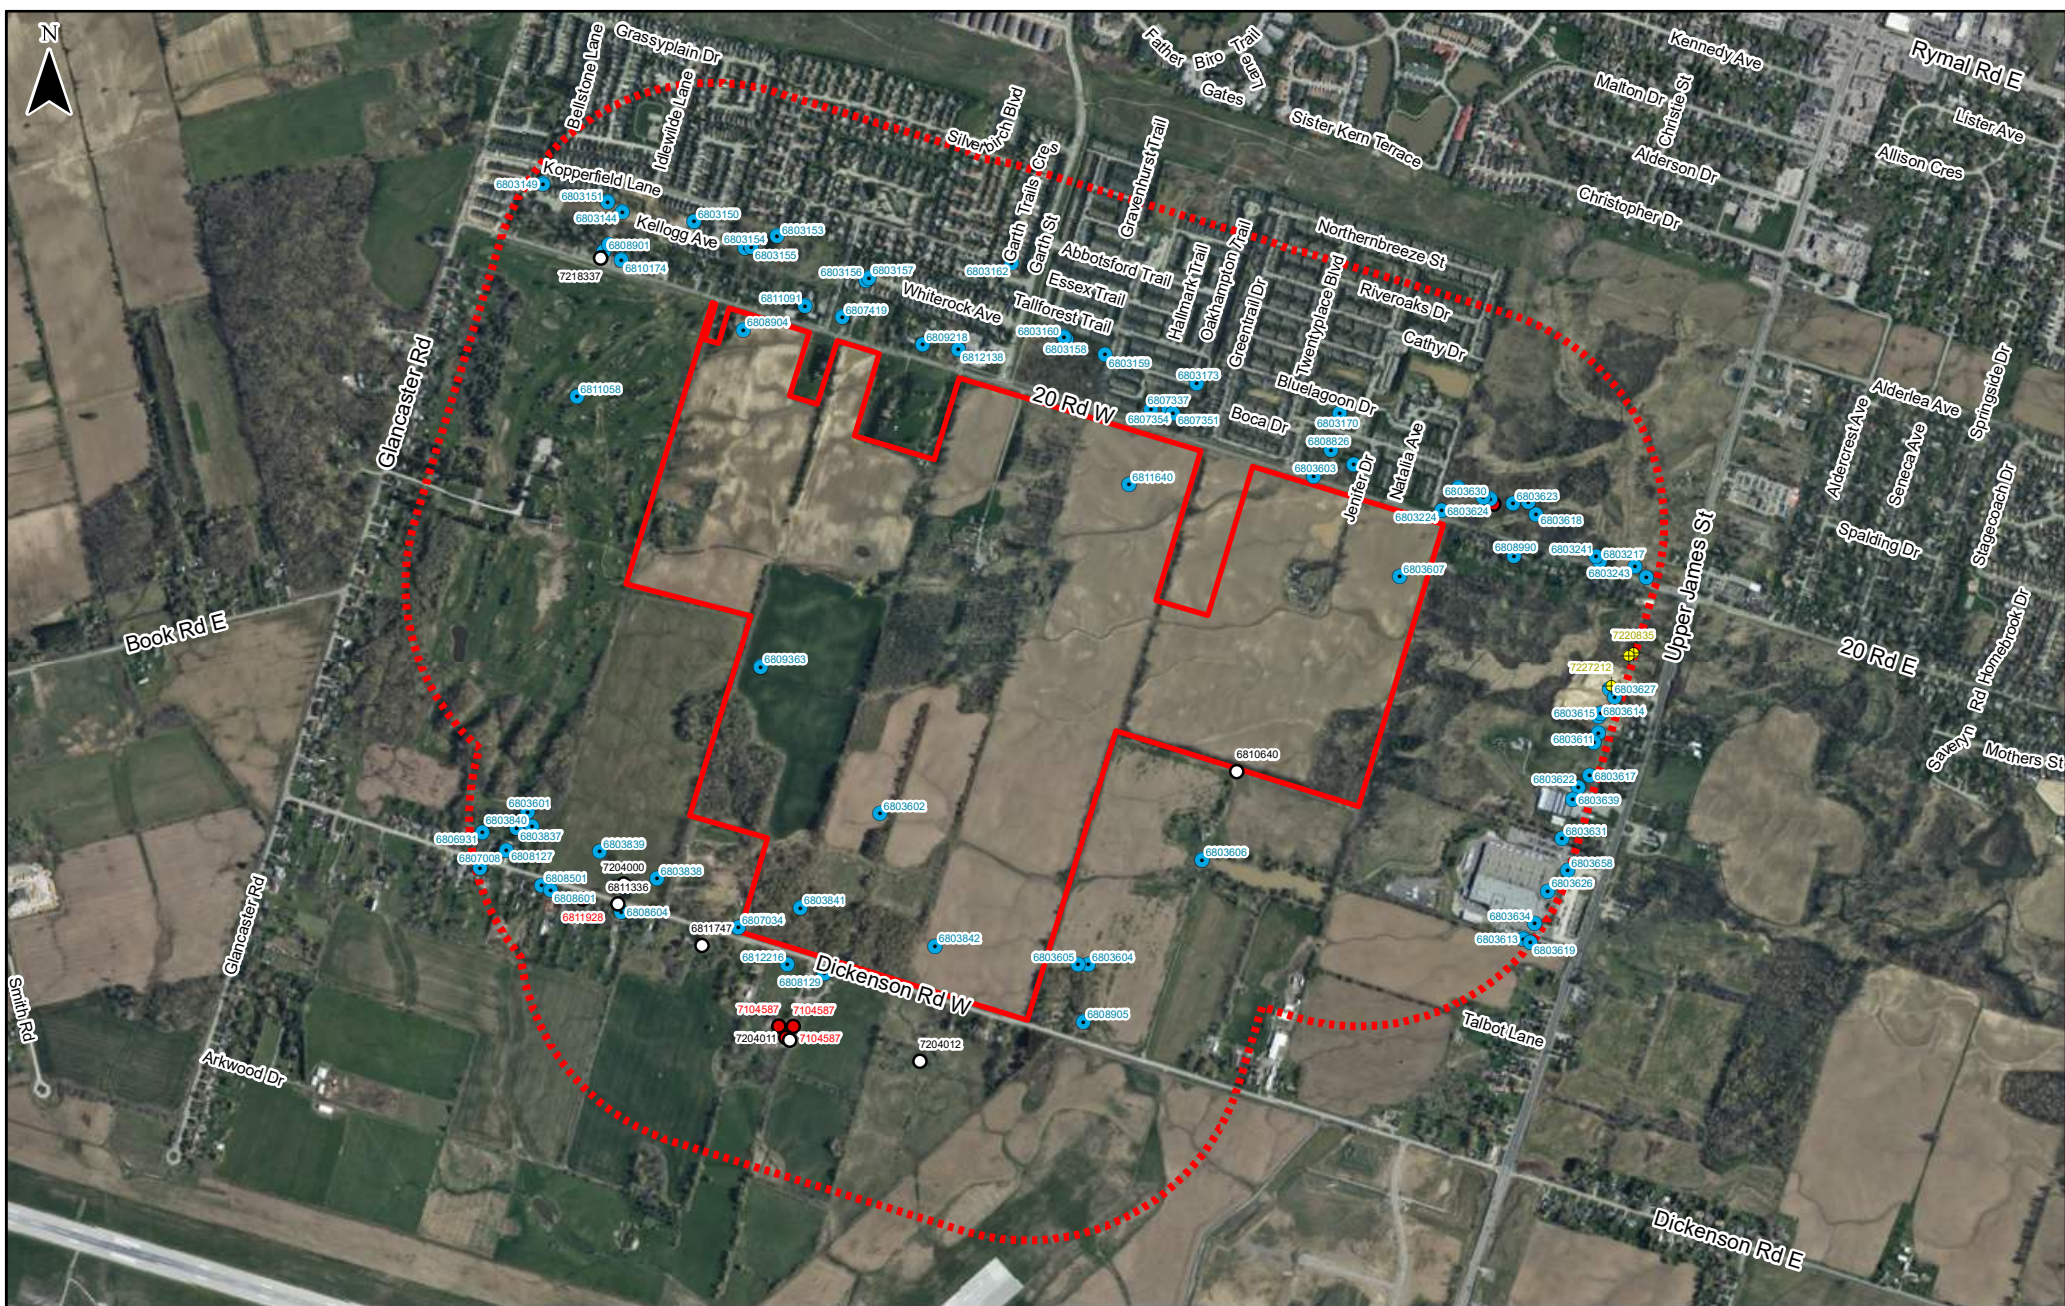
PROJECT No.:	BRM-00801363-B0	DWN:	AC
SCALE:	AS NOTED	CHKD:	RS
DATE:	FEBRUARY 2018	DWG. No.:	4

- Legend**
- Approximate Site Boundary
 - Water Supply Well
 - Abandoned Well
 - 500 m Zone
 - ⊕ Monitoring Well / Test Hole
 - Unclassified / Unfinished Well

DRAWING TITLE:
 MOECC WATER WELL
 RECORDS MAP

The MOECC WWR database indicated total of ninety-seven (97) WWRs in the 500 m zone. These included seven (7) records of wells reportedly located on-site and ninety (90) off-site well records. All the on-site well records are reported as domestic water supply wells, observation/monitoring wells, and abandoned or not used. The domestic wells were reportedly installed from 1949 to 1989, with water found at depths of between 5.1 and 29.4 m.
