CITY OF HAMILTON

# Mountain Brow Vista Study & Management Plan

FINAL REPORT

SEPTEMBER 2016

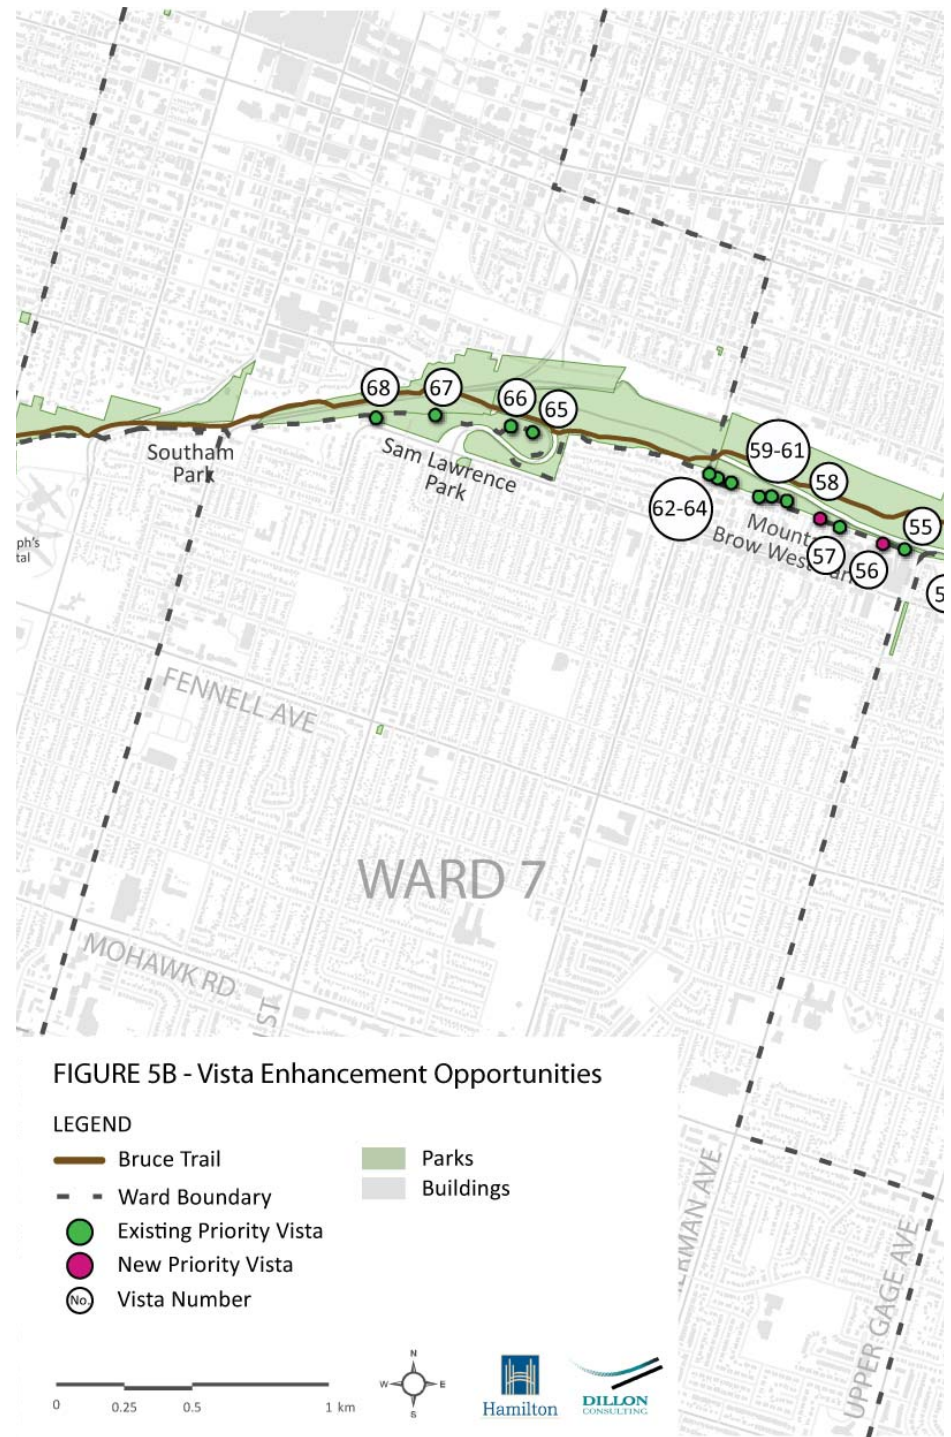
FIGURE 5B - Vista Enhancement Opportunities

Existing vistas are abundant along Mountain Park Avenue and Sam Lawrence Park with 12 existing vistas and two enhancement areas being observed (see **Figure 5B**). Sam Lawrence Park specifically has large viewing areas with benches, paved walkways and interpretive signage. The overall area contained moderate potential for the creation of new vistas. Efforts to improve these areas, especially near Juravinski Hospital and Cancer Centre, are recommended. Improvements to these areas include removal of non-native vegetation, pruning of existing vegetation to improve sightlines, and planting low growing native vegetation.

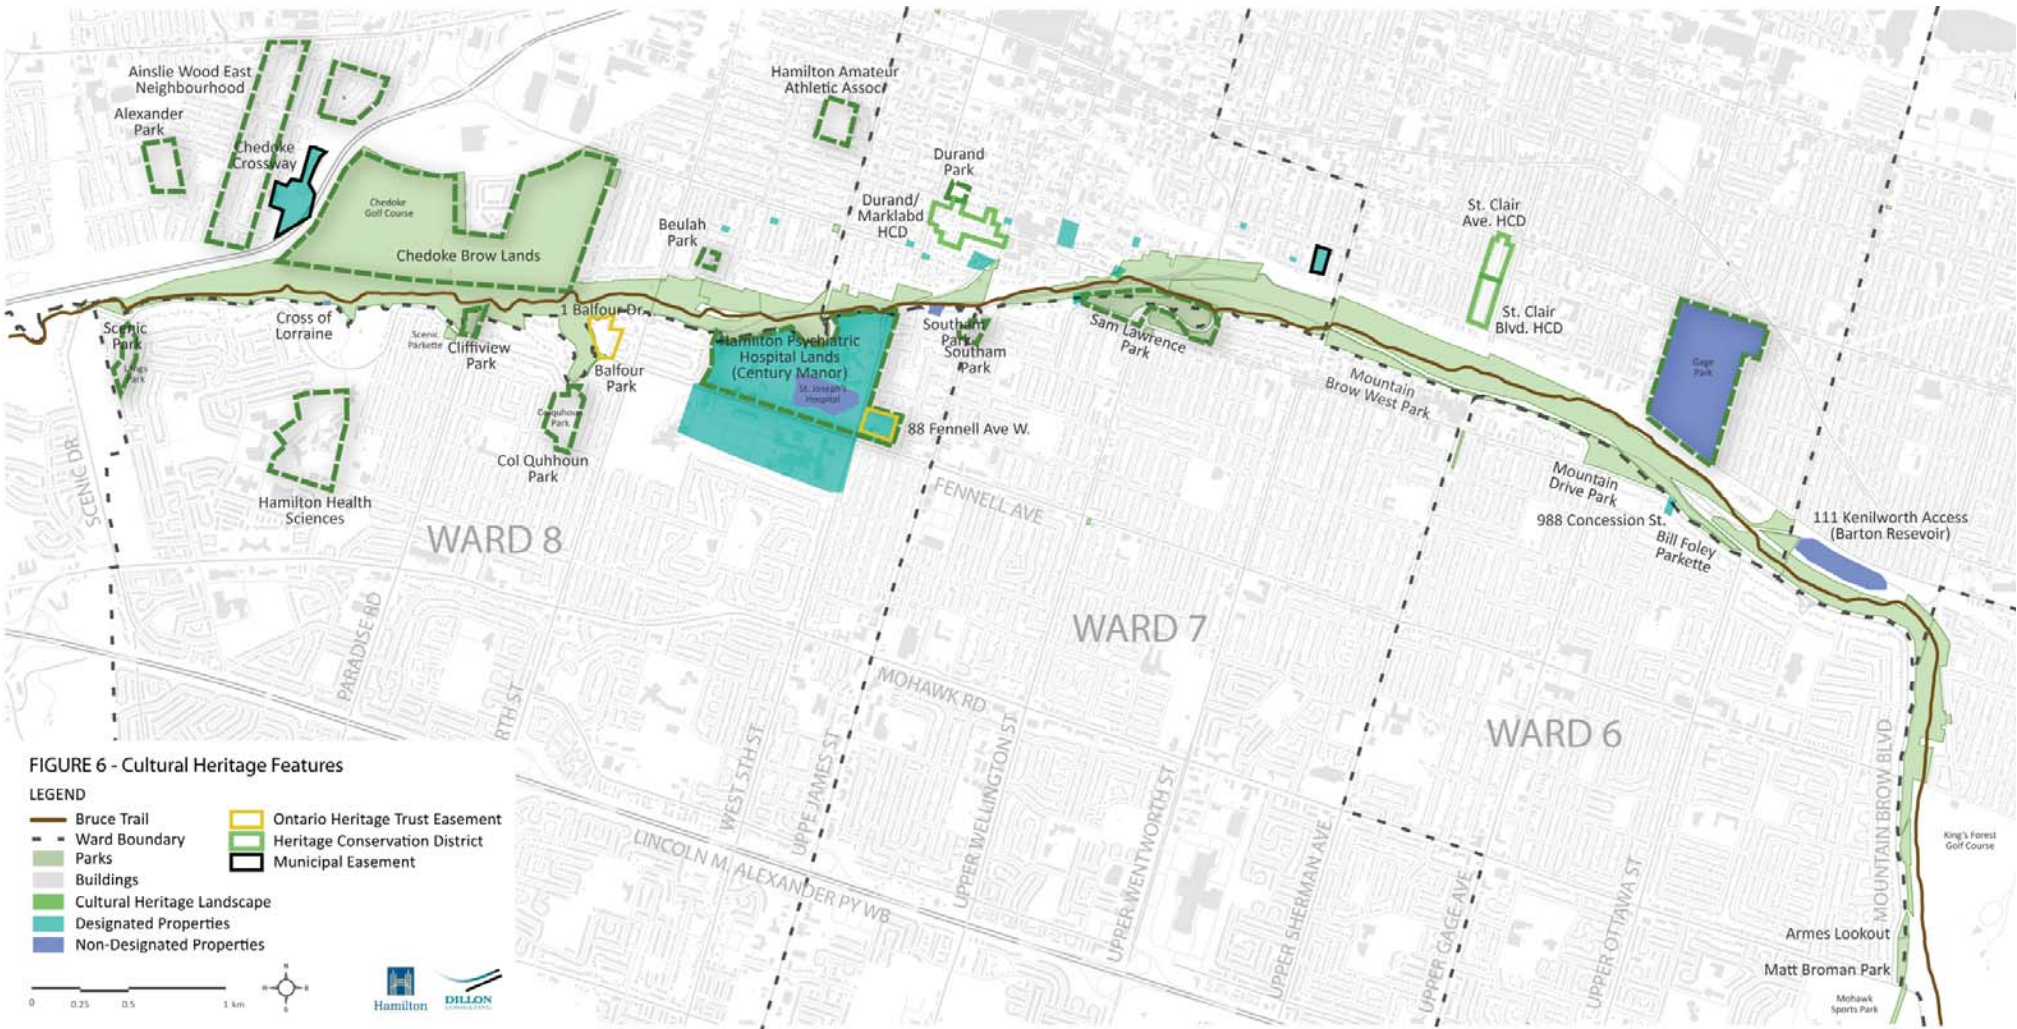
There are many cultural heritage features within and adjacent to the Niagara Escarpment in Hamilton (see **Figure 6**). Significant cultural heritage features include the Hamilton Psychiatric Hospital Lands, Chedoke Brow Lands, Gage Park, Sam Lawrence Park, Colquhoun Park, Cliffview Park and Scenic Park. Heritage Conservation Districts are located north of the study area including St. Clair Avenue, St. Clair Boulevard and Durand/Markland.

In Ward 6 specifically, there is a designated property near Mountain Drive Park on Concession Street and vista openings looking into the Cultural Heritage Landscape (CHL) of Gage Park (see **Figure 6**).

Ward 7’s primary cultural heritage features along the Escarpment brow are Sam Lawrence Park and Southam Park, which are CHLs (see **Figure 6**).

Ward 8 has a rich cultural heritage along the Escarpment brow (see **Figure 6**), including Ontario Heritage Trust Easement for Balfour Park and CHLs of Colquhoun Park, Cliffview Park and Scenic Park. The Cross of Lorraine, a non-designated property, is also located within the study area, with vista openings looking into the Chedoke Brow Lands. Perhaps the most significant cultural heritage feature in Ward 8 is the Hamilton Psychiatric Hospital Lands, also known as Century Manor and St. Joseph’s Hospital, which are not within the study area, but adjacent to the Escarpment public access.

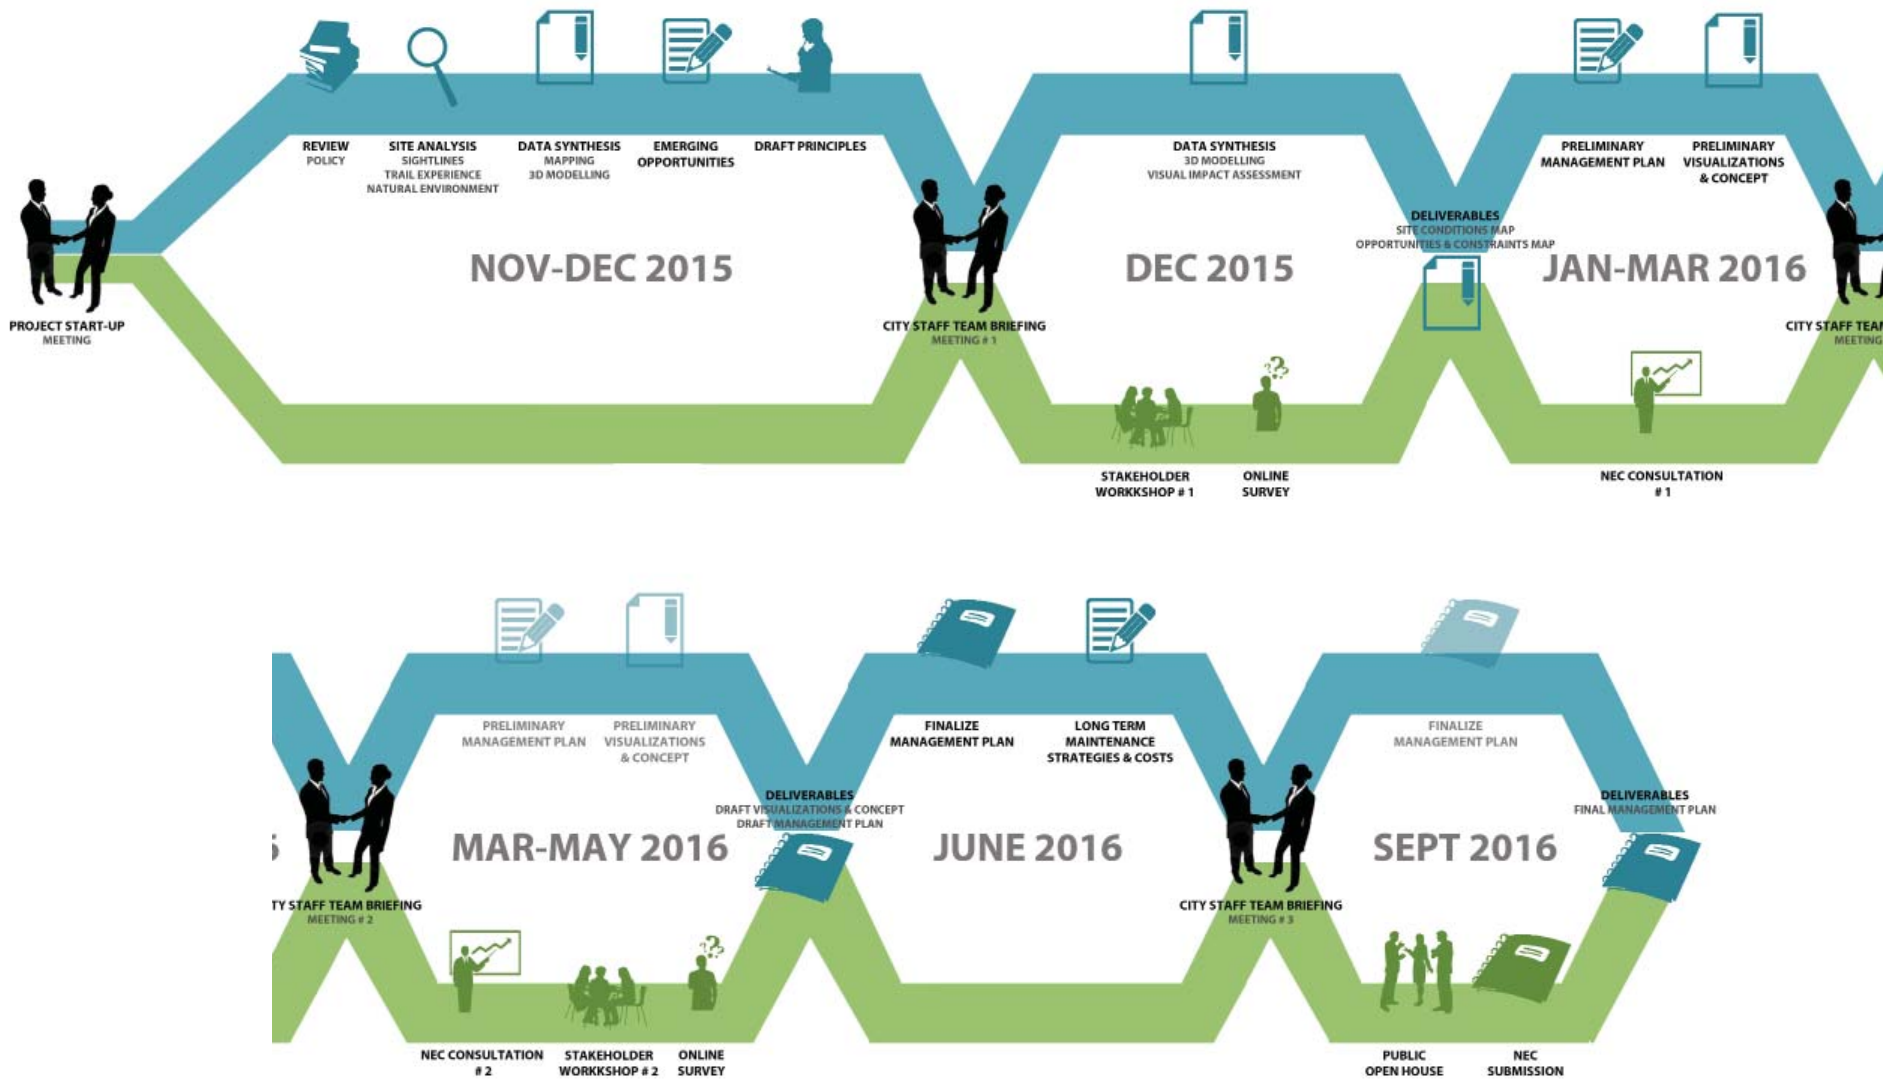
FIGURE 13 - Mountain Brow Study and Management Plan - Methodology

As per **Figure 13**, two stakeholder meetings were held with the community residents, two online surveys were conducted and the final concept and recommendations were presented at the final public meeting. Some community residents also provided their comments via email, which were included in the community consultation summaries. The following sections provide the meeting purpose, summary and online survey results.

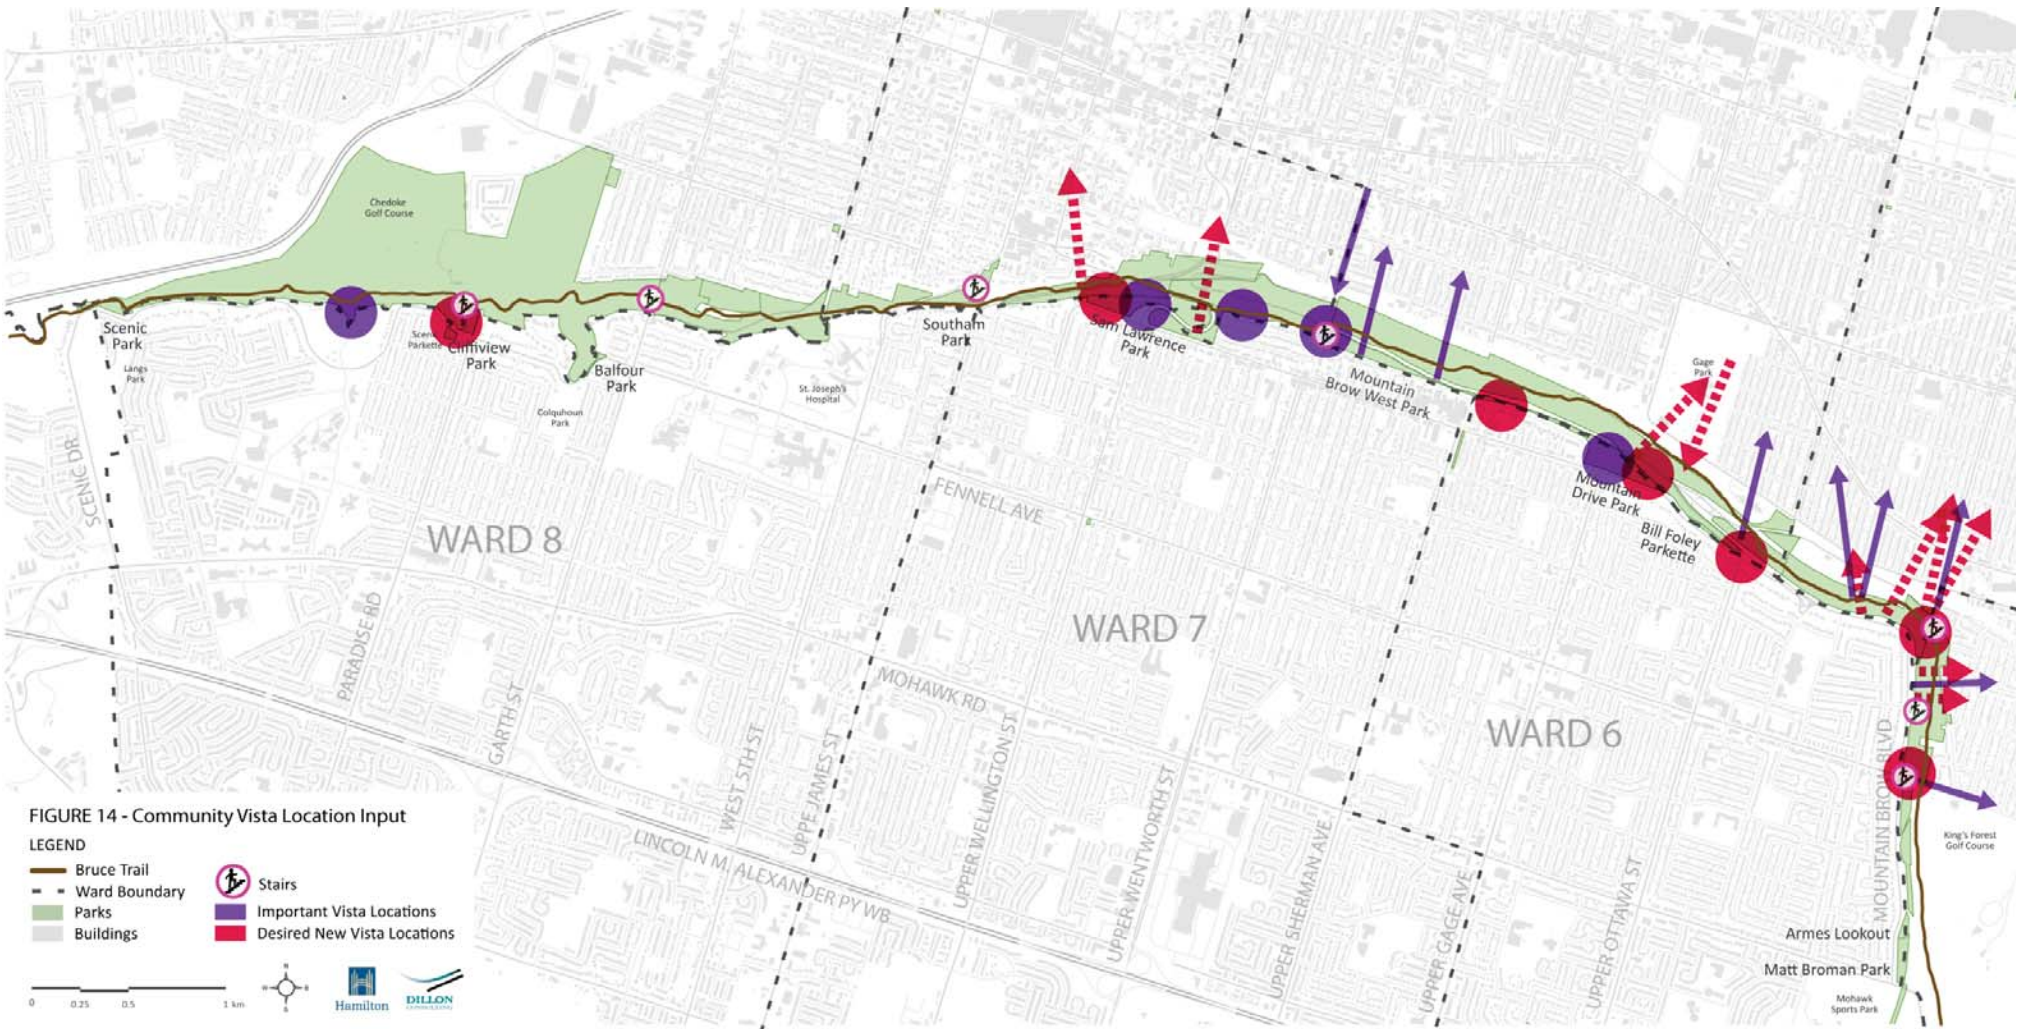
**FIGURE 14 - Community Vista Location Input**  
**LEGEND**  
 — Bruce Trail  
 - - - Ward Boundary  
 Parks  
 Buildings  
 Stairs  
 Important Vista Locations  
 Desired New Vista Locations

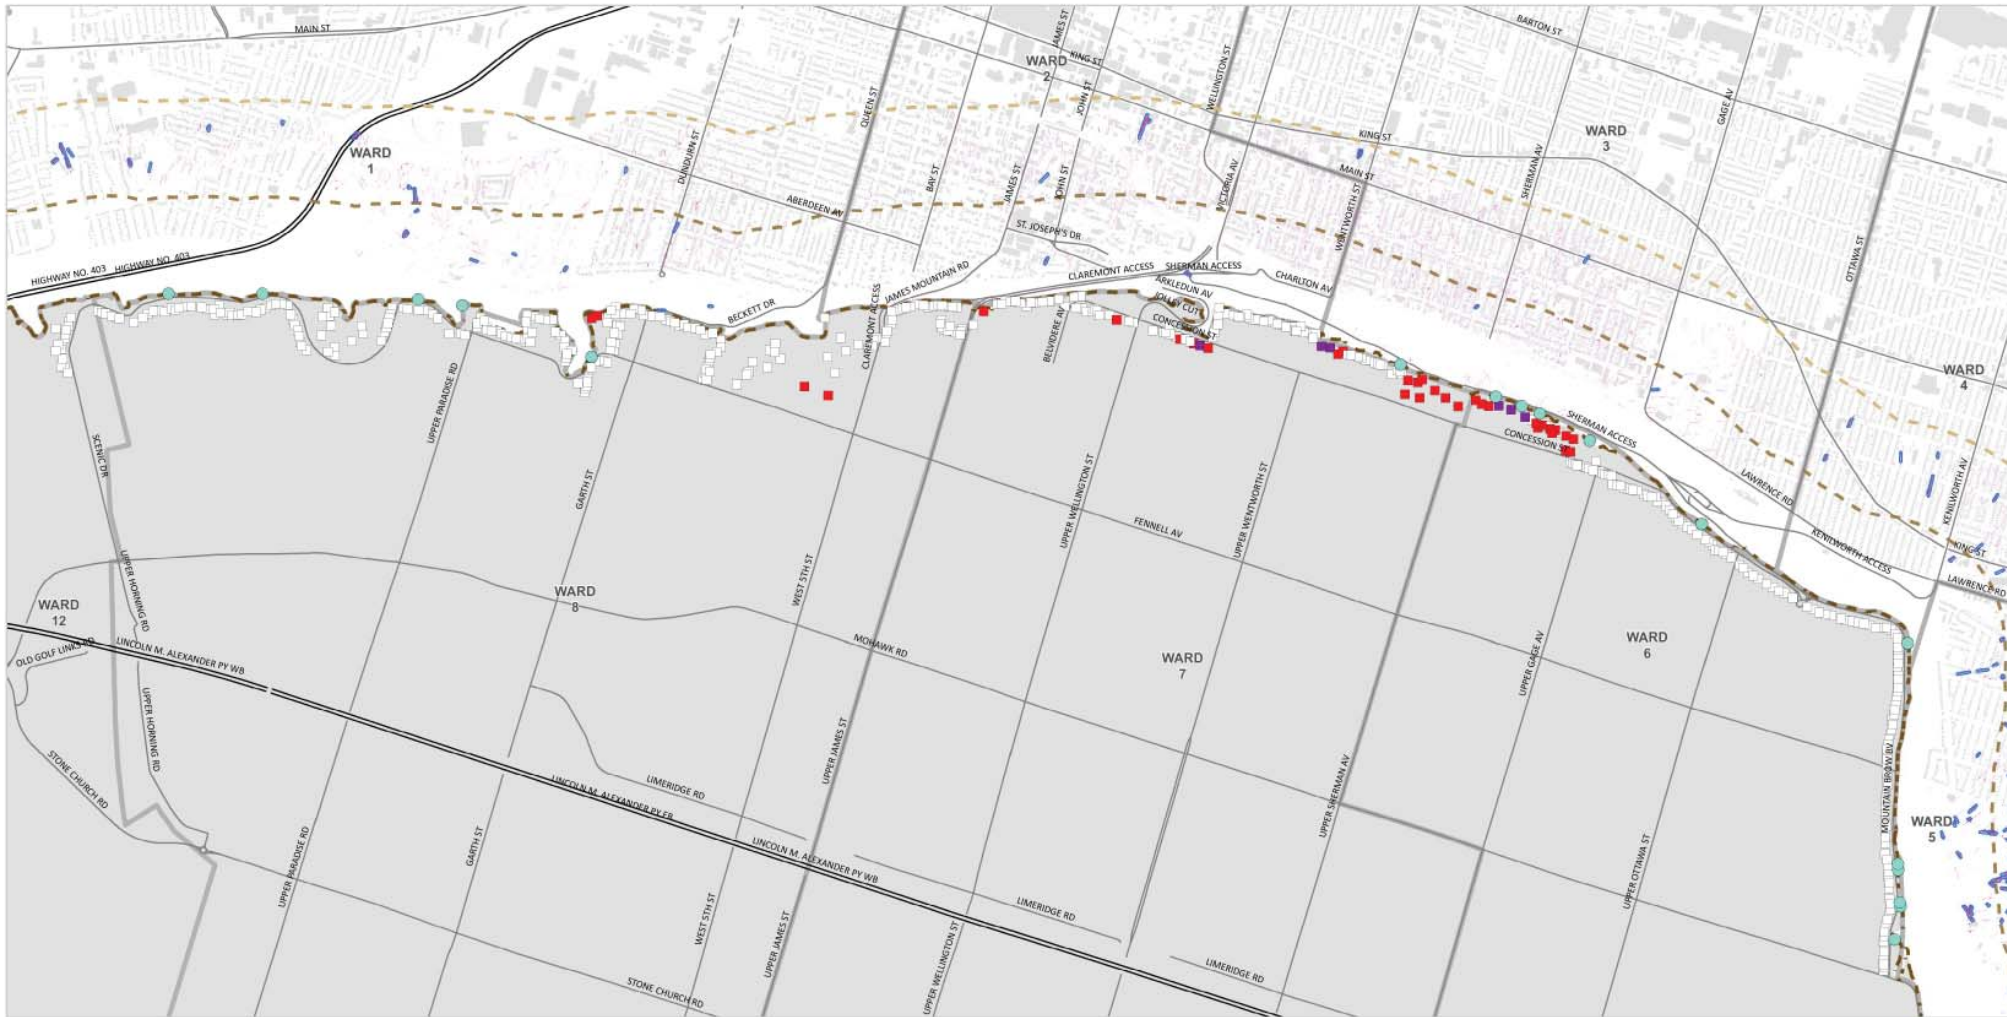
**Mountain Brow Vista Study Wards 6, 7 & 8**

The conclusion of the Visual Impact Assessment was that, although there were a number of locations where there was new visibility of the lands beyond the brow of the Escarpment, these locations were isolated and obscured by the urban fabric of the neighbourhood. Additionally, the tree canopy in the urban area beyond the brow provided additional screening, making it difficult to discern the vegetation on the face of the Escarpment from that in the background urban area. Views will differ in the winter when the surrounding woodlands are leafless; however the density of the vegetation and localized landscaping will continue to provide a visual screen.

- New Vistas (Vegetation Extruded to 1 m)
- Buildings Used in the Visibility Analysis (1 - 2 Stories)
- Buildings Used in the Visibility Analysis (3 - 6 Stories)
- Buildings Used in the Visibility Analysis (> 6 Stories)
- Escarpment
- Escarpment 500m Offset
- Escarpment 1000m Offset
- Major Road
- Highway
- Ward Boundaries
- Visibility Changes
- No Changes
- Visibility Changes > 50 sqm
