# White Church Boundary Expansion Area

**Sub-Watershed Study**

January 2025

Phase 1 Subwatershed Study	
White Church Boundary Expansion Area, City of Hamilton

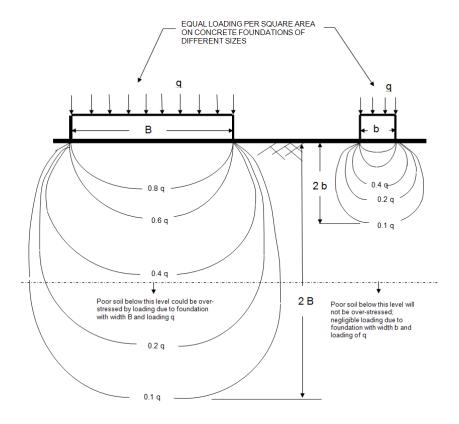
Figure 5.1.1.1: Illustration of Load Distribution below Variable Size Foundations with the Same Applied Loading

for the proposed development. The impact on foundation size and soil bearing pressure is illustrated in Figure 5.1.1.1 and emphasizes that foundation design sizes, bearing pressures, and bearing levels must be taken into account to avoid excessive consolidation settlements.

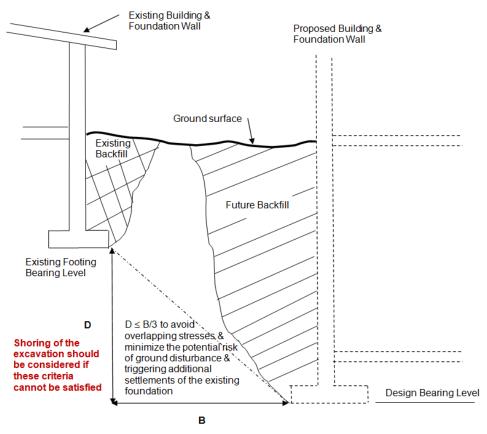
Example: If the separation between existing and new proposed footings is 2 m the difference in bearing elevation should not exceed 0.67 m.

Figure 8.1.1: Criteria for Assessing Excavation Shoring Requirements (Not to Scale)

Excavations for new foundations will be required to satisfy the criteria given in the example shown in Figure 8.1.1. This is to avoid overlapping stresses and minimize the risk of undermining existing adjacent structures, including utilities, and/or triggering additional settlements of the existing structures due to soil disturbance.

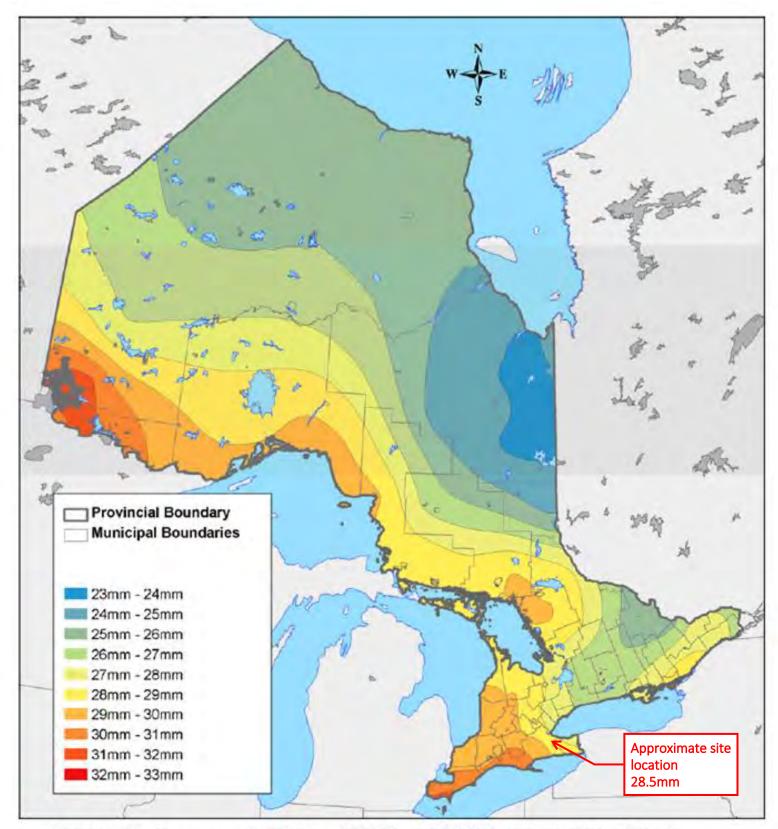
Figure 3.67 – Recommended Regional 90% Percentile Volume Targets for Ontario (represented by the 95th percentile daily rainfall contours April - October, where daily volume exceeds 2mm).

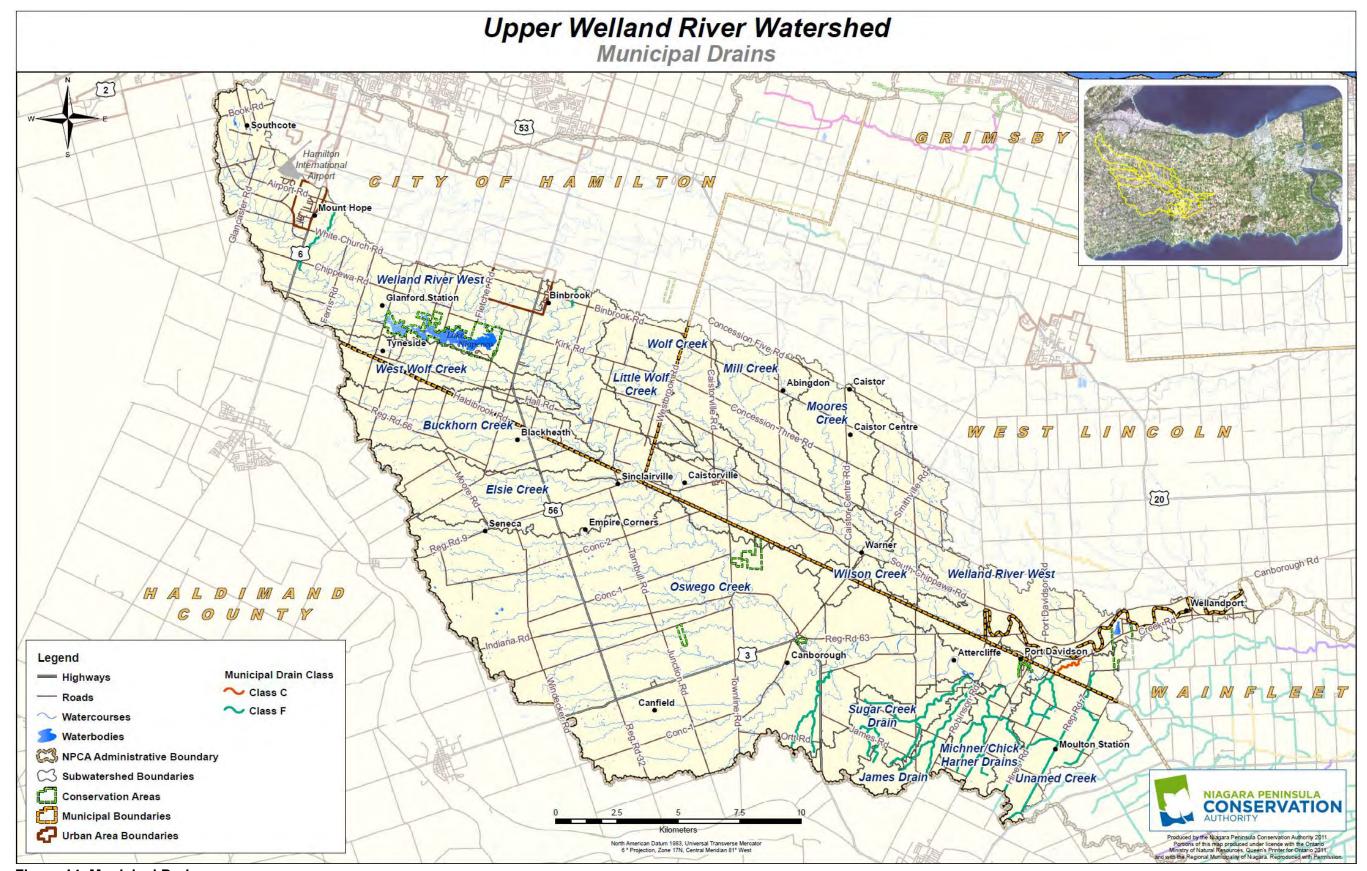
Figure 14: Municipal Drains

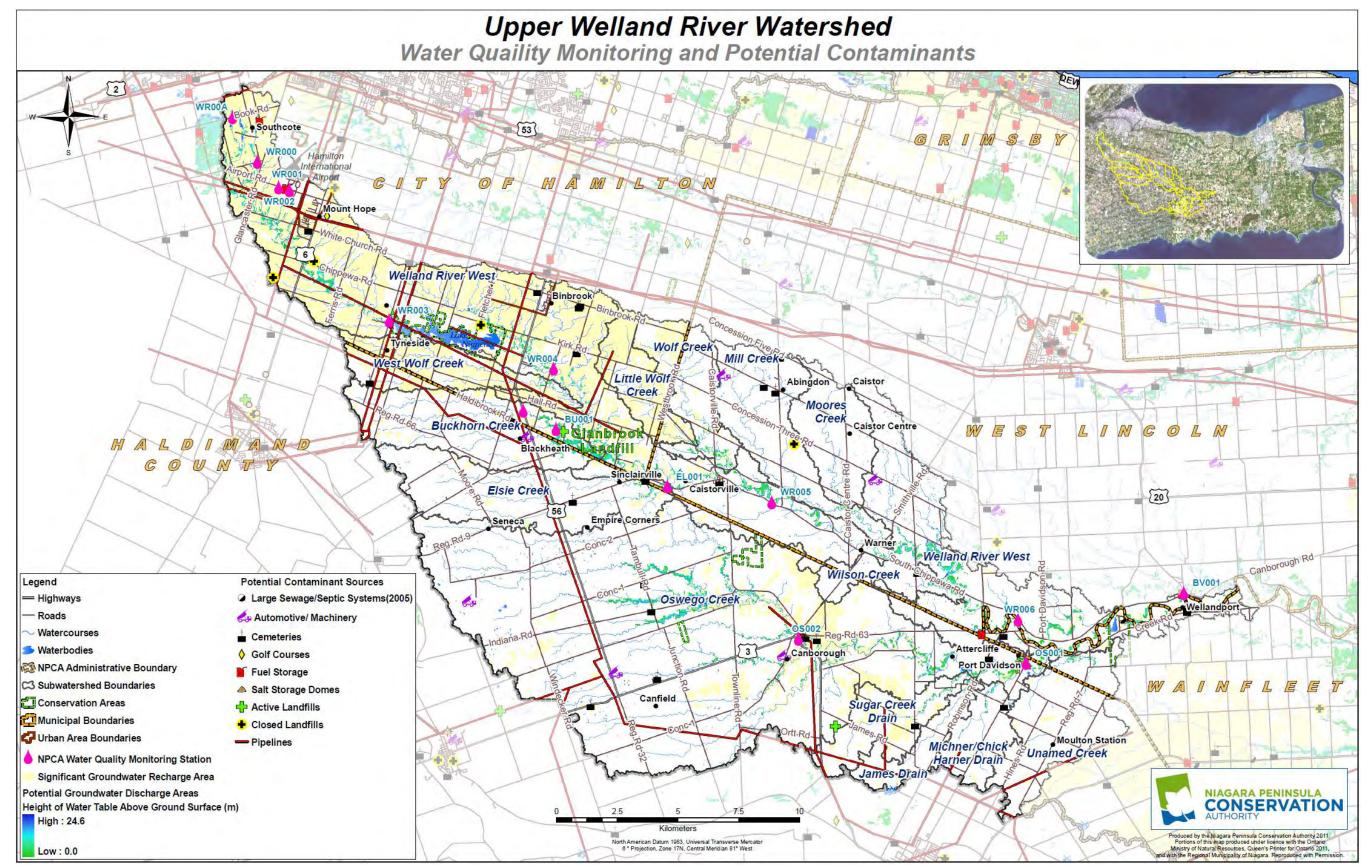
**Figure 15: Water Quality and Potential Contaminants**

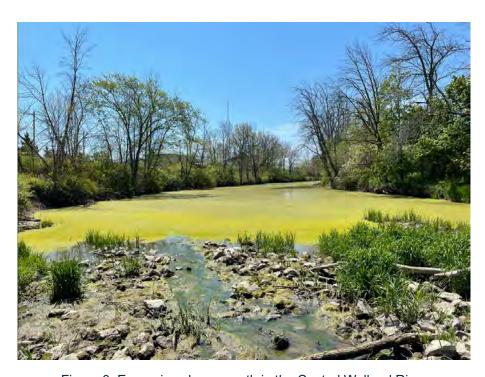
Figure 3: Excessive algae growth in the Central Welland River

Based on the 2019-2023 data, elevated concentrations of total phosphorus are a widespread cause of water quality impairment in the Welland River. Greater than 95% of samples collected in the main Welland River exceeded the PWQO with some concentrations greater than 20 times the PWQO. High phosphorus in the Welland River has stimulated the overgrowth of algae and duckweed throughout the watershed. When these plants transpire, and decompose they deplete dissolved oxygen in the water and this in turn stresses aquatic organisms such as fish and benthic invertebrates. Manure from livestock operations, sewage discharges, soil erosion, fertilizers, and pesticides are sources of total phosphorus in the Welland River.
