# Shoreline Inventory and Assessment of City of Hamilton Owned Assets

City of Hamilton

Final Report

Document No. 663821-1000-4PER-0001\_R0.docx

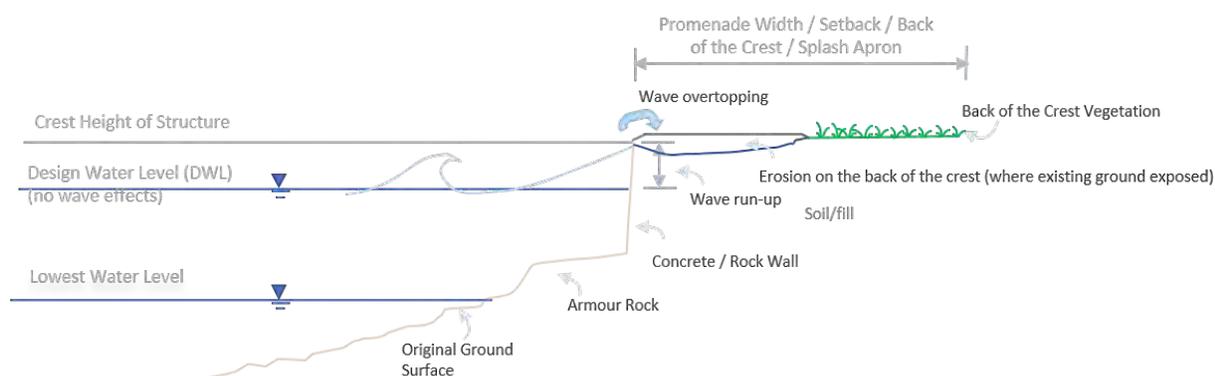
**Typical Shoreline Protection Assessed**

The figure below shows a sketch of the typical shoreline assessed in this study. The shoreline protection generally consists of a shoreline concrete or rock wall, generally with rock armour protection at the toe of the wall. Wave overtopping is causing erosion of upland, usually unprotected, promenade surfaces because of the low crest elevation and characteristics of the structures.

Recommendations and suggestions for repairs are given, although a permanent solution needs to be studied in more detail, giving consideration of the City’s adjacent land use priorities. The repairs suggested are provisional solutions to avoid further damage on the shoreline and should be final solutions should be detailed and carried out by suitable qualified professional engineers with coastal engineering experience. The potential solutions are described below.

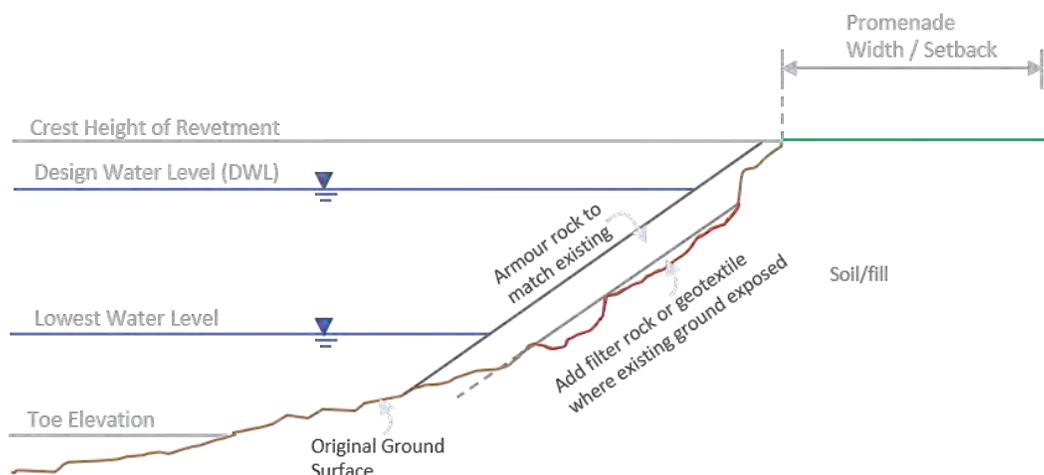
**Figure 17 Option A1 Repair Solution**

Figure 17 shows a generic Option A1 solution, where existing damage occurs on the rock slope. The repair consists of adding armour rock to match the existing design, and adds filter rock or geotextile where existing ground is exposed.

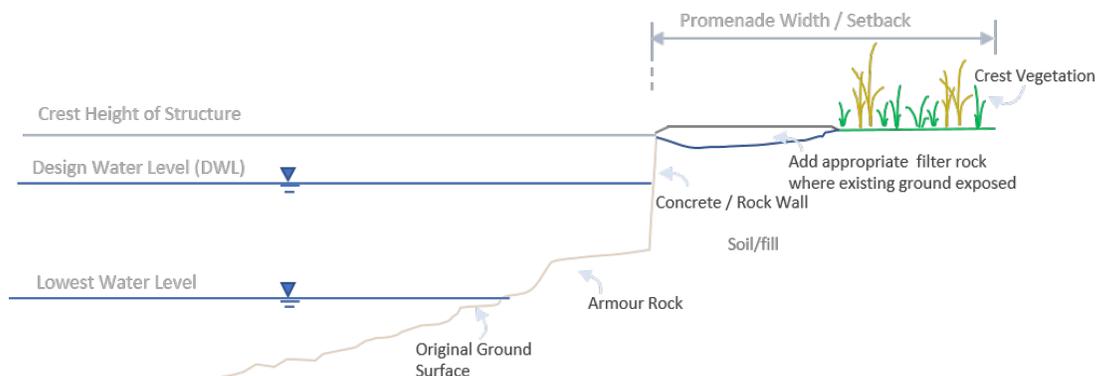
**Figure 18 Option A2 Repair Solution**

Figure 17 shows an Option A2 solution, where the damage occurs at the back of the crest and the existing structure consists of rock / concrete wall and armoured rock toe. The repair consists of adding appropriate filter rock where existing ground is exposed and complementing the area with vegetation. This is a frequent issue at the smaller sites where the crest is not at the required elevation.

The existing rock armour or wall might be designed and built to withstand the wave climate, but the back of the crest is not protected enough to receive and drain the overtopping volume during storm events without damage.

As the repairs do not include upgrades to the shoreline protection design – including slope, crest elevation, toe location, etc., the life of a repair will be contingent on the adequacy of the original design and construction of the slope protection for the wave climate and climate change. It is recommended that an evaluation regarding the structure conditions and stability to be undertaken after extreme events, and execute local repairs when necessary.

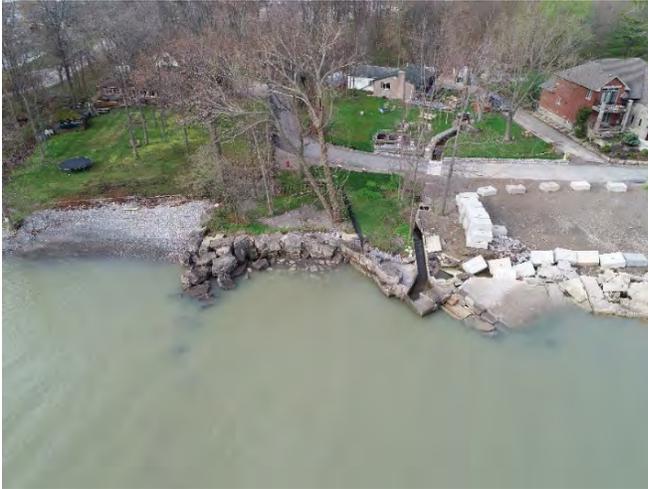
The Site 1 shoreline is approximately seven meters long and consists of a shore parallel seawall of large blocks of rock with a crest elevation of approximately 77.0 m. The armour consists of two layers of stacked rock blocks. The backside of the seawall crest includes a geotextile, which is deteriorating and filter rock (diameter 100 -150 mm) (Figure 1-2). There is a storm outfall channel and a concrete platform (approximately 2.5 m wide) at the west end of the site. The rock blocks seem to be stable but erosion of the adjacent upland area was observed.

The concrete platform is not stable and it might be a concern for public safety. It is recommended to put in fences to restrict public access until the structure is repaired.

The concrete platform on the property to the west is close to collapse. It is recommended to clean up the area to remove failed material and debris and to monitor the integrity of the west property boundary.

Figure 1-1 Oblique view of Site 1 (middle) and adjacent properties

A permanent solution to repair the shoreline is dependent of the adjacent shoreline protections because of the short site length. A potential short-term solution is to create a transition from the large armour rocks and reinforce the back of the crest. Replacing the geotextile with filter rock in different gradations is also recommended to improve drainage from precipitation and overtopping. The concrete walls protecting the channels can also be protected with sloped armour rock. The short-term solution would require monitoring and potential repairs after extreme events. Rehabilitation of the groin should also increase protection but it will likely not solve the ongoing issue.

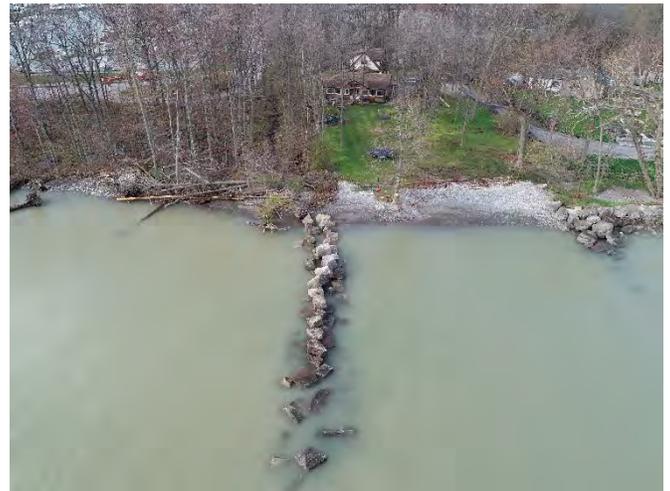
Figure 1-4 Site 1 Windermere Rd – adjacent property.

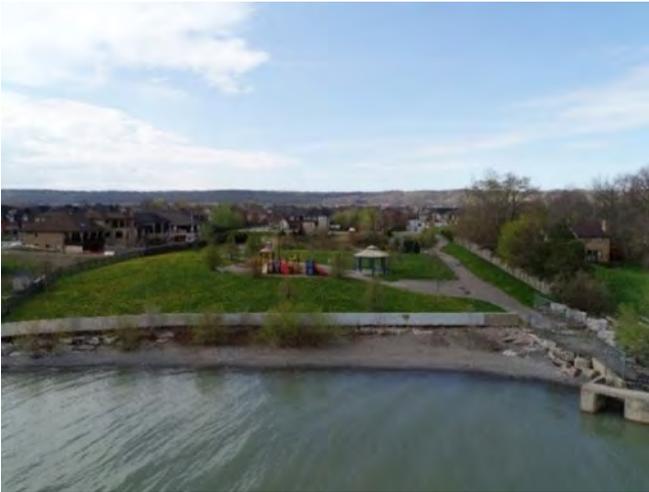
Site 3 consists of a City park with a playground, grass area and beach in very good condition. The shoreline is protected by a sheet pile wall. A concrete wall was placed on the top of the sheet pile wall by adjacent property developers. The elevation of the top of the wall is approximately 79 m.

The wall is unevenly protected with large rocks at both east and west ends. Buried boulders are also present along the shoreline further away from the wall. No significant damage has been identified in the area. The wall appears to be stable. Some vegetation is present on the beach area.

Figure 3-1 Oblique view of shoreline and park

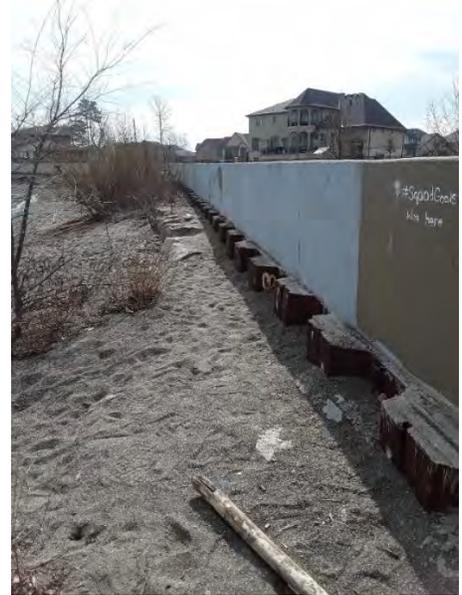
Figure 3-2 Sheet pile wall with concrete wall on top

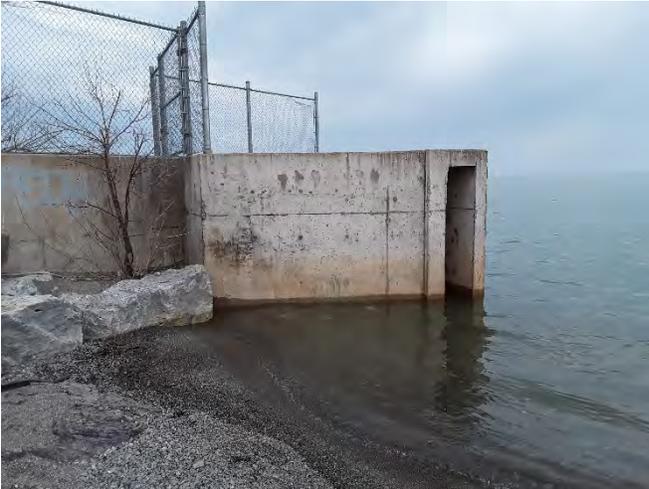
Figure 3-5 Outfall protected by concrete walls

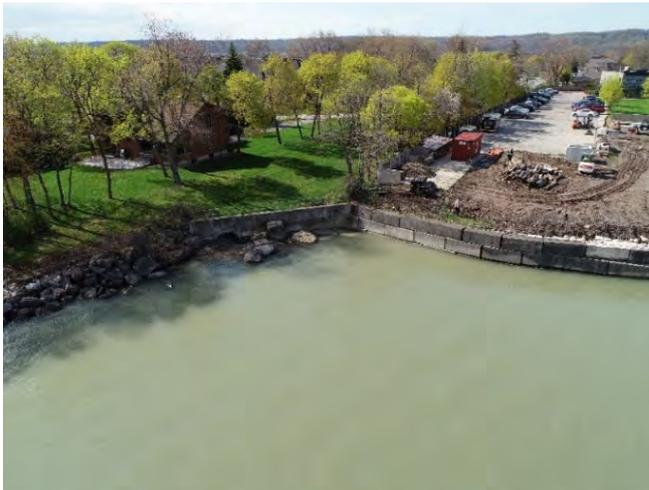
The transition between the concrete wall and the east adjacent property protection is by an old timber wall (approximately 1.5 m long), which was likely the previous protection of the site. The area landward the timber wall is a weak point on the shoreline and erosion was observed. Erosion was also observed on the shoreline close to the transition between the concrete wall and the west adjacent property whose shoreline protection consists of three layers of approximately 2 – 3 m long concrete blocks.

Figure 4-1 Site 4 Oblique view (middle section) and adjacent properties

The elevation of the concrete wall is approximately 78 m and wave overtopping during storms likely reaches the backside of the wall. It is recommended to protect the upland area behind the wall to reduce damage due to overtopping and reduce surface run-off.

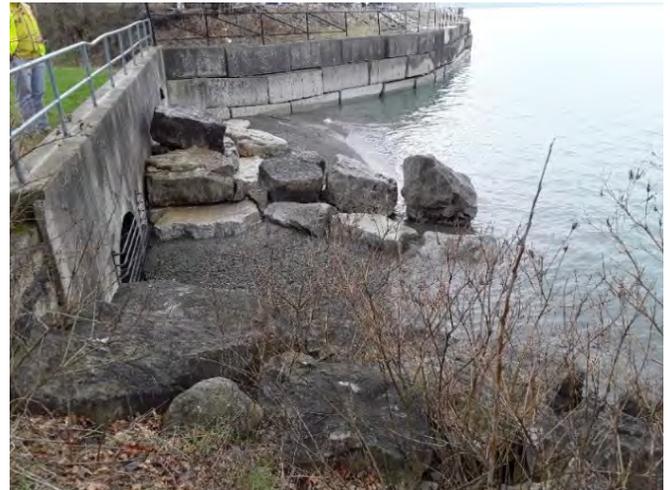
Site 4 is a street right of way (RoW) consisting of natural grass area with public access. The site shoreline, of approximately 25 m length, is protected by a vertical concrete wall and there is a guard rail in reasonable condition on the top of the wall. An outfall channel that discharges through the concrete wall is protected on the west side by large rocks and on the east side by the adjacent property shoreline protection (armour rock), Figure 4-2.

Figure 4-2 Concrete wall, outfall channel and armour rock protection

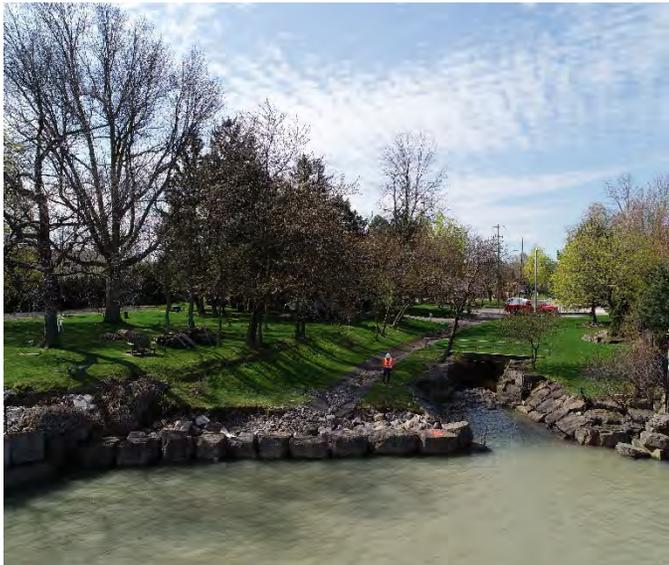
Site 5 is a street right of way (RoW) with an asphalt pathway to the shoreline and a storm outfall. The shoreline is protected by large rectangular rocks (approx. 1.5 m). The system consists of one rock layer with top elevation of approximately 76.7 m. The large rocks seem to be stable but significant erosion of the crest was observed at the asphalt pathway. The crest is composed by rocks not large enough to theoretically withstand the overtopping volume experienced. The crest is significantly eroded in the east part of the site with exposed (and deteriorated) geotextile, there is also loss of grass area. The crest is not stable, and it might be a safety concern for public safety.

The current conditions of the shoreline are generally good at the west channel but fair on the east part of the site.

Figure 5-1 Site 5 Oblique view

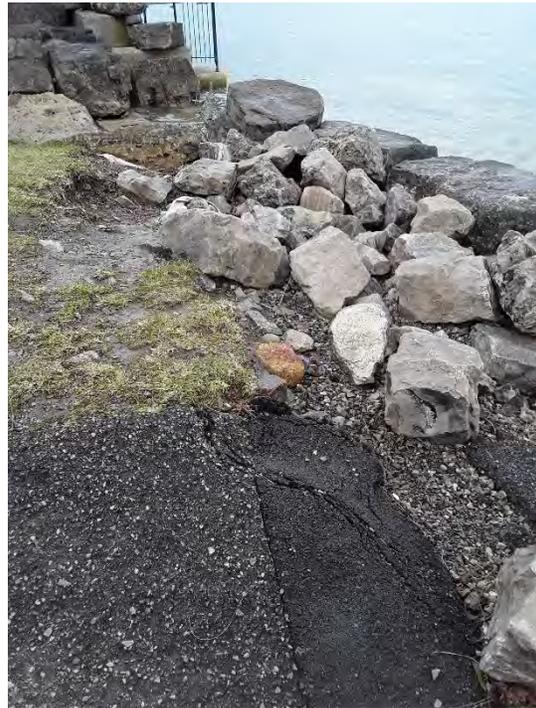
Figure 5-2 Site 5 eroded crest

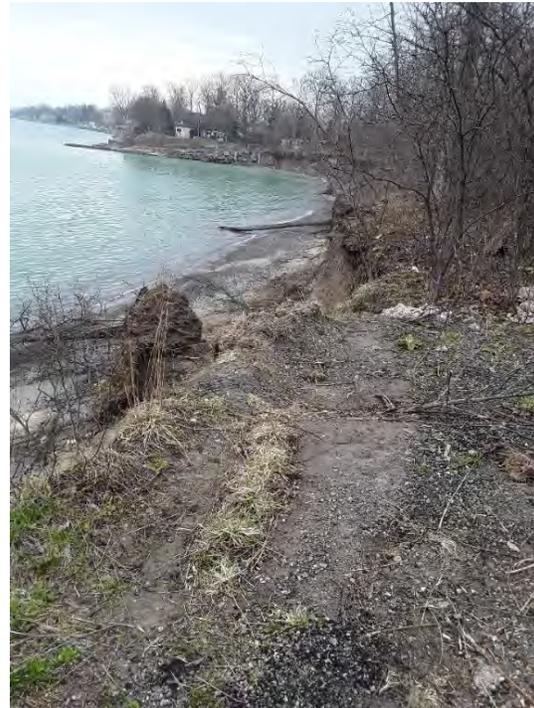
Figure 7-2 Shoreline erosion

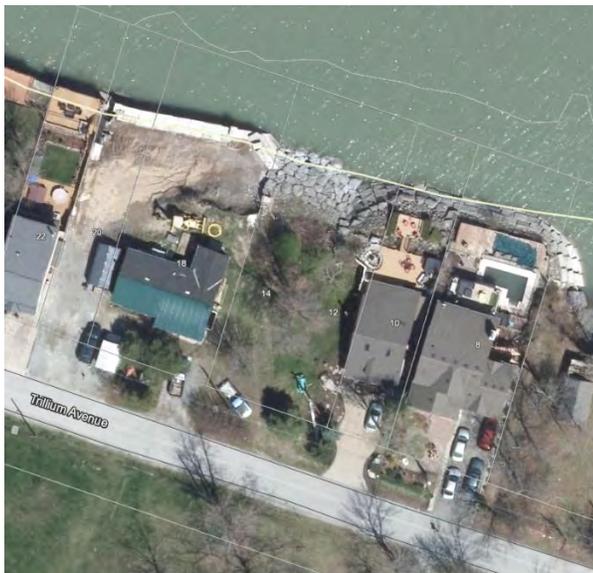
Figure 9-3 East adjacent property encroaching into City property

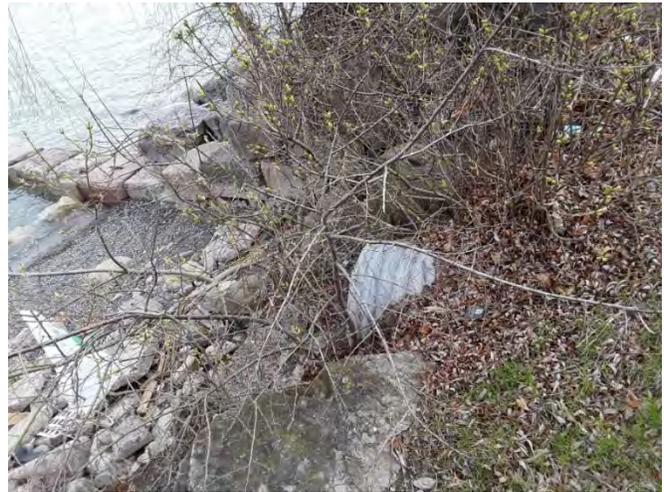
A storm outfall is present at the east end of the property (see Figure 10-2) but is starting to be exposed due to erosion.

Figure 10-2 Storm Outfall Pipe

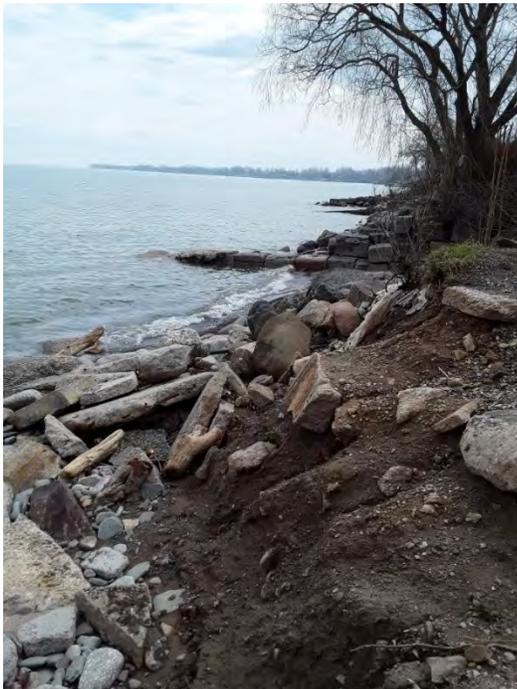
Figure 10-3 Crest erosion

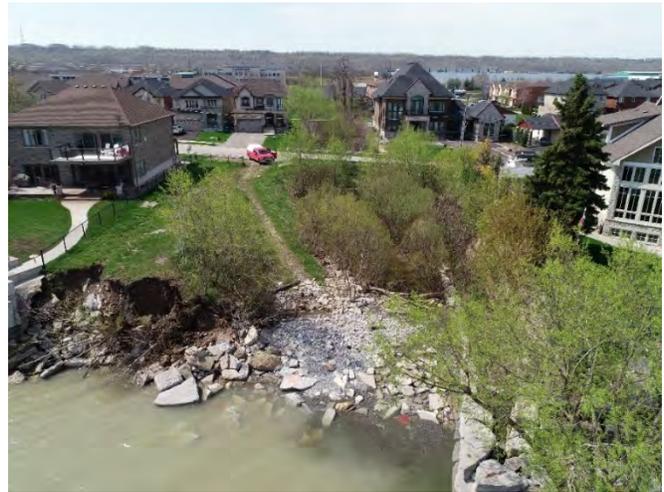
The east side of the property shoreline is characterized by a grass area followed by a failed rock armour system. There is significant erosion of the grass area and it might compromise the adjacent property shoreline protection. It also presents a safety hazard for the public. It is recommended adding signs (or a fence) for pedestrian safety until the slope is repaired. Due to the steep eroded slope, overtopping and run-up are moderate. It is recommended to cut back the slope and reinforce armour and crest to be as similar to the west side as possible.

Figure 11-2 Site 11 East and west side shoreline protection feature

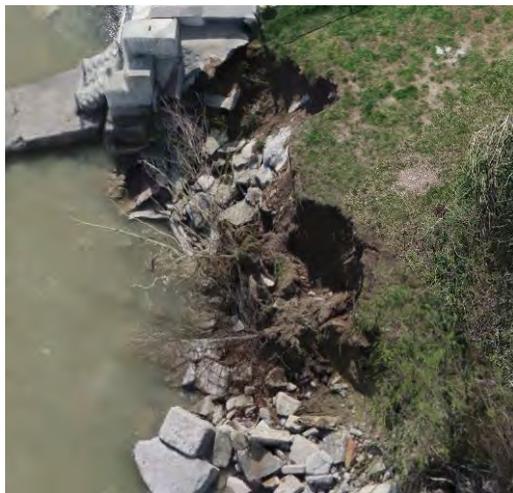
Figure 11-3 Significant erosion east side of shoreline

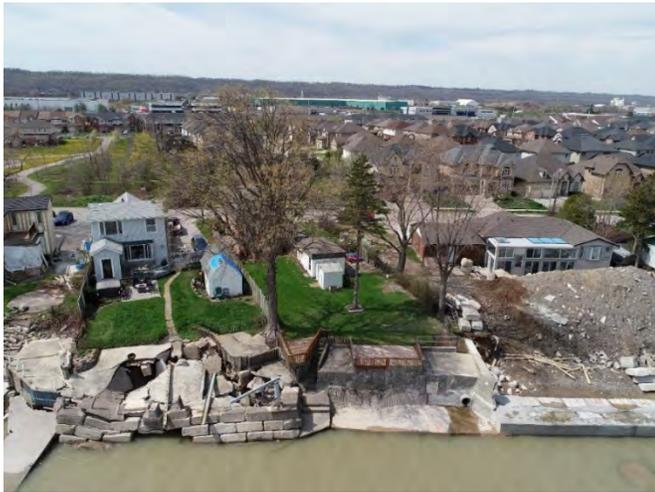
The shoreline protection is subject to the performance of the adjacent property’s protection systems. As shown in Figure 12-1 (failed east property protection), protecting the shoreline with wall is not sustainable in this wave climate and water level conditions.

Figure 12-1 Site 12 oblique view

Based on the elevations of the platforms, the structure is likely experiencing high volumes of overtopping. Even though the structure’s condition is reasonable, it could present a risk to pedestrians during a severe storm at high lake levels event. It is recommended to protect the storm water outfall creating a gentler and more permeable slope.

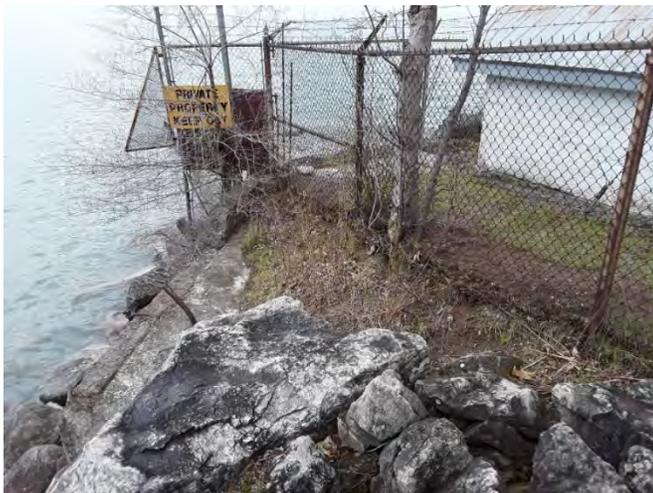
The transitions to the east and west adjacent properties should be reinforced. The east side transition is in poor condition and could affect the adjacent property shoreline protection. The crest is not protected enough and soil is being eroded. It is recommended to repair this side of the protection with the crest reinforced with one more layer of large rock, followed by smaller rocks to protect the underlying soil. The structure permeability should be maintained to support drainage and reduce wave effects.

Figure 13-3 East Side of Shoreline experiencing erosion, close to adjacent property

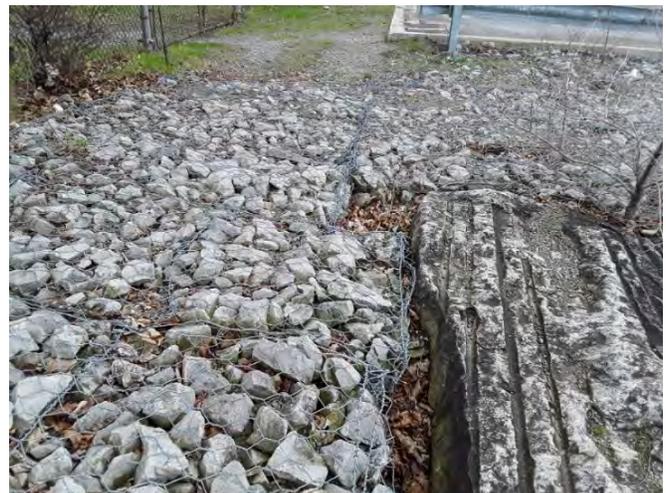
Figure 13-4 Gap between rocks and gabions

It is recommended to add a filter transition between the large rocks and gabions at the crest. This will help maintain reasonable permeability and fill up the existing gaps.

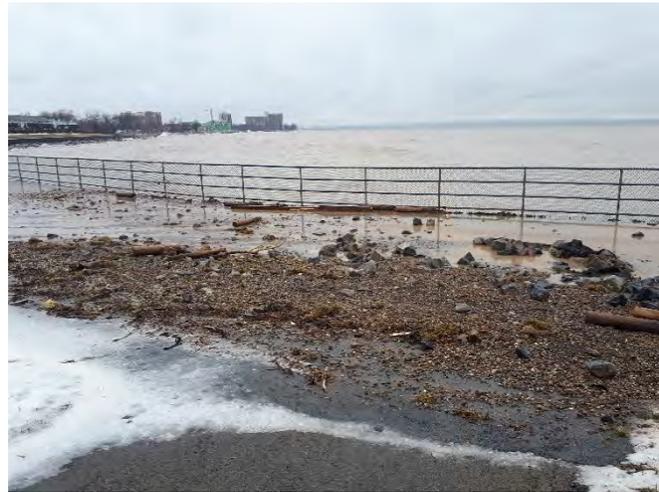
Figure 19-2 shows the shoreline conditions during an extreme event, where rocks were carried from the shoreline protection system and the lakebed in front of the shoreline and up to the pathway.

Figure 19-2 Site 19 storm event (credit: City of Hamilton)

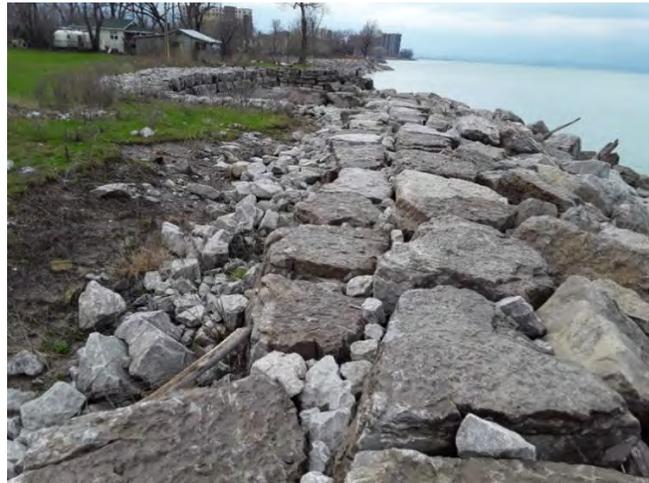
Figure 20-2 Erosion at the Back of Crest

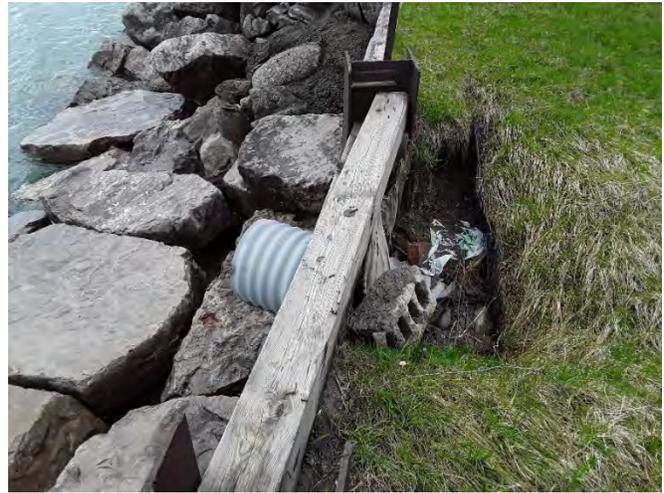
**Figure 22-2 Exposed Outfall Exposed to Erosion**

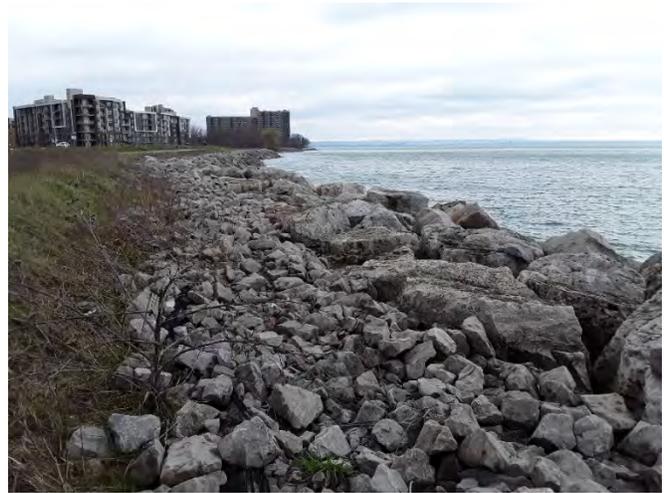
Figure 22-6 Site 22B Crest of Shoreline Protection System, showing mild Erosion and exposed geotextile (in some areas)

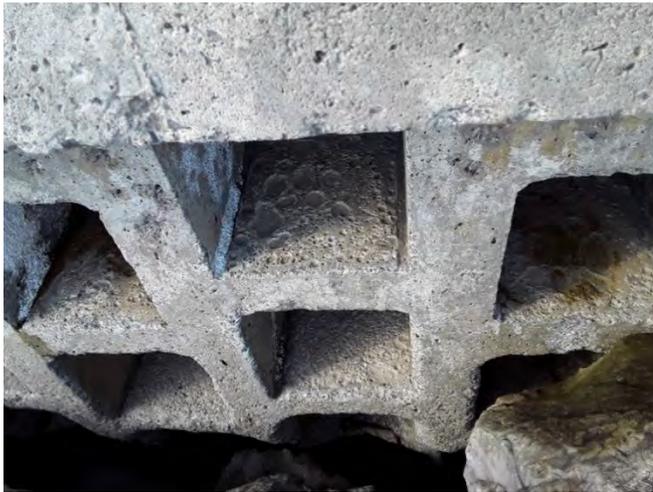
This part of the shoreline is composed of an outfall concrete channel and the shoreline on both sides of the channel are protected by a concrete wall with square details (Figure 23-1) and rock armour (Figure 23-2). The back of the wall (landwards) is protected by small rocks (filter size 100-300 mm) on top of a geotextile. Most of the rocks were washed out and the geotextile is exposed and deteriorated. The conditions of the shoreline on both sides of the channel are poor but the east side is slightly worse.

Figure 23-1 Detail of the Concrete Wall

It is recommended to adapt the shoreline structure to a gentle slope system with possible removal or adaption of the existing wall.

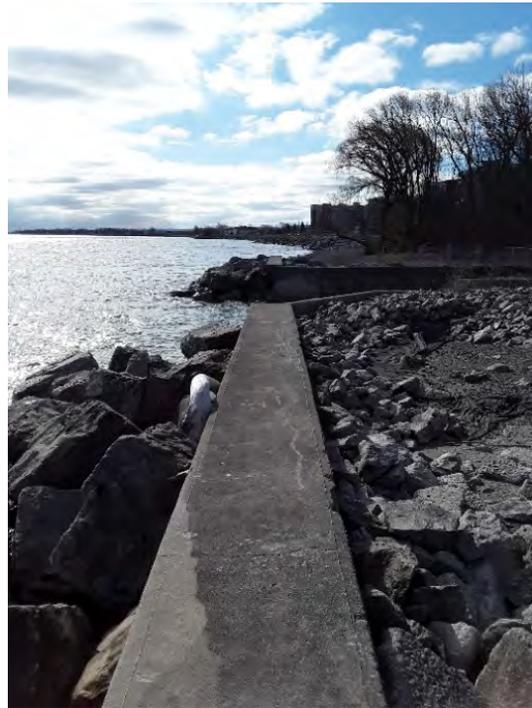
Figure 23-2 Concrete Wall and Landward Erosion

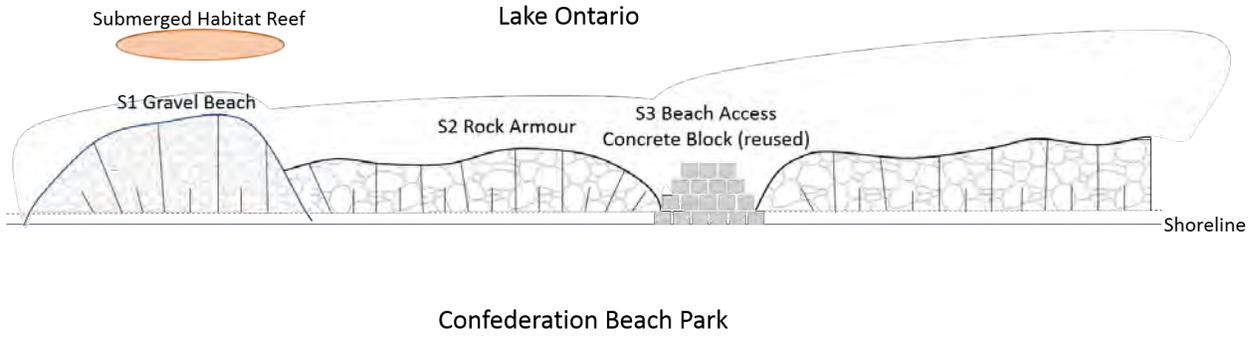
**Figure 27-2 Potential Solutions Sites 27.5 to 27.15**

Sites 27.5 to 27.15 shorelines are currently protected, eroded or natural. A mixed solution can be considered including reuse of existing material. Figure 27-2 shows options for shoreline protection by a gravel beach (S1) or rock armour (S2). The existing concrete blocks could be reused as beach access (S3).

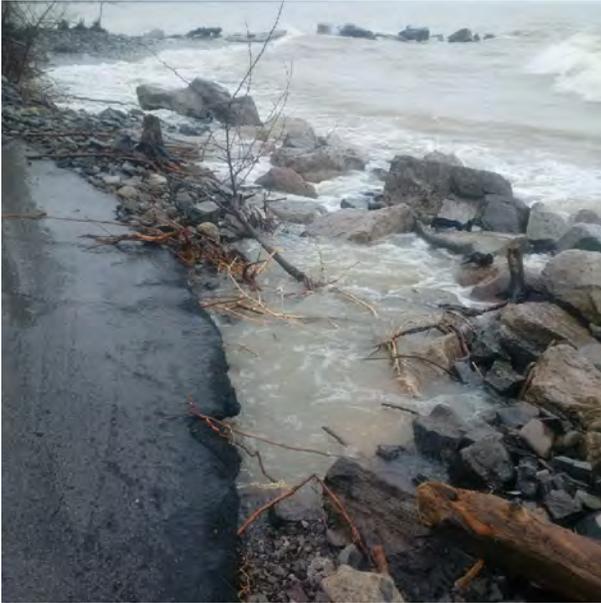
**Figure 27-3 Pathway During High Water Levels during Storm Event (credit: City of Hamilton)**

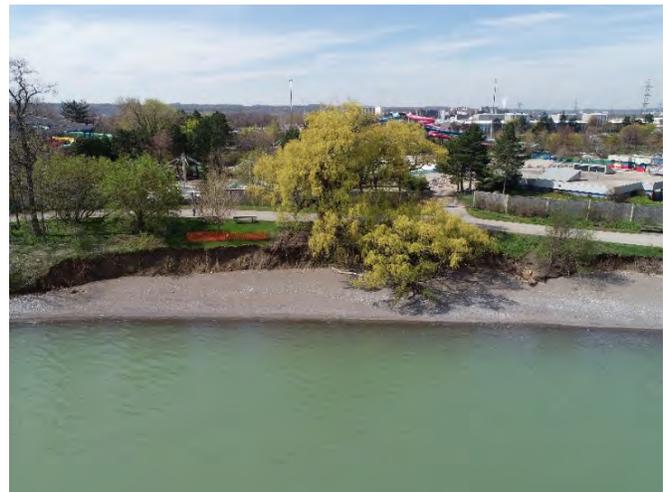
Figure 27-6 shows a section of the shoreline that is not protected and includes an eroding scarp along the backshore. The erosion is reducing the vegetated area beside the pathway. Tree roots are exposed at the shoreline.

**Figure 27-6 Eroding Shoreline (scarping)**

It is recommended to add signs warning the public of the abrupt change in elevation and monitor future scarping (erosion) activity. Figure 27-7 shows a section of the same shoreline protected by a sheet pile wall. It was noted that erosion of the grass area behind the wall is occurring.

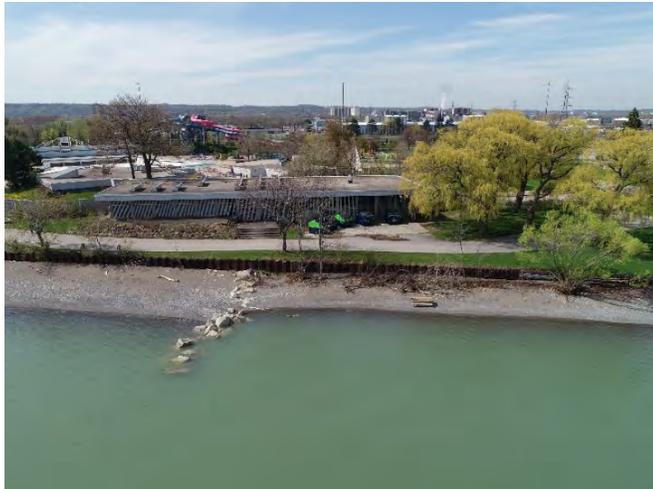
Figure 27-7 Site 27 Sheet Pile Wall

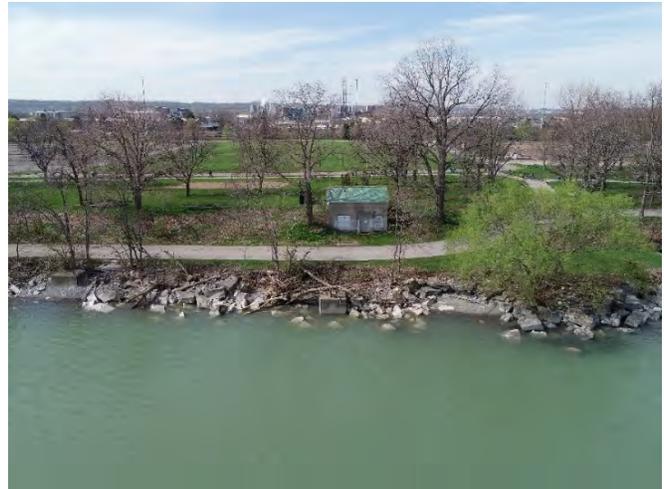
The section shown in Figure 27-8 is protected by large rocks randomly placed at the shoreline. It was noted that some of the rocks were displaced and the tentative protection is not performing well. Parts of the section are significantly eroded. There is also debris present along the shoreline including the remains of fallen trees.

Figure 27-8 Site 27 Rock armour, debris and fallen trees

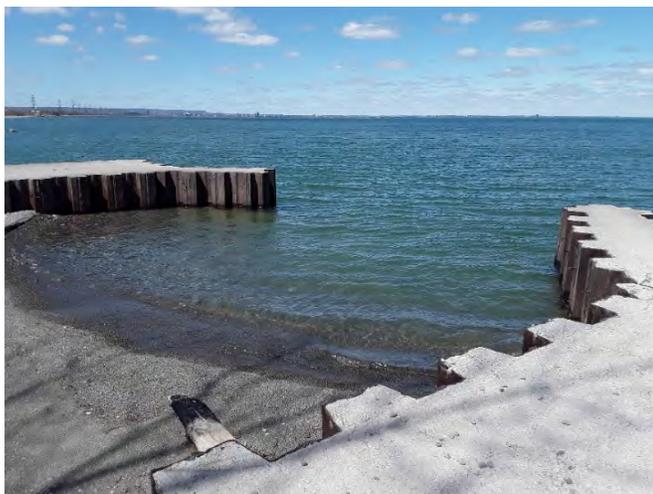
A few structures, like the one shown in Figure 27-9 were noted along the shoreline. This structure is not under service, but it needs maintenance or complete removal. Figure 27-10 shows the deterioration of the structure that might be a safety hazard for the public.

Figure 27-9 Site 27 Structure out of service

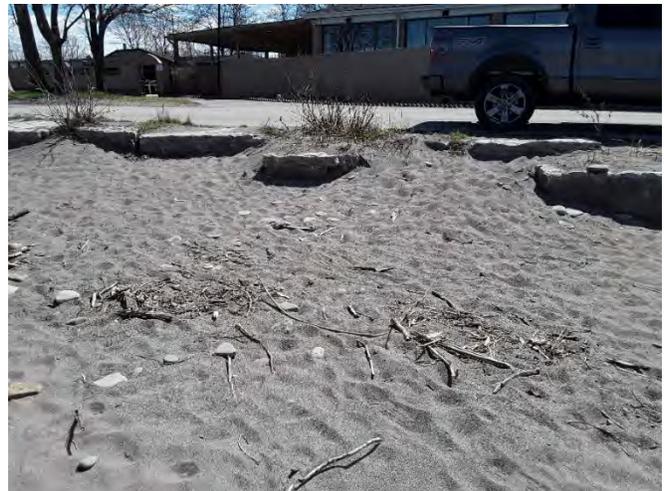
Figure 27-12 shows a section of the shoreline protected by boulders with sediments likely deposited during storms. The protection is not performing well due to the low elevation and possible overtopping volumes during extreme events. Erosion pockets were observed and sand is reaching the pathway.

Figure 27-12 Site 27 Sedimentation

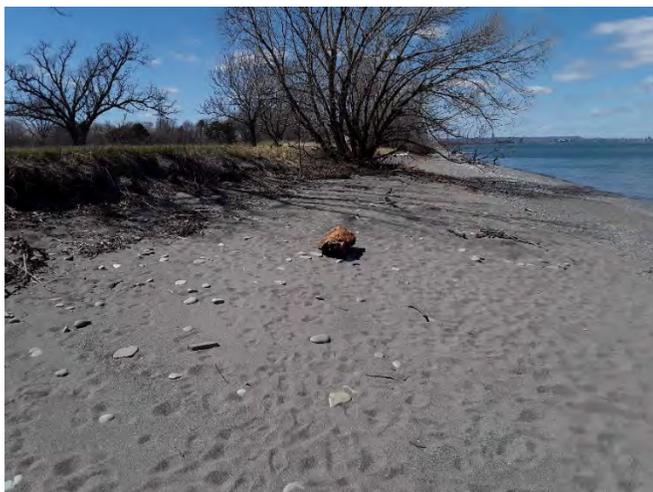
The shoreline section east of the volleyball courts shows erosion likely caused by the 2017 storms during high water levels. Figure 27-13 shows vegetation area added after the storm to tentatively protect the shoreline. There is a protected part of the shoreline at Section 27.13, which is characterized by side by side large rock blocks (1.5 to 2.0 m long) placed on top of geotextile (Figure 27-14). It was noted that large voids exist between the blocks and the erosion behind the rocks (landwards).

Figure 27-13 Site 27 Unprotected shoreline subject to erosion

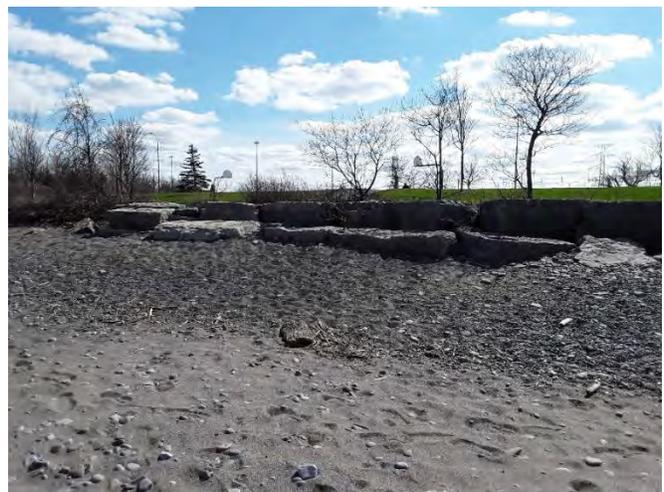
Figure 27-14 Site 27 Shoreline protection structure

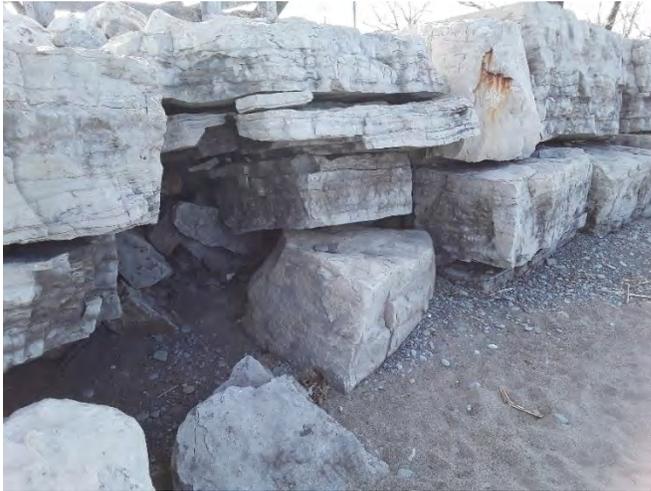
Figure 27-15 shows a detail of the shoreline protection in front of the Lake House. The blocks are not interlocked or stable, creating a safety hazard for the public. It is recommended to add signs to advise the public of the gaps and instability of the structure until repairs are done to this section of this area.

Figure 27-15 Site 27 Shoreline Protection at Lake House

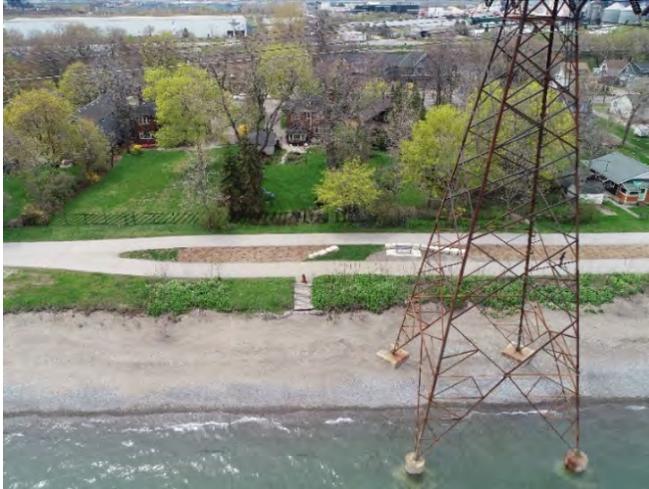
The area of the transmission towers (Section 28.1) is characterized by a vegetated shoreline without protection from any coastal structures. It was noted that pockets of mild erosion exist mostly at the beach access points. The section close to the lift bridge (Section 28.2) was impacted by the 2017 storms and is protected by an engineered design solution.

**Figure 28-1** Transfer Towers area with vegetated shoreline

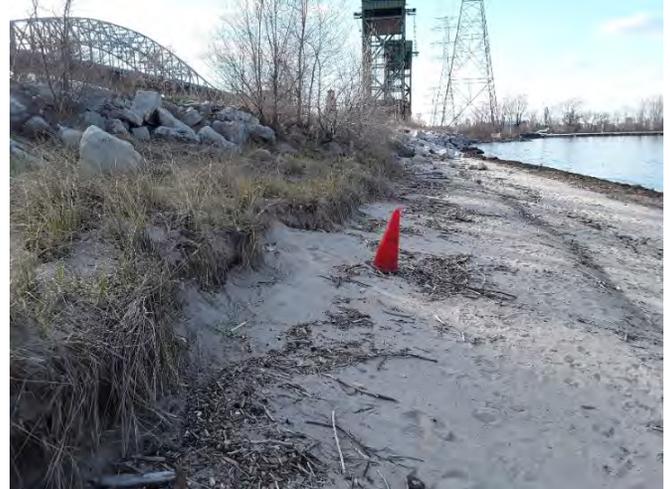
**Figure 28-2** Shoreline protection works in progress

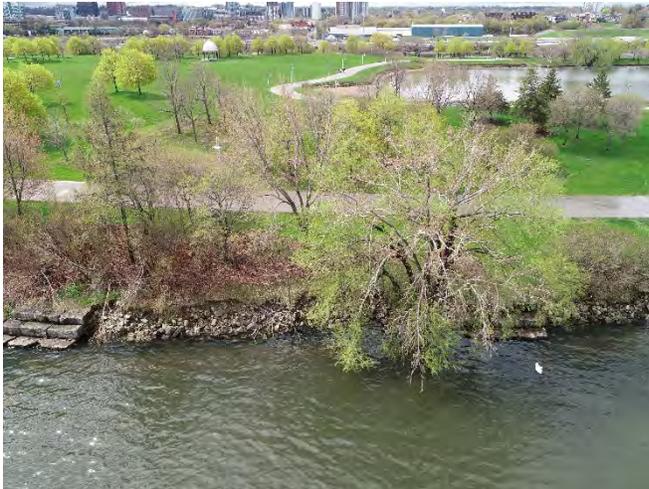
Figure 29-5 Site 29.05 Bayfront Park

29.5	failed rock wall and non-engineered rock protection (smaller rocks), erosion	45
29.6	rock wall with two layers, significant erosion of the back of the wall (grass area)	65

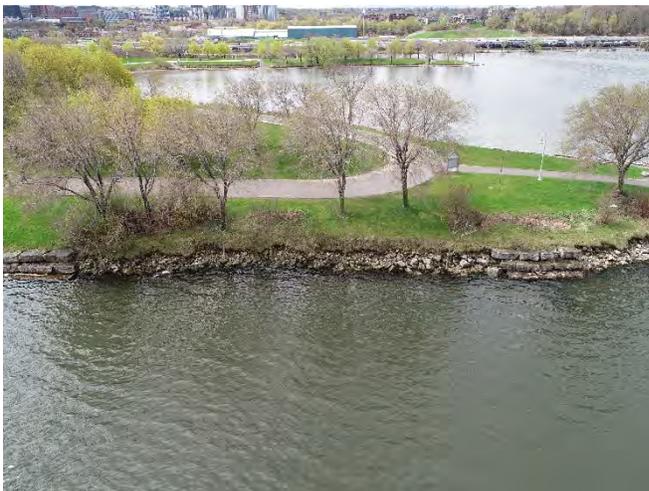
Figure 29-7 Site 29.07 Bayfront Park

29.7	eroded rock wall replaced by non-engineered armour (small rocks, grass area erosion)	50
29.8	rock wall, one layer in two levels, first level is mostly submerged	120

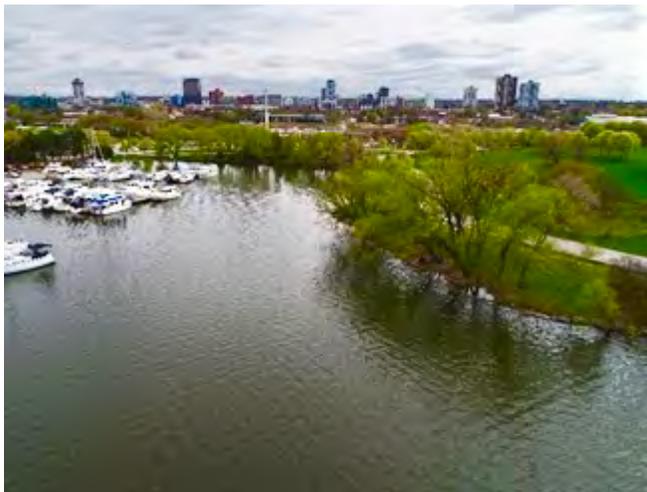
Figure 30-1 Site 30 Macassa Bay Marina

The shoreline assessed consists of approximately 190 m on the east side of the Macassa Bay Marina, adjacent to the Bayfront Park. The site elevation is below the design condition water level. The site is relatively sheltered from wave actions, but the shoreline is submerged in high water level periods even without any wave effects.

Site 30 Macassa Bay Marina	
Conditions	Poor
Crest Elevation	75.9 m IGLD
Solution	Replacement
Options	C

Replacement of the current protection and addition of a headwall is recommended to increase the crest elevation. The performance of the structure will also depend on the conditions / protection of the adjacent properties.

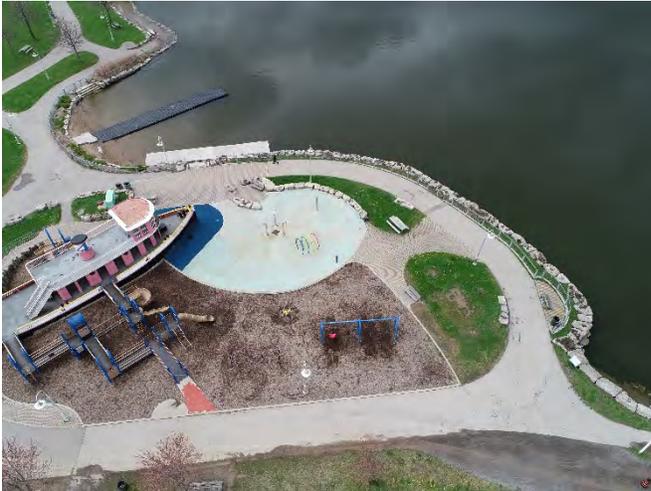
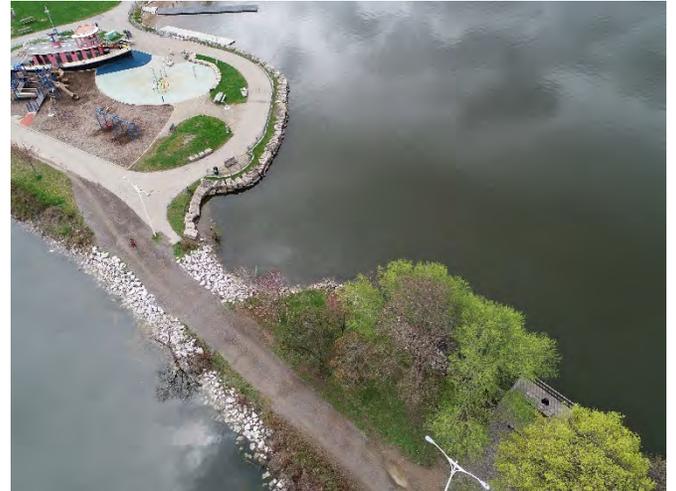
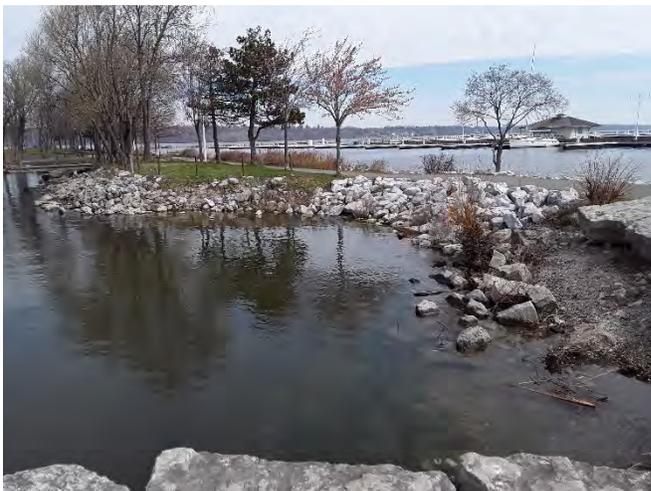
Figure 31-1 Site 31.01 Pier 4 Park

Section Number	Comments	Approx. Length (m)
31.1	scattered rock armour and vegetation. Low elevation, erosion reaching the pathway in some sections	155
31.2	damaged and submerged armour (mostly failed). Very low elevations, part of the pathway submerged.	70
31.3	large rock blocks side by side, low elevation. Rip rap only visible on the east side of the section	70
31.4	unprotected	20
31.5	one layer of large rock blocks not visible but assumed rip rap in front of it (failed). Large gaps between armour rocks with localized erosion	75
31.6	scattered rock armour (mostly failed)	55
31.7	two layers large rock blocks	130
31.8	unprotected shoreline	100
31.9	rock block wall	115
31.10	unprotected shoreline	70
31.11	one layer rock blocks side by side	20

Section Number	Conditions	Solutions	Options
31.1	poor	Repair / Replacement	A1 / B, C
31.2	poor	Repair / Replacement	A1 / B, C
31.3	poor	Replacement	B, C
31.4	very poor	Replacement	B, C, D
31.5	fair	Repair	A1, A2
31.6	poor	Repair / Replacement	A2 / B, C, D
31.7	fair	Repair / Replacement	A2 / B, C, D
31.8	poor	Replacement	C, D
31.9	poor	Replacement	C, D
31.10	poor	Replacement	B, C, D
31.11	poor	Replacement	B, C, D

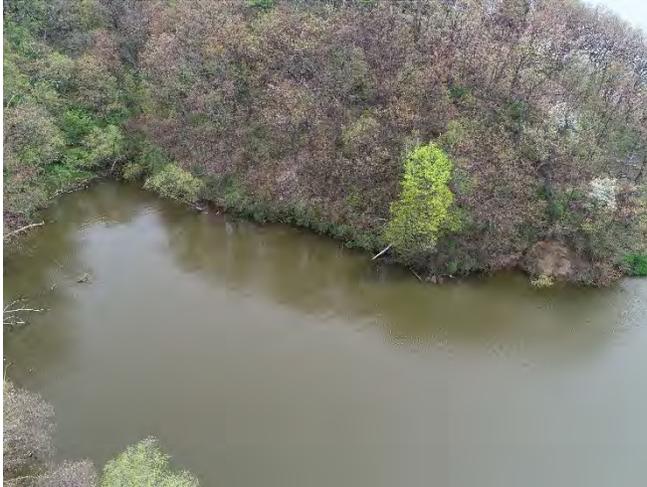
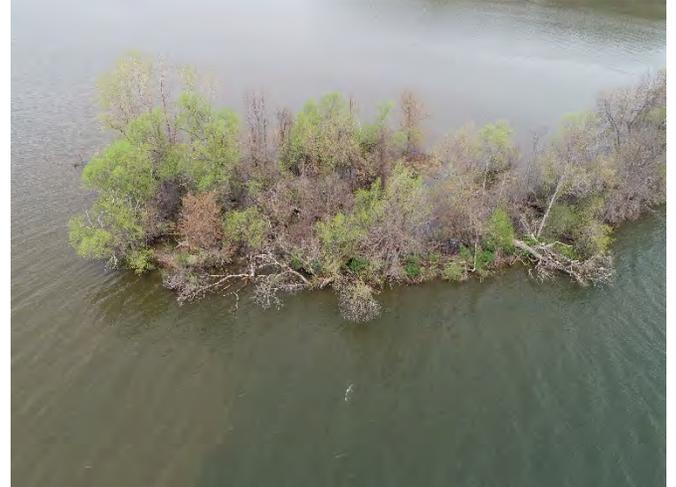
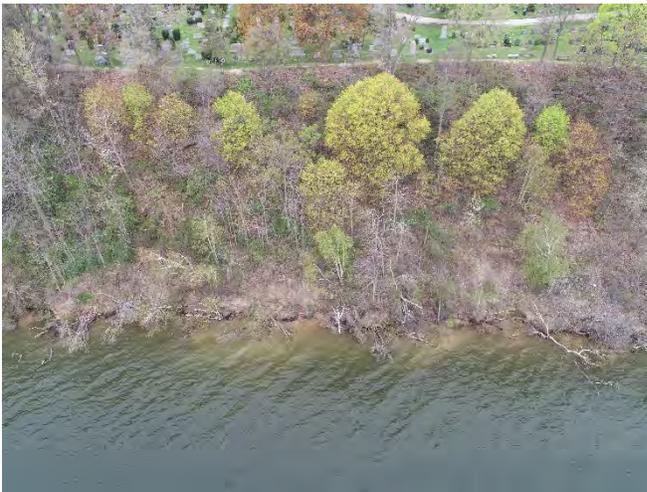
Figure 33-1 Site 33 Woodland Cemetery

Site 33 Woodland Cemetery	
Conditions	Not Rated
Crest Elevation	Various
Solution	Replacement
Options	D
