# Shoreline Inventory and Assessment of City of Hamilton Owned Assets

City of Hamilton

Final Report

Document No. 663821-1000-4PER-0001\_R0.docx

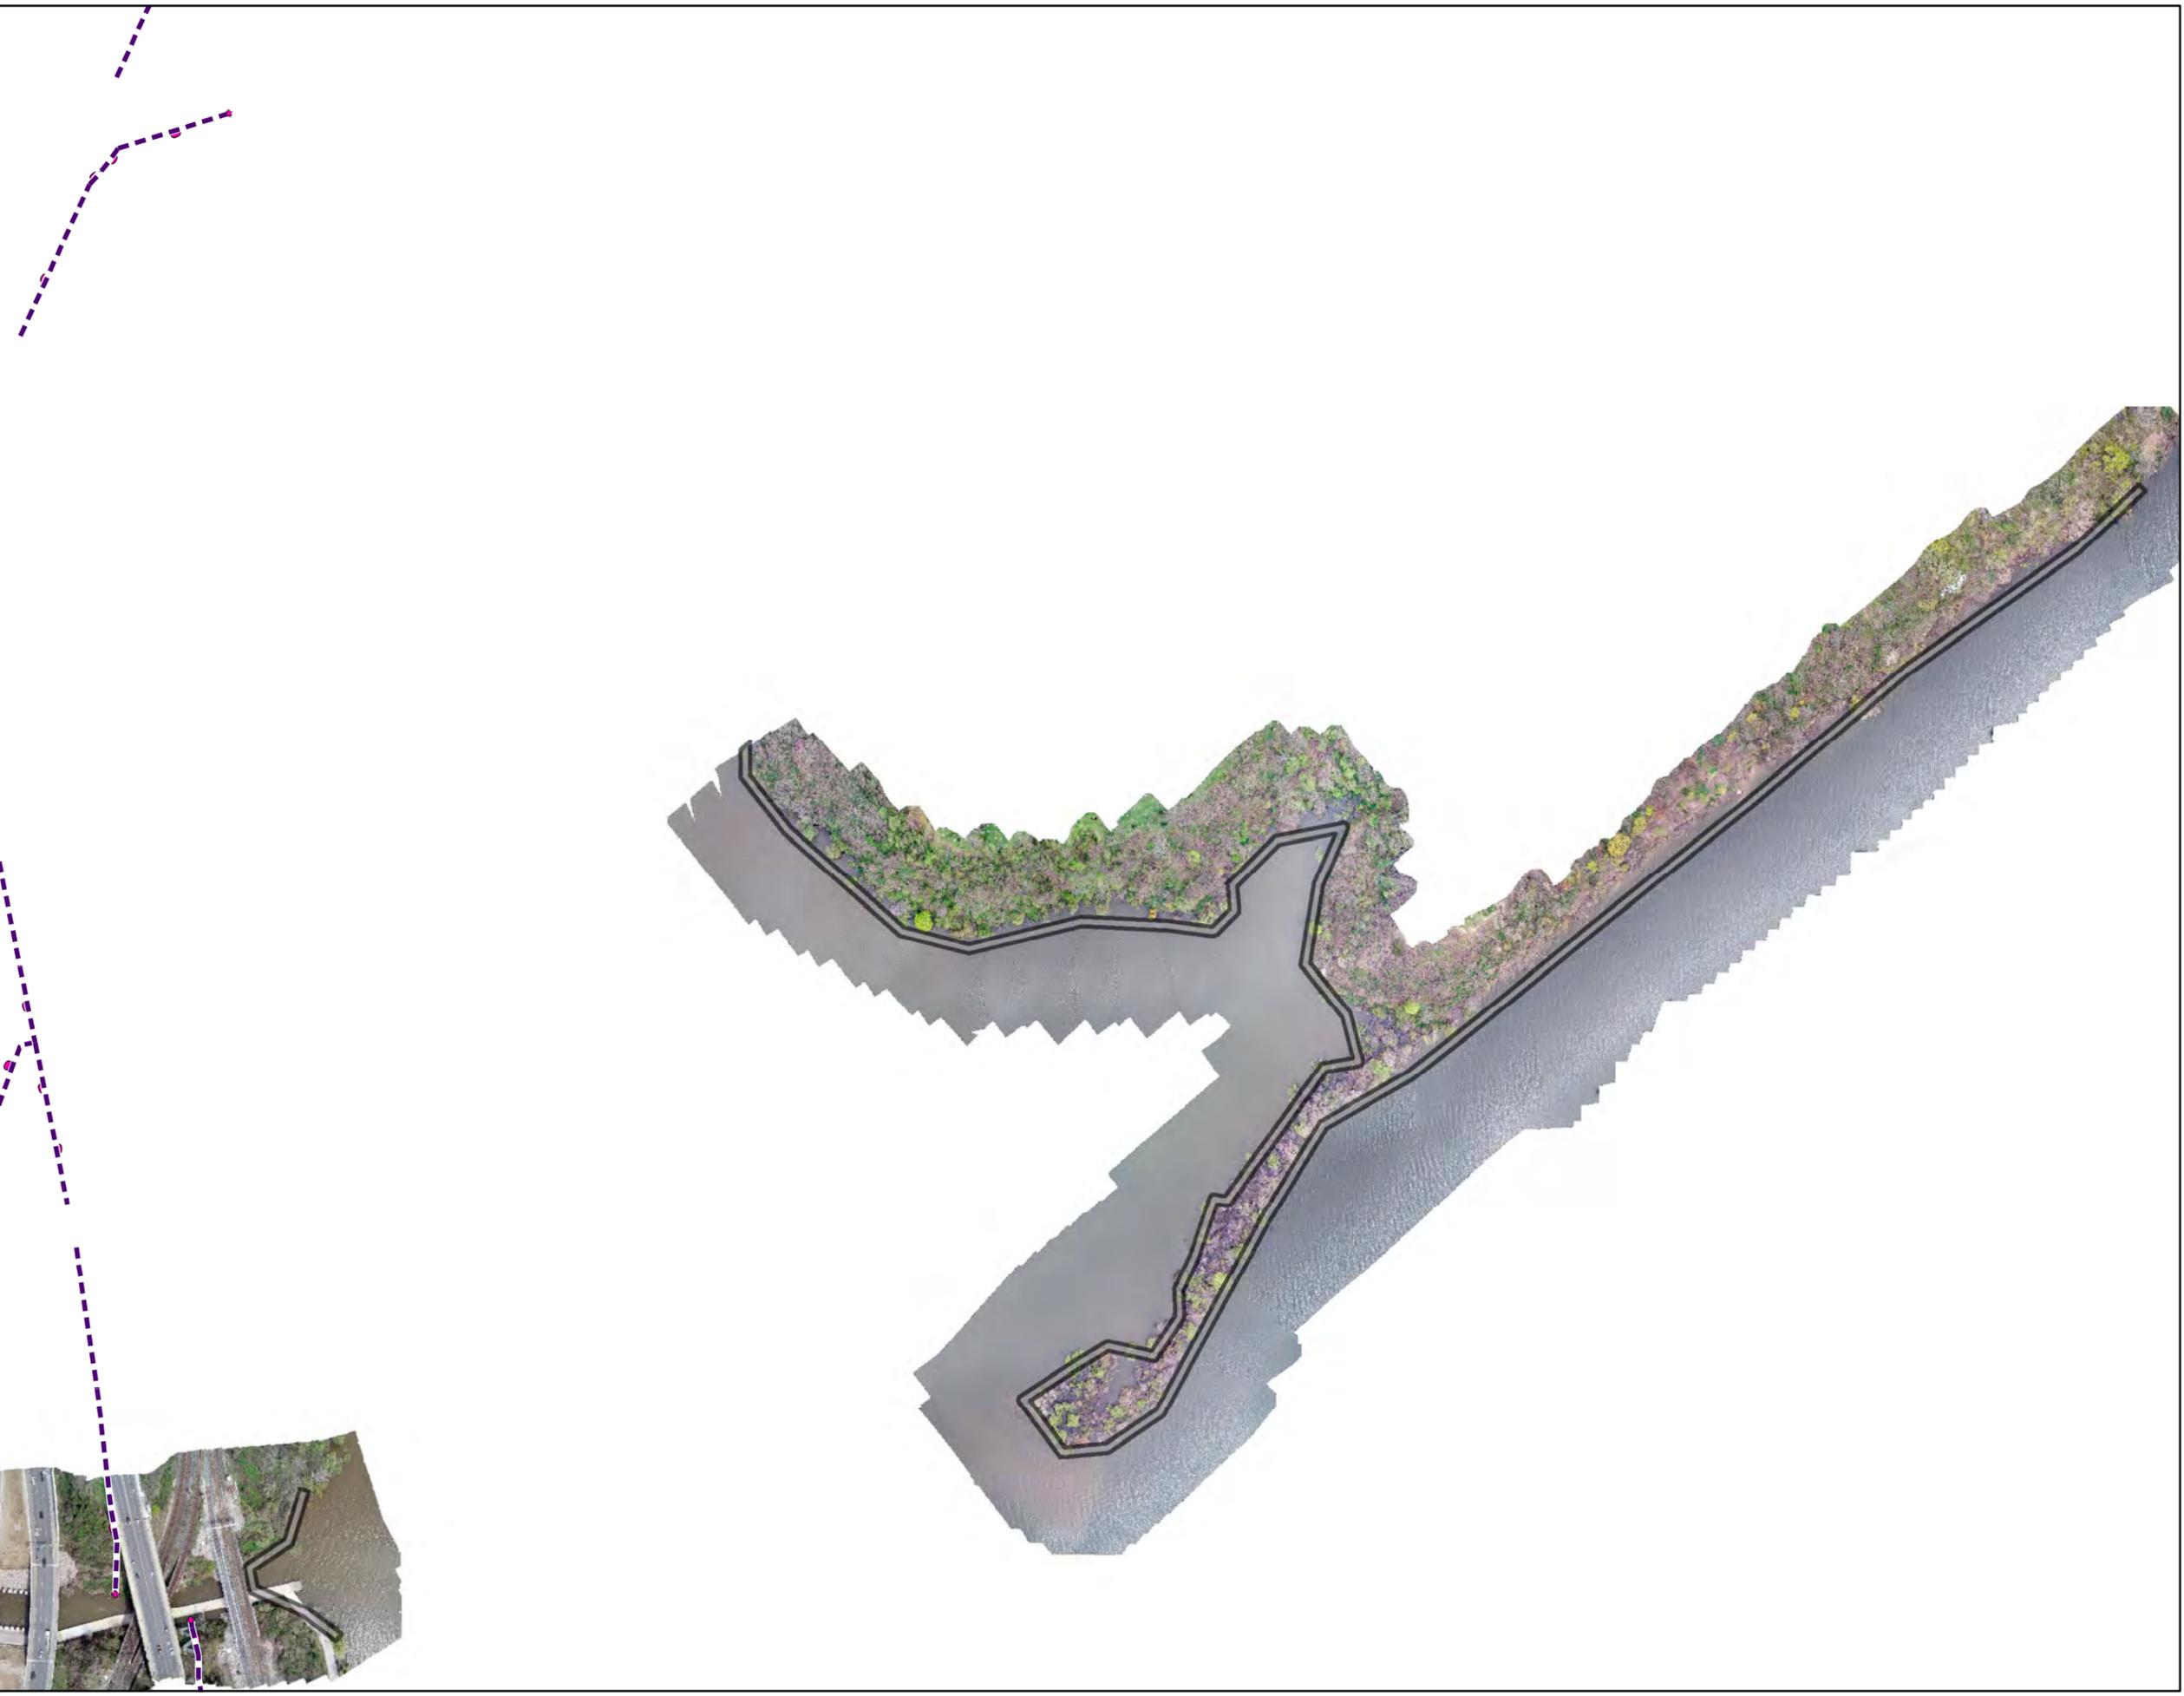
City of Hamilton  
 2019 Shoreline Assessment  
**Site 32&33**  
**Desjardins Canal & Woodland Cemetery**

Site 32 Desjardins Canal	
Conditions	Not Rated
Crest Elevation	-
Solution	-
Options	-

Site 33 Woodland Cemetery	
Conditions	Not Rated
Crest Elevation	Various
Solution	Replacement
Options	D

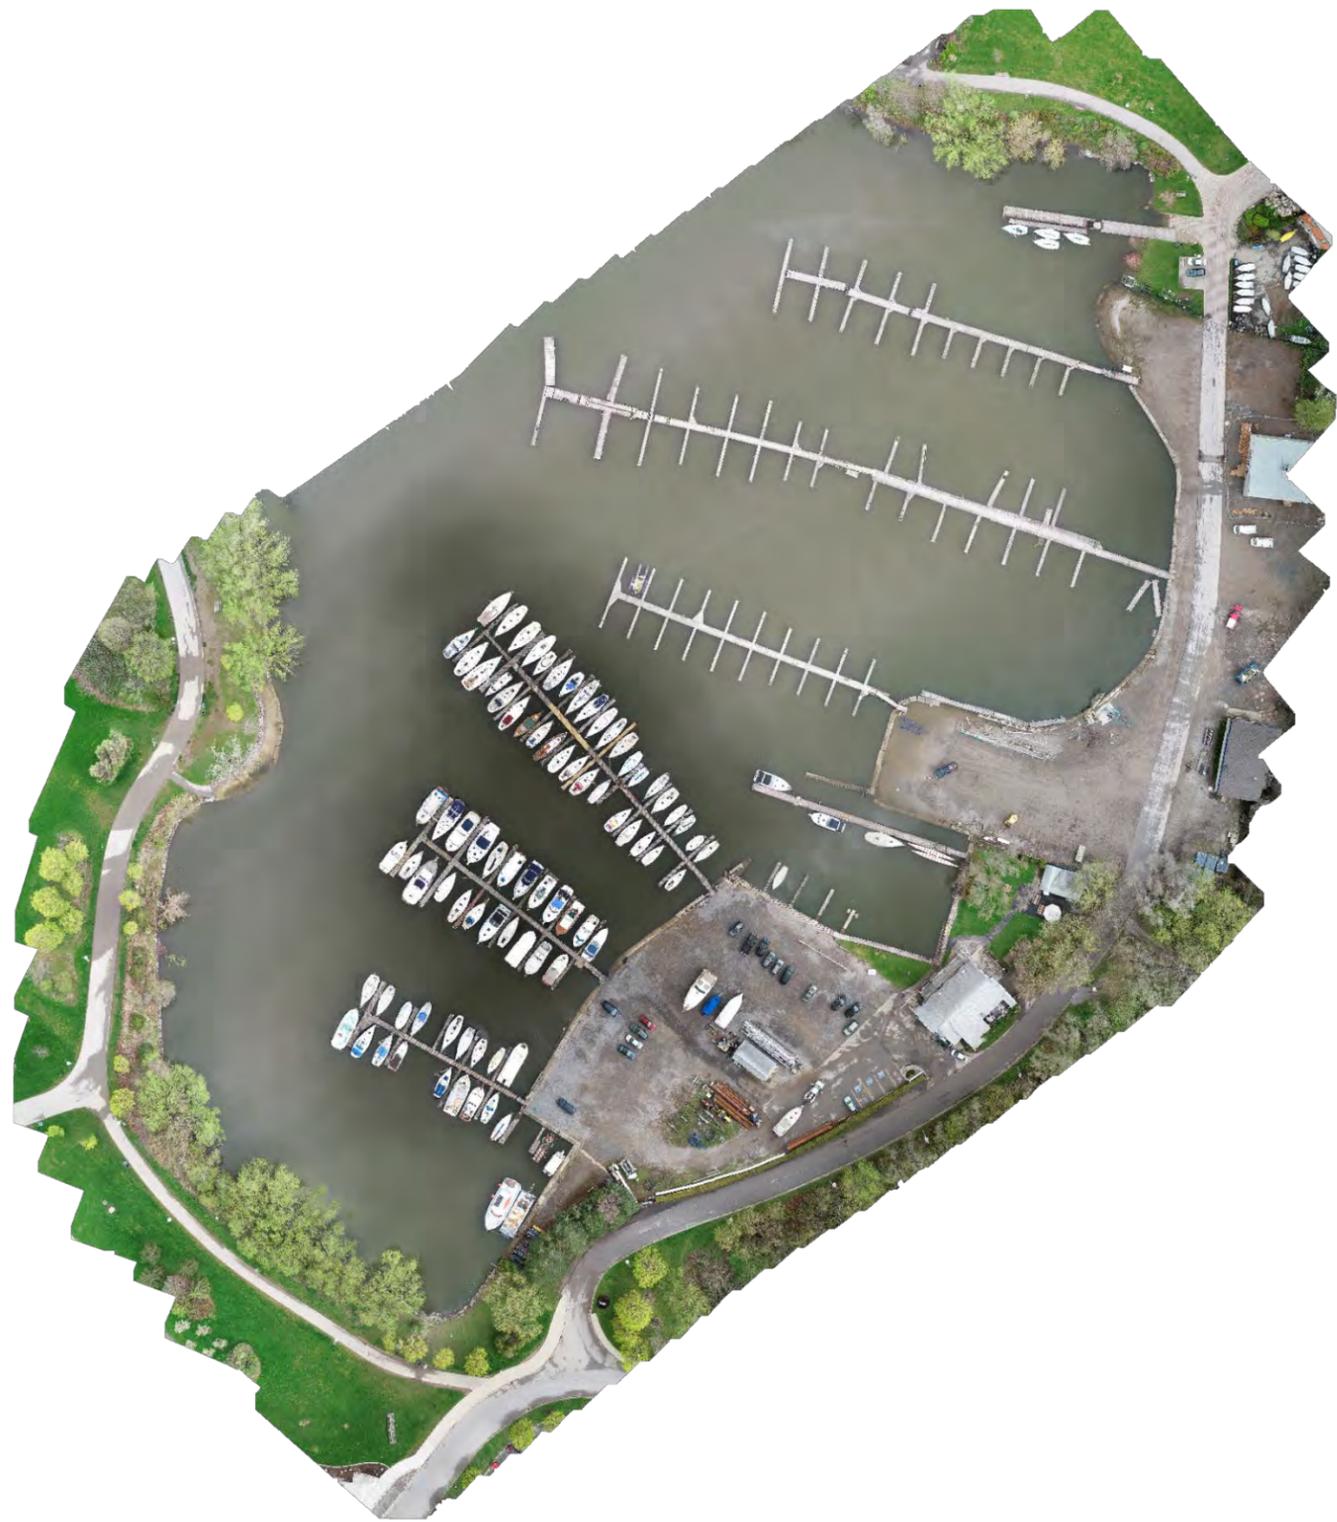
## Site 30 Macassa Bay Marina – Assessed Condition: Poor

Site 30 Macassa Bay Marina	
Conditions	Poor
Crest Elevation	75.9 m IGLD
Solution	Replacement
Options	C

Replacement of the current protection and addition of a headwall is recommended to increase the crest elevation. The performance of the structure will also depend on the conditions / protection of the adjacent properties.

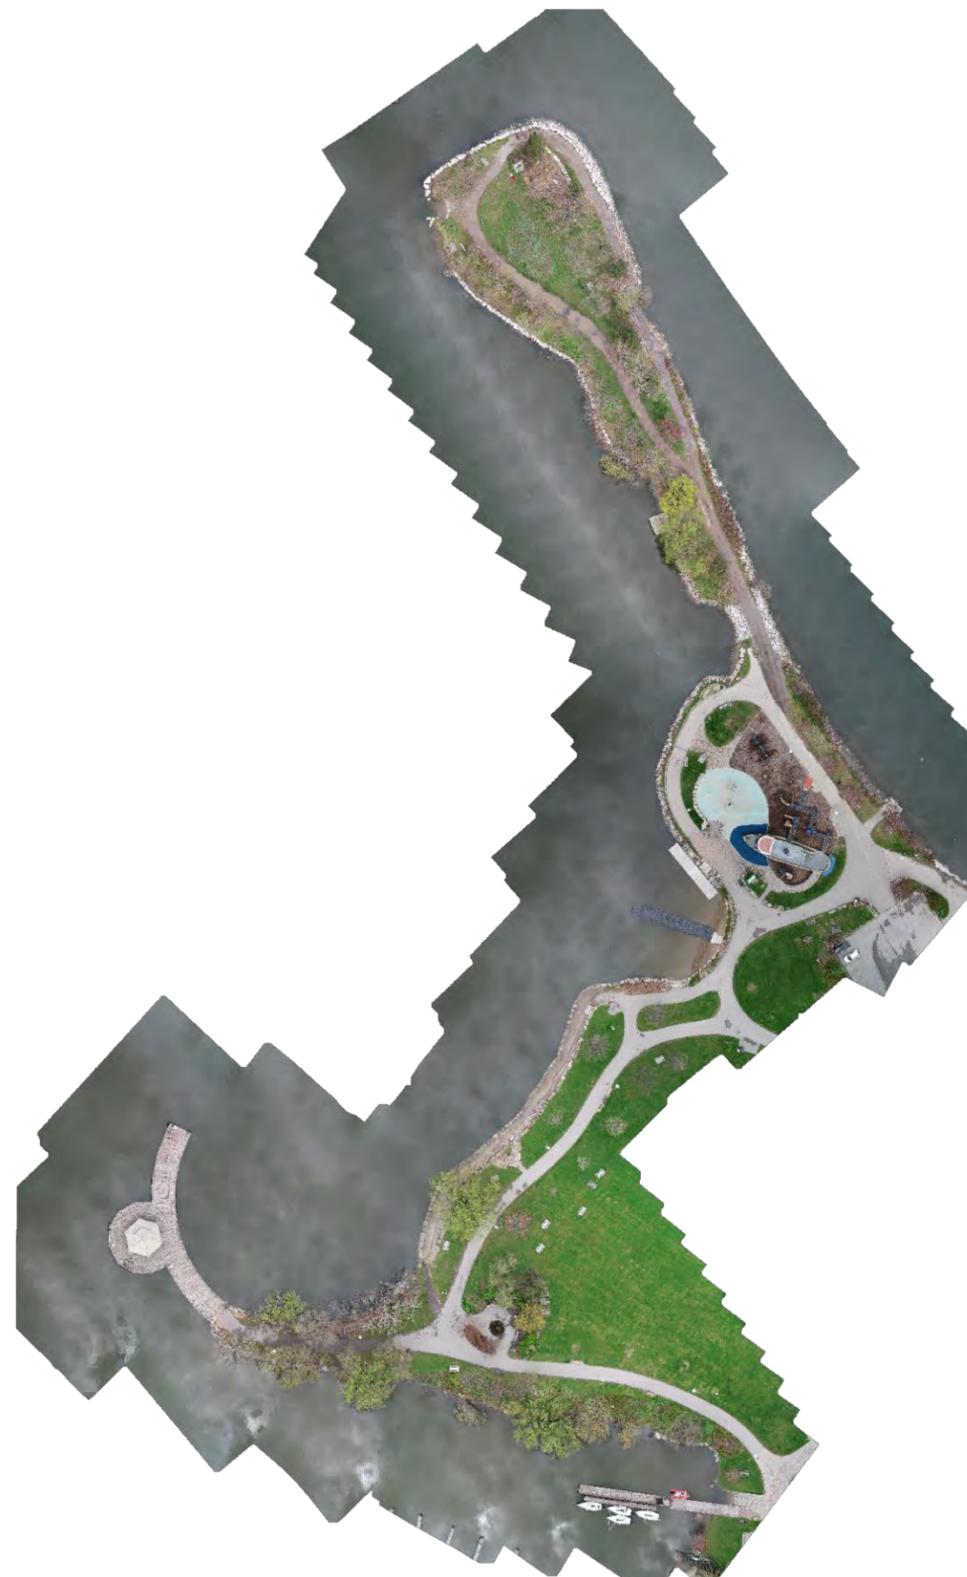
Site 31 Pier 4 Park

Section Number	Comments	Approx. Length (m)
31.1	scattered rock armour and vegetation. Low elevation, erosion reaching the pathway in some sections	155
31.2	damaged and submerged armour (mostly failed). Very low elevations, part of the pathway submerged.	70
31.3	large rock blocks side by side, low elevation. Rip rap only visible on the east side of the section	70
31.4	unprotected	20
31.5	one layer of large rock blocks not visible but assumed rip rap in front of it (failed). Large gaps between armour rocks with localized erosion	75
31.6	scattered rock armour (mostly failed)	55
31.7	two layers large rock blocks	130
31.8	unprotected shoreline	100
31.9	rock block wall	115
31.10	unprotected shoreline	70
31.11	one layer rock blocks side by side	20

Section Number	Conditions	Solutions	Options
31.1	poor	Repair / Replacement	A1 / B, C
31.2	poor	Repair / Replacement	A1 / B, C
31.3	poor	Replacement	B, C
31.4	very poor	Replacement	B, C, D
31.5	fair	Repair	A1, A2
31.6	poor	Repair / Replacement	A2 / B, C, D
31.7	fair	Repair / Replacement	A2 / B, C, D
31.8	poor	Replacement	C, D
31.9	poor	Replacement	C, D
31.10	poor	Replacement	B, C, D
31.11	poor	Replacement	B, C, D

Similar to Site 29B, recommendations for repairing the shoreline are not feasible without a Master Plan of the overall area to re-define the public areas and to re-arrange the public pathways appropriately, given the low-lying character of the area. Table 7 summarizes the site sections and conditions.

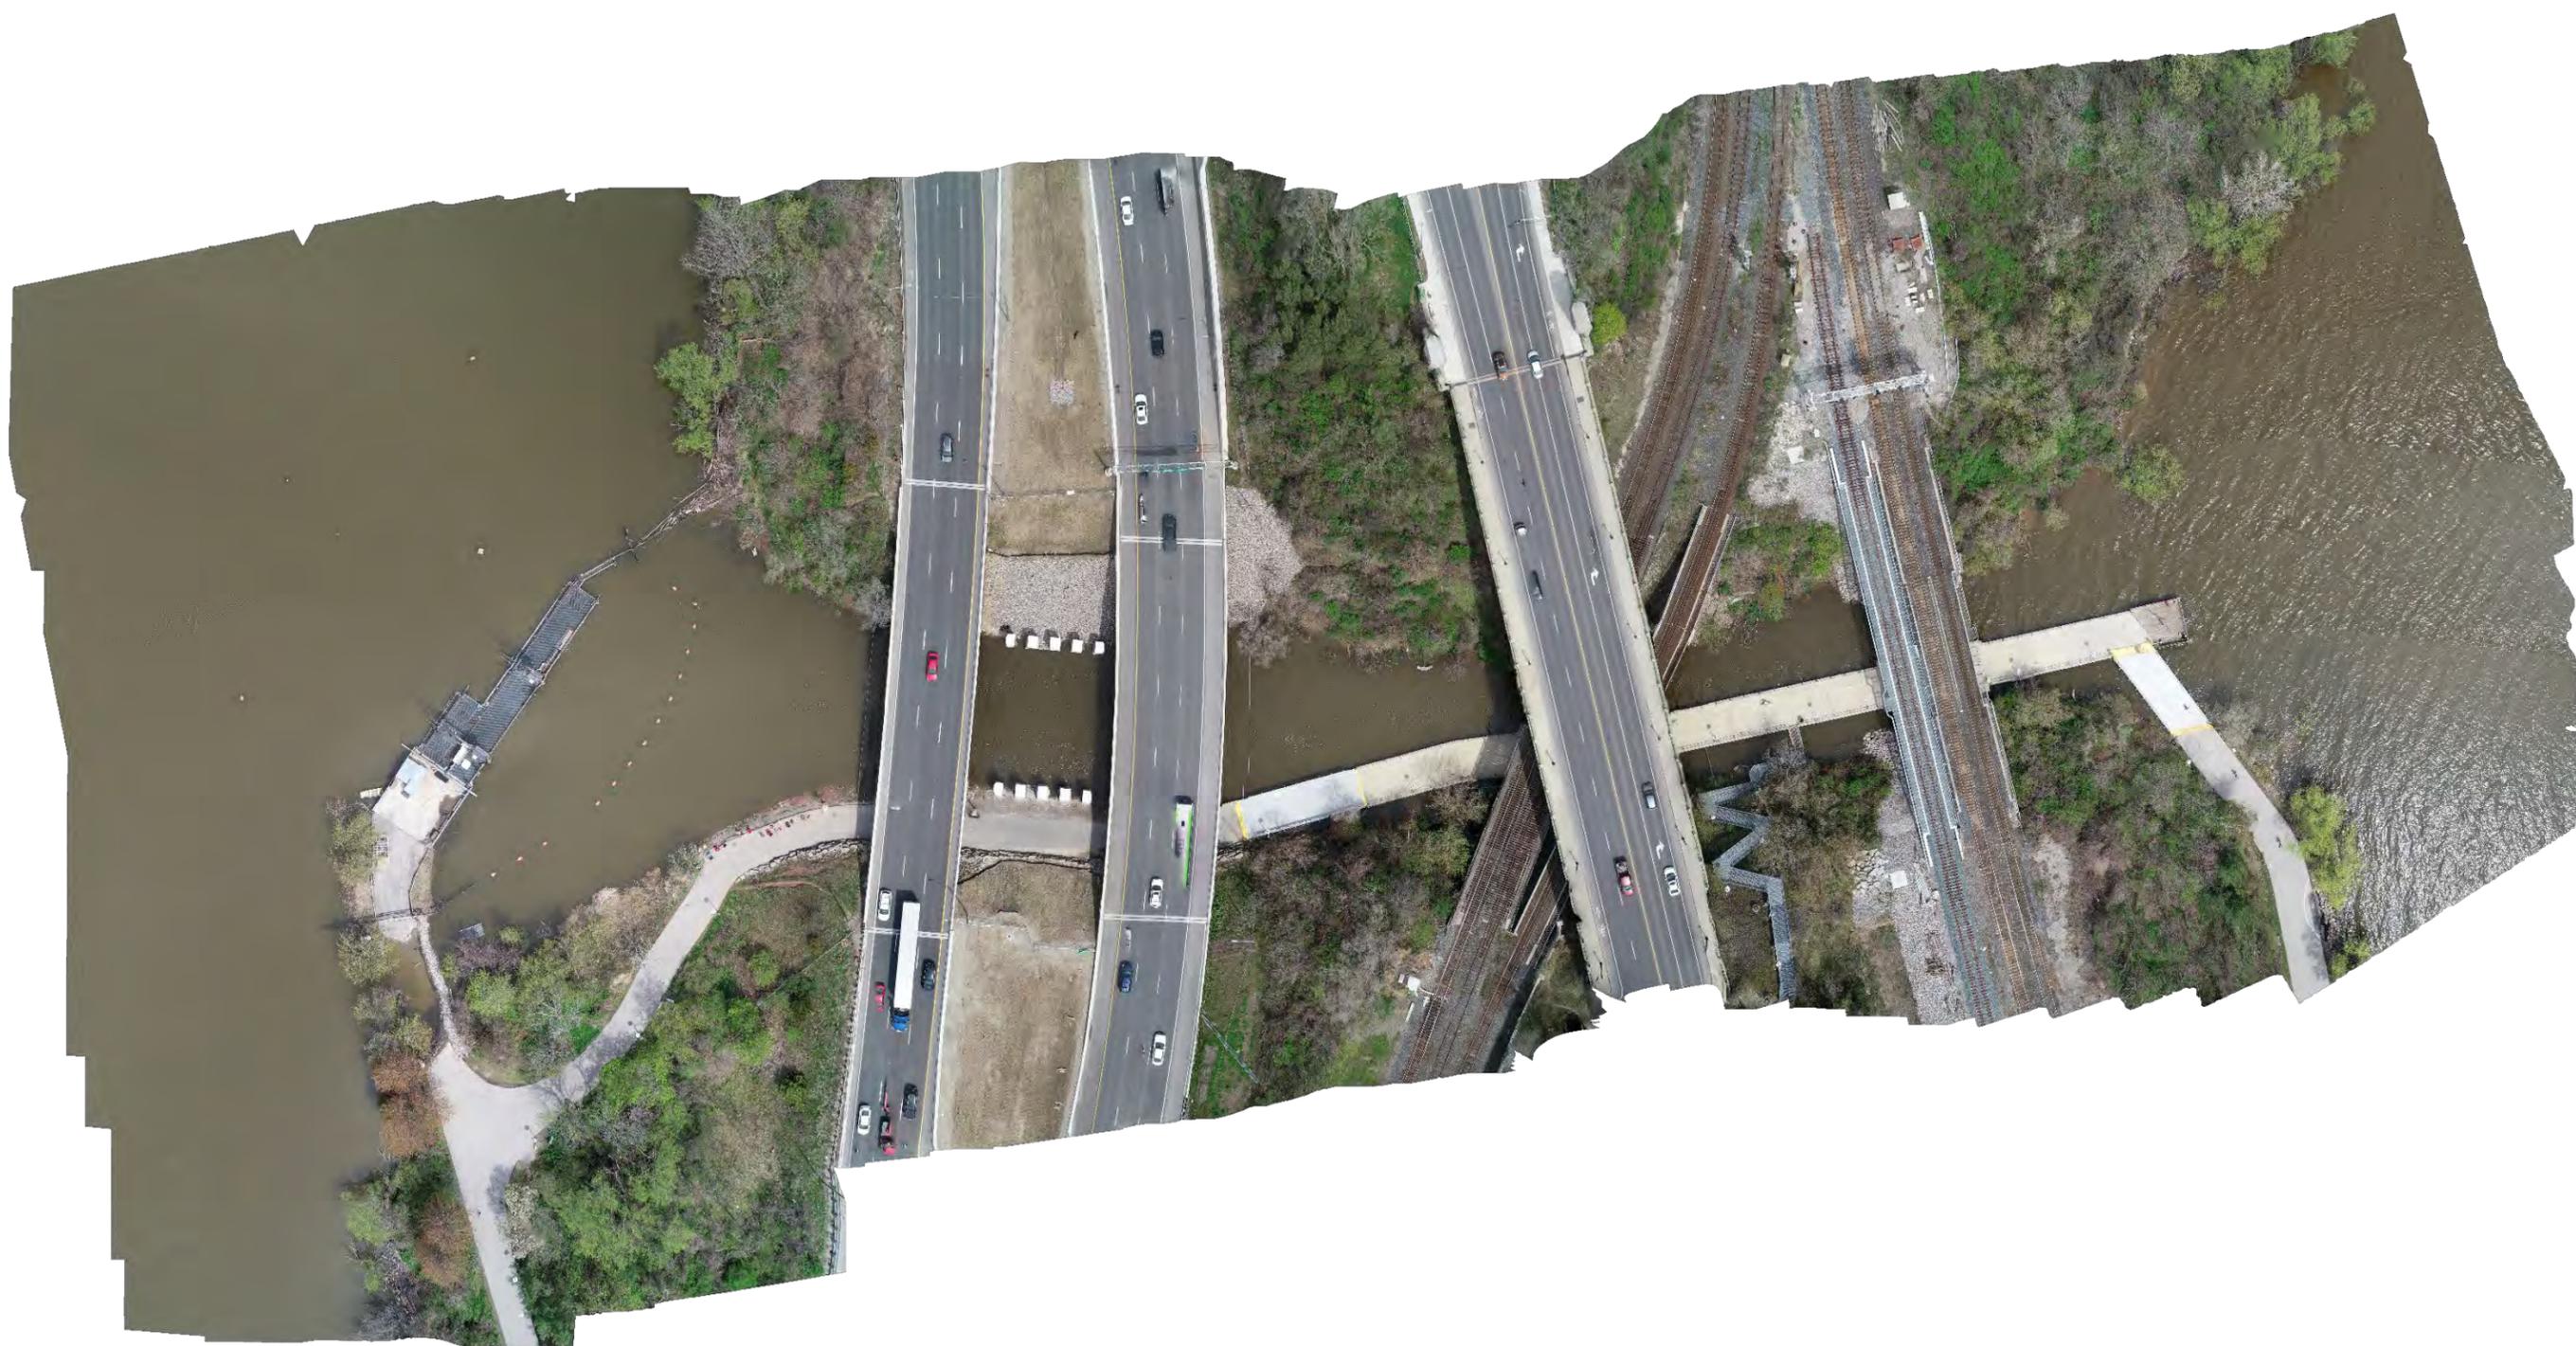
Site 32 Desjardins Canal

## Site 32 Desjardins Canal– Assessed Condition: Not Rated

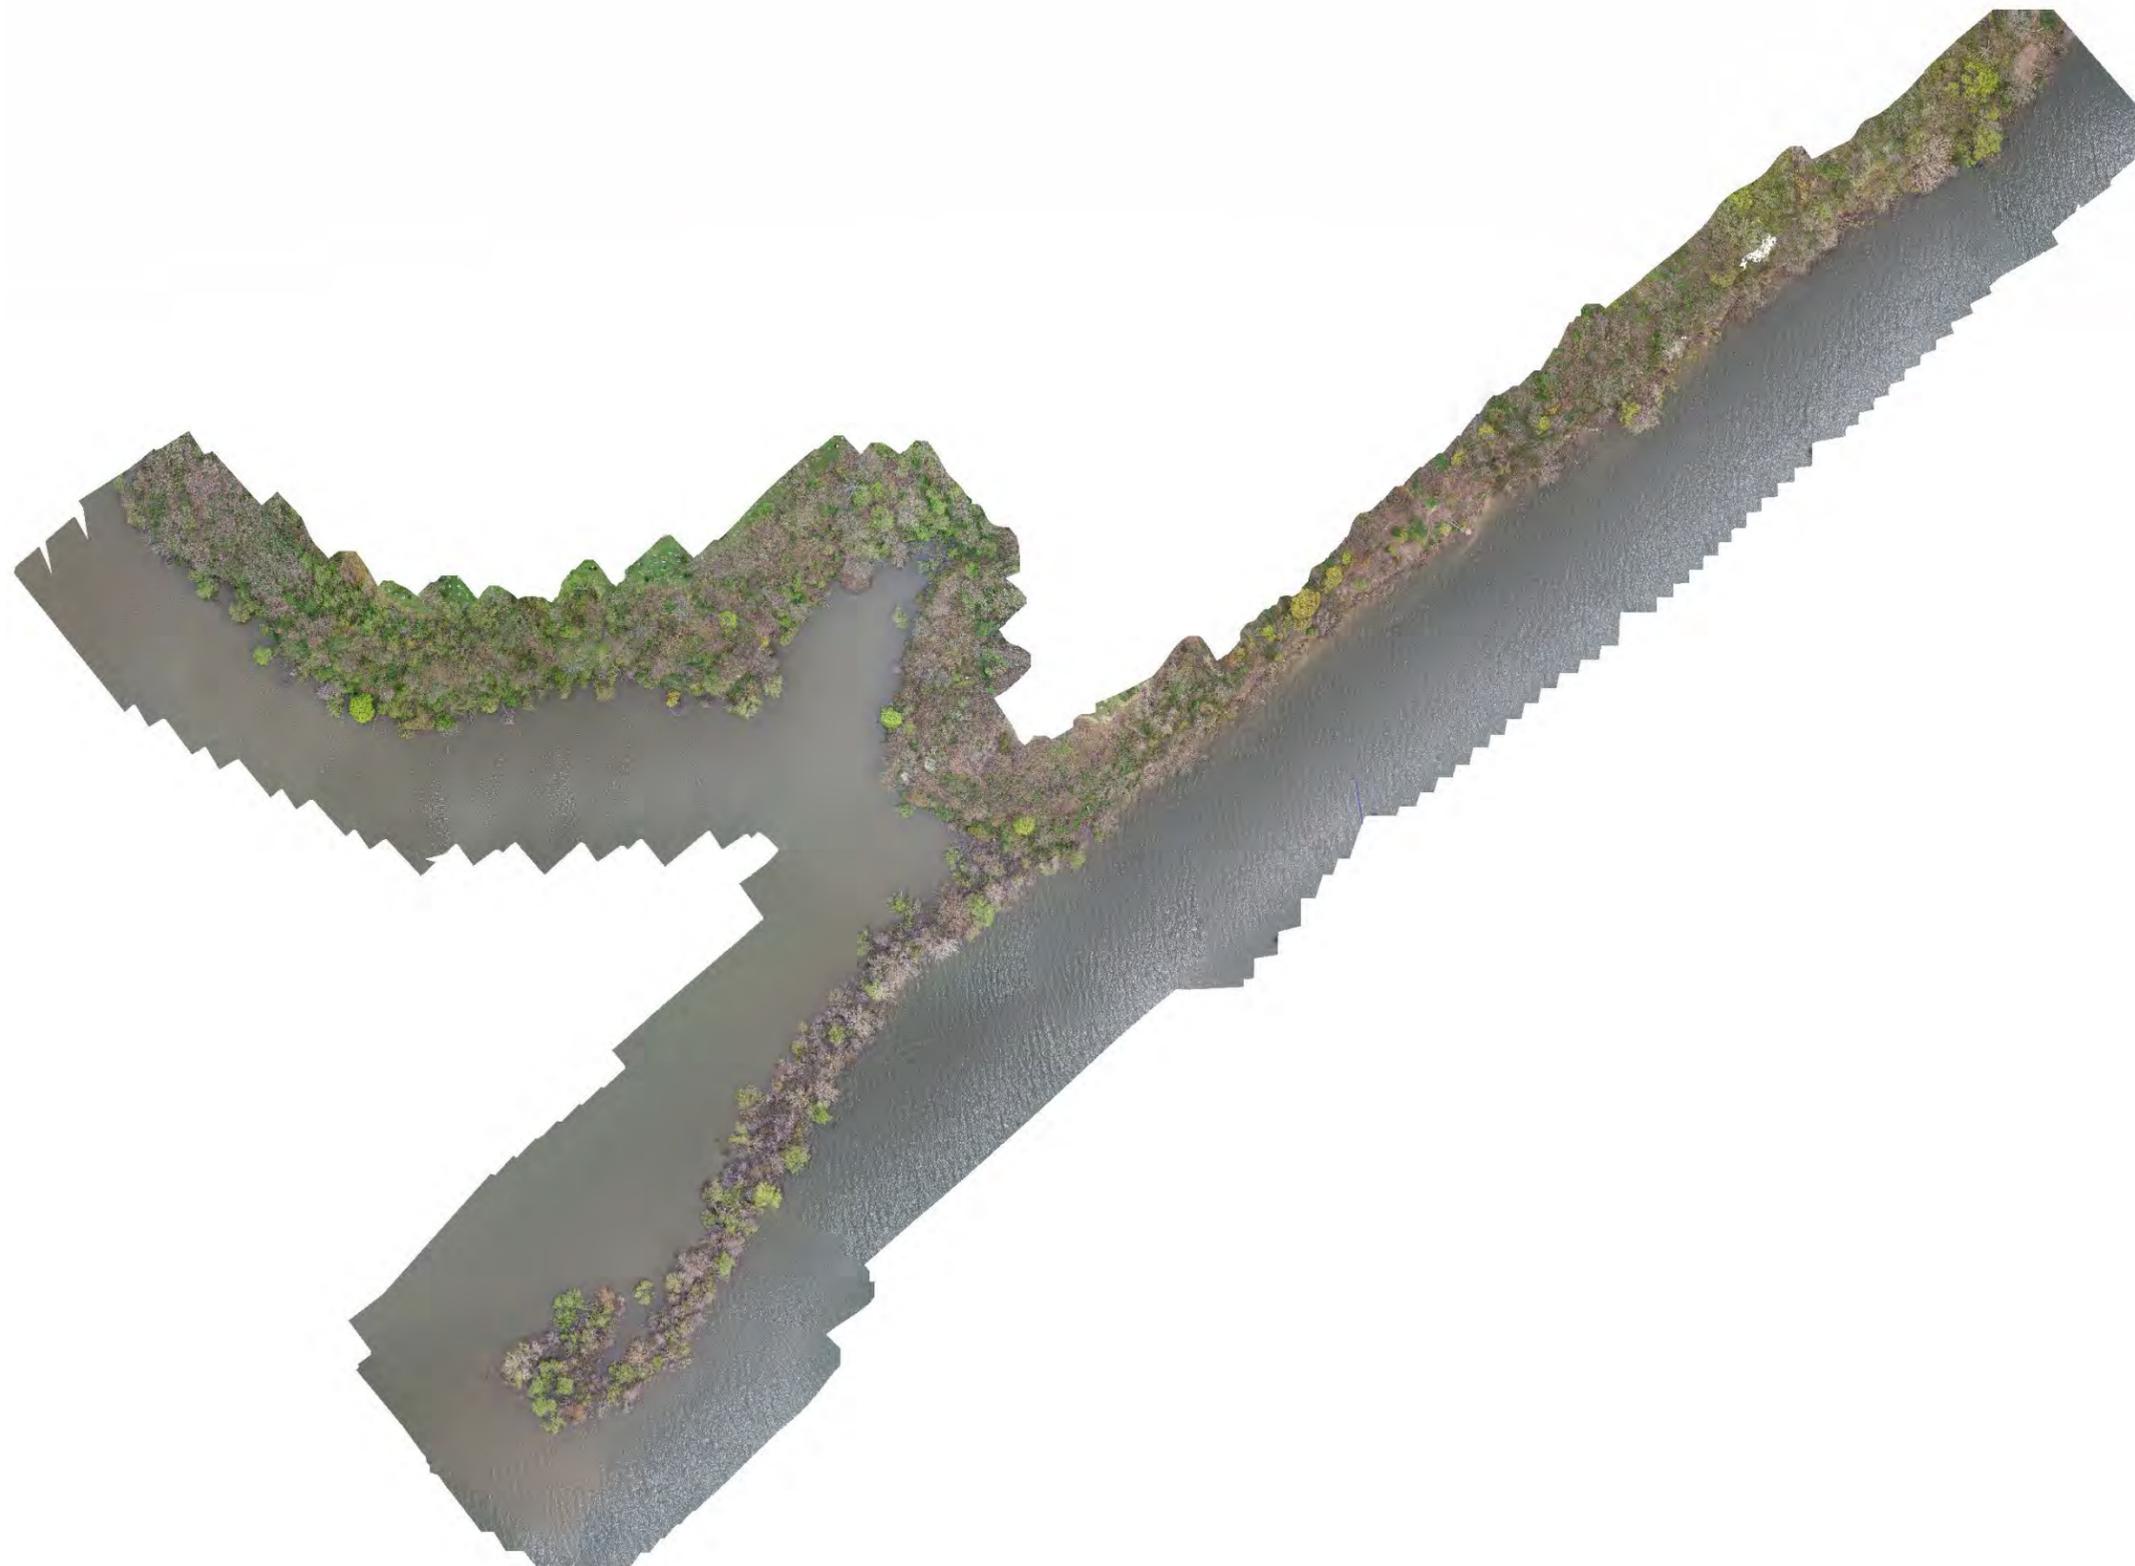
## Site 33 Woodland Cemetery – Assessed Condition: Not Rated
