Fluvial Geomorphology

Fluvial Geomorphology Study Fruitland-Winona Block 1 Servicing Strategy City of Hamilton, Ontario

March 8, 2024
PN21043

Report Title: Fluvial Geomorphology Study - Fruitland-Winona Block 1
Servicing Strategy

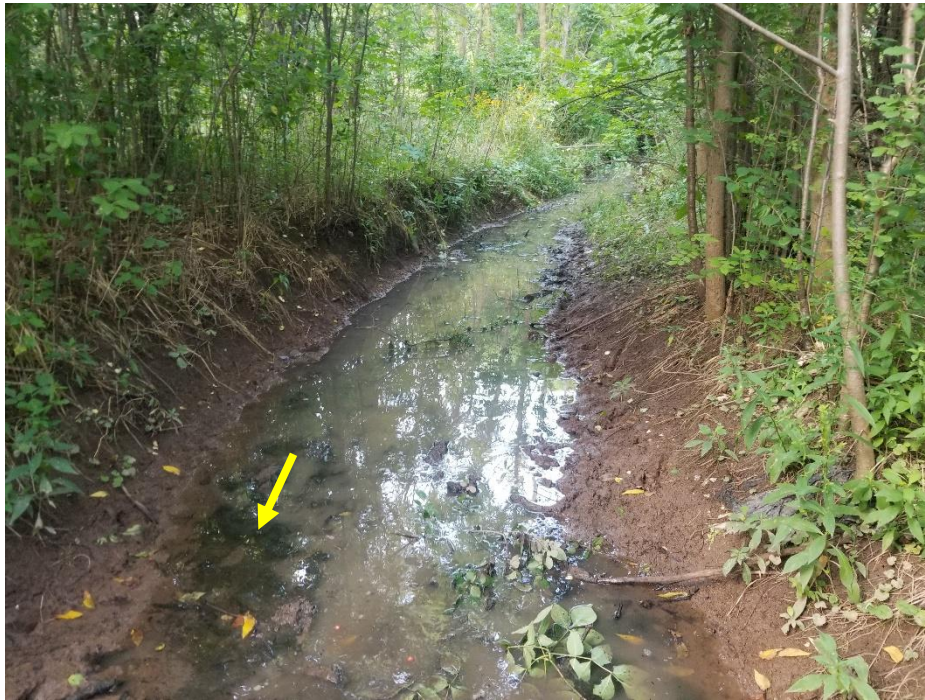
Photo 7
Reach **WC5**

Exposed material is common at toe of bank. Riparian vegetation provides some level of stabilization, but roots are typically small and immature.

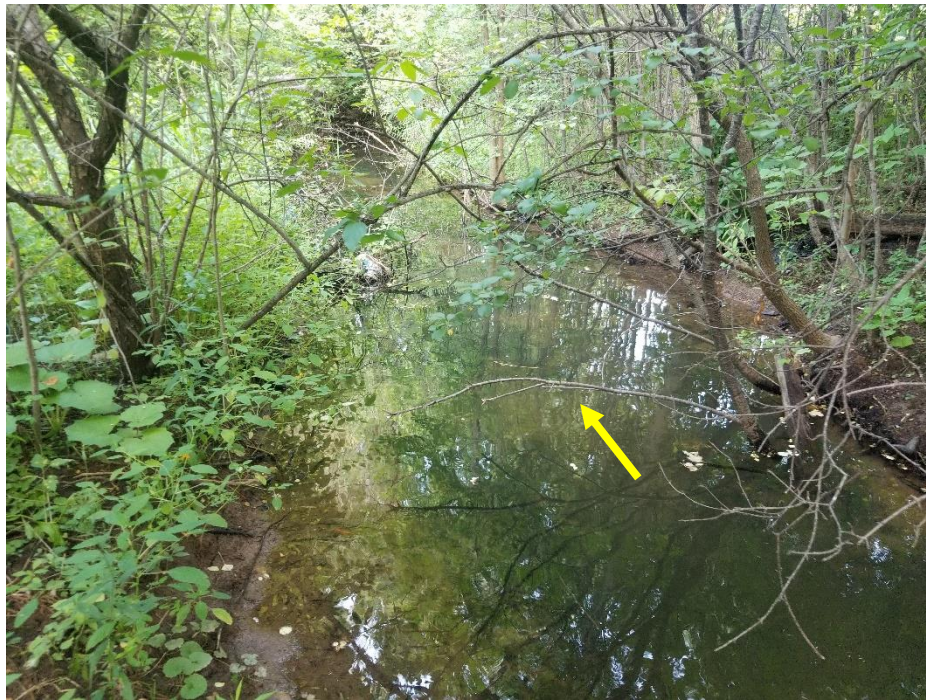
Evidence of erosion largely subsides near the downstream extent, as the channel exhibits more depositional tendencies, indicated by siltation on the bed.

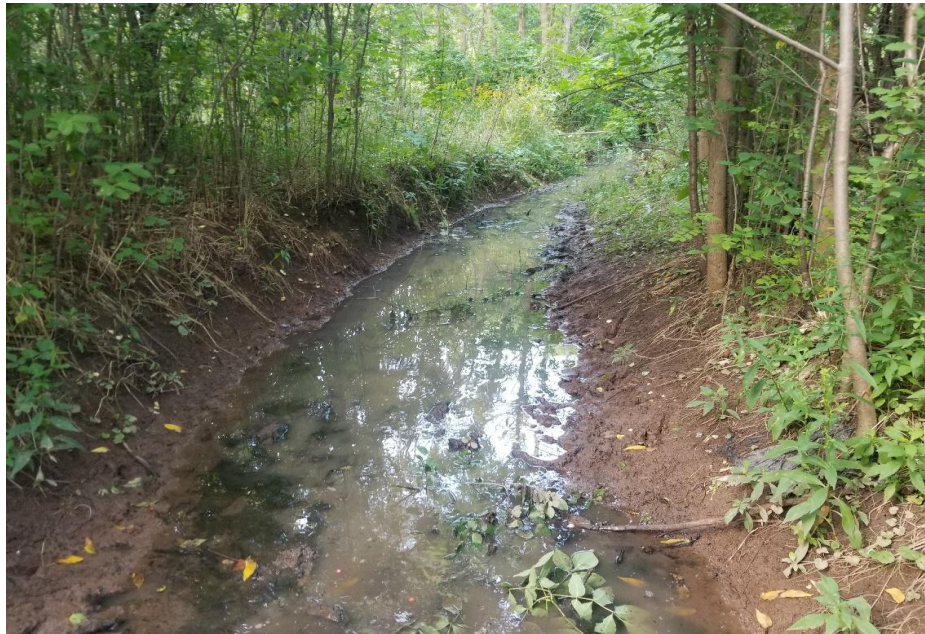
Photo of typical channel conditions, facing upstream

Watercourse 5 flows through an unconfined valley surrounded by a mix of residential and agricultural areas. The continuous extent of riparian vegetation consists of grasses, herbaceous vegetation, shrubs, and trees. This vegetation is established on the landscape and only minimally encroaches upon the channel. The average bankfull width and depth are 3.64 m and 0.34 m, respectively. Both the bed and bank material is comprised primarily of a compact silty clay loam, with trace amounts of shale pebbles observed. No riffle-pool sequences are present within the reach. The channel generally exhibits a trapezoidal cross-section shape, with bank angles ranging from 30 to 85. Undercutting and active erosion of the banks was not prevelant. Flow velocities were imperceptible during the assessment.
