FINAL REPORT

Cultural Heritage Impact Assessment

Twenty Road West Plan of Subdivision in Glanbrook, City of Hamilton, Ontario

19125764-R01

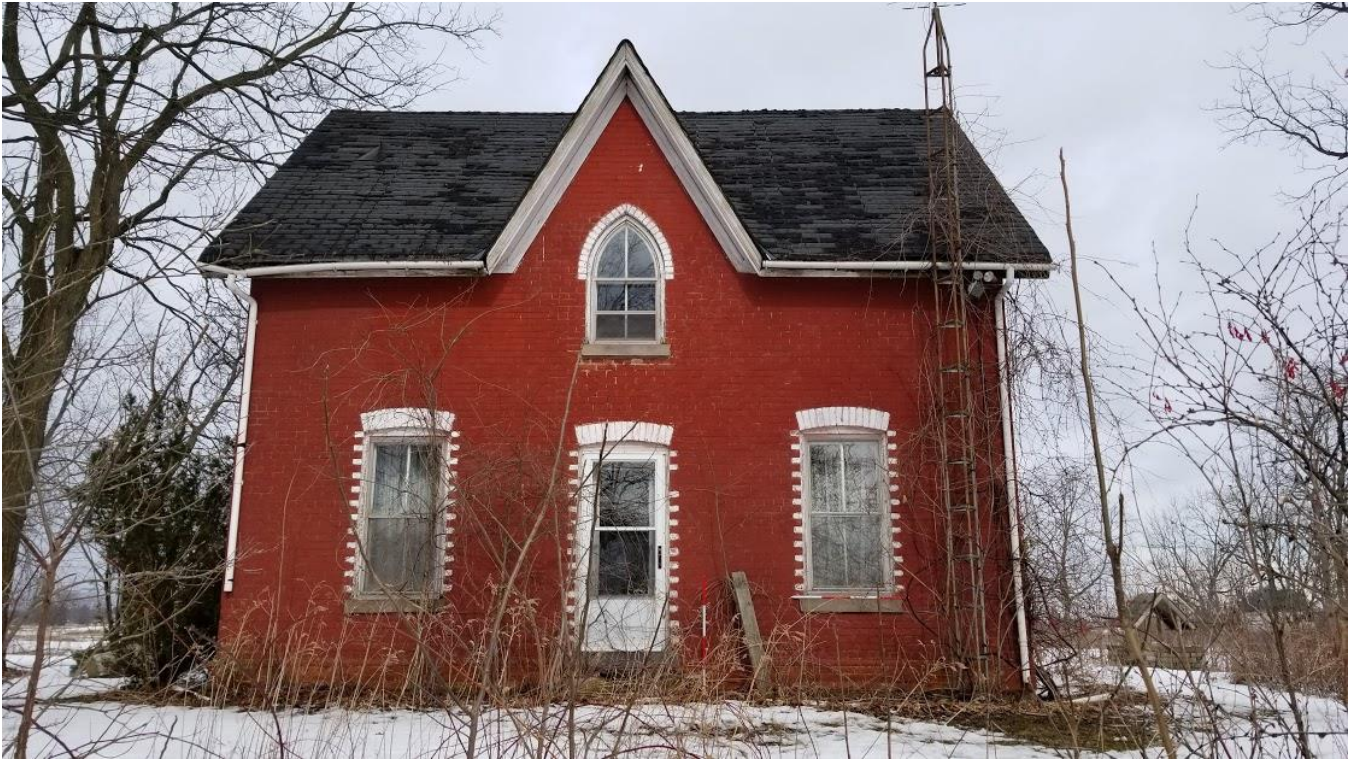
Figure 32: 9751 Twenty Road West: South façade

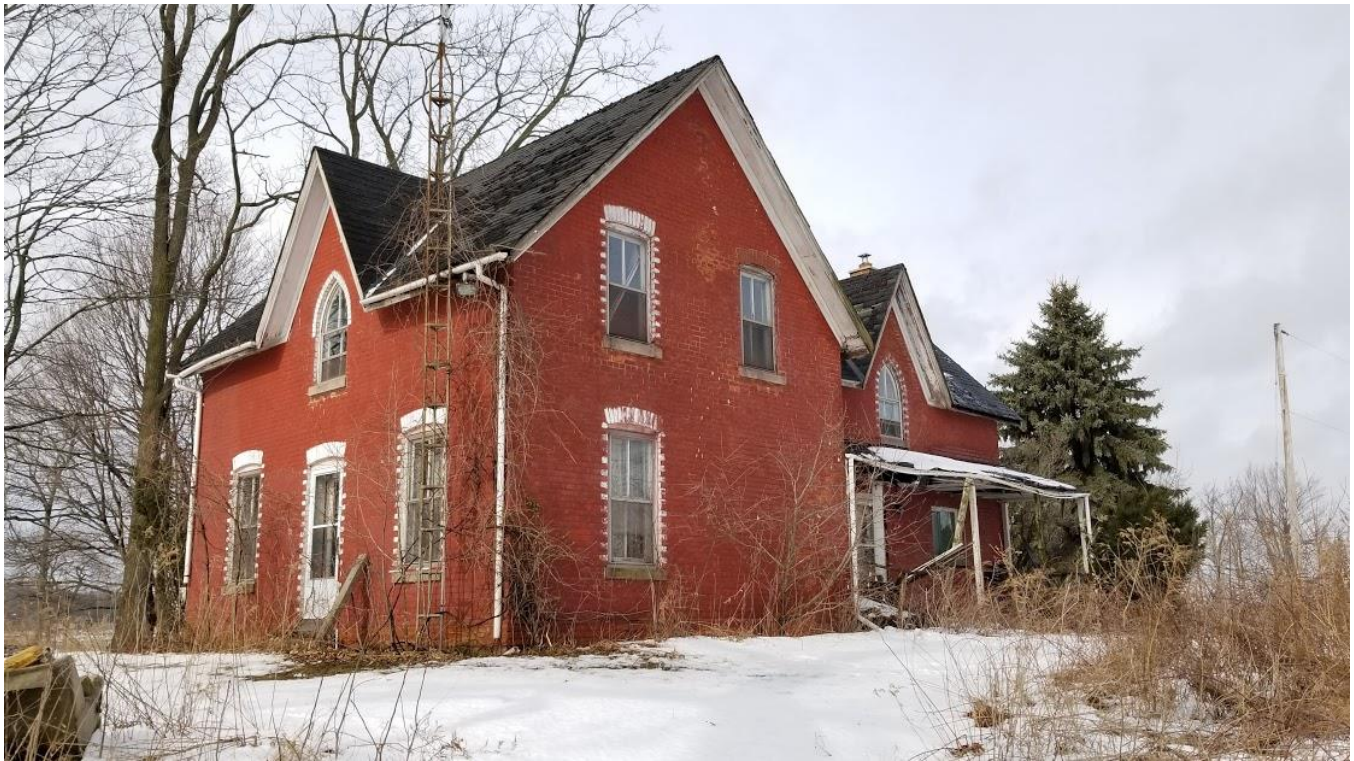
Figure 33: 9751 Twenty Road West: South and east façades

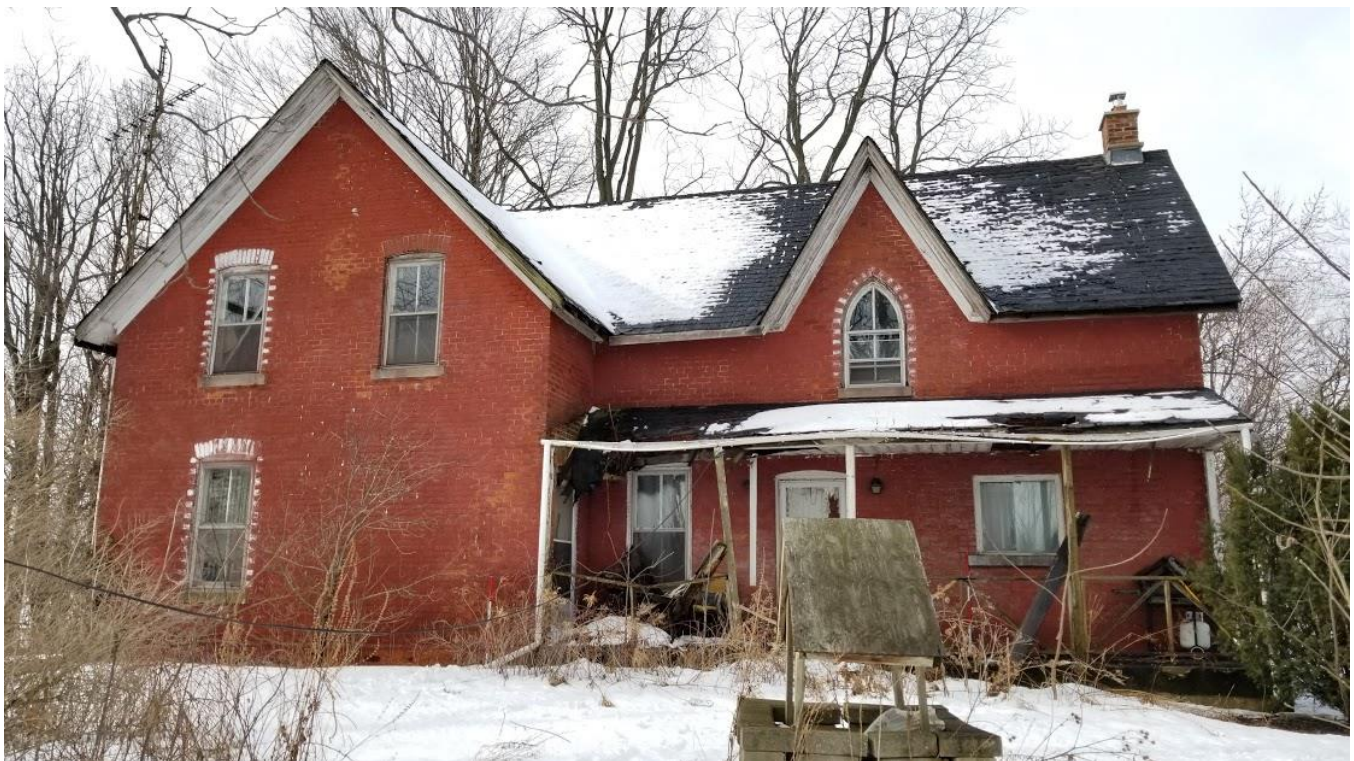
Figure 34: 9751 Twenty Road West: East façade

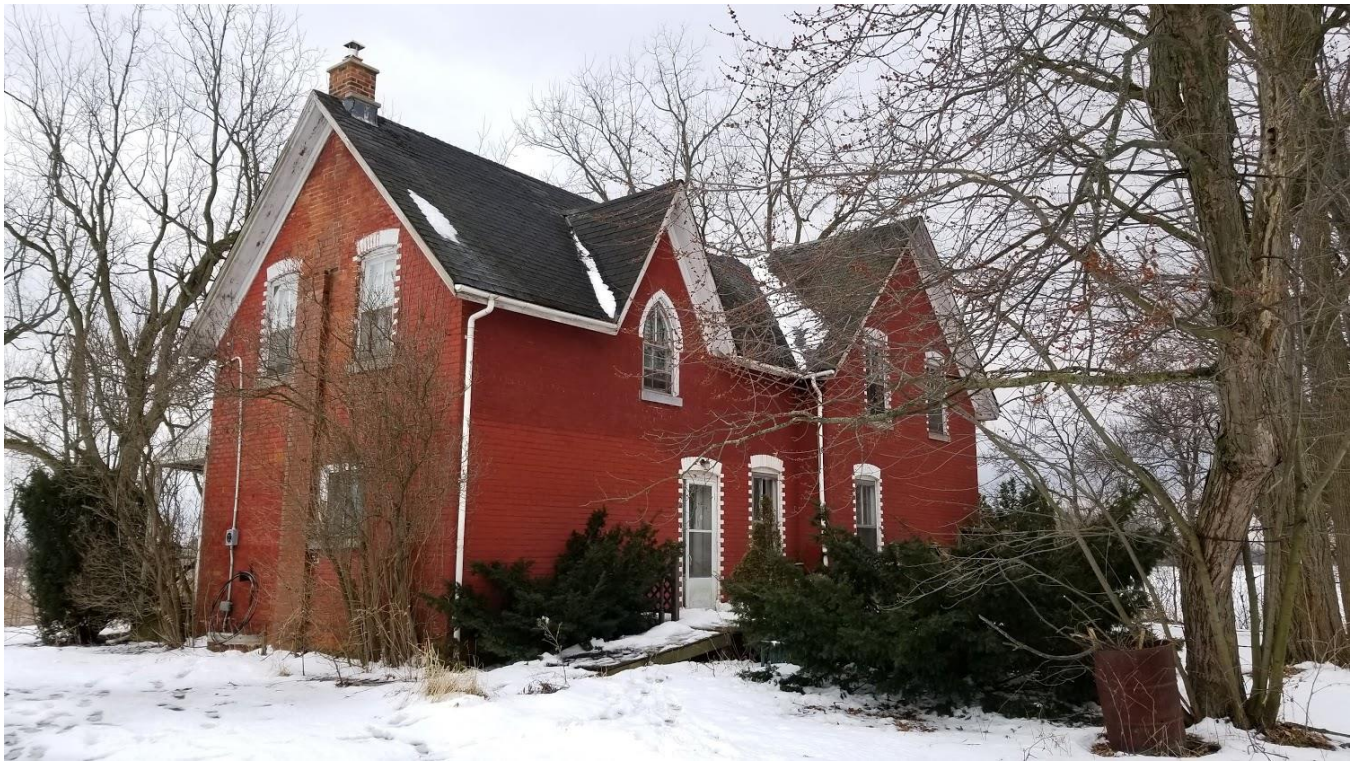
Figure 35: 9751 Twenty Road West: North and west façades

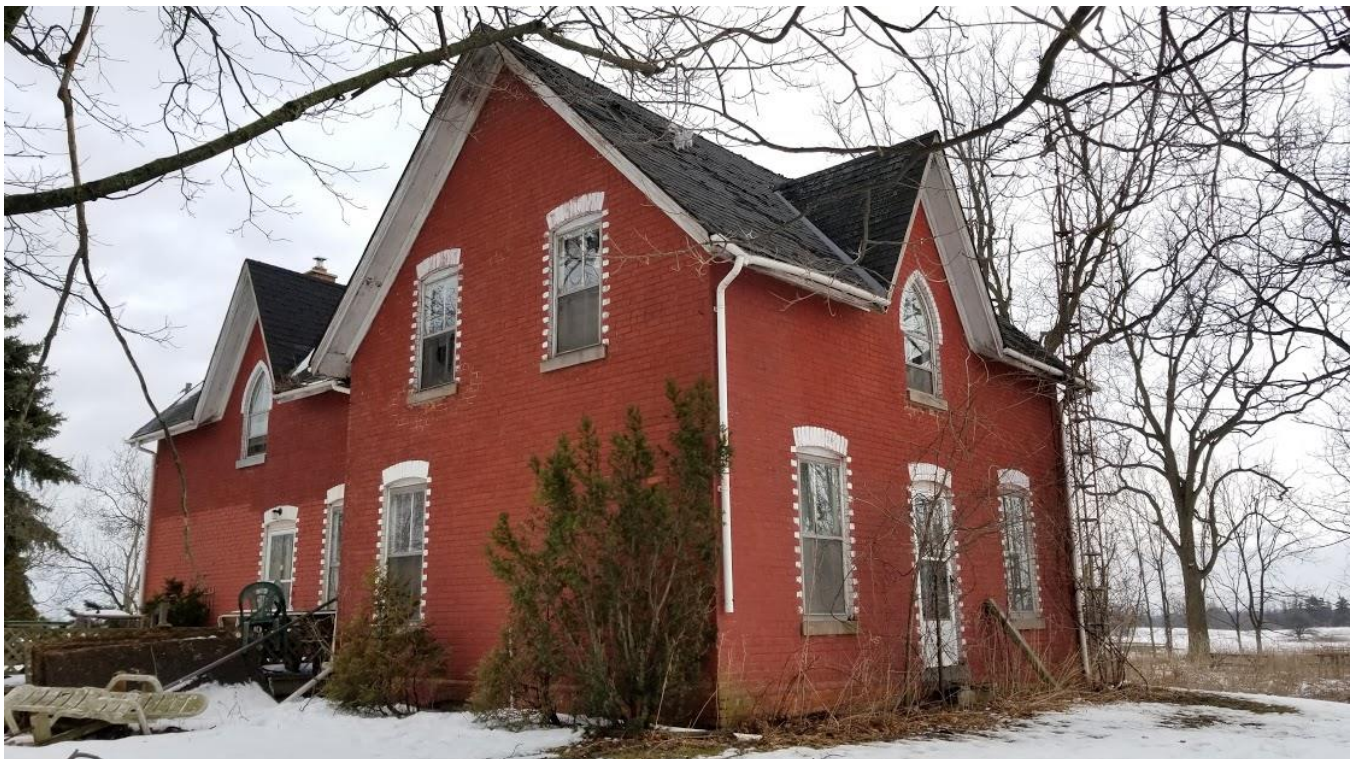
Figure 36: 9751 Twenty Road West: West and south façades

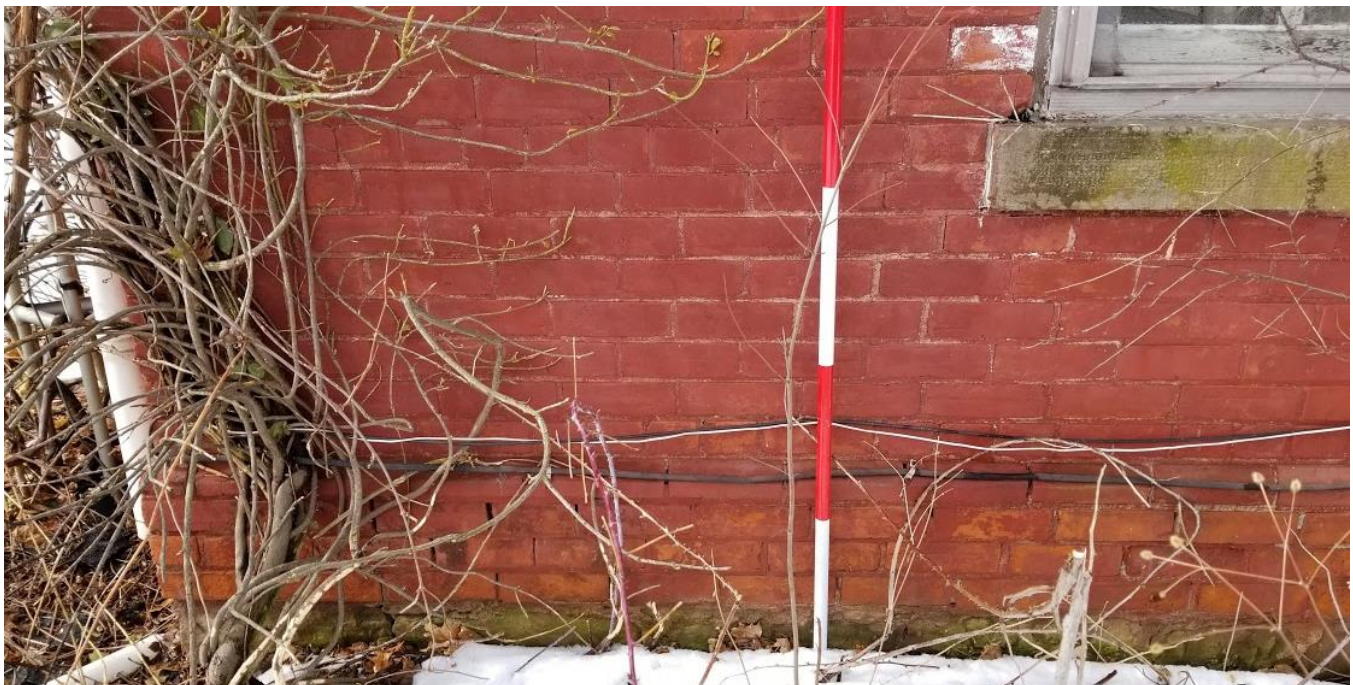
The building has a L-shaped plan and stands on a coursed rubble foundation with red common brick cladding and water table (Figure 37). It has a medium gable roof with projecting eaves and a centre gable on the south façade that is clad in asphalt shingles. Cross gables are on the east and west façades with moulded fascia and frieze and plain soffit (Figure 38 and Figure 39). A single brick chimney is located to the side left and there are remnants of an exterior chimney on the north façade.

Figure 37: 9751 Twenty Road West: Coursed rubble foundation with red common brick cladding

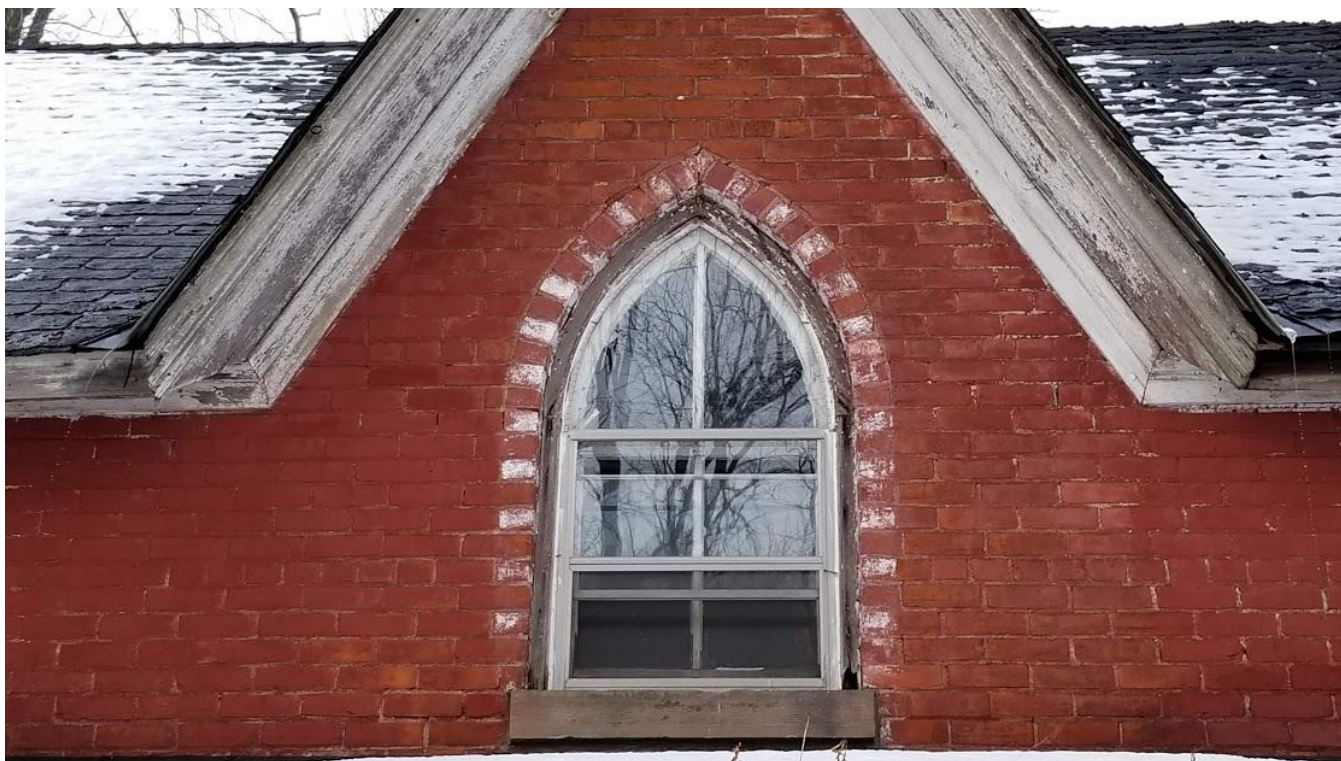
Figure 40: 9751 Twenty Road West: Pointed window at the centre of cross gable with bush hammered lug sill

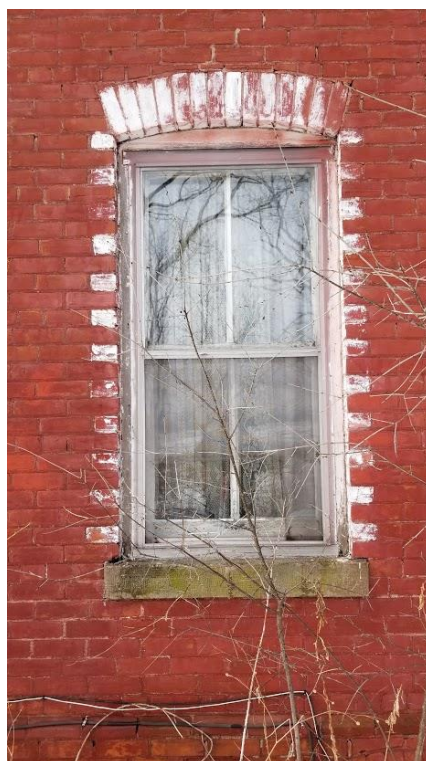
Figure 41: 9751 Twenty Road West: Segmental arch window with soldier brick voussoirs painted white and bush hammered lug sill

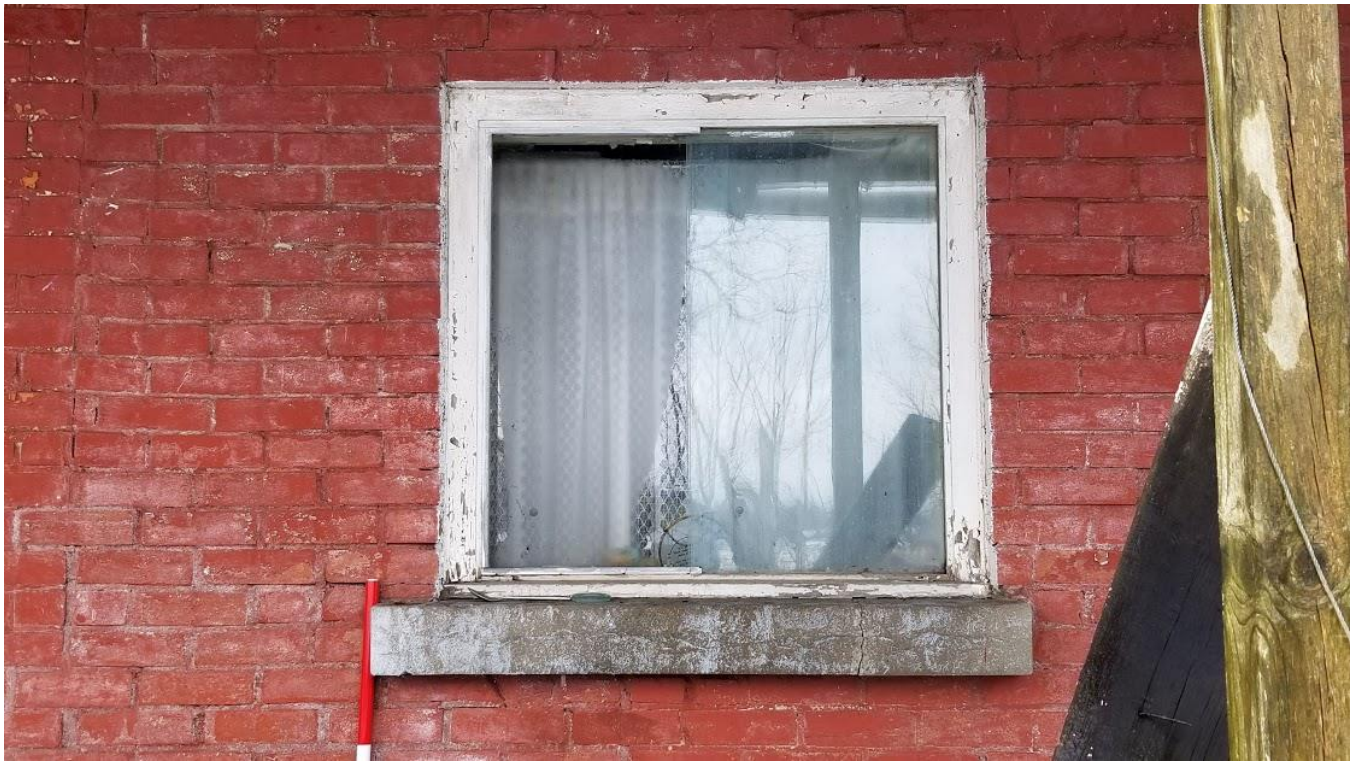
Figure 42: 9751 Twenty Road West: Square window on the east façade

Windows	Wood, pointed and segmental arch	Segmental arch windows have been replaced with square headed windows	75	Good	No additional comment
Roof	Medium gable roof with a centre gable and cross gable	No change	100	Very Good	No additional comment
Chimneys	Single brick chimney	Exterior side chimney on the north façade	95	Very Good	The original brick chimney has been retained
Water systems	Metal	All gutters and downspouts have been replaced	0	Poor	No additional comment

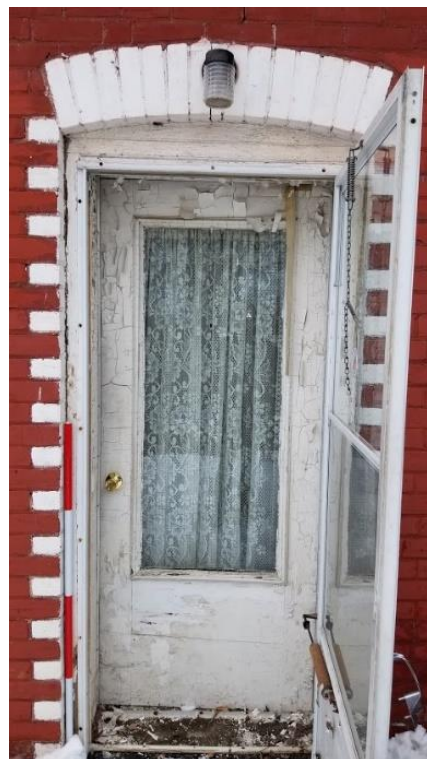
Figure 43: 9751 Twenty Road West: Main entrance on the west facade with painted soldier voussoirs

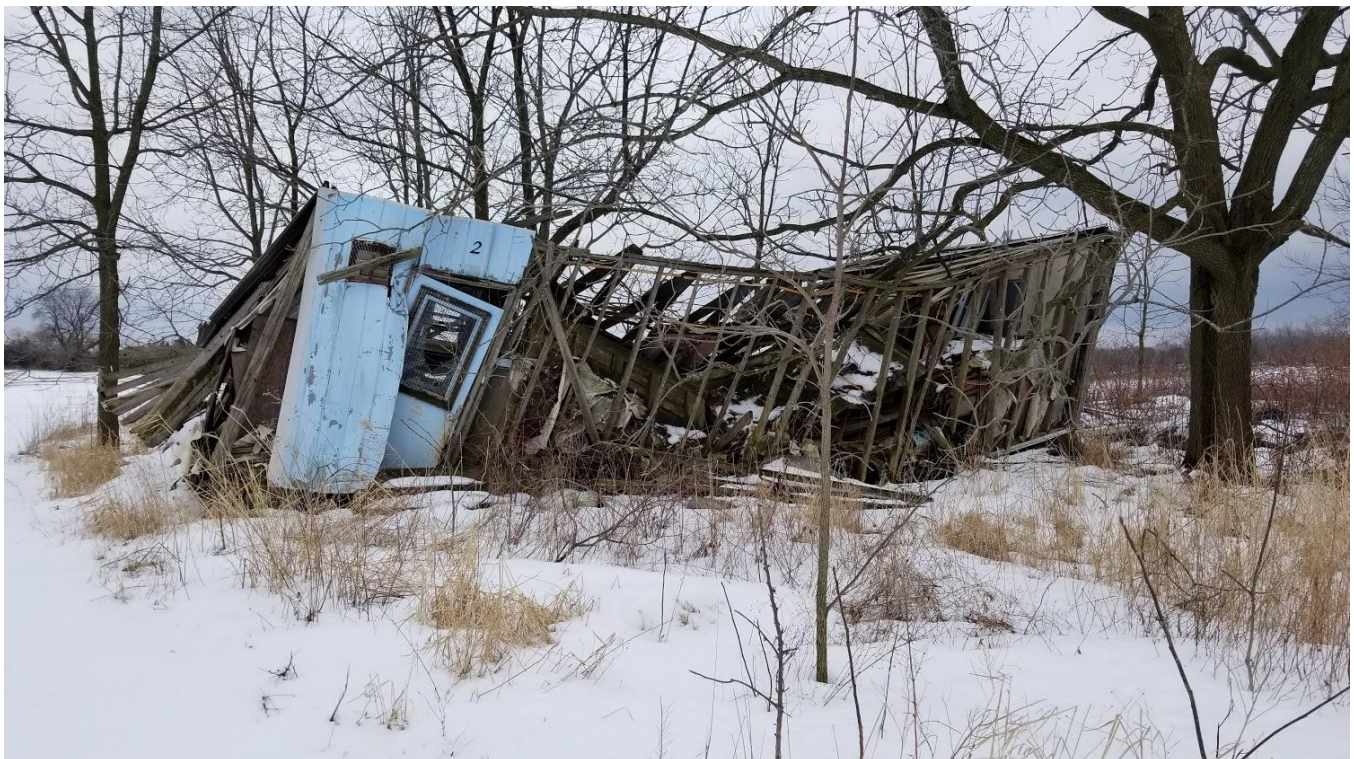
Figure 49: 9751 Twenty Road West: Remnants of an outbuilding to the northeast of the house

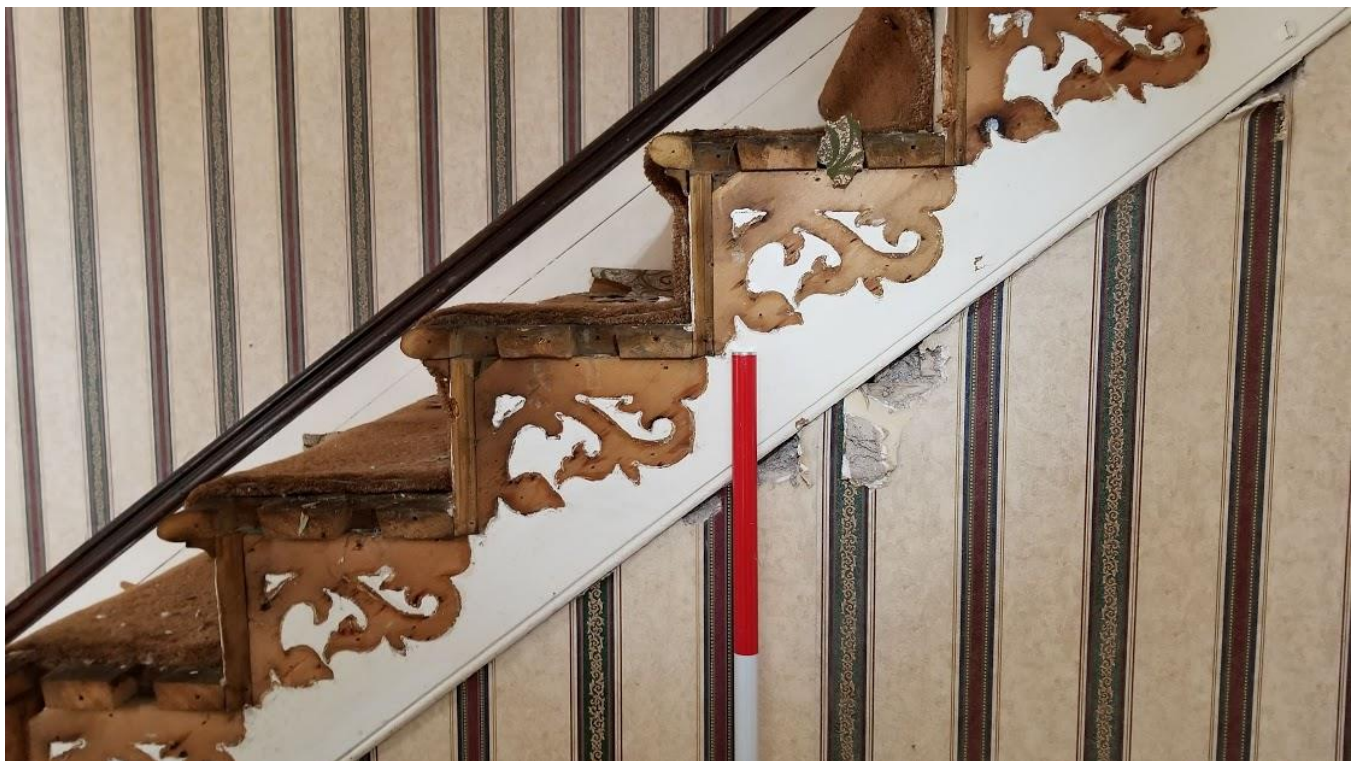
Figure 56: 9751 Twenty Road West: Staircase with railing and decorative trim removed

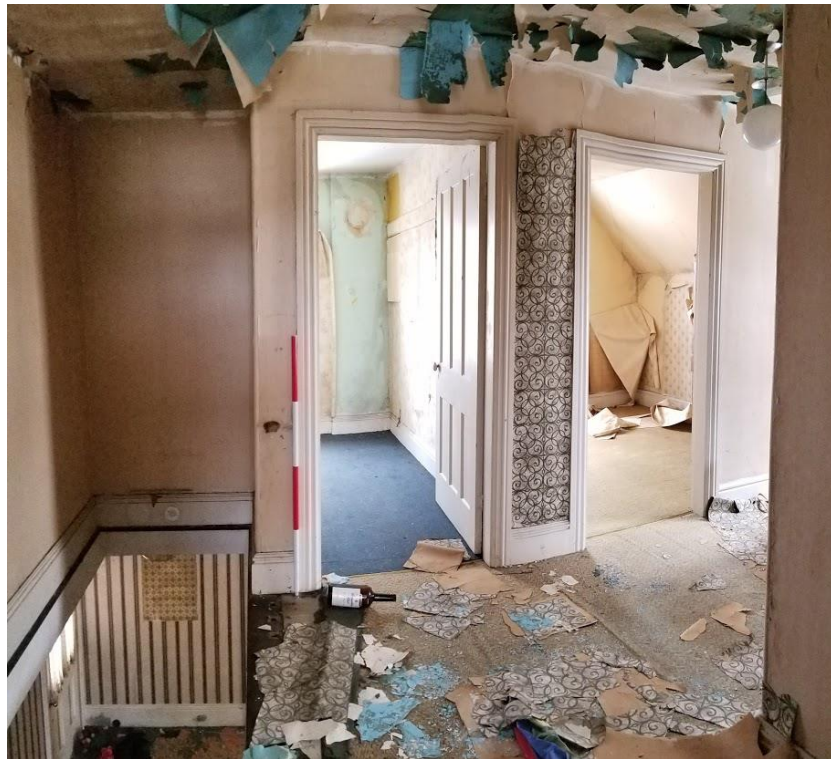
The staircase opens up into a central hallway which provides access to five rooms. The hallway was once clad in wallpaper which has begun to peel and has carpet flooring (Figure 62 to Figure 65). To the east of the hallway are two rooms: one to the immediate east which has carpet flooring, peeling wallpaper and baseboards (Figure 66 and Figure 67); and another at the southeast corner of the house which also has peeling wallpaper, carpet flooring and baseboards (Figure 68 and Figure 69). There are two other bedrooms to the west of the hallway which also has carpet and peeling wallpaper.

Figure 62: 9751 Twenty Road West: Second storey central hallway

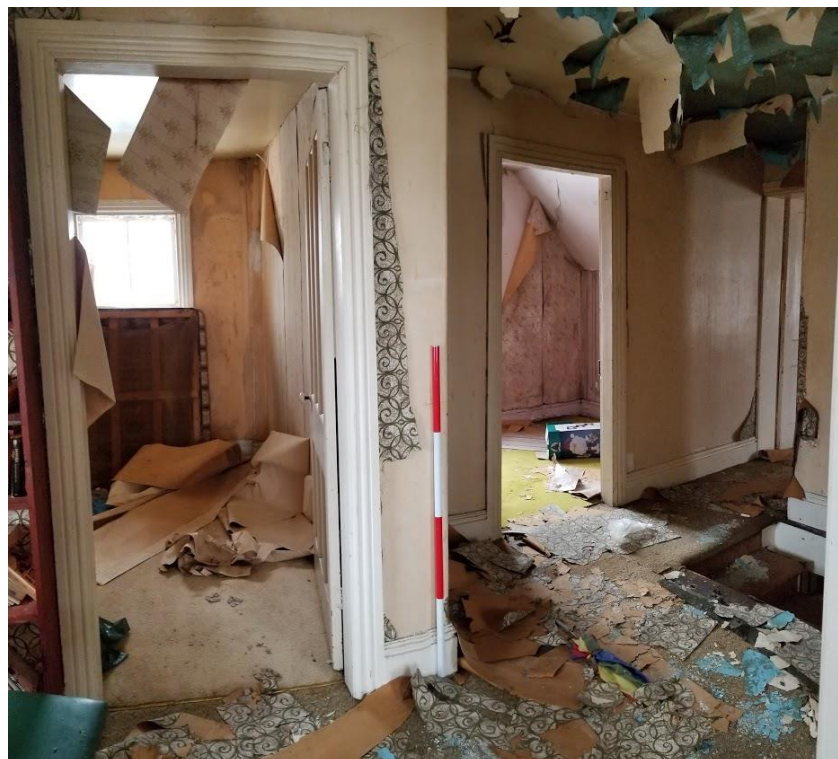
Figure 63: 9751 Twenty Road West: Central hallway

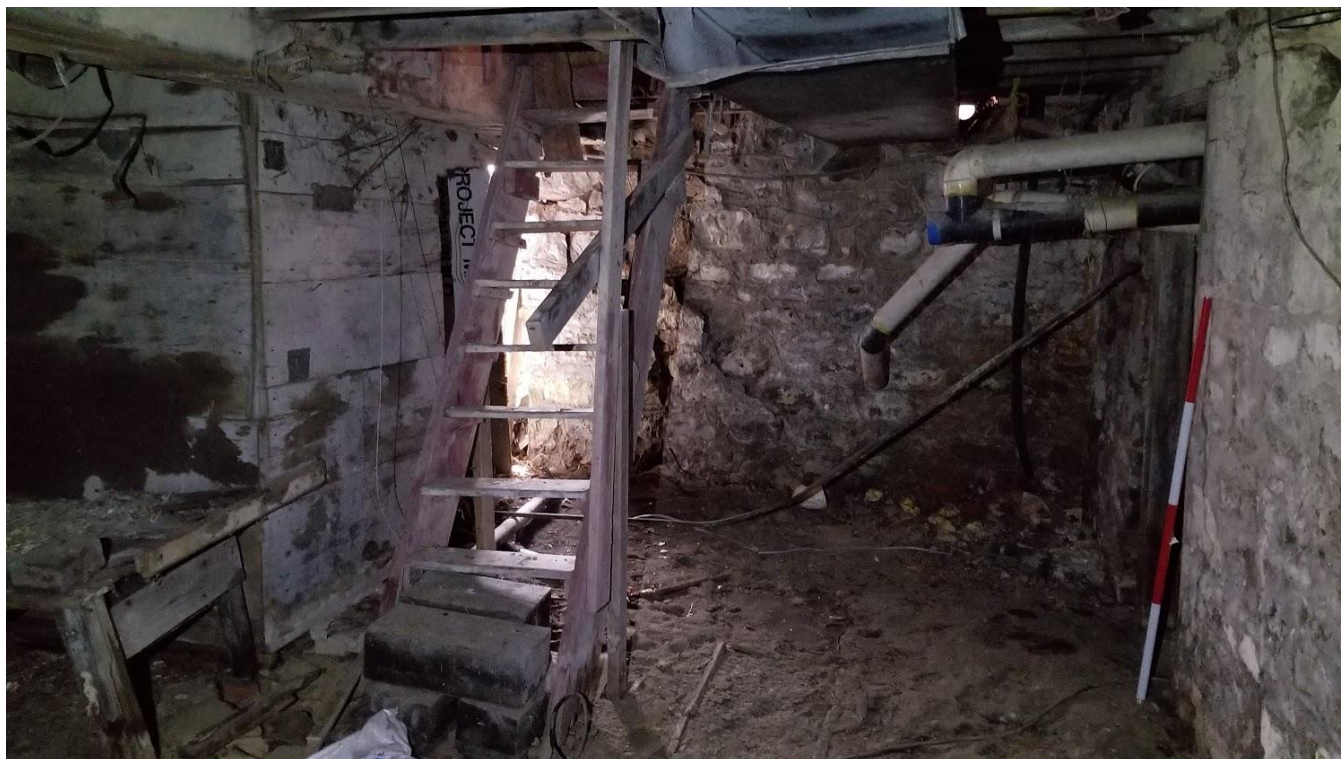
Figure 114: 9285 Twenty Road West: Wood stairs and room providing access to the large room to the west as well as the exterior

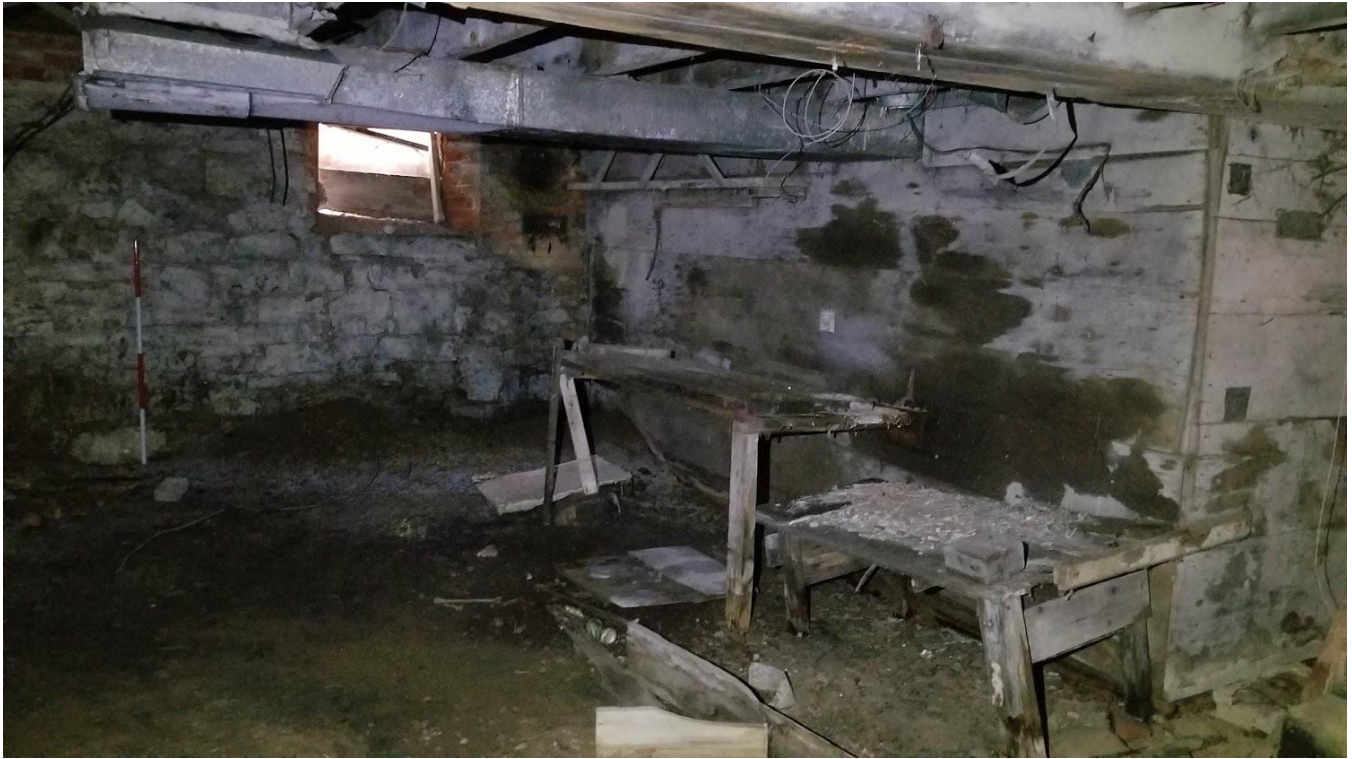
Figure 115: 9285 Twenty Road West: basement facing east with timber boards visible to the right

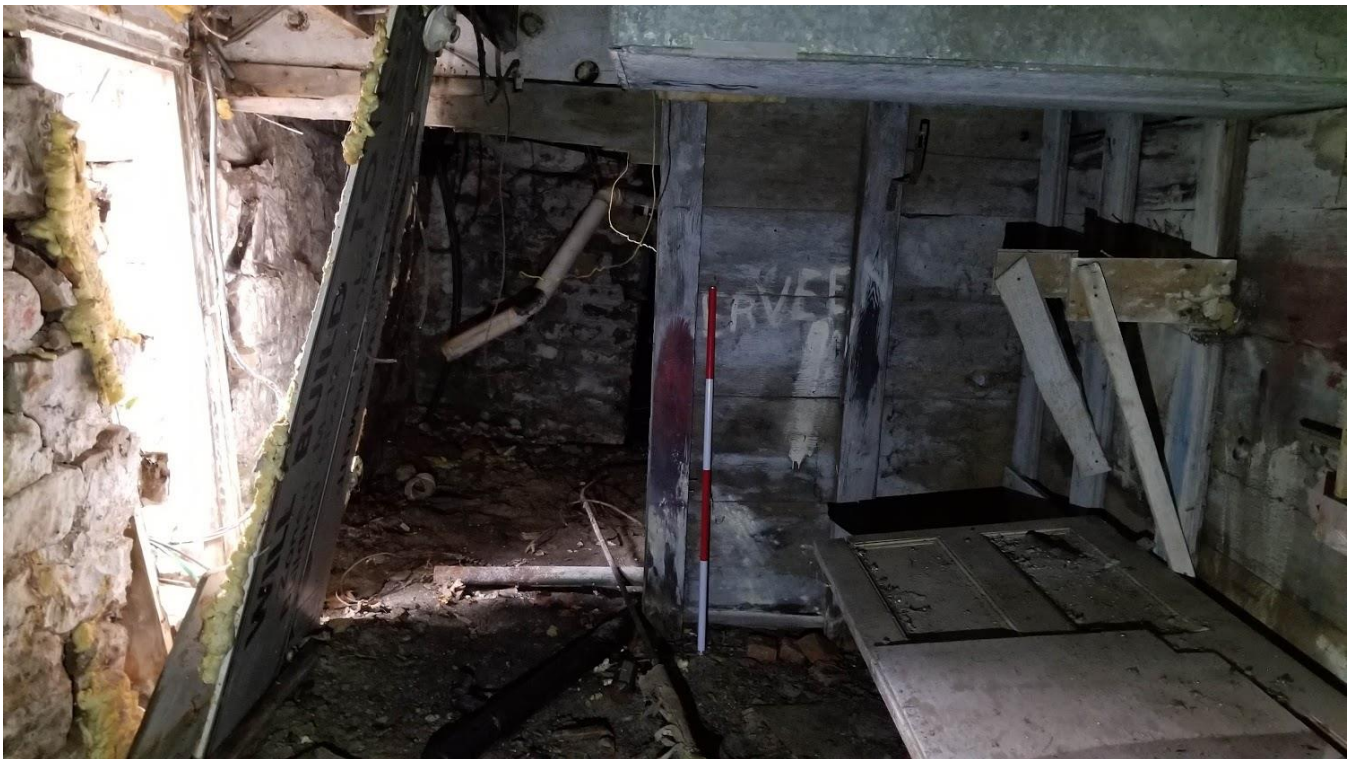
Figure 116: 9285 Twenty Road West: Room to the east with access to the exterior to the left

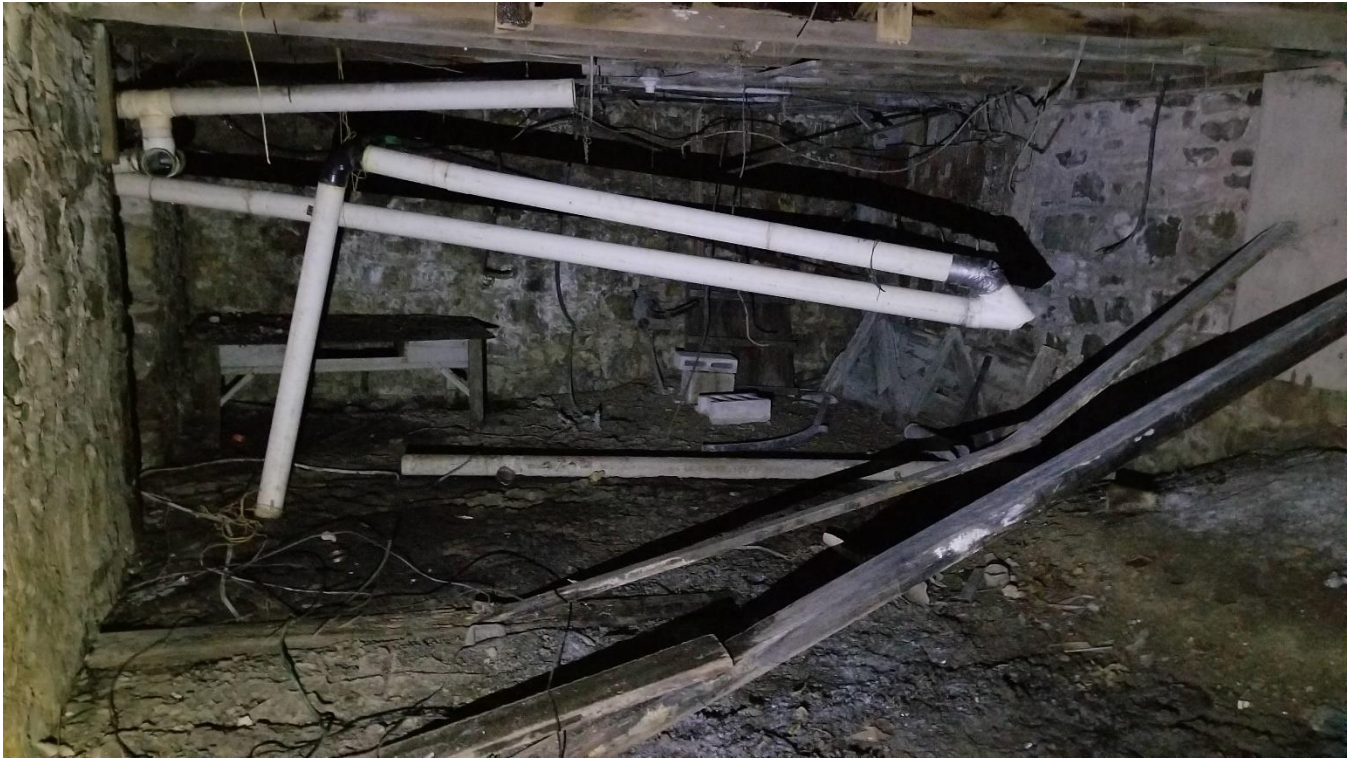
Figure 117: 9285 Twenty Road West: Large room to the west, facing south

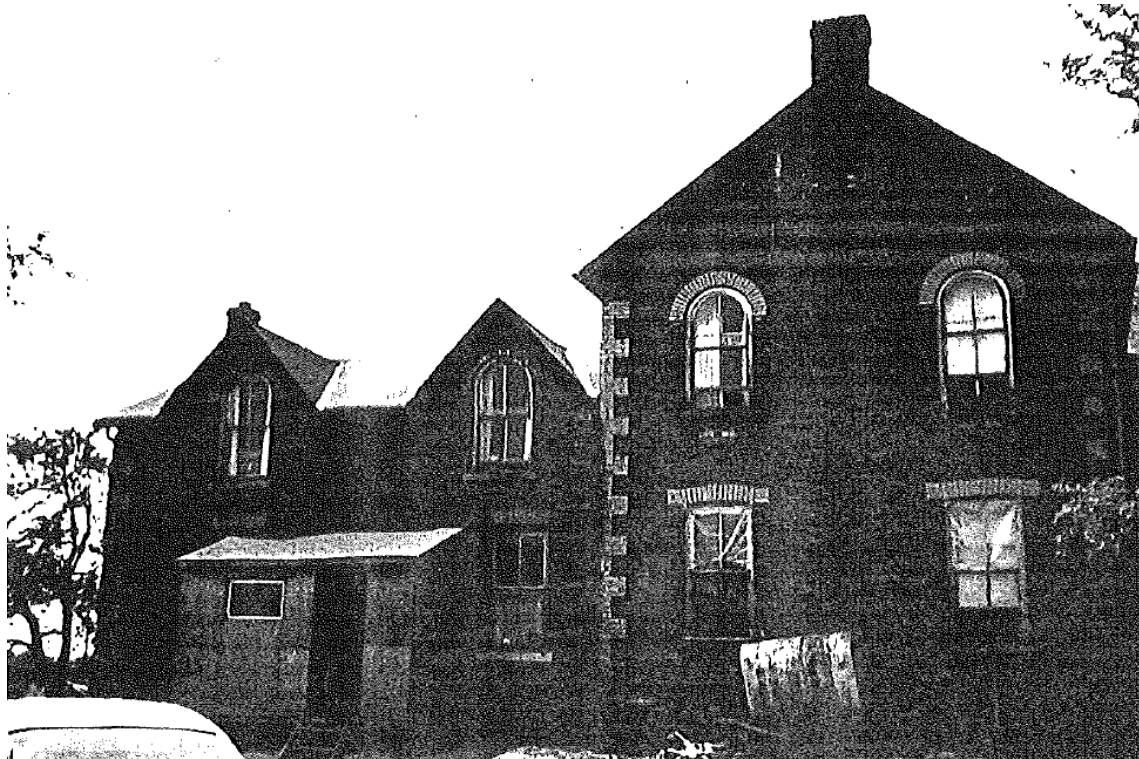
A Glanbrook Local Architectural Conservation Advisory Committee (LACAC) document completed in 1984 depicts 9285 Twenty Road West as having a side-hall or gabled ell addition on the south façade (Figure 122). There is physical evidence on the south façade that a portion of the building had been demolished, which has been partially repaired by concrete parging (Figure 123). Based on the architectural style, it is likely that this addition took place shortly after the initial construction of the building.

Figure 122: Photo of 9285 Twenty Road West circa 1984 (Source: LACAC 1984)

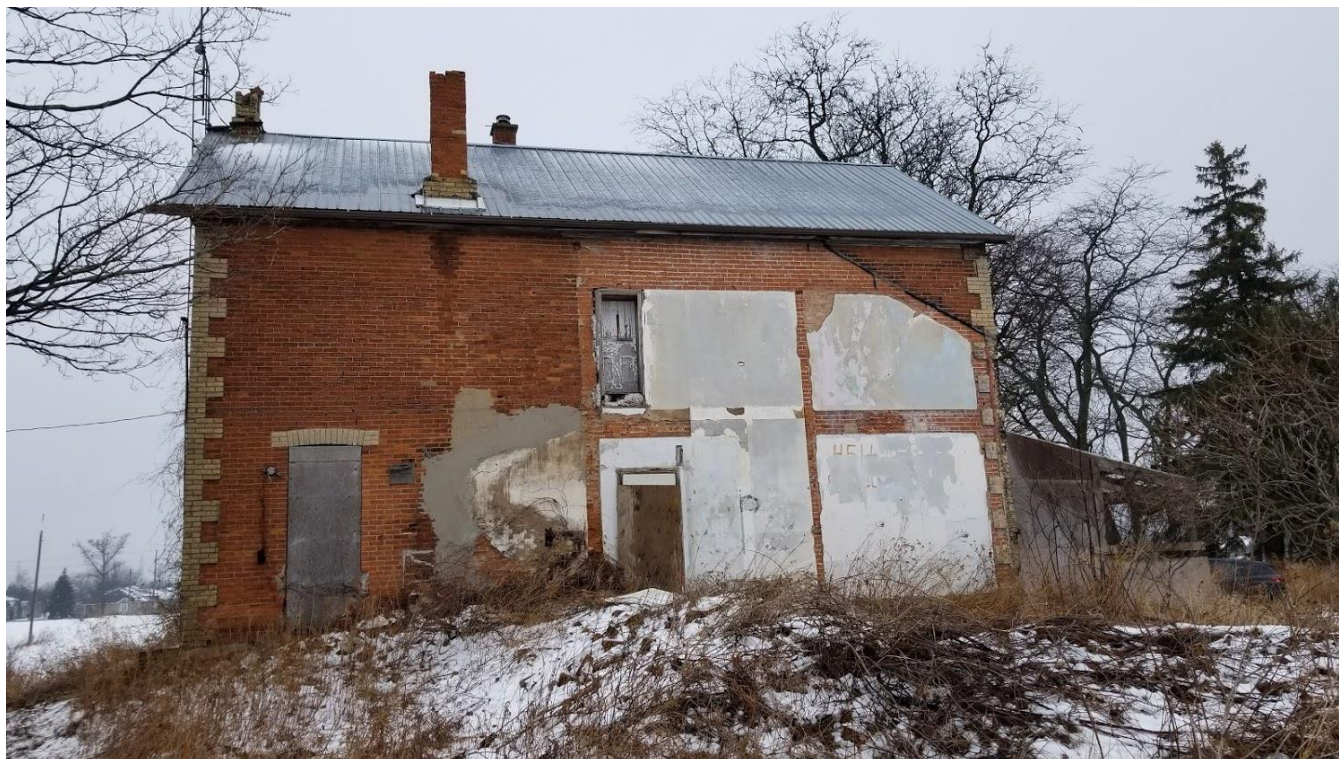
Figure 123: 9285 Twenty Road West: Concrete parging at the former location of the side-hall or gabled ell portion of the structure

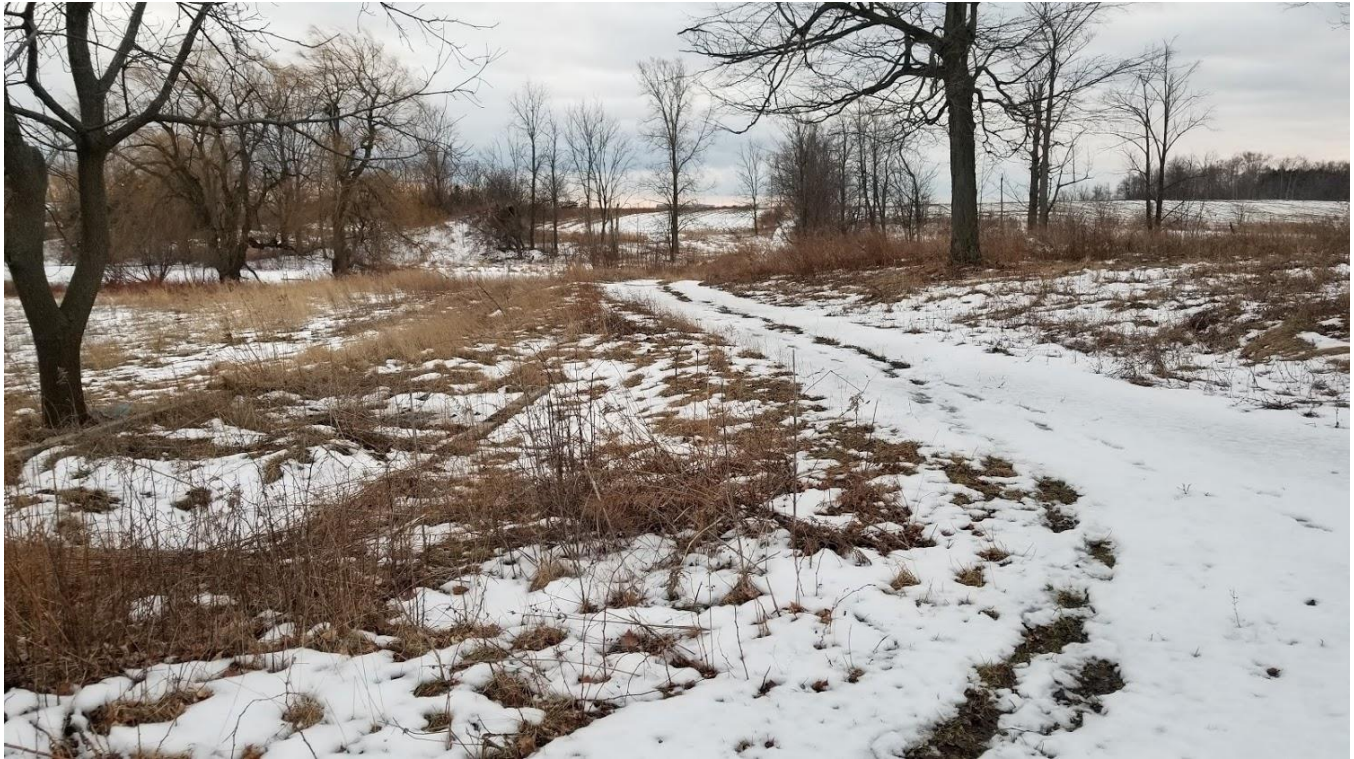
Adjacent to 9285 Twenty Road West is 9322 Dickenson Road West, a municipally inventoried heritage property. It is assumed the property was inventoried for its two-storey, single detached dwelling and barn remnants, which are now demolished (Figure 125).

Figure 125: 9322 Dickenson Road West (February 2020)

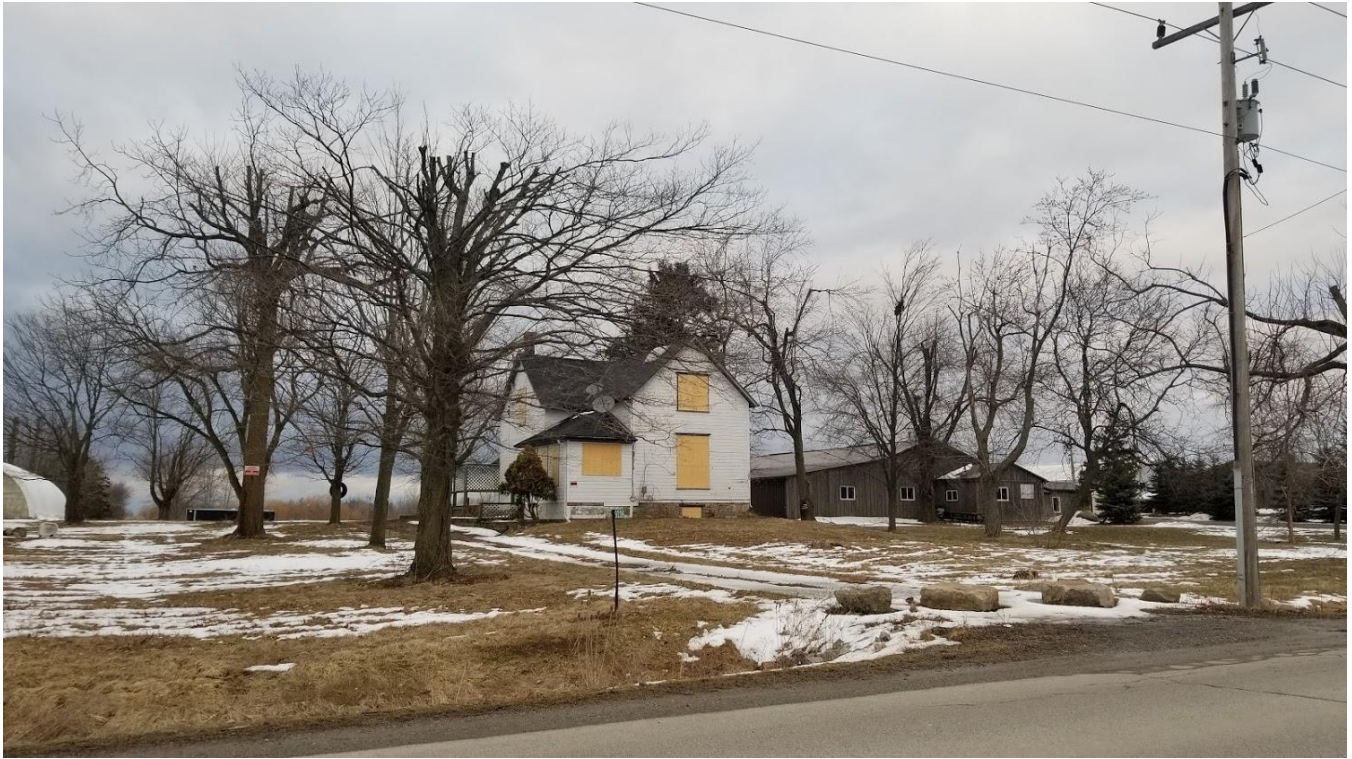
Adjacent to 9285 Twenty Road West is 9236 Dickenson Road West, a municipally inventoried heritage property. The property includes a one-and-a-half storey, single detached, wood-framed house with clapboard cladding, identified as being constructed in 1892 (Figure 126). All fenestration is currently boarded with plywood.

Figure 126: 9236 Dickenson Road West (February 2020)

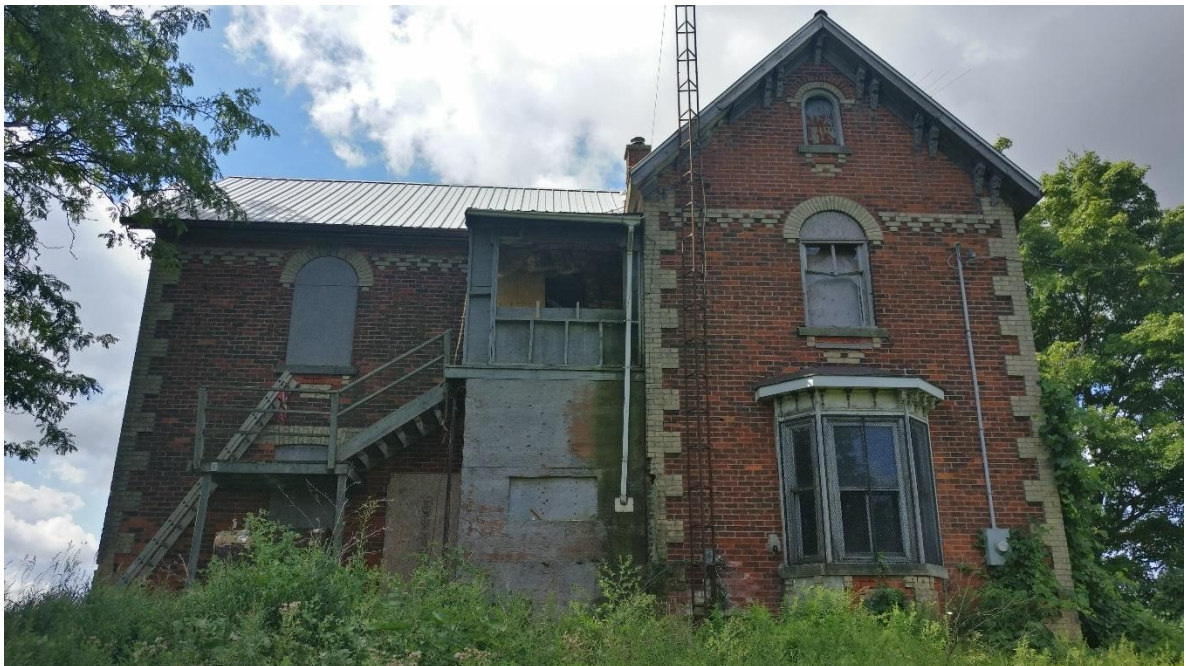
There is a small exterior stair access to the 2nd level of the building on the north side which consists of two sets of stairs and a mid and upper landing. (See **Figure 4.0**) The stairs from grade to the mid landing have been removed. The upper landing is framed with walls and a roof above. The framing of the roof of the landing appears to be severely weathered, and in very poor condition. (See **Figure 19.0**) The framing of the two landings appear to also be severely weathered, and in poor condition. These areas are all structurally damaged and beyond reasonable repair.

Figure 4.0: North Façade of Building
Featuring exterior stair access to 2nd floor

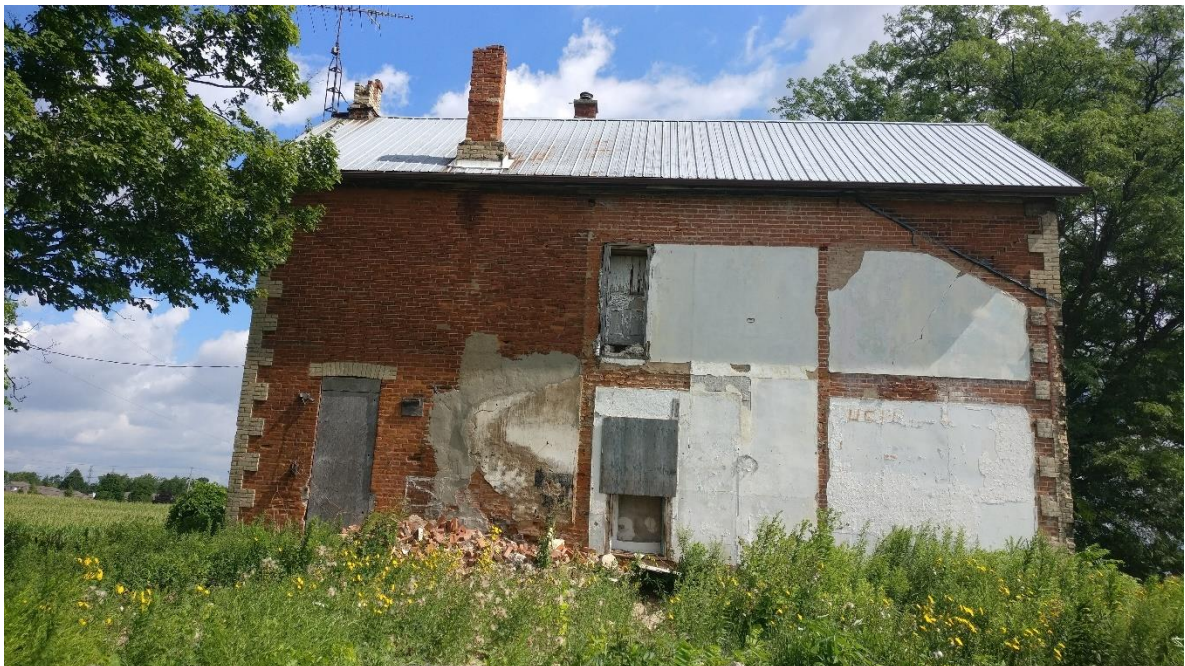
Figure 6.0: South Façade of Building
Evidence of south addition with parged and discoloured brick
