FINAL REPORT

Cultural Heritage Impact Assessment

Twenty Road West Plan of Subdivision in Glanbrook, City of Hamilton, Ontario

19125764-R01

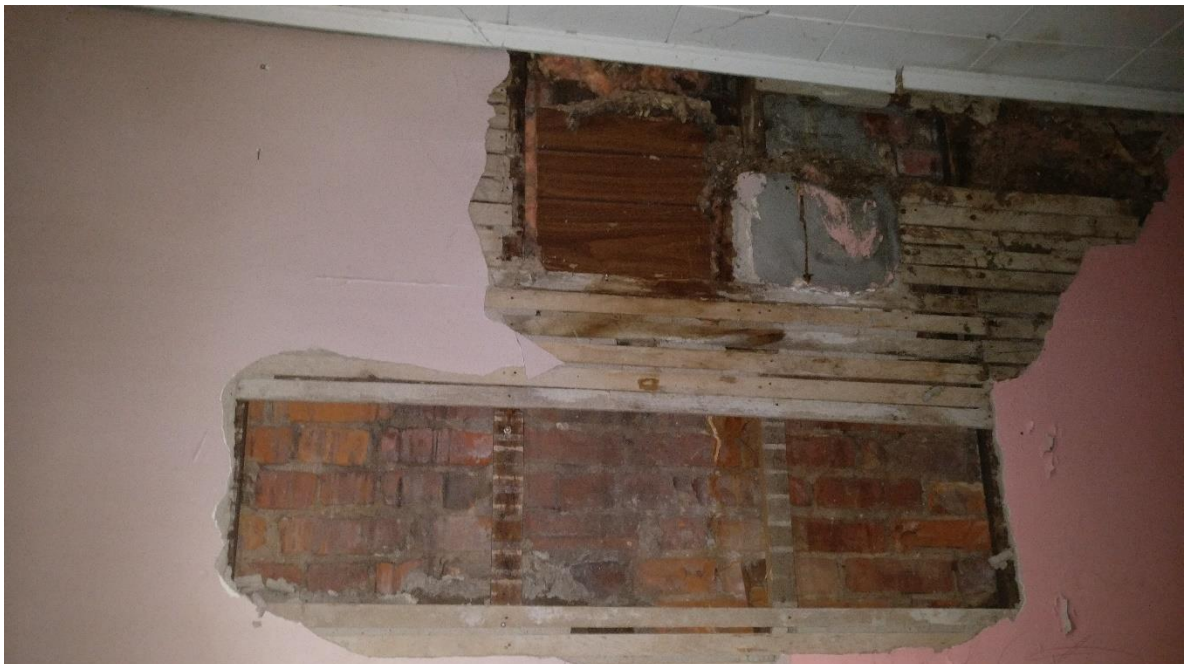
The inside face of the exterior walls is clad with 1"x2" wood strapping and shims with wood lath and plaster. (See **Figure 8.0**)

Figure 8.0: Interior Face of Exterior Brick Walls
Multi-wythe brick with 1"x2" wood strapping, wood lath and plaster

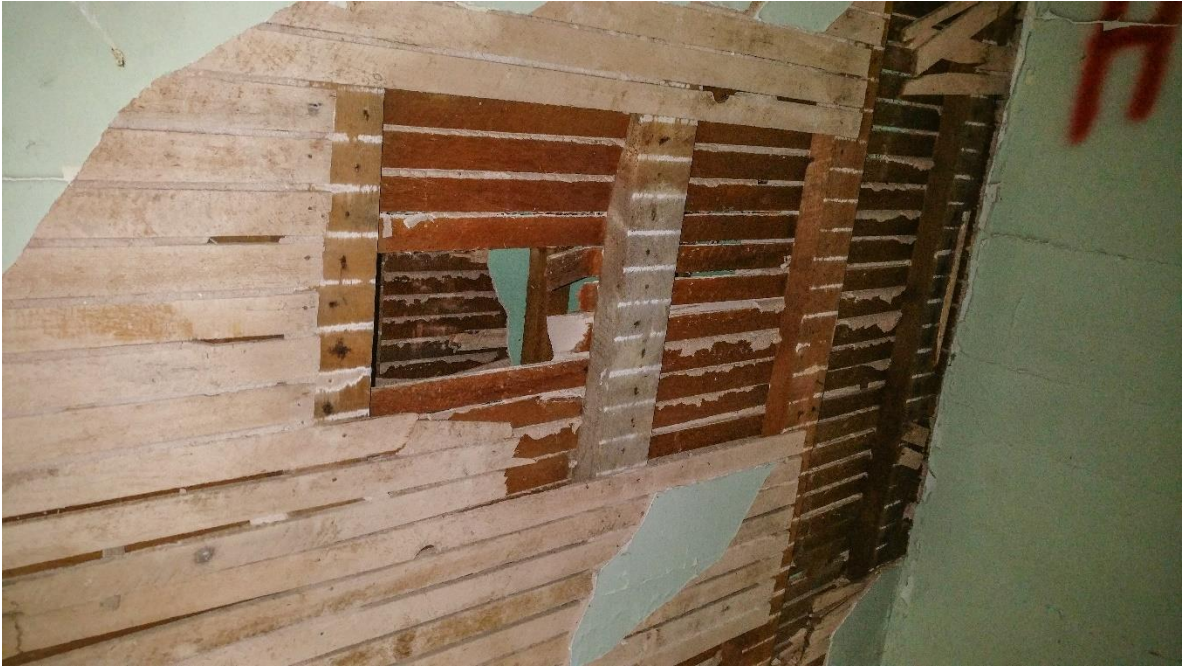
A portion of the interior load bearing walls were exposed at the time of our assessment. The wall construction consists of 2"x4" timber studs rotated 90° from standard and spaced 18" o/c with lath and plaster on each side. (See **Figure 9.0**) The current construction of the load bearing walls do not provide any lateral bracing of the weak axis of the wall studs. Therefore, due to the lack of bracing and large spacing of the studs, the interior load bearing walls are structurally deficient.

Figure 9.0: Interior 2nd Floor Load-Bearing Wall
2"x4" studs at 18" o/c, rotated 90° with wood lath and plaster on each side

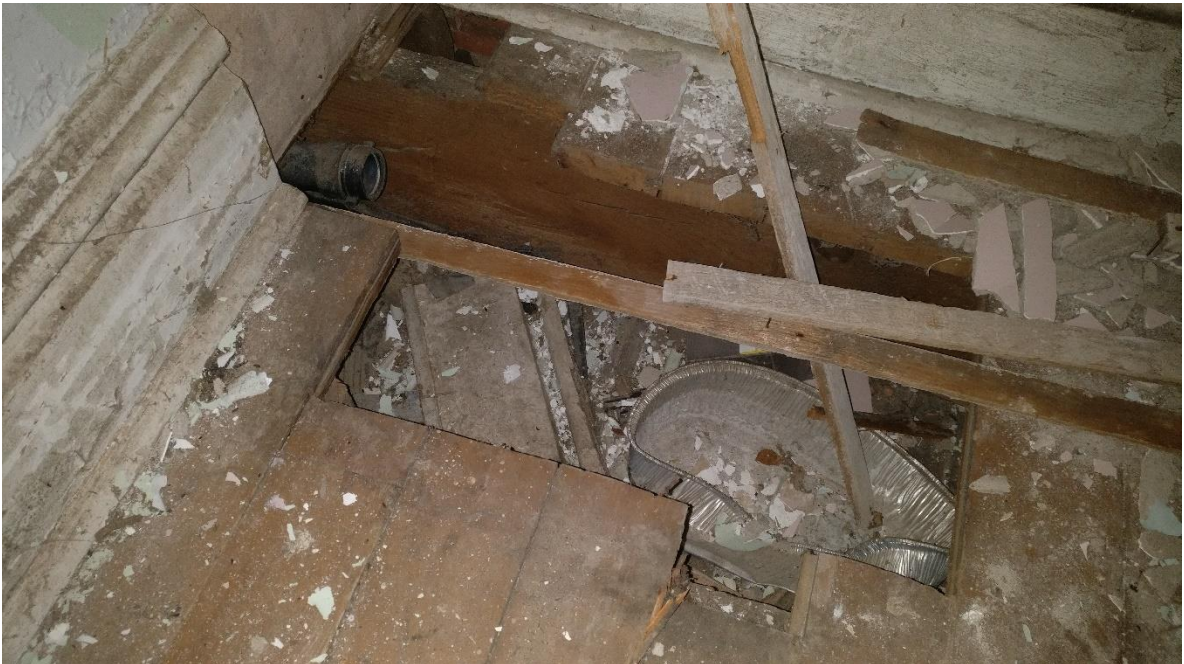
The floor joists throughout the building consisted of 2"x10" timber joists at 18" o/c with a 1" thick wood tongue-and-groove decking. (See **Figure 10.0**) The joists were supported on the brick wall at the exterior and load-bearing walls at the interior. The ceilings consisted of wood lath and plaster on the underside of the floor joists throughout. (See **Figure 11.0**) The majority of the floor joists supporting the 2nd floor was hidden beneath floor and ceiling coverings and therefore only a small portion of the floor joists could be assessed.

Figure 10.0: Typical Existing Floor Joists on 2nd Floor
2"x10" timber floor joists at 18" o/c with 1" wood T&G decking

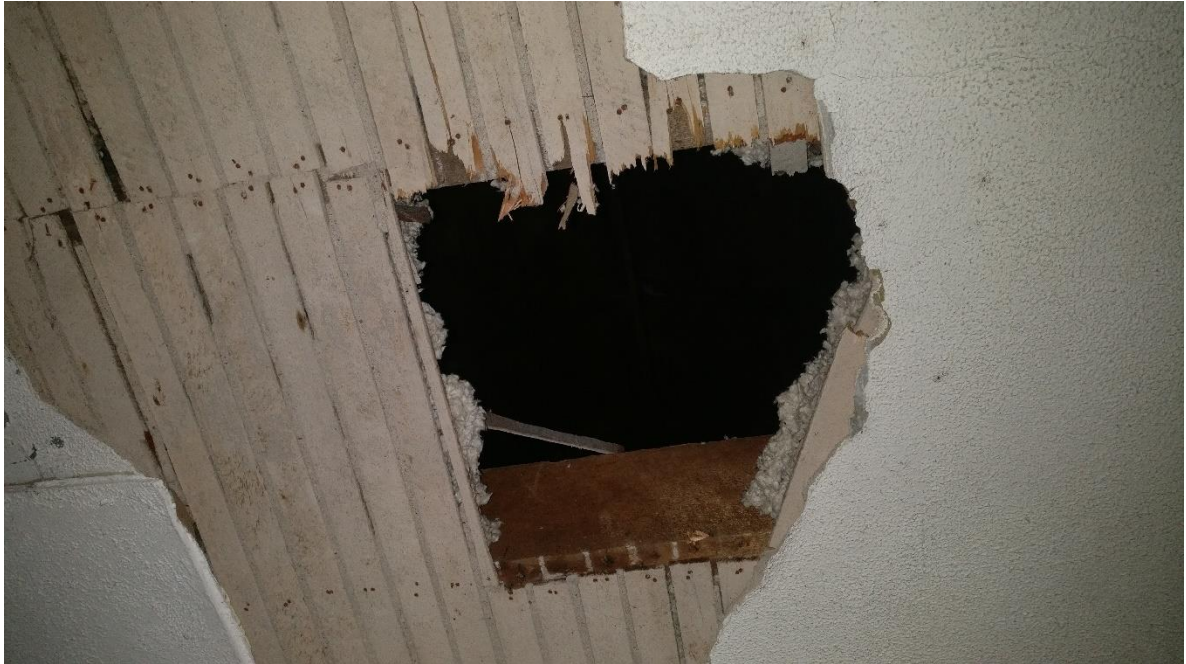
Figure 11.0: Typical Ceiling
Wood lath and plaster on underside of ceiling and floor joists

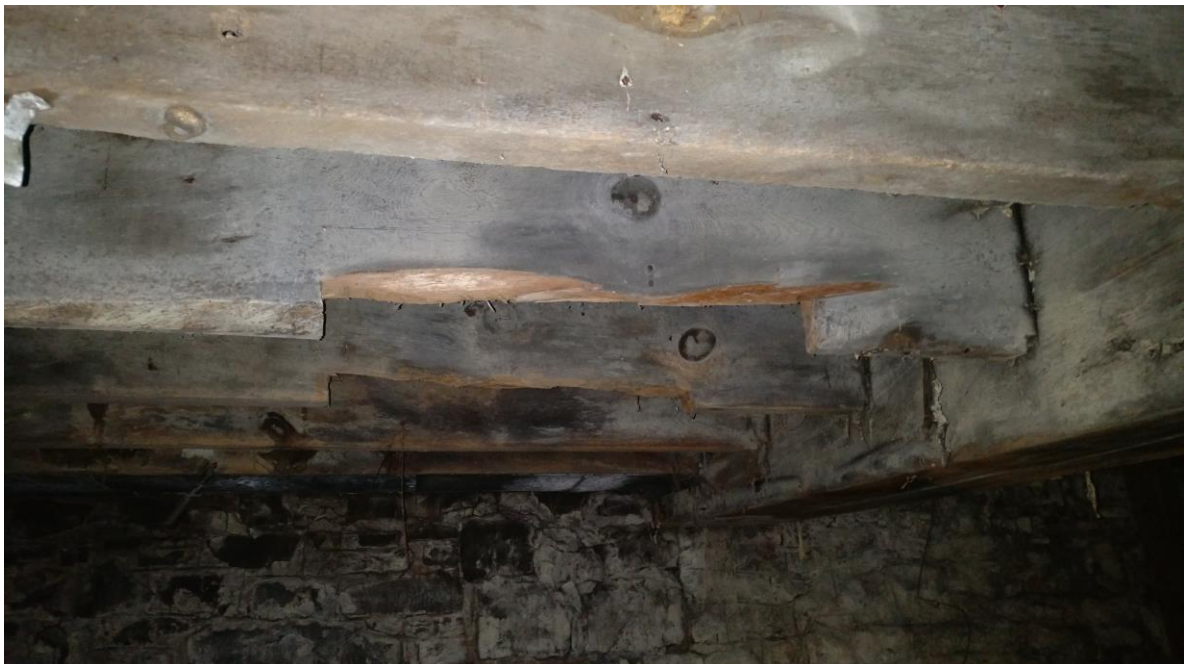
Figure 12.0: Multiple Notched Ground Level Floor Joists
Floor joists supported by large wood beam on right side

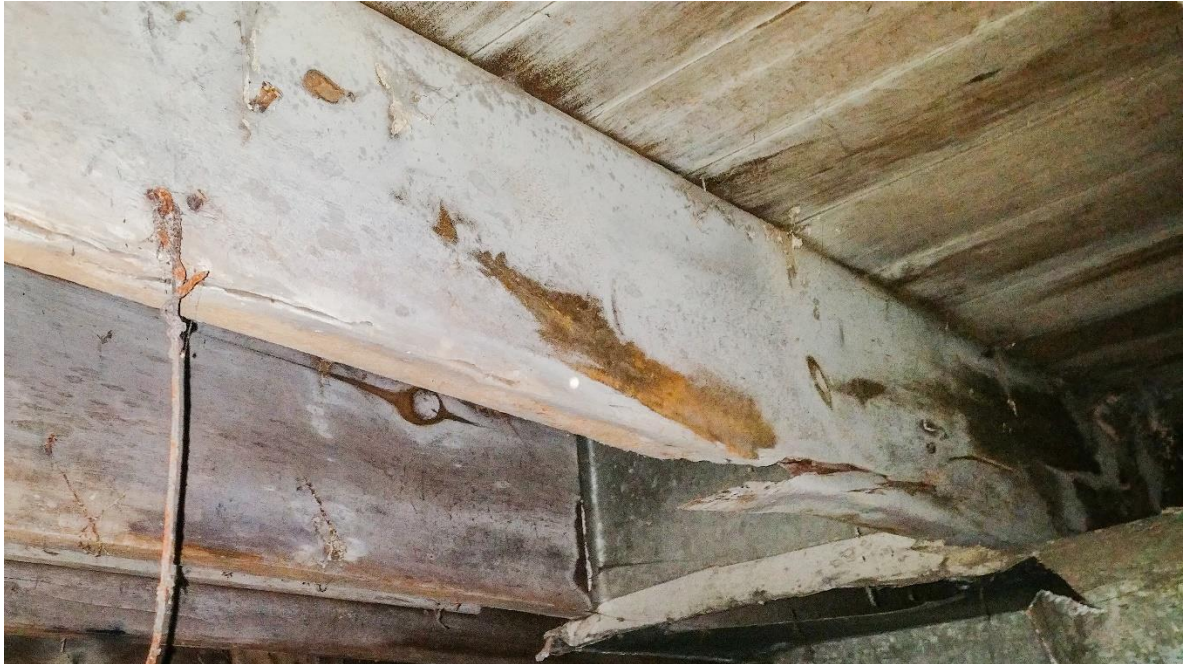
Figure 13.0: Typical Split Ground Level Floor Joist

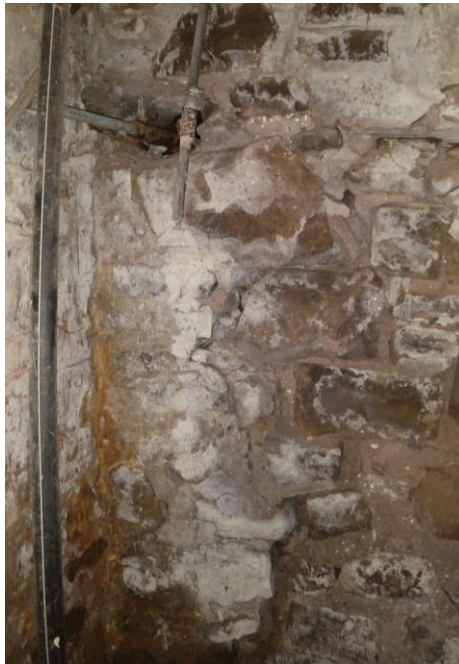
The foundation of the building consists of rubble stone approximately 16" thick. (See **Figure 16.0**) It is assumed that there is no footing under the foundation as typical of buildings at the time it was constructed. A small portion of the basement floor consists of a concrete deteriorated slab on grade at the north side of the building. (See **Figure 17.0**) The rest of the basement floor consists of soil only. At the south end of the building, the foundation wall has shifted significantly approximately 4" out-of-plane. Large

Figure 16.0: Typical Rubble Stone Foundation Wall

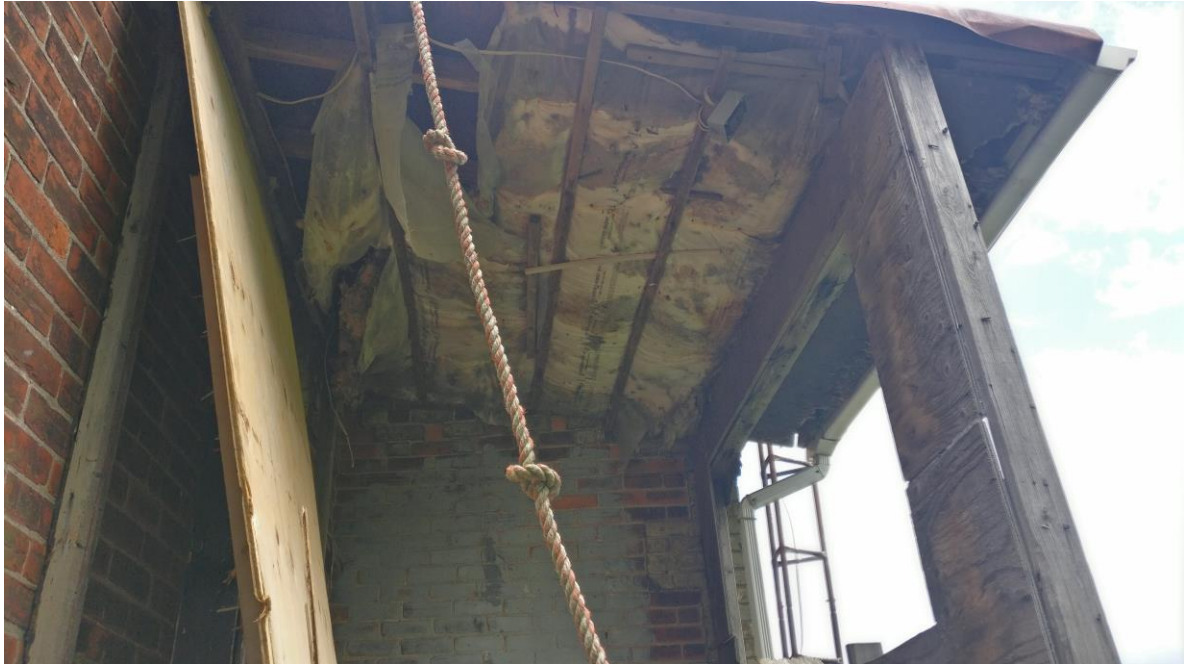
There is a small exterior stair access to the 2nd level of the building on the north side which consists of two sets of stairs and a mid and upper landing. (See **Figure 4.0**) The stairs from grade to the mid landing have been removed. The upper landing is framed with walls and a roof above. The framing of the roof of the landing appears to be severely weathered, and in very poor condition. (See **Figure 19.0**) The framing of the two landings appear to also be severely weathered, and in poor condition. These areas are all structurally damaged and beyond reasonable repair.

Figure 19.0: Exterior Stair Landing Roof Framing

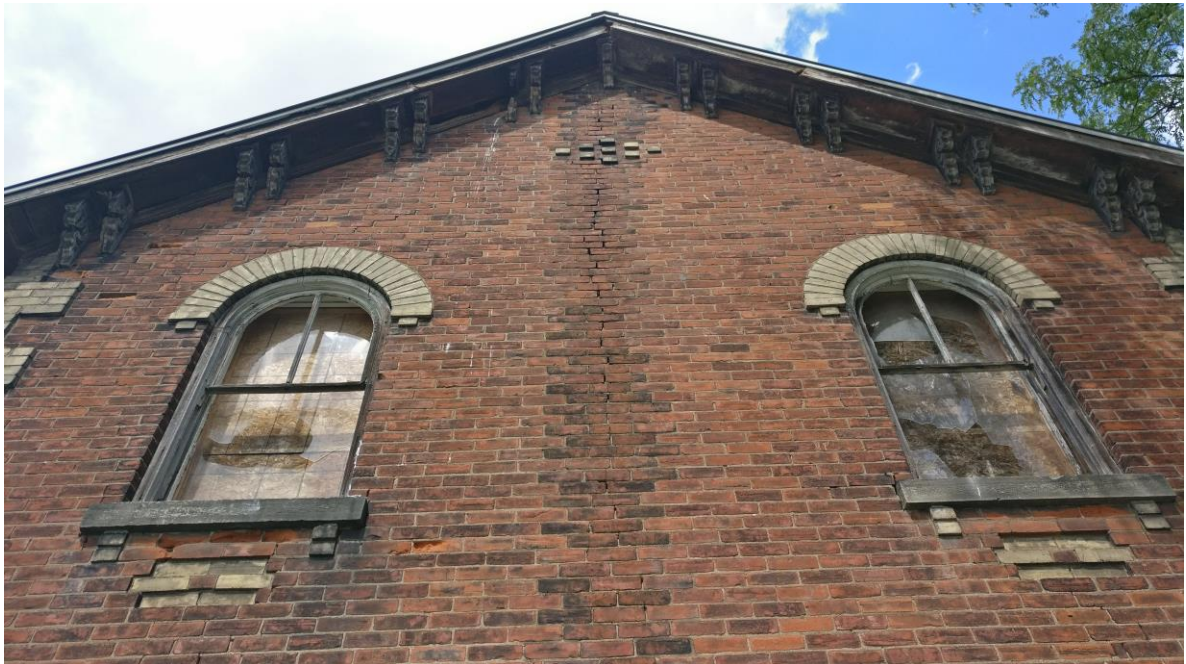
The exterior walls of the building are load bearing and consist of multi-wythe brick from the ground floor datum-to-roof. In general, the brick was found to be in poor condition and exhibit progressive signs of water migration. Separation of the brick is apparent on the east face of the building with large gaps present in the mortar joints. (See **Figure 20.0**) Gaps in the mortar joints was also noted on the south face of the building. Years of continued water penetration will result in severely damaged load bearing brick. The west face of the building was nearly completely covered in vines; therefore, the condition of the brick could not be assessed. However, vine growth typically speeds up the deterioration of brick and mortar joints, causing it to be more susceptible to water migration. (See **Figure 7.0**)

Figure 20.0: Large Gaps in Brick Joints on East Face

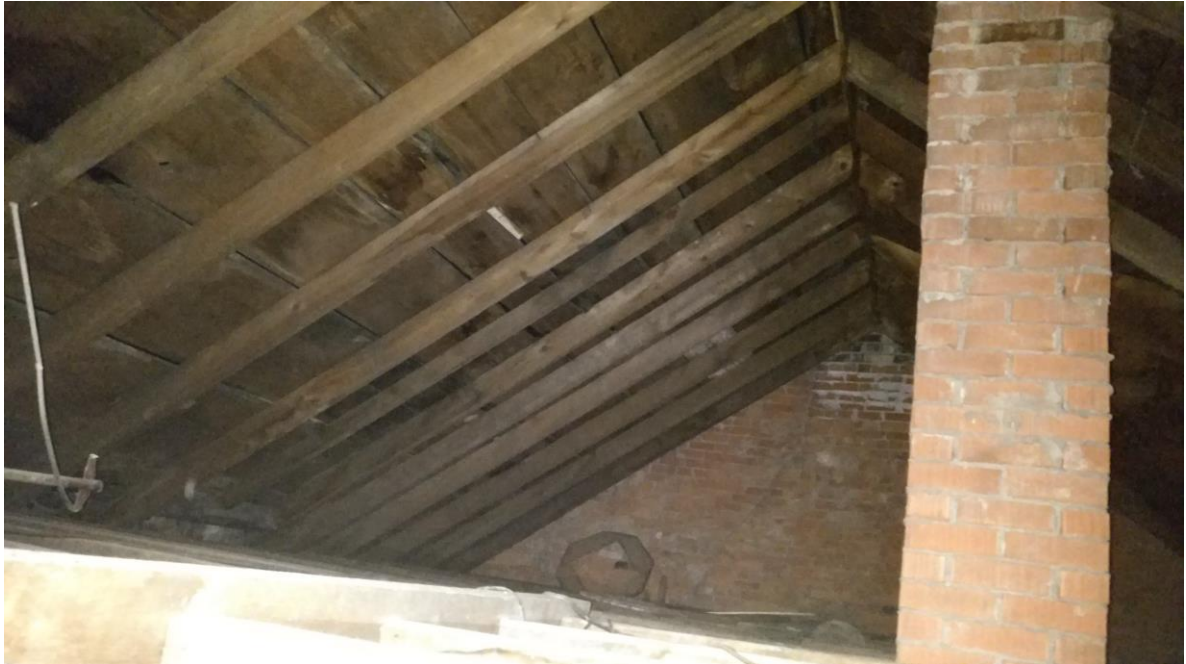
The roof of the building is constructed with timber roof rafter and ceiling joists with a wood ridge board at the peak. (See **Figure 21.0** and **22.0**) The roof consisted of intersecting open gables. The rafters are covered in wood planking and a metal roof. It appears that current metal roof cladding has done a reasonable job of preserving the structure from water as no water stains from the roof were noted at the time of the assessment.

Figure 21.0: Typical Roof Framing
