# Upper West Side - Fluvial Geomorphological Assessment Twenty Road West, City of Hamilton

June 12, 2020  
PN18013

Report Title: Upper West Side Draft Plan of Industrial Subdivision  
Fluvial Geomorphological Assessment - Update

Project Number: PN18013

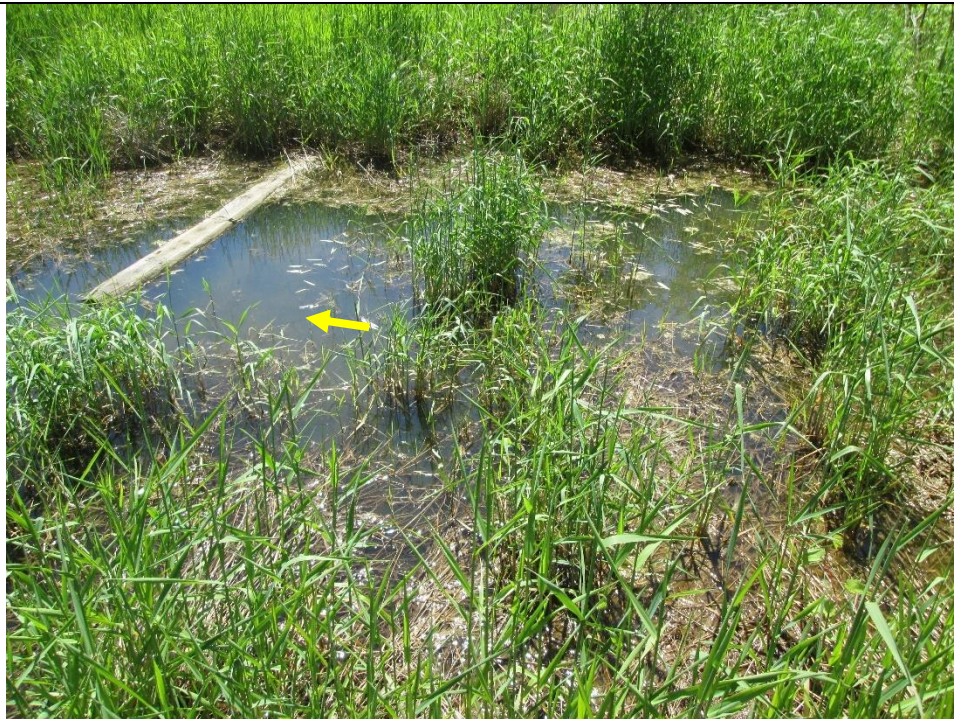
Photo 8  
Tributary of Twenty Mile Creek: Visit 2  
Reach **TTMC2-10-1**

The wet meadow corridor consisted mostly of hydrophilic herbaceous and grass species. Bed materials were silt and organic material.

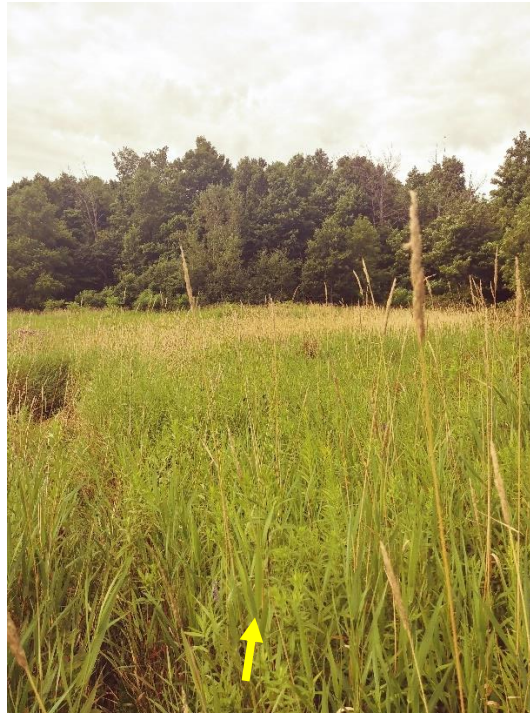
Photo 9  
Tributary of Twenty Mile Creek: Visit 3  
Reach **TTMC2-10-1**

The feature was dry and indistinguishable from the surrounding landscape during the summer, with no channel formation.

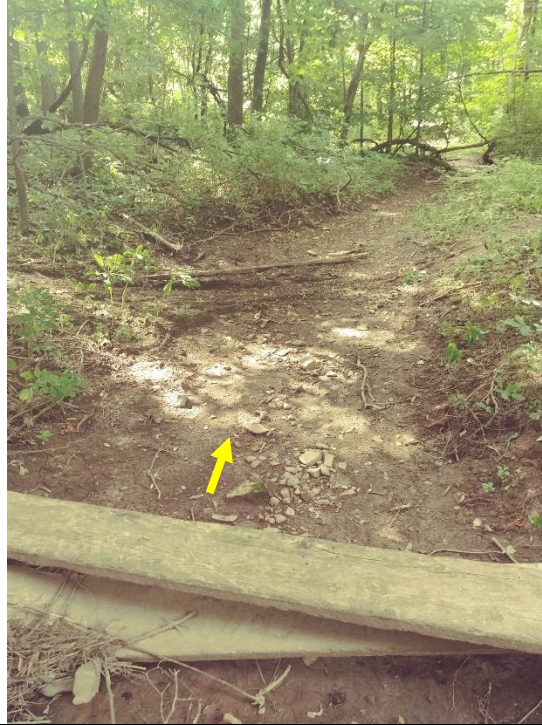
Photo 15  
Tributary of Twenty Mile Creek: Visit 3  
Reach **TTMC2-11**

Feature was dry but distinguishable from the surrounding landscape in the summer visit. Bed materials consisted predominantly of silt, clay and some gravel which were poorly sorted.

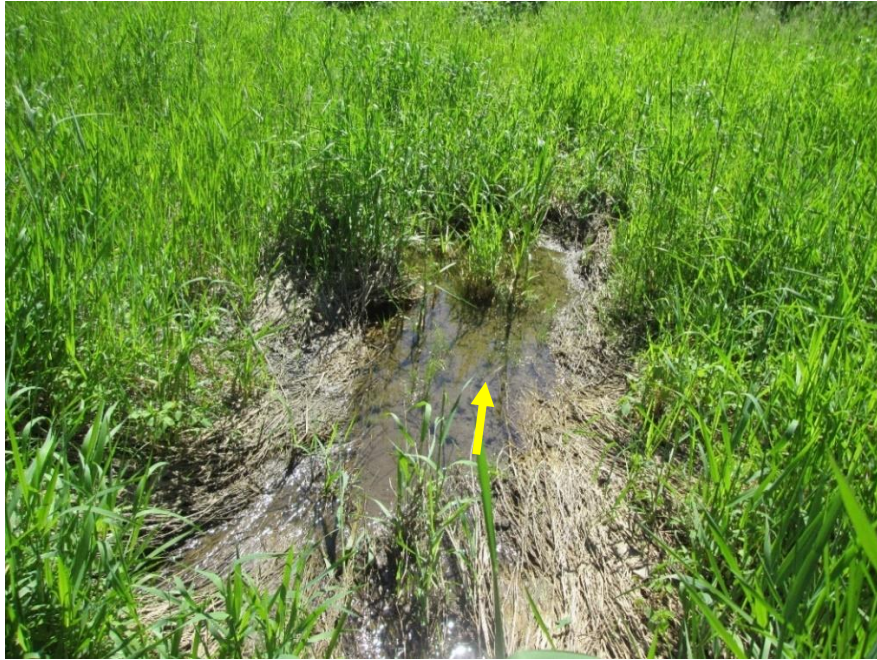
Photo 17  
Tributary of Twenty Mile Creek: Visit 2  
**Reach TTMC2-12**

The poorly defined channel had some standing water during the second visit, and lacked banks to distinguish it from the adjacent grassland.

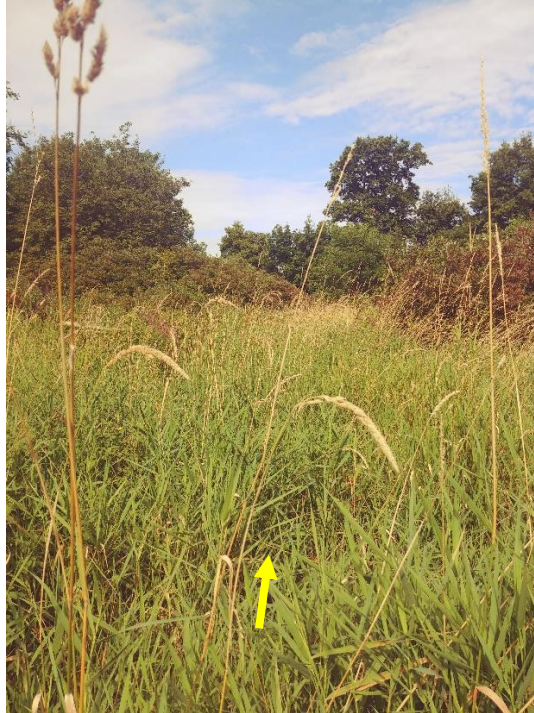
Photo 18  
Tributary of Twenty Mile Creek: Visit 3  
**Reach TTMC2-12**

The feature was dry and indistinguishable from the surrounding landscape during the summer, with no channel formation. Bed materials consisted of clay, silt and organic matter.

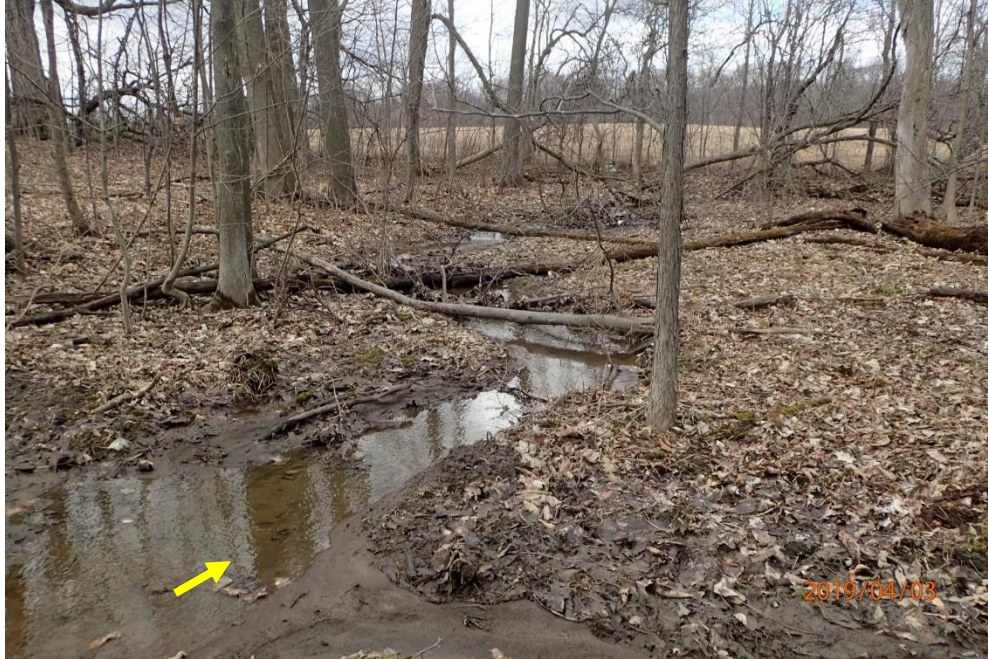
Photo 19  
Tributary of Twenty Mile Creek: Visit 1  
Reach **TTMC2-12-1**

The feature lacked defined bed and banks and conveyed minimal flow through the woodlot during the spring visit.

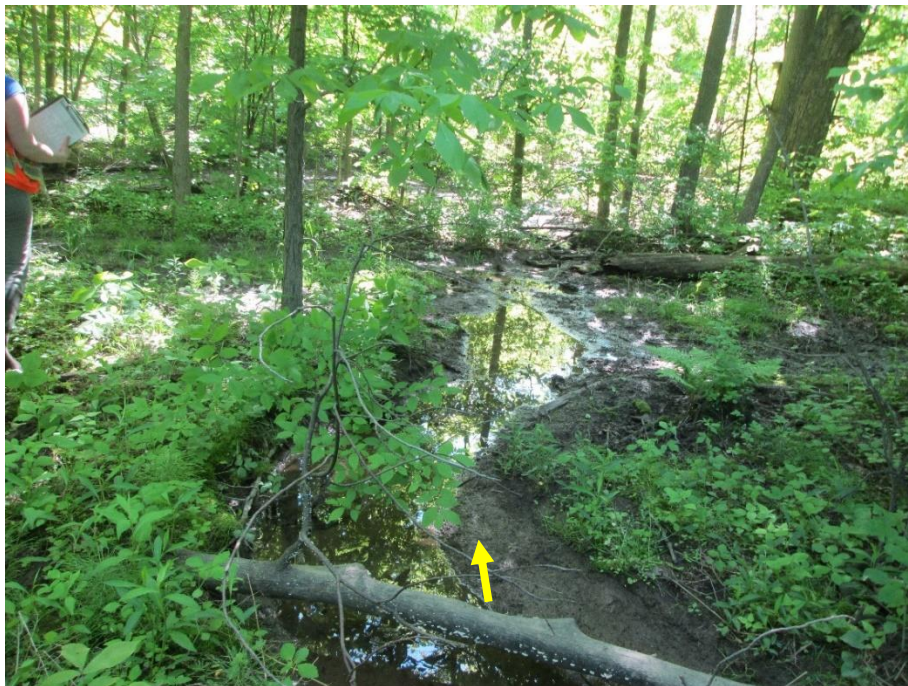
Photo 20  
Tributary of Twenty Mile Creek: Visit 2  
Reach **TTMC2-12-1**

Riparian vegetation for the reach consisted predominantly of deciduous trees. Standing water was present during the second visit.

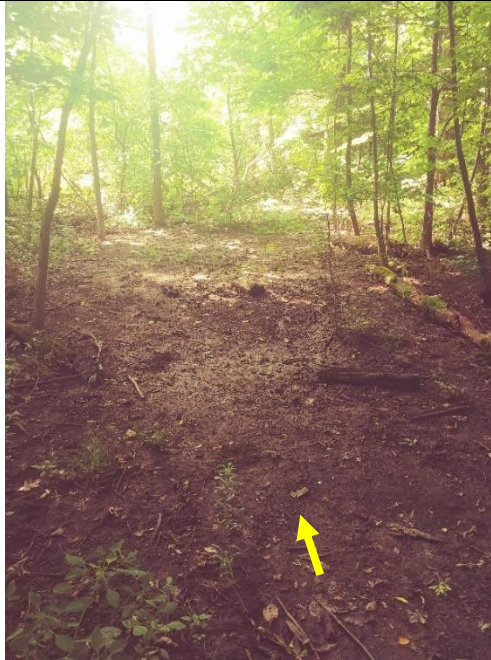
Photo 21  
Tributary of Twenty Mile Creek: Visit 3  
Reach TTM2-12-1

The feature was dry during the summer visit but was distinguishable from the surrounding woodlot. Bed materials consisted of clay, silt and organic matter.

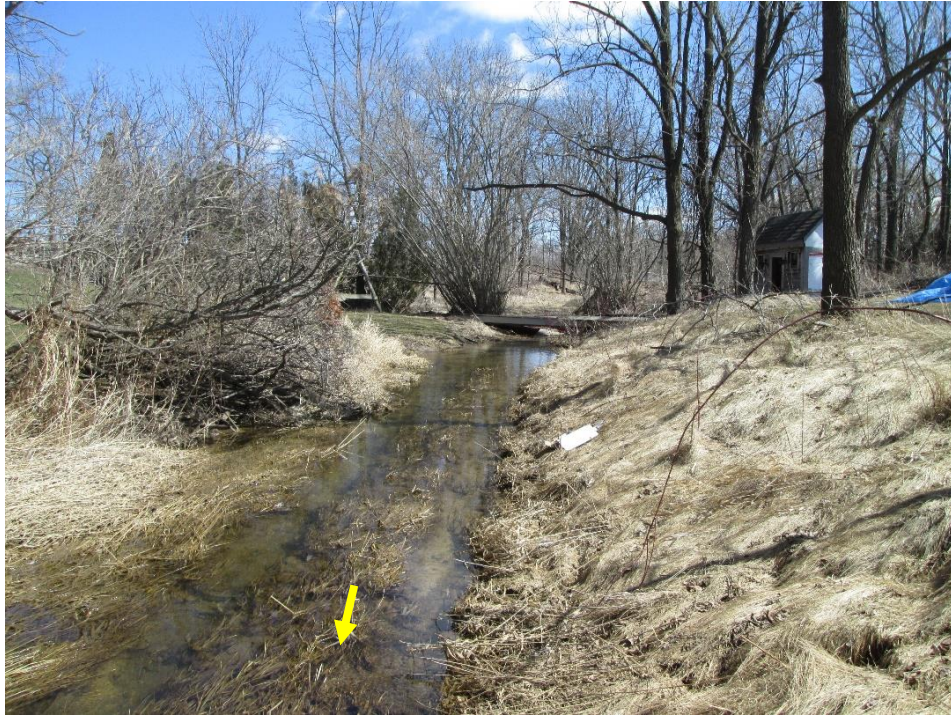
Photo 25  
Tributary of Twenty Mile Creek: Visit 1  
**Reach TTMC3-1**

The feature was a defined straight channel conveying flows towards its confluence with Twenty Mile Creek on the east side of Upper James Street.

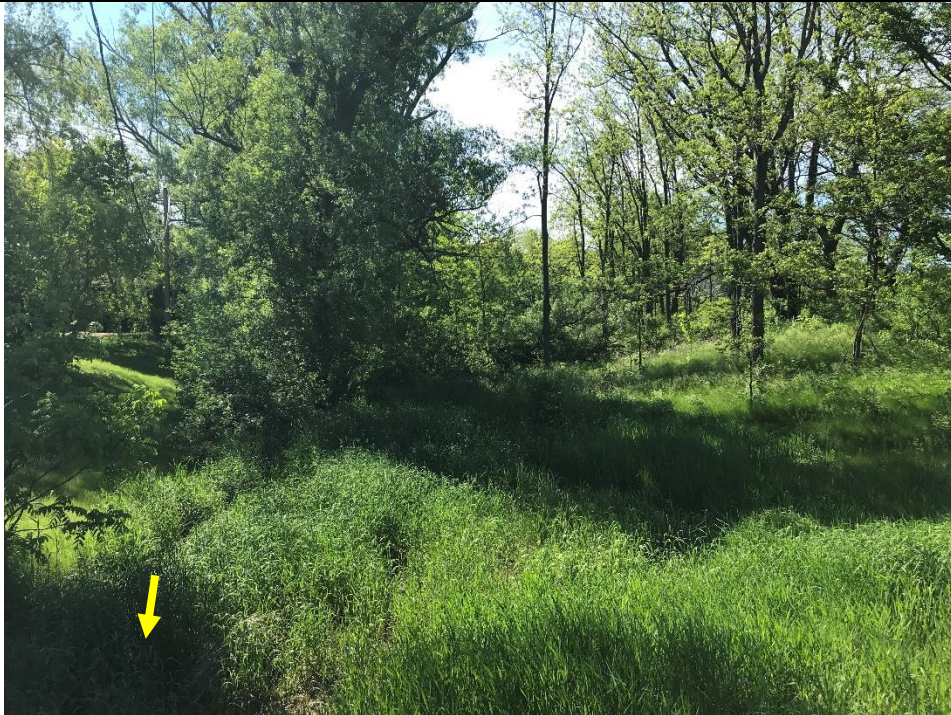
Photo 26  
Tributary of Twenty Mile Creek: Visit 2  
**Reach TTMC3-1**

Riparian vegetation consisted of scrubland and some hydrophilic vegetation. Bed materials consisted of clay and silt.

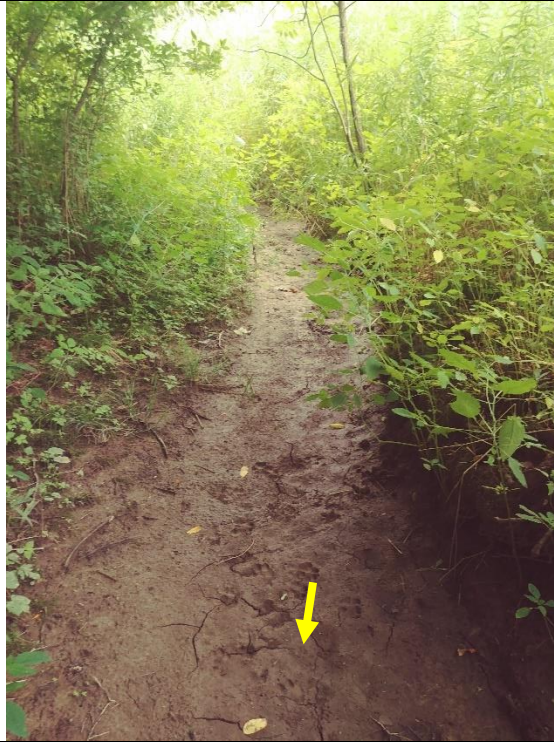
Photo 33  
Tributary of Twenty Mile Creek: Visit 3  
Reach **TTMC3-2-1**

The feature was dry during the summer visit but distinguishable from the surrounding landscape. Bed materials consisted predominantly of clay, silt and organic material

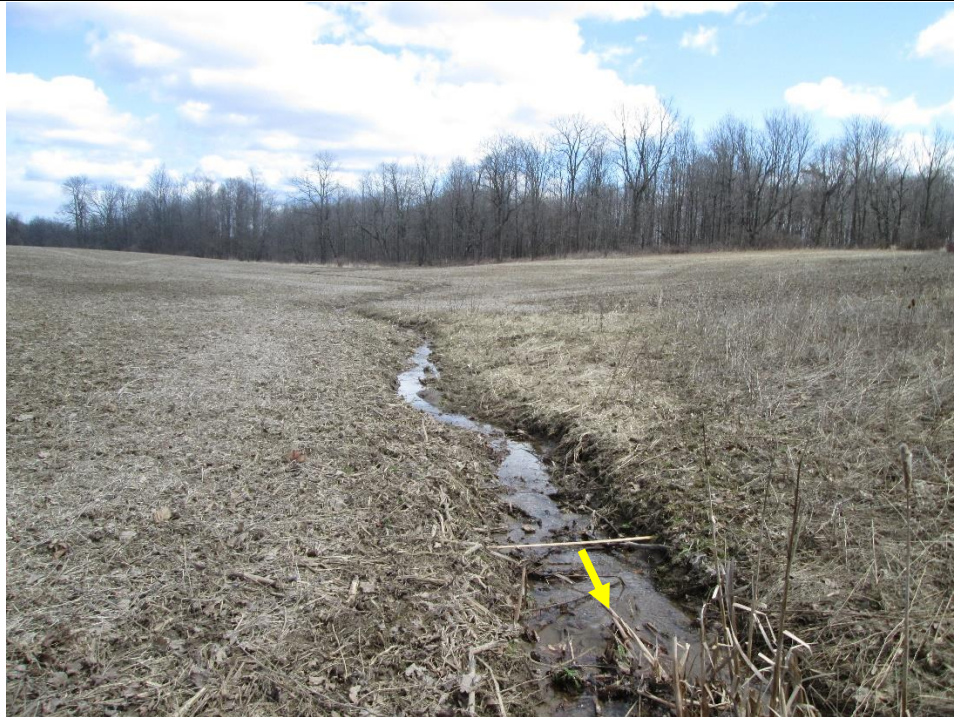
Photo 34  
Tributary of Twenty Mile Creek: Visit 1  
Reach **TTMC3-2-2**

The feature had defined bed and banks within the agricultural lands during freshet.

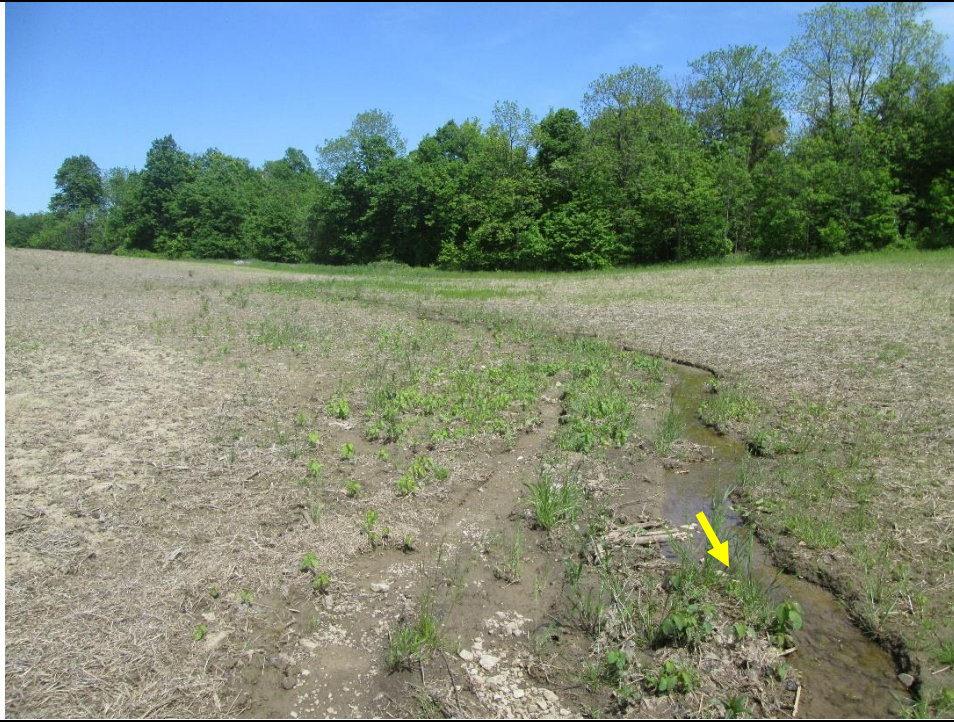
Photo 35  
Tributary of Twenty Mile Creek: Visit 2  
Reach **TTMC3-2-2**

The feature was surrounded by agricultural crops along its upstream section and ends in a woodlot populated by deciduous trees. Some water was flowing during the second visit.

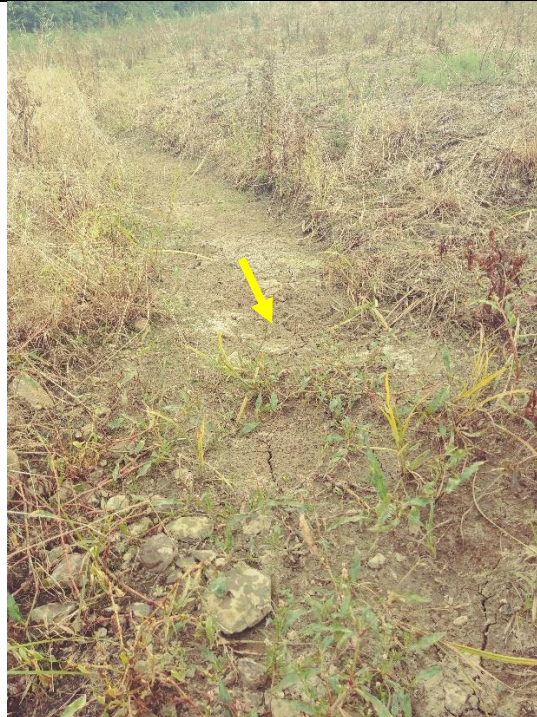
Photo 36  
Tributary of Twenty Mile Creek: Visit 3  
Reach **TTMC3-2-2**

The feature was dry during the last visit and the substrate consisted predominantly of clay, silt and gravel.

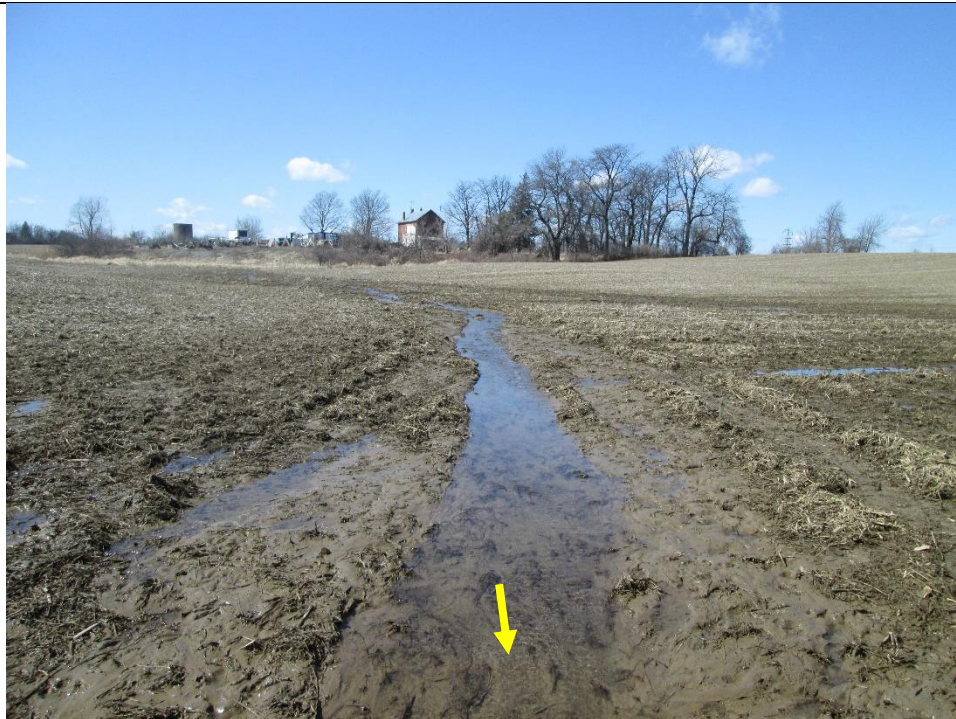
Photo 37  
Tributary of Twenty Mile Creek: Visit 1  
Reach TTM3-3

The feature lacked defined bed and banks and conveyed flows through an agricultural field during the spring visit.

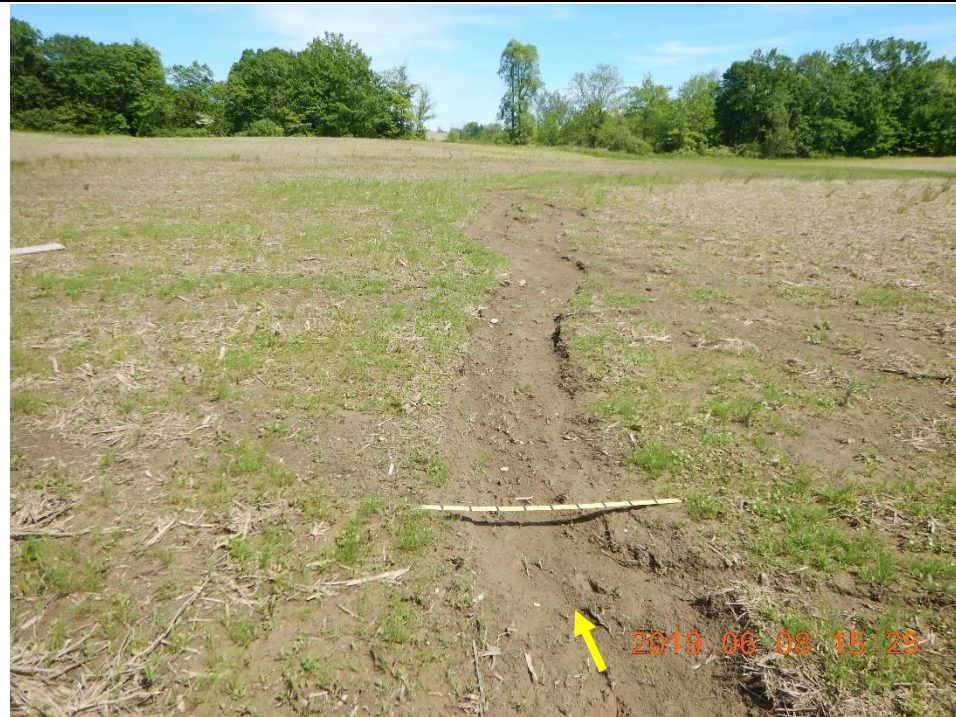
Photo 38  
Tributary of Twenty Mile Creek: Visit 2  
Reach TTM3-3

Riparian vegetation consisted predominantly of crops, with some grasses. Bed materials were indistinguishable from the surrounding fields.

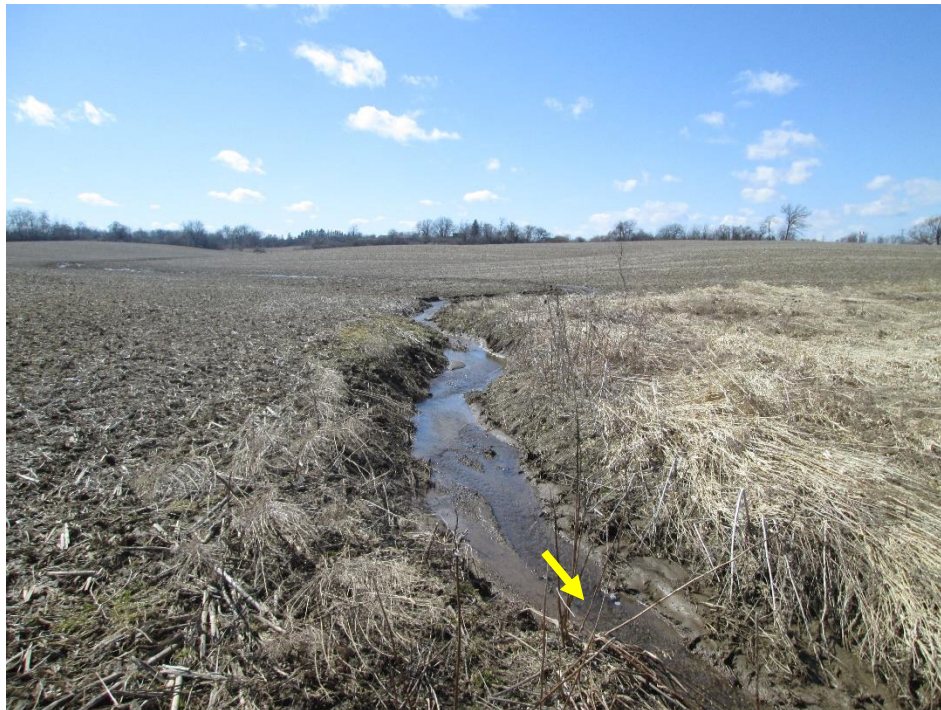
Photo 40  
Tributary of Twenty Mile Creek: Visit 1  
Reach **TTMC3-4**

The feature had well defined bed and banks within the agricultural fields during the spring visit and was conveying flow.

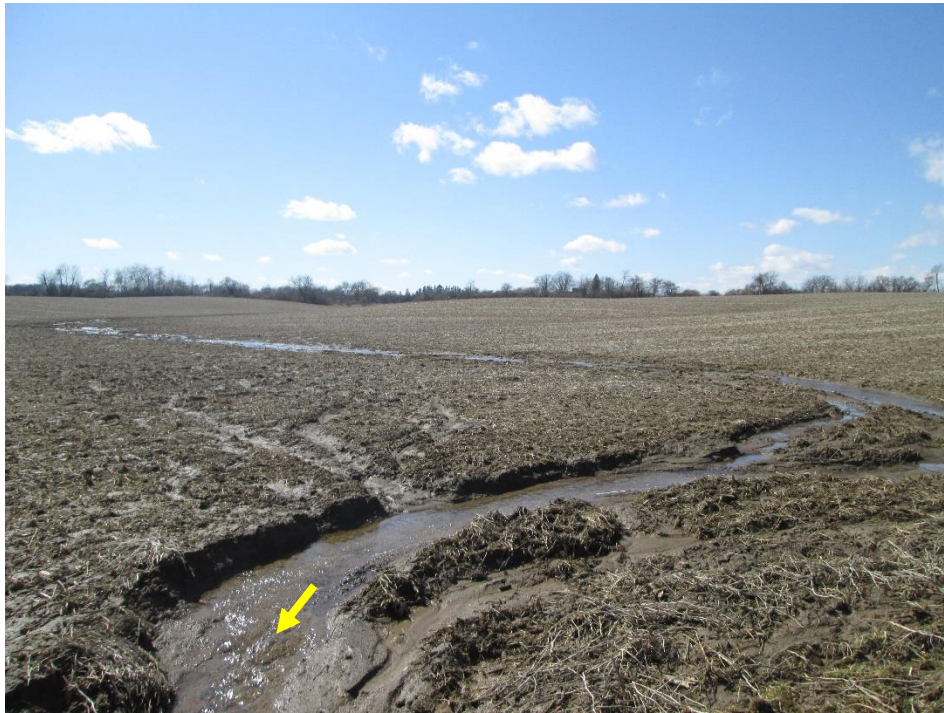
Photo 43  
Tributary of Twenty Mile Creek: Visit 1  
Reach TTM3-5

The feature had some bed and bank definition within the agricultural lands during the spring and was conveying flow.

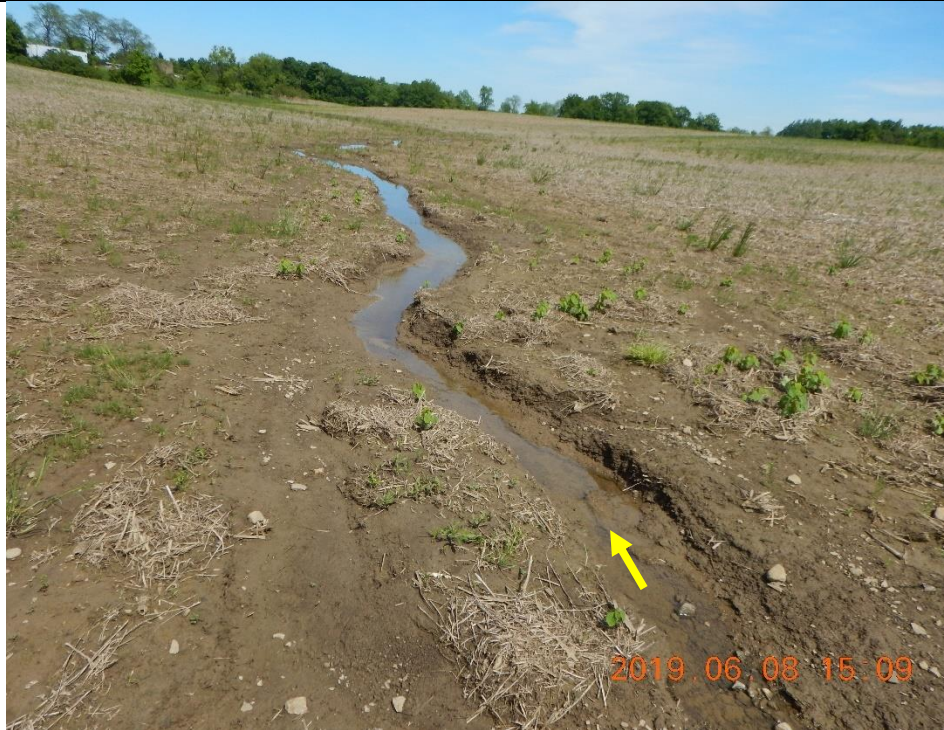
Photo 44  
Tributary of Twenty Mile Creek: Visit 2  
Reach TTM3-5

The majority of the riparian buffer consisted of agricultural crops.

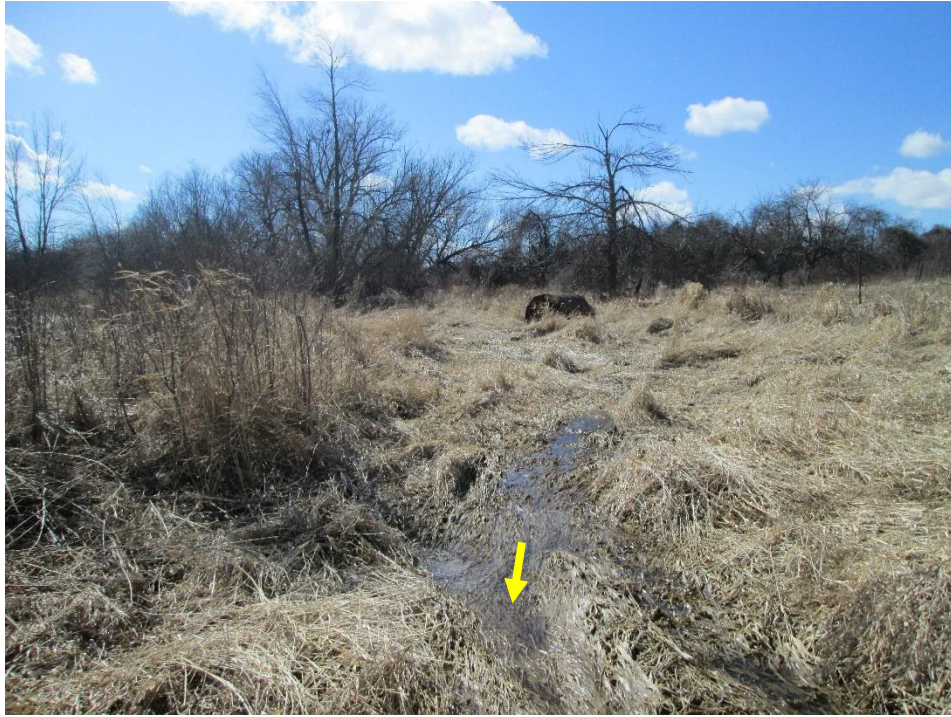
Photo 49  
Tributary of Twenty Mile Creek: Visit 1  
Reach **TTMC3-7**

The feature lacked bed and bank definition and conveyed flows from the central woodlot through a meadow to the agricultural field.

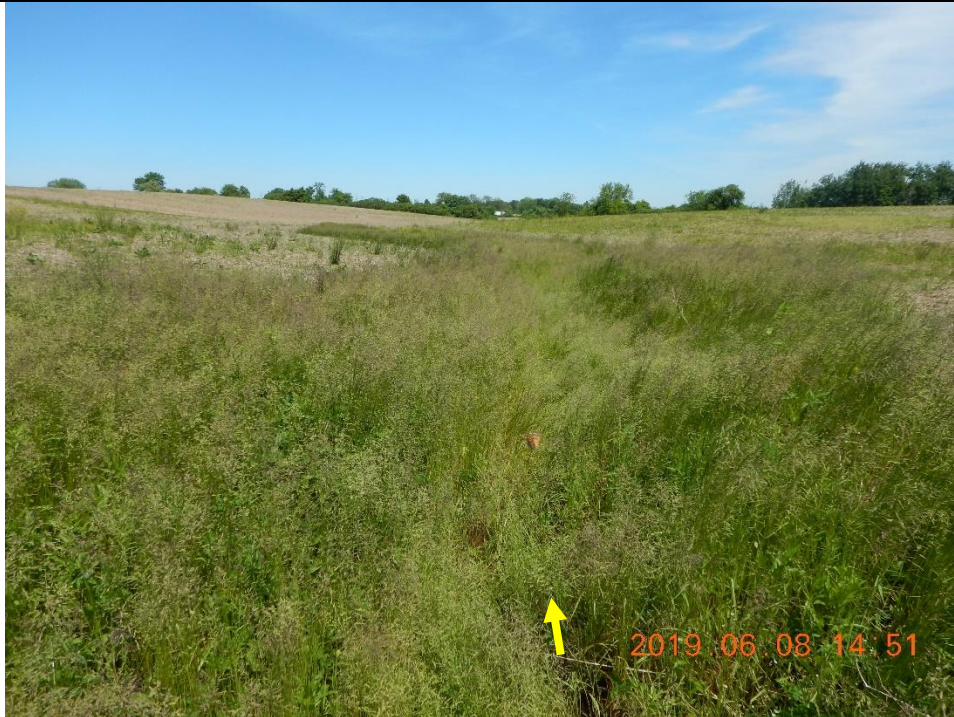
Photo 50  
Tributary of Twenty Mile Creek: Visit 2  
Reach **TTMC3-7**

The feature was dry and indistinguishable from the surrounding landscape during the summer, with no discernible channel.

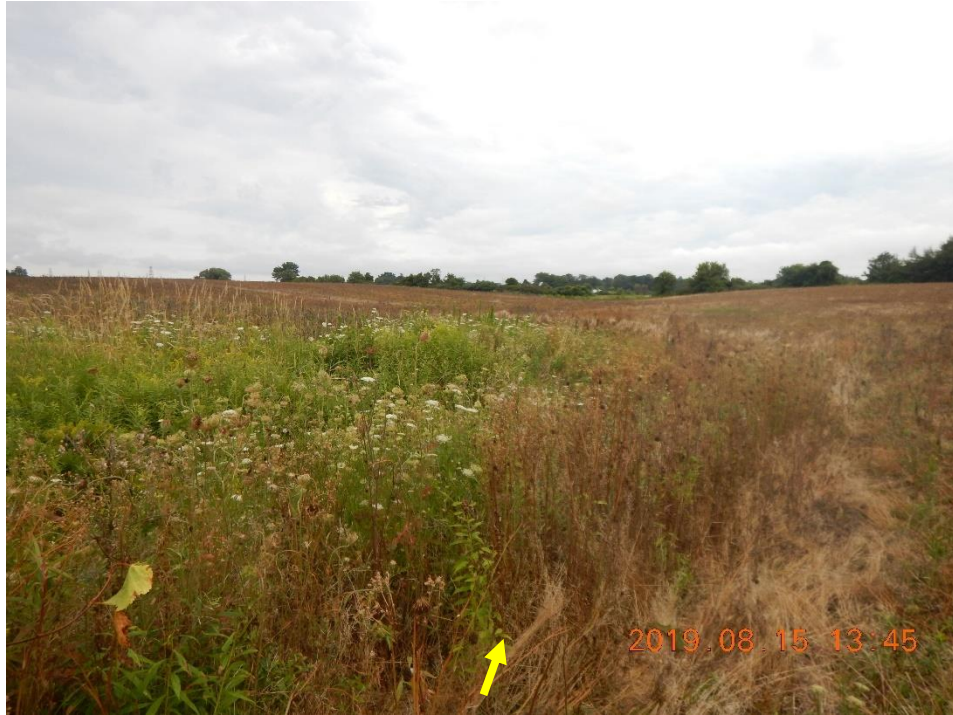
Photo 51  
Tributary of Twenty Mile Creek: Visit 3  
Reach **TTMC3-7**

The bed was composed of poorly sorted clay, silt, sand and sparse gravel. The feature was dry during the summer visit.

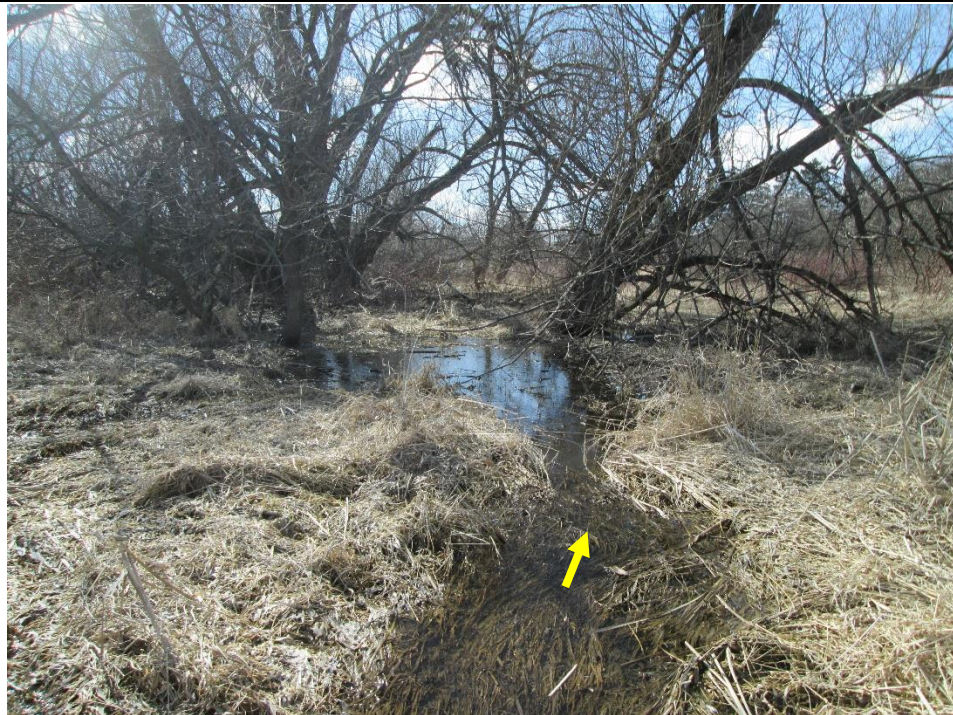
Photo 52  
Tributary of Twenty Mile Creek: Visit 1  
Reach **TTMC3-8**

The feature was poorly defined and conveyed flows from the online pond to the meadow flanking the agricultural field to the east.

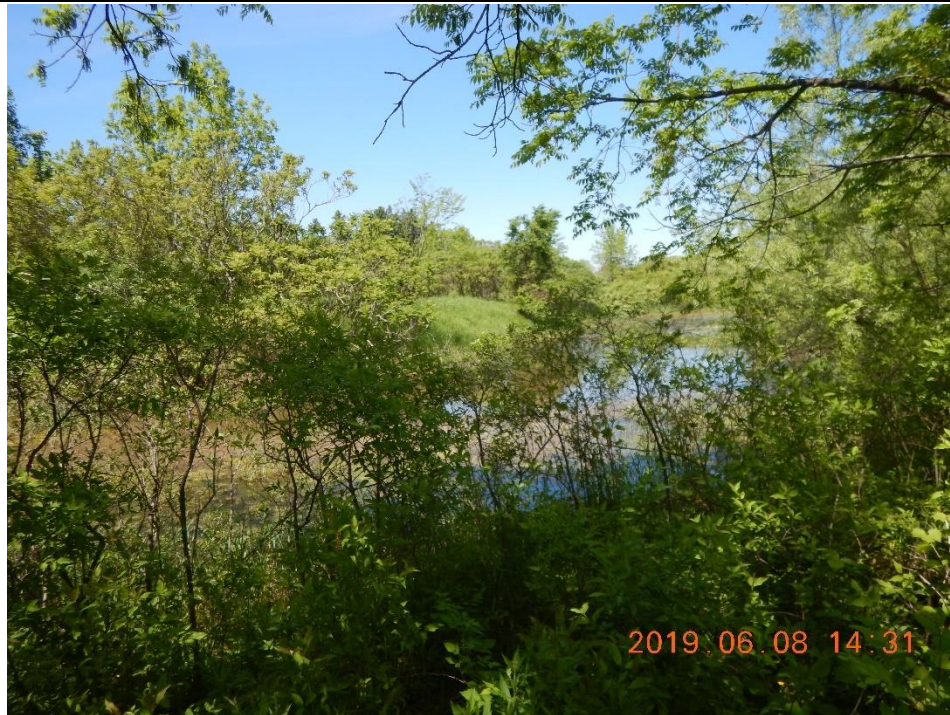
Photo 55  
Tributary of Twenty Mile Creek: Visit 2  
Reach **TTMC3-9**

The feature was an online pond located roughly in the middle of the subject lands within a woodlot.

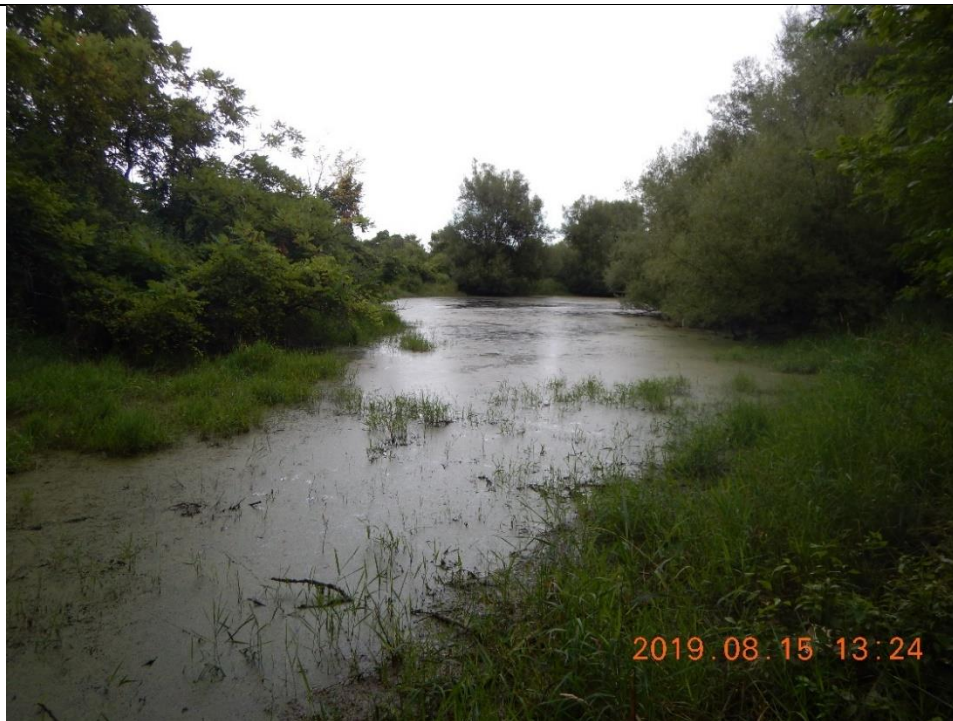
Photo 56  
Tributary of Twenty Mile Creek: Visit 3  
Reach **TTMC3-9**

Riparian vegetation consisted predominantly of mature deciduous trees which provided shading to the pond

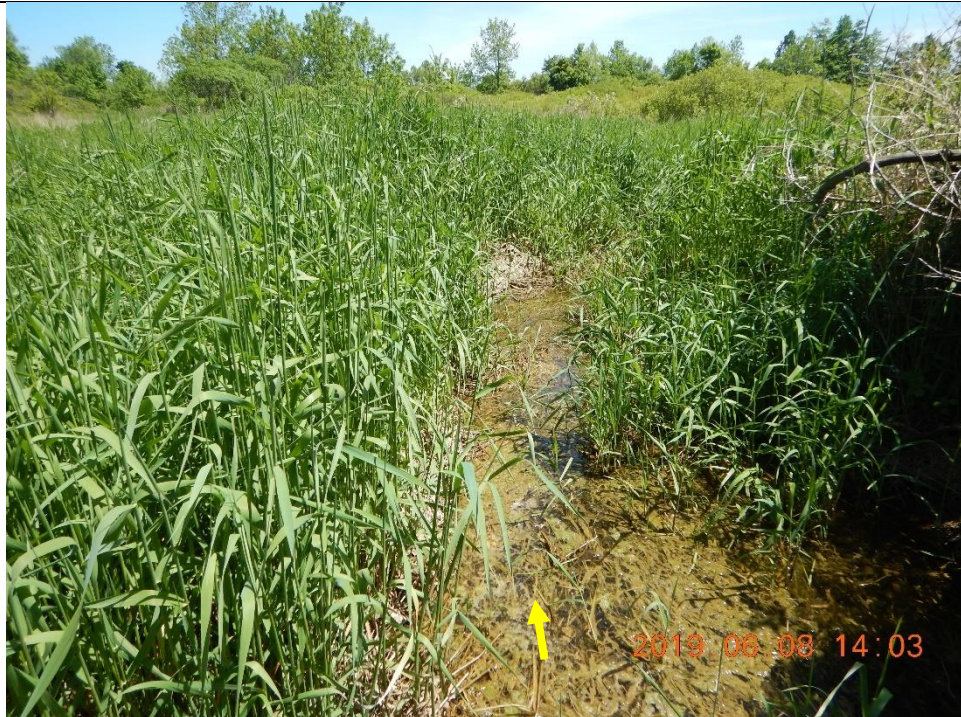
Photo 58  
Tributary of Twenty Mile Creek: Visit 2  
Reach TTM3-10

The swale was populated by dense hydrophilic vegetation in the feature itself and its riparian zone.

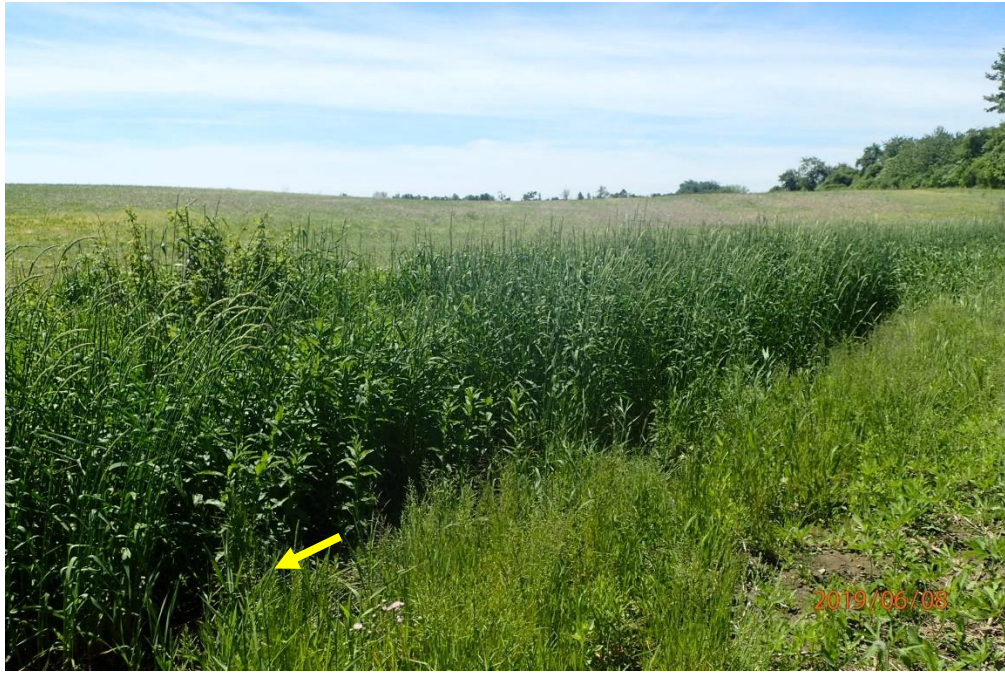
Photo 61  
Tributary of Twenty Mile Creek: Visit 2  
Reach **TTMC5-4**

The feature occupied a relatively wide corridor composed of hydrophilic herbaceous vegetation and grasses.

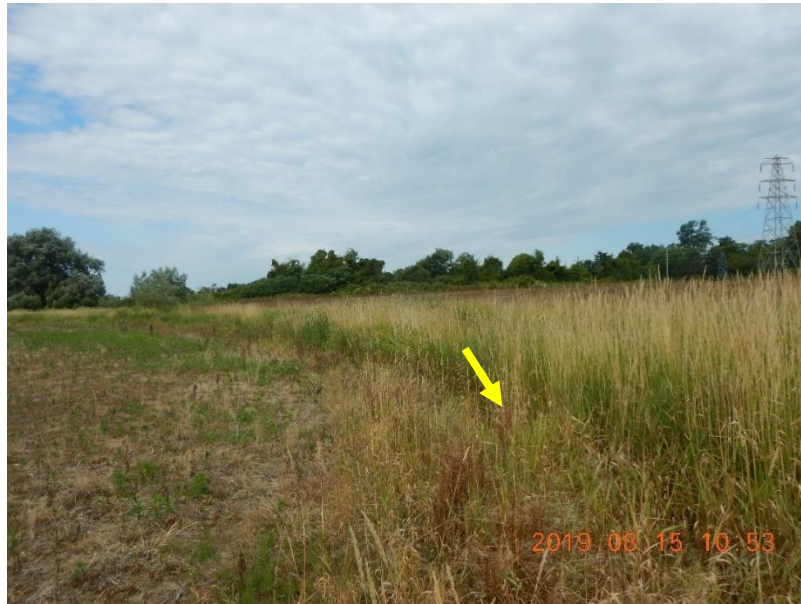
Photo 62  
Tributary of Twenty Mile Creek: Visit 3  
Reach TTMC5-4

The substrate material was equivalent to the surrounding fields and consisted of clay, silt and sand.

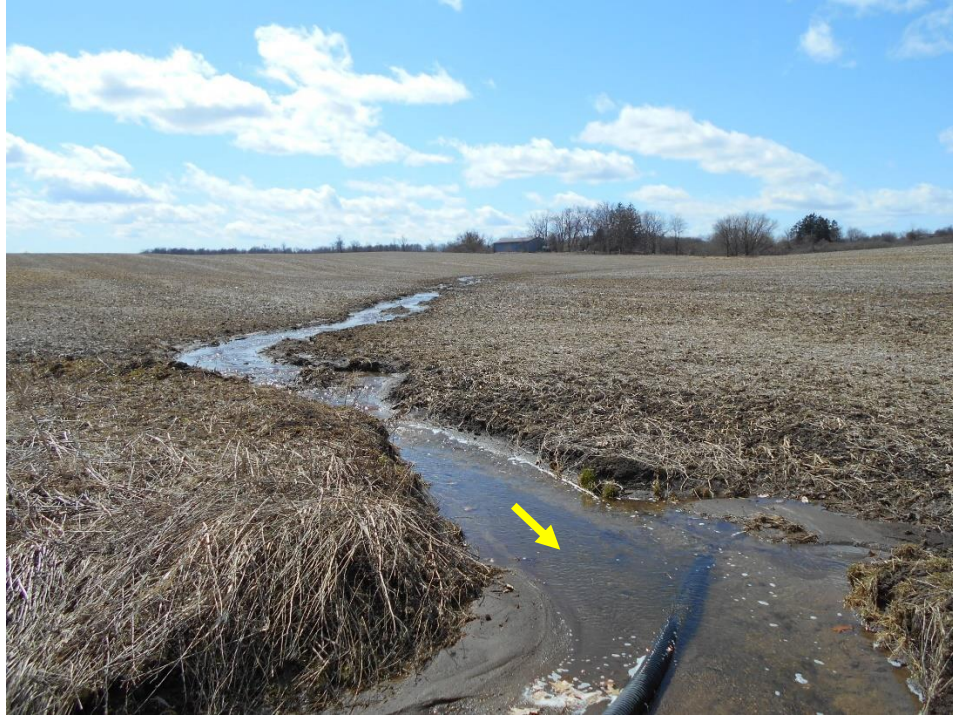
Photo 63  
Tributary of Twenty Mile Creek: Visit 1  
**Reach TTMC5-5**

The feature lacked bed and bank definition and conveyed flows through an agricultural field.

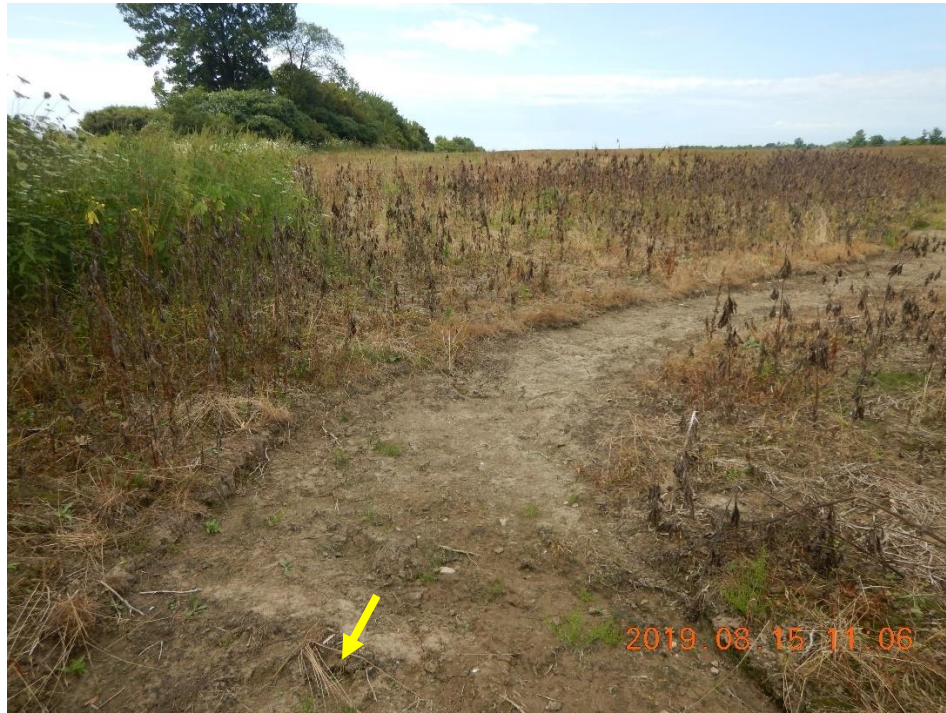
Photo 65  
Tributary of Twenty Mile Creek: Visit 3  
**Reach TTMC5-5**

The feature was dry during the summer visit and substrate was generally consistent with the adjacent fields.

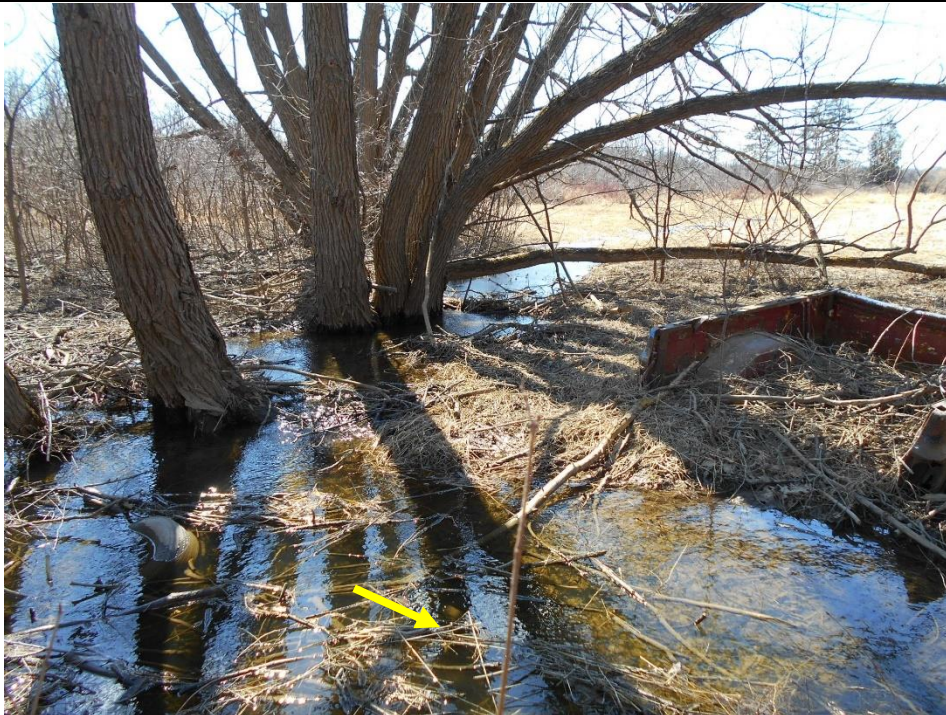
Photo 66  
Tributary of Twenty Mile Creek: Visit 1  
**Reach TTMC5-6**

The feature lacked bed and bank definition and conveyed flows within a wooded area.

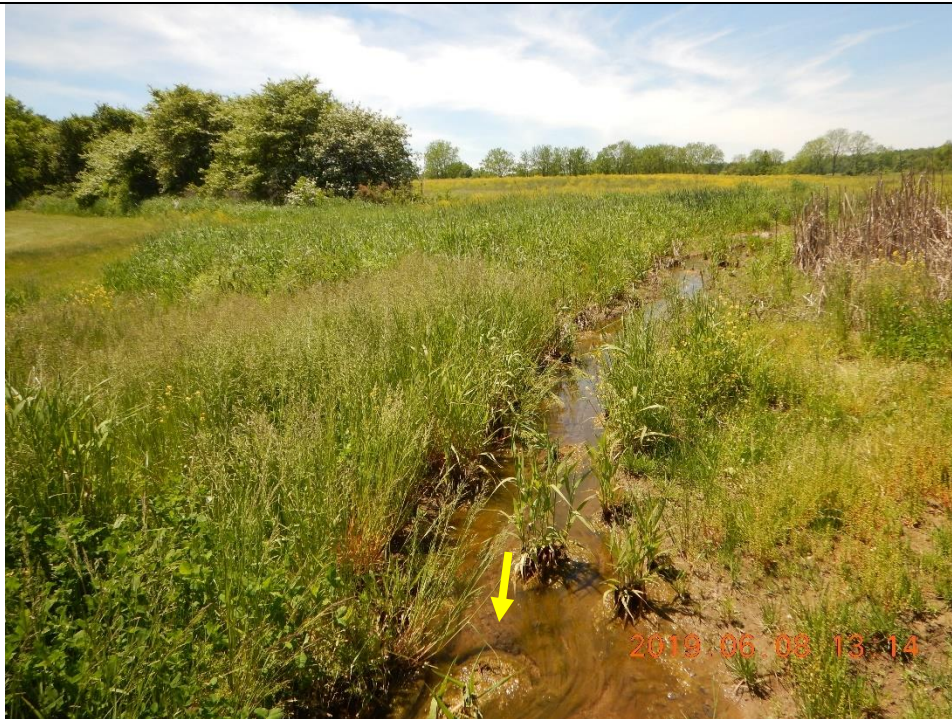
Photo 70  
Tributary of Twenty Mile Creek: Visit 2  
**Reach TTMCS-7**

Riparian vegetation consisted of grasses, with some areas lacking a buffer and instead being flanked by crops.

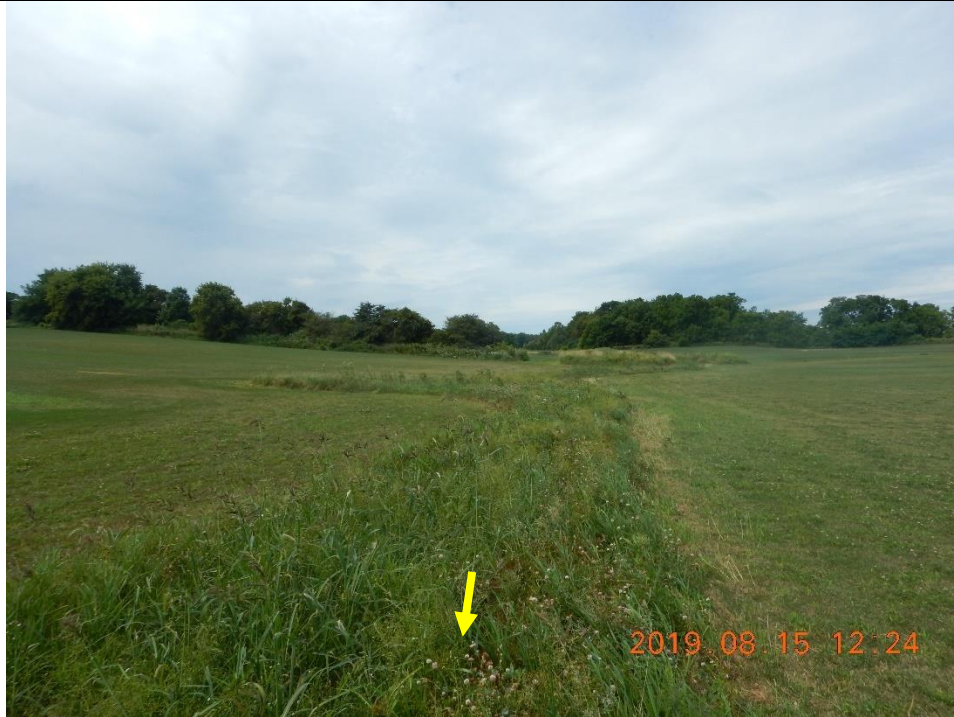
Photo 71  
Tributary of Twenty Mile Creek: Visit 3  
Reach **TTMC5-7**

Substrate within the feature consisted of clay, silt, and sand and the channel was occupied by sparse rooted emergent aquatic vegetation and grasses.

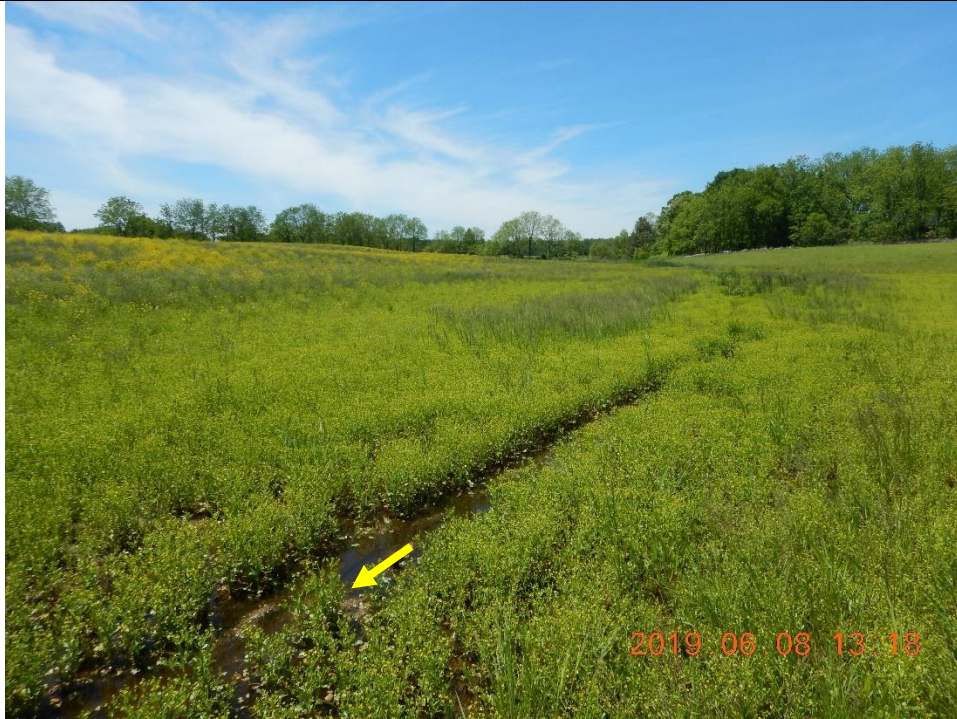
Photo 73  
Tributary of Twenty Mile Creek: Visit 2  
**Reach TTMC5-8**

The feature was a swale which conveyed flows through an agricultural field.
