# Upper West Side - Fluvial Geomorphological Assessment Twenty Road West, City of Hamilton

June 12, 2020  
PN18013

Report Title: Upper West Side Draft Plan of Industrial Subdivision  
Fluvial Geomorphological Assessment - Update

Project Number: PN18013

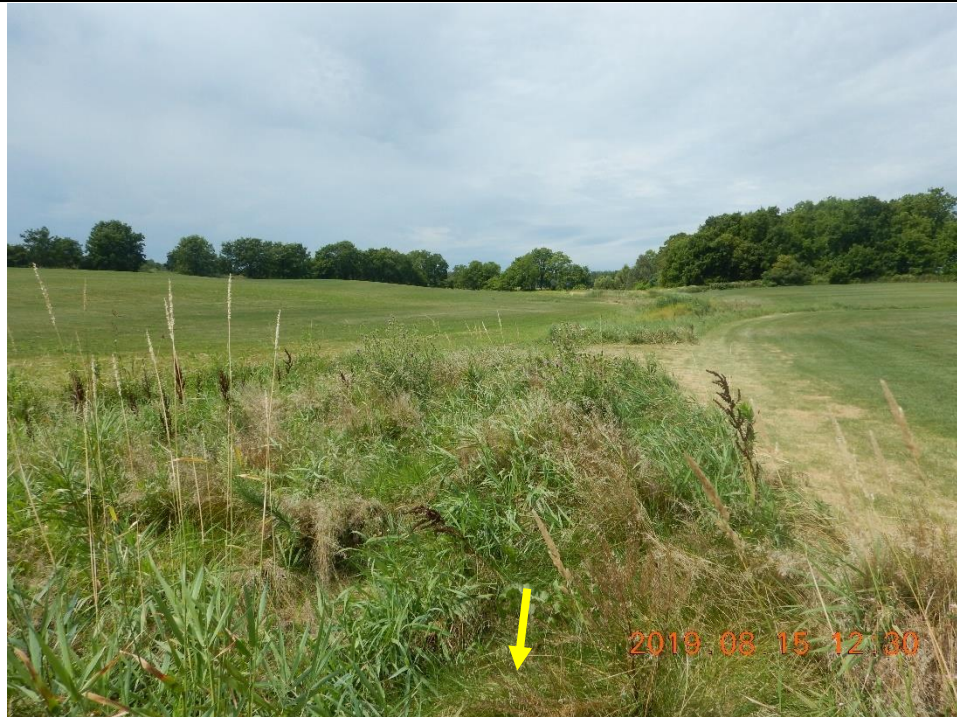
Photo 74  
Tributary of Twenty Mile Creek: Visit 3  
**Reach TTMC5-8**

The feature had a narrow riparian corridor composed of herbaceous vegetation and grasses.

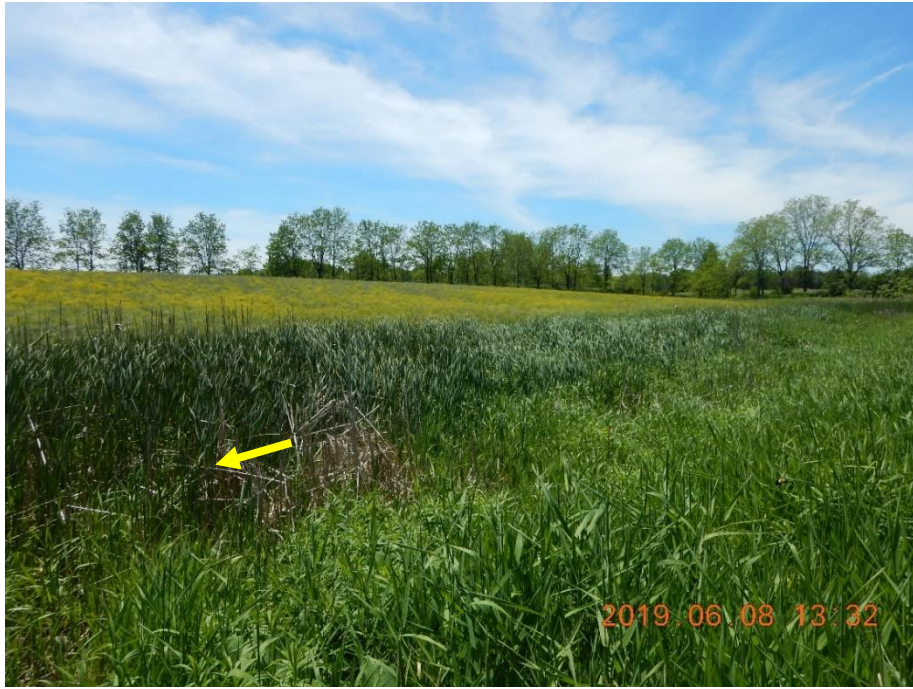
Photo 79  
Tributary of Twenty Mile Creek: Visit 2  
**Reach TTMC5-9**

The feature originated at the outlet of a small pond within the former Glancaster Golf and Country Club and conveyed flows through an agricultural field.

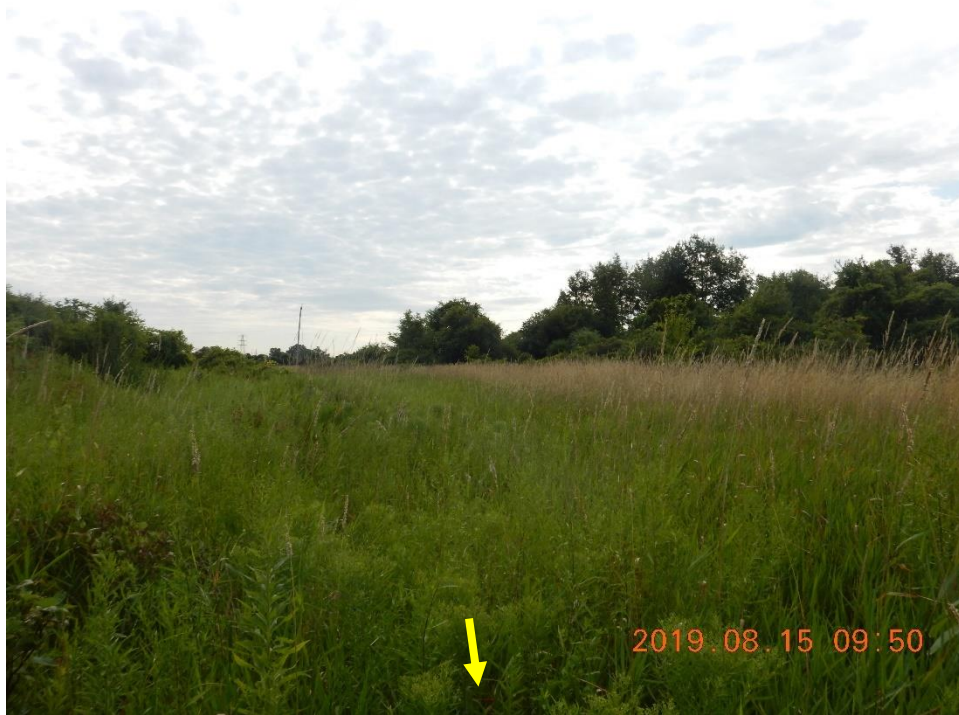
Photo 85  
Tributary of Twenty Mile Creek: Visit 3  
Reach TTM6-2

The feature was filled with dense, rooted emergent aquatic vegetation, particularly grasses, and was flanked by both meadow and scrubland within the riparian buffer.

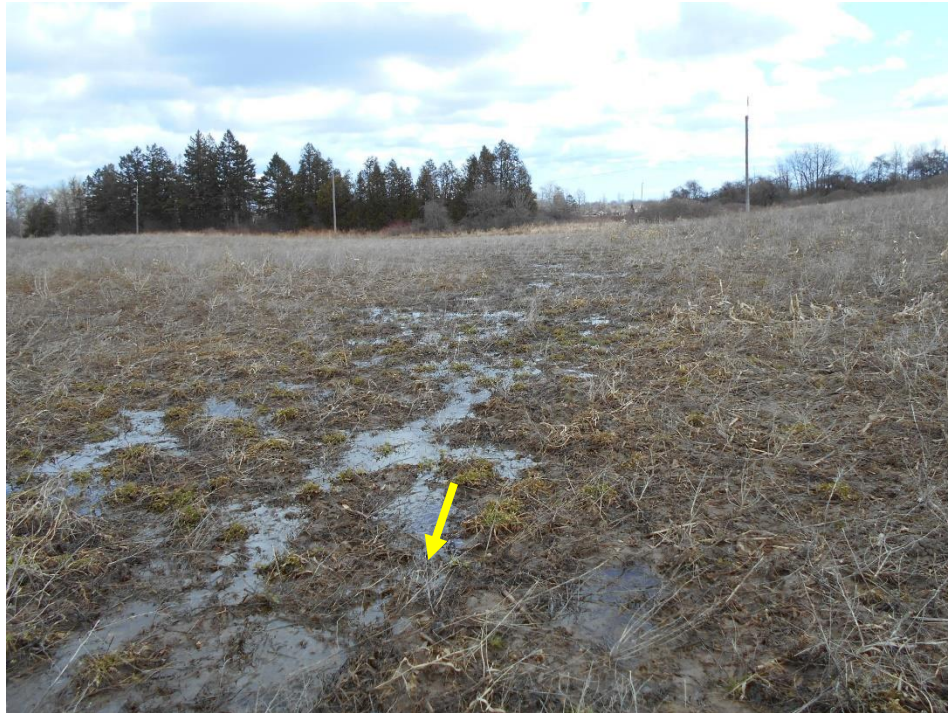
Photo 86  
Tributary of Twenty Mile Creek: Visit 1  
Reach TTM6-3

Bed substrate within the feature was predominantly clay, silt and sand. No water was present during the summer visit.

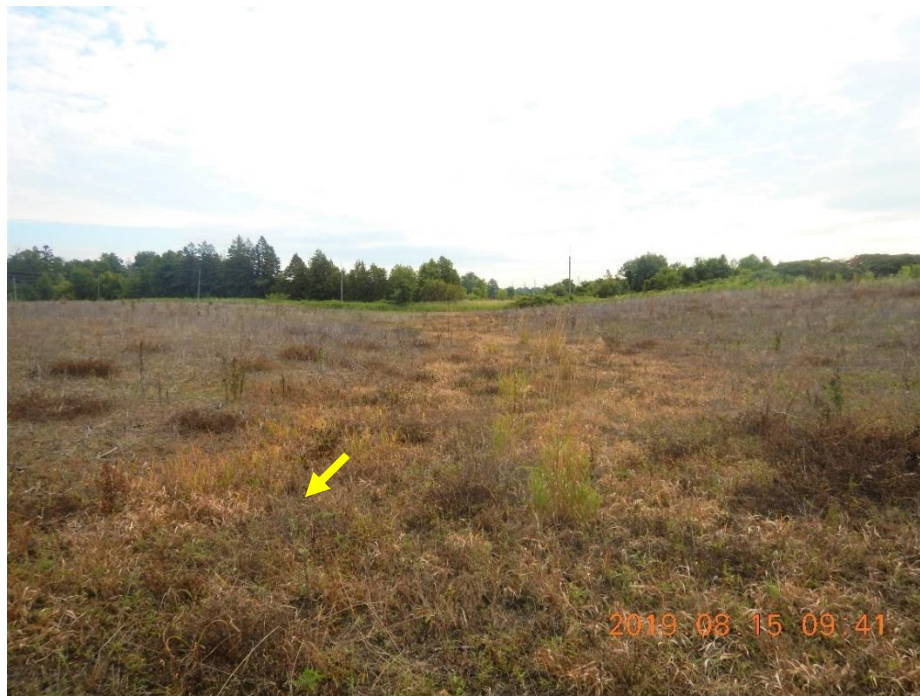
Photo 88  
Tributary of Twenty Mile Creek: Visit 3  
**Reach TTMC6-3**

The channel was located adjacent to an un-planted agricultural field and had a narrow herbaceous riparian buffer.

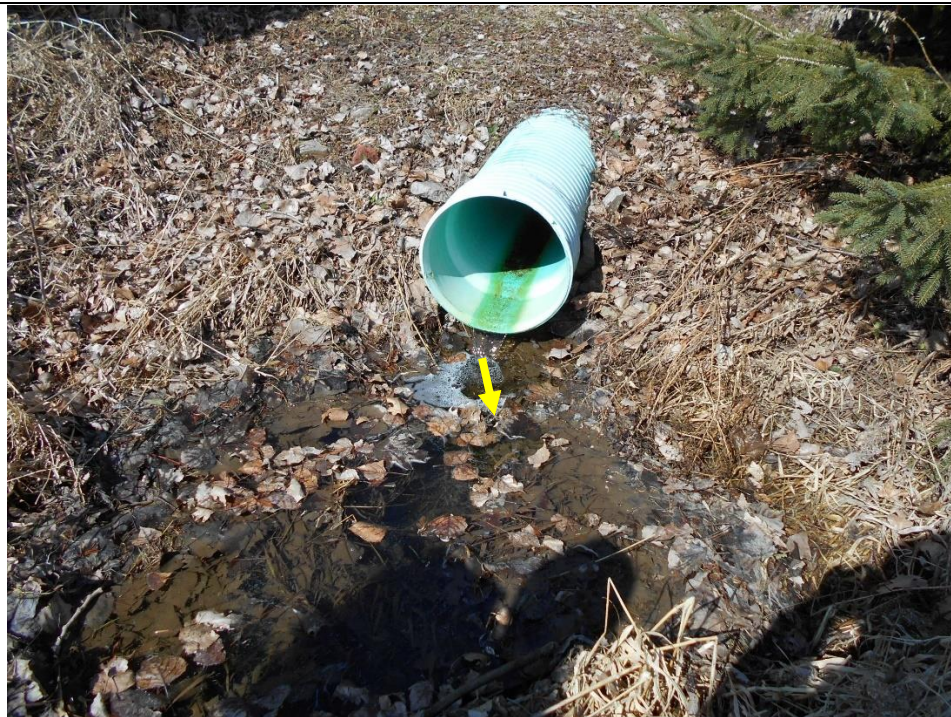
Photo 92  
Tributary of Twenty Mile Creek: Visit 1  
Reach **TTMC7-1**

The feature was dry during the summer visit and its substrate consisted predominantly of decomposing organics.

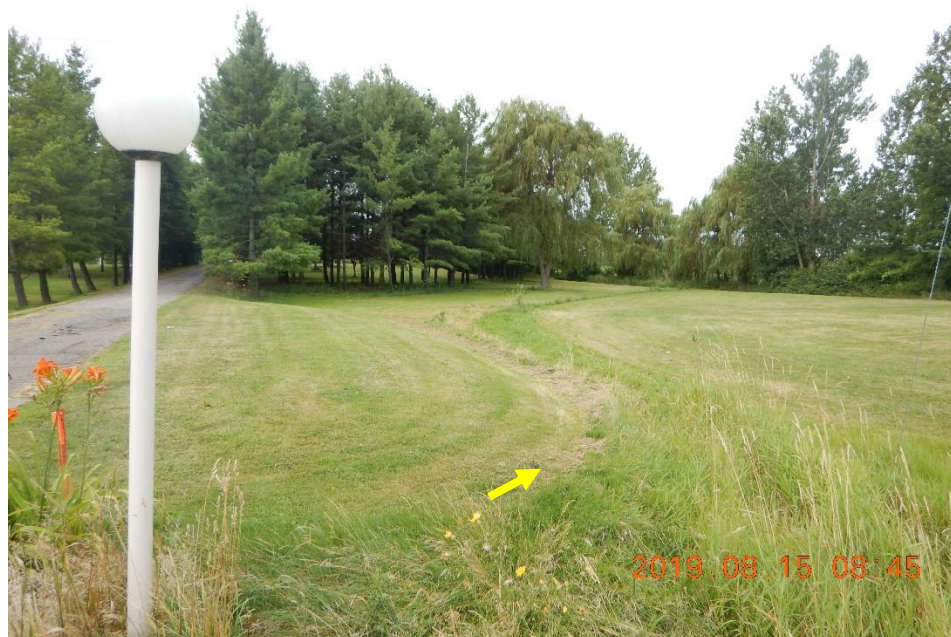
Photo 96  
Tributary of Twenty Mile Creek: Visit 2  
**Reach TTMC8-6**

The feature lacked bed and bank definition and conveyed flows towards a roadside ditch at Twenty Road West.

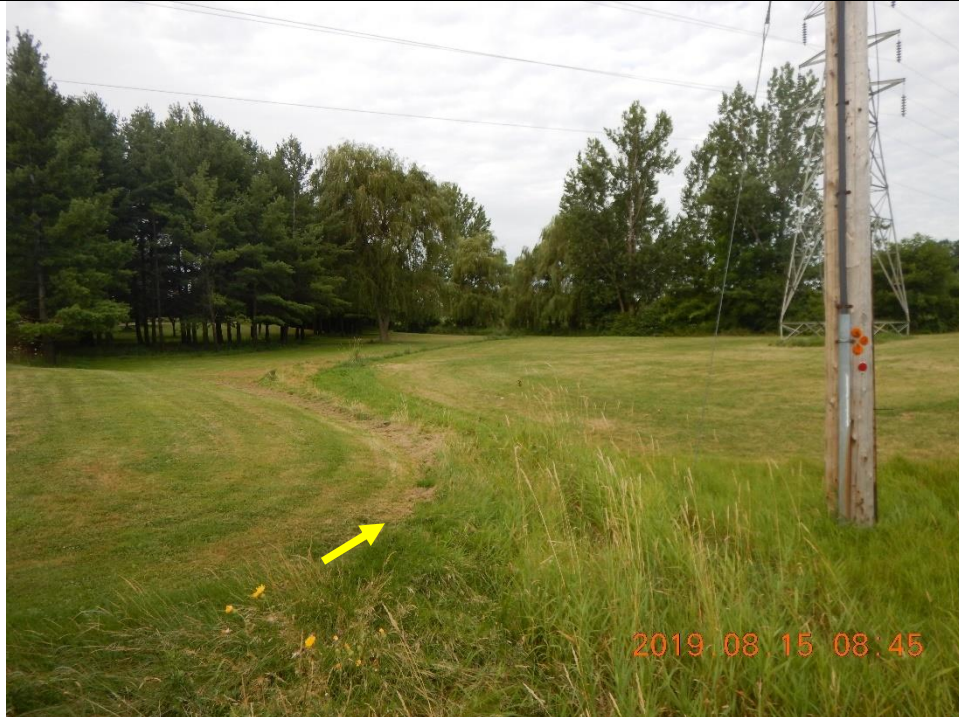
Photo 97  
Tributary of Twenty Mile Creek: Visit 2  
Reach **TTMC8-6**

The feature's vegetation was equivalent to the surrounding area, and consisted of a manicured lawn.

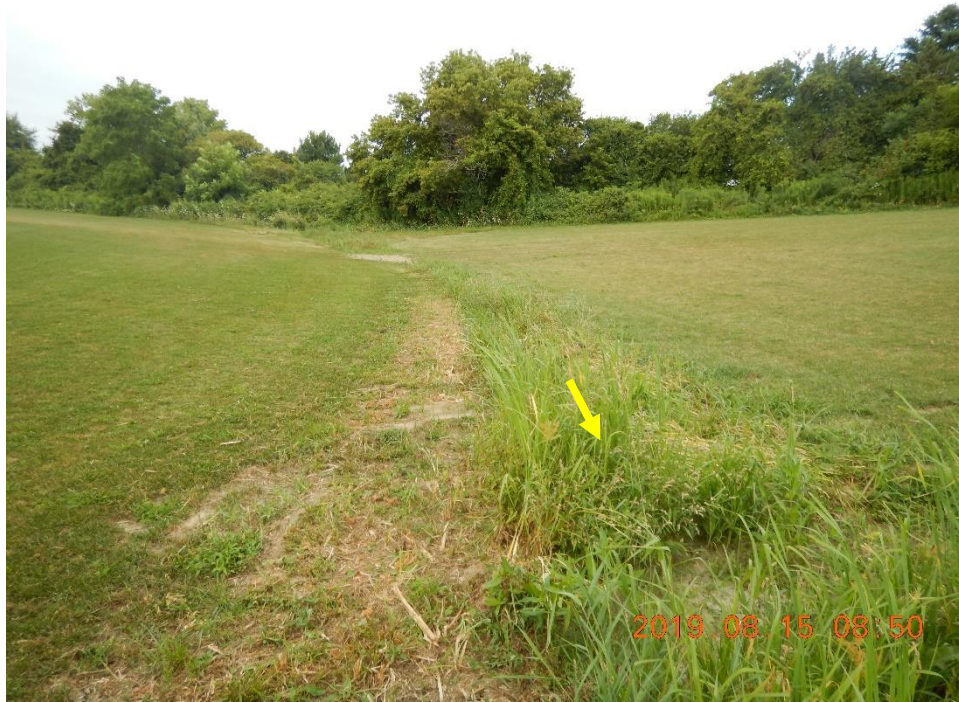
Photo 99  
Tributary of Twenty Mile Creek: Visit 3  
Reach **TTMC8-7**

The feature lacked a natural riparian buffer, and was predominantly cropped with some areas lacking any vegetation.

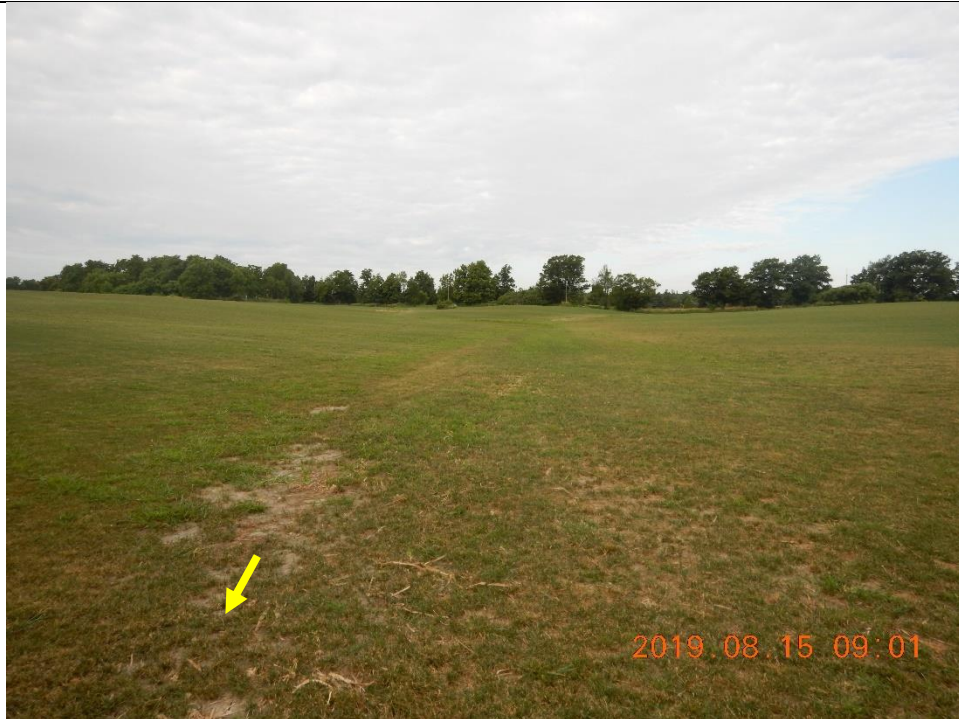
Photo 102  
Tributary of Twenty Mile Creek: Visit 3  
**Reach TTMC8-9**

Riparian vegetation consisted predominantly of agricultural crops, which were generally absent from the channel during the spring.

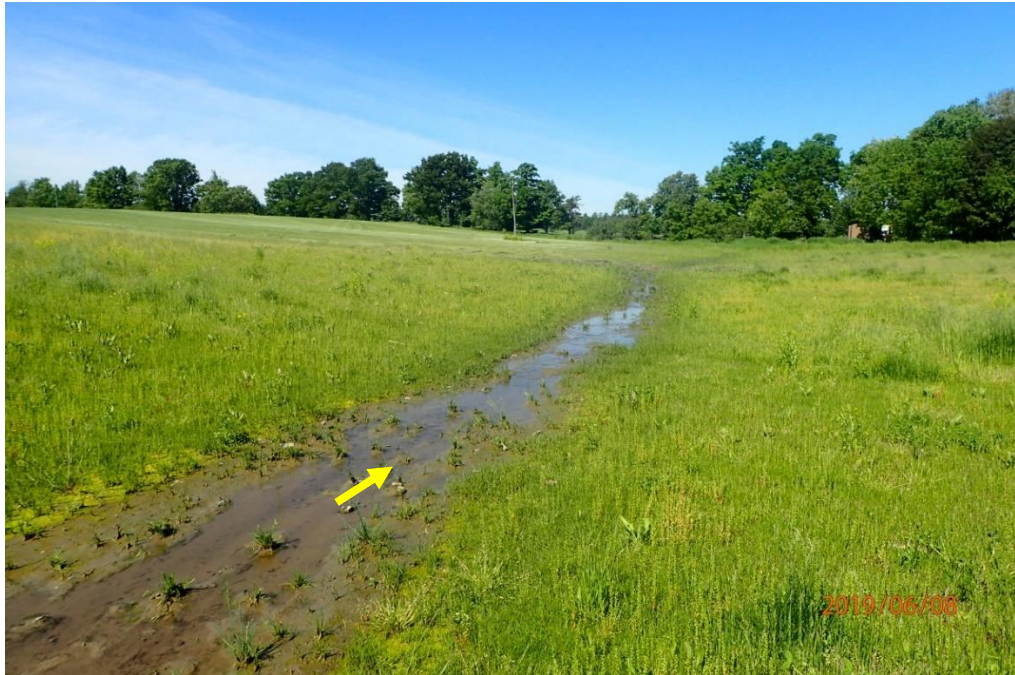
Photo 106  
Tributary of Twenty Mile Creek: Visit 2  
Reach **TTMC8-3-3**

The feature lacked channel definition and conveyed flows through an agricultural field.
