Fluvial Geomorphological Assessment and Erosion Hazard Delineation

Sulphur Creek and Tributaries
159 and 163 Sulphur Springs Road
Ancaster, Ontario

Submitted:
November 26, 2024

GEO Morphix Project No. 24108

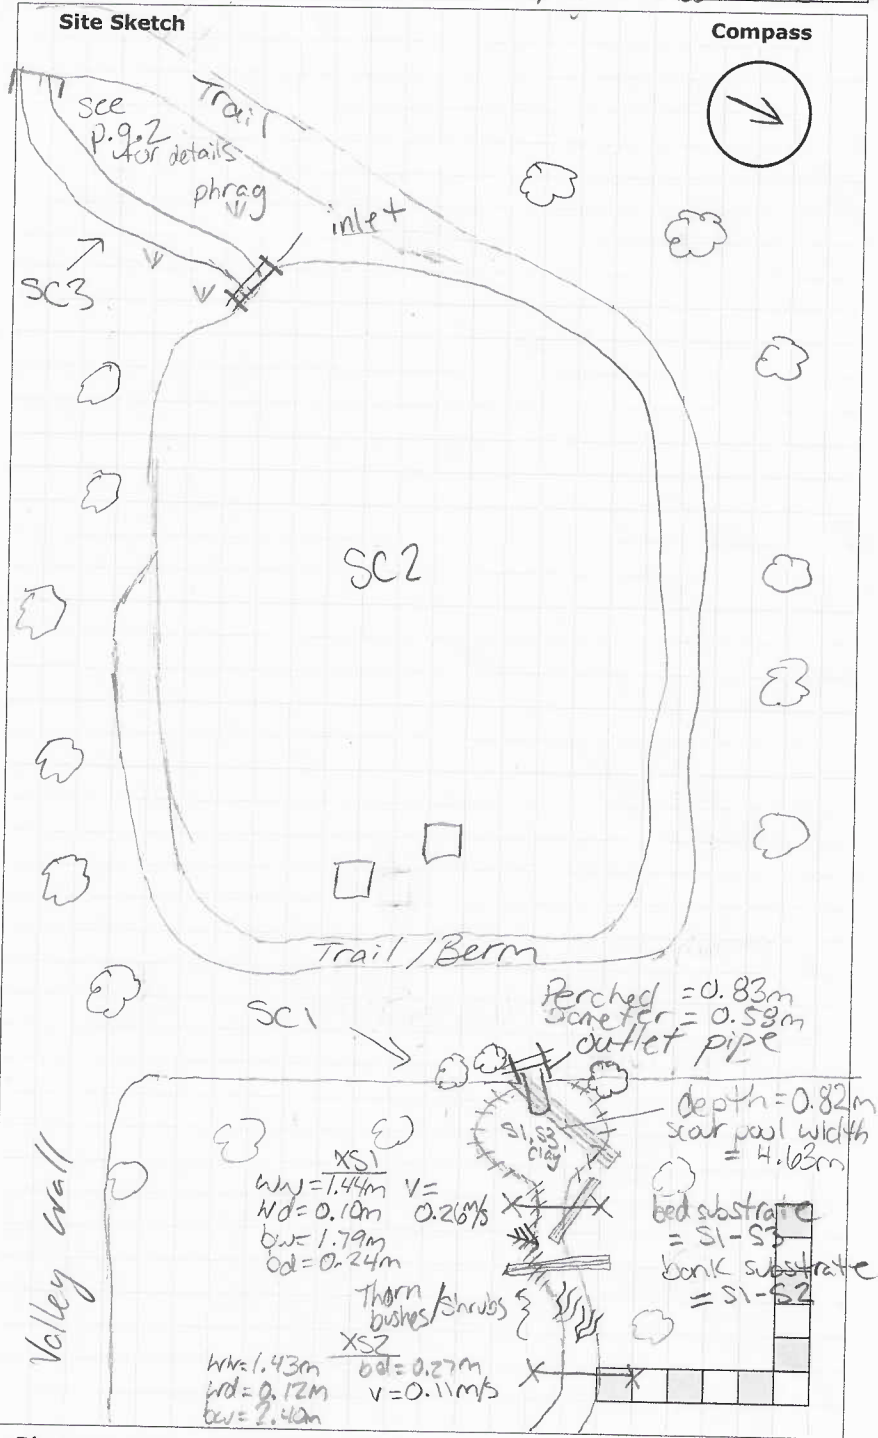
Photos:

Notes: Perched height from bottom of pipe to depth of scarp pool (scarp pool deepest at centre).
Pipe observed to be degrading. Banks 1.5m high.

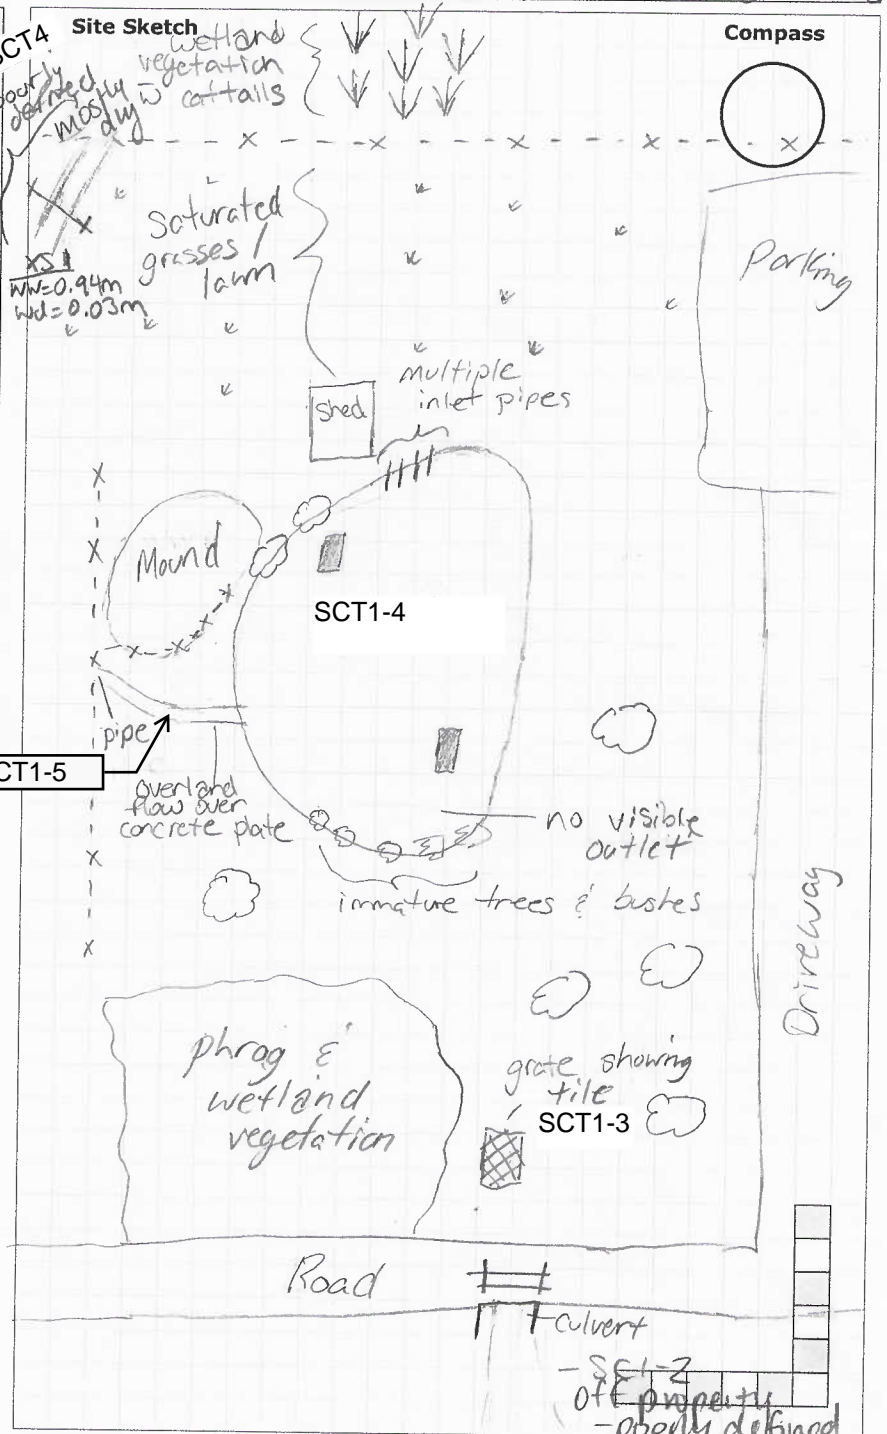
Photos:

Notes: Algae on pond and pond is green.
