Carlisle Water Storage Study

Project File Report

Final

RVA 215933

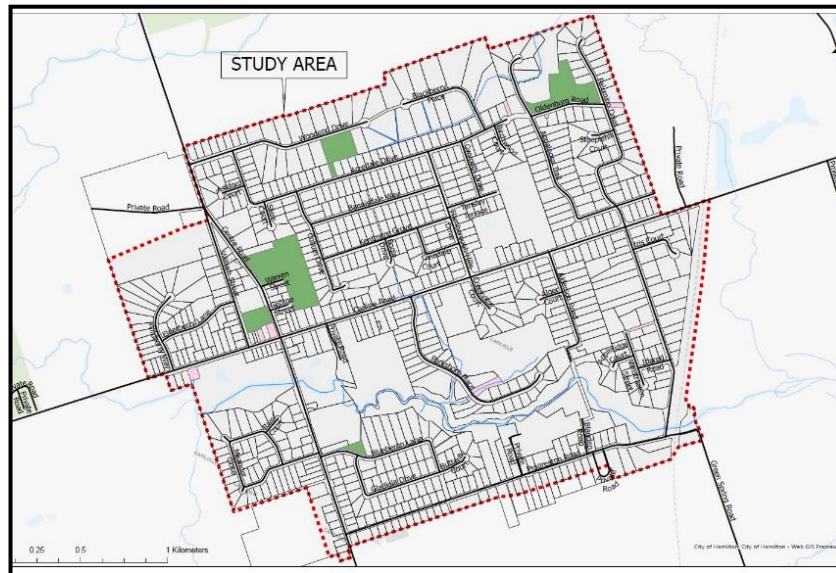
Figure ES 1 Study Area

The City of Hamilton (City) retained R.V. Anderson Associates Limited (RVA) to complete a Schedule 'B' Municipal Class Environmental Assessment (EA) and Conceptual Design (Study) for a water storage facility in the Carlisle Rural Settlement Area and its immediate vicinity. The EA was later reclassified to be 'Exempt' based on guidance within the Municipal Class EA process. The Study Area is show in Figure ES 1 below.

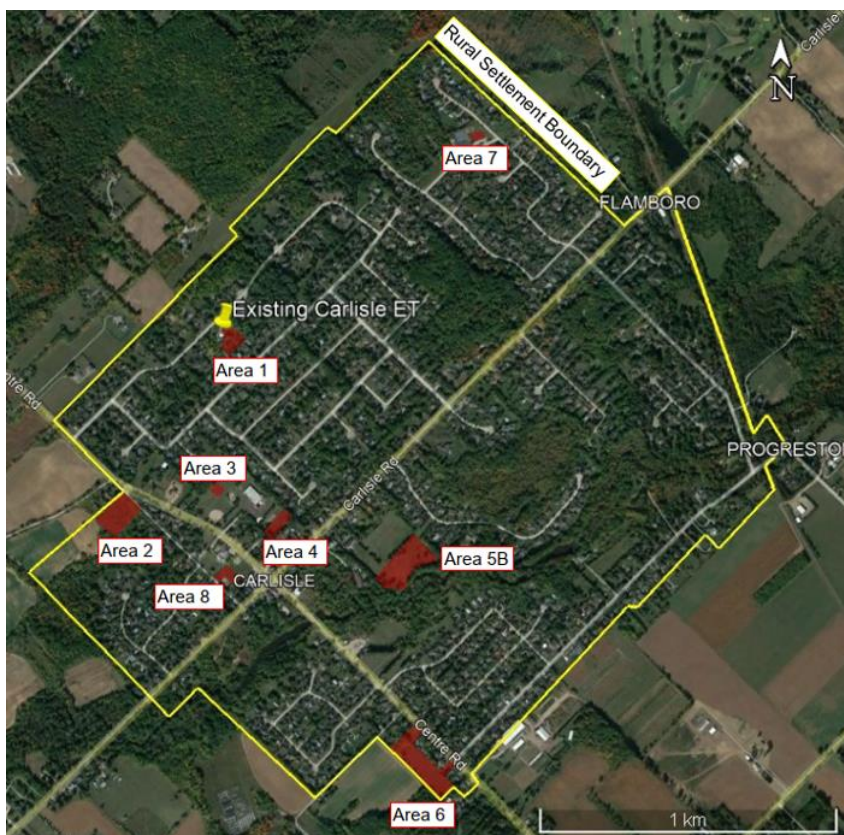
Figure 4.1 Long-List of Alternative Water Storage Site Locations

The following is a summary of the long list of alternative locations identified as part of this EA study. The long list of alternatives was identified based on initial screening for potential suitability and screened against pass or fail criteria to confirm feasibility before proceeding to a detailed evaluation for a shortlist of alternative sites. For an alternative to proceed, it had to pass all three criteria.

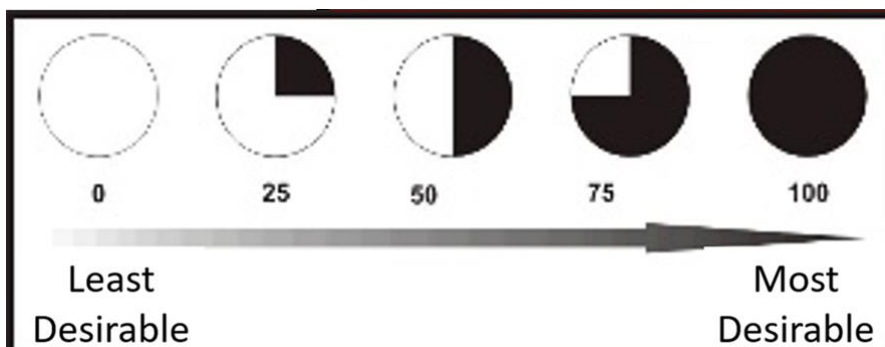
preferred solution(s). Figure 5.1 demonstrates the rating scale used in the evaluation of alternative locations and water storage systems described below.

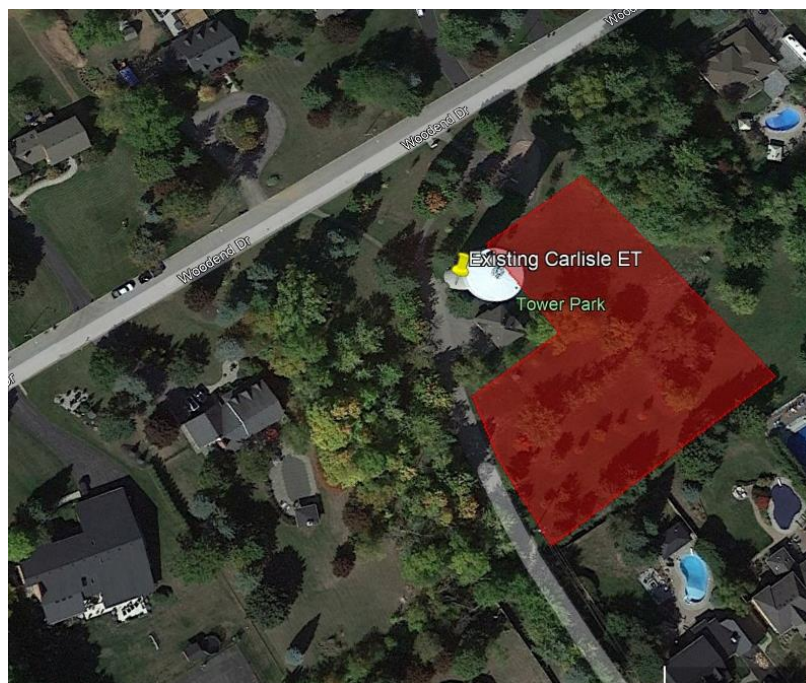
Figure 5.3 Area 1: Tower Park

As previously mentioned, Tower Park is located on City owned property off Woodend Drive and is already connected to the existing water supply system. Tower Park can be easily accessed from Acredale Drive or through a new access from Woodend Drive. It is located in a community park in between residential homes and can accommodate an above-ground or below-ground water storage facility. This site could support the construction of a new facility to replace the existing tower or accommodate an additional facility to provide the required storage.

The recommended location for the future water storage facility is Area 1: Tower Park, which is the location of the existing elevated water tank. This is the preferred location as there is existing driveway access and pipe network on the property. The property is owned by the City, which is generally preferable to purchasing private property as it reduces costs associated with acquiring land. Tower Park is located on higher ground and therefore meets the hydraulic (water pressure) requirements. Tower Park is located in an urban area on a disturbed site, thus reducing impacts to natural environment. Additionally, there are lower construction costs with this location in comparison to the Area 2: William Street at Centre Road.
