## **Carlisle Water Storage Study**

Project File Report

December 10, 2024

RVA 215933

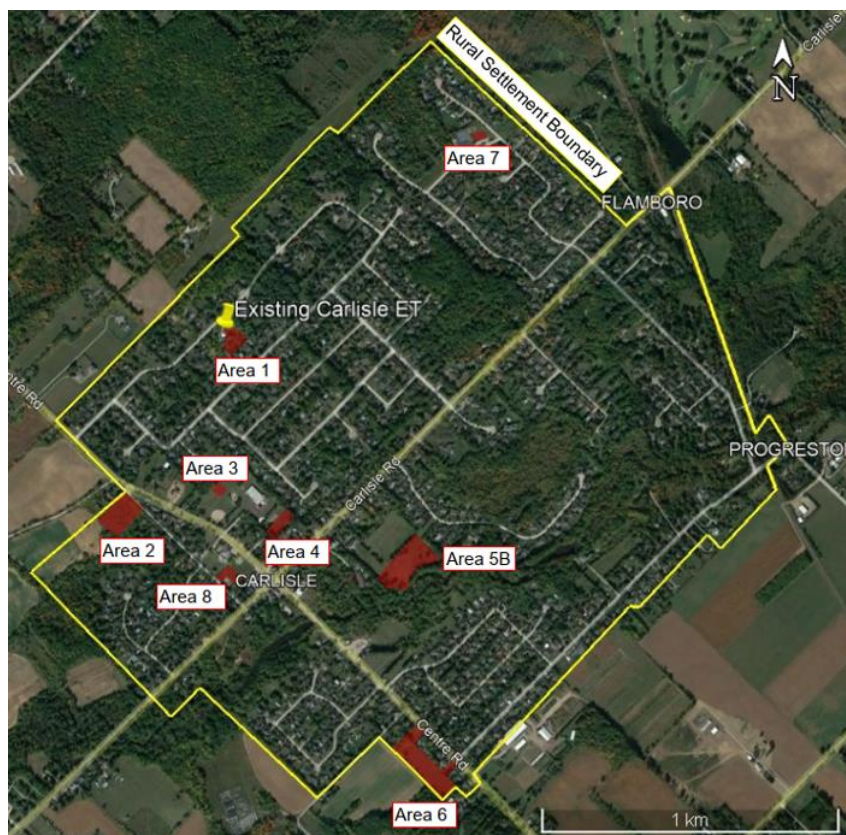
Figure 4.1 Long-List of Alternative Water Storage Site Locations

The following is a summary of the long list of alternative locations identified as part of this EA study. The long list of alternatives was identified based on initial screening for potential suitability and screened against pass or fail criteria to confirm feasibility before proceeding to a detailed evaluation for a shortlist of alternative sites. For an alternative to proceed, it had to pass all three criteria.
